Inventory Sheet for River/Channel

Station: From KM305 to KM306 **Sheet No.: CH- KM 305**

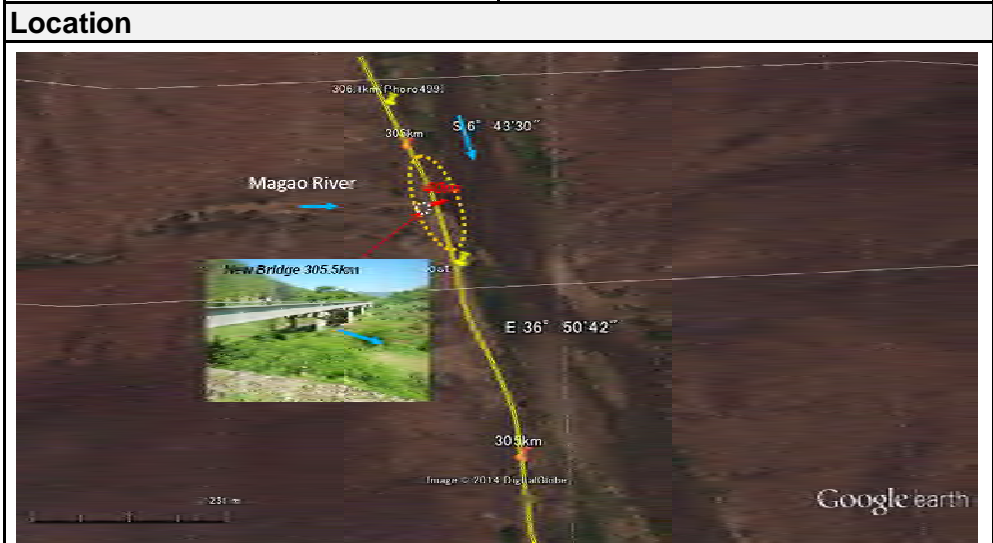
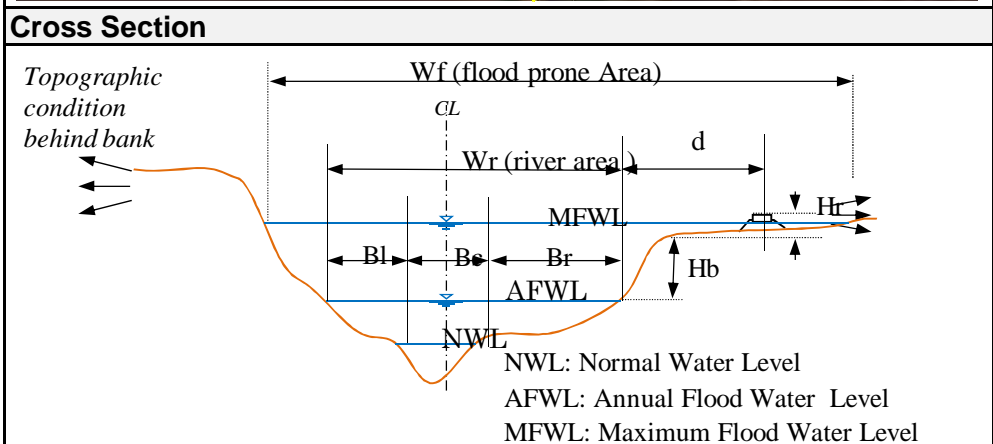
Photo Upstream	Photo Downstream

2-18	Damaged Record, if any (year/month)	The bridge of right side tributary had been broken by flood in 2010. The bridge had been rebuilt.
2-19	Reason of	
2-20	Pattern of Riverbed

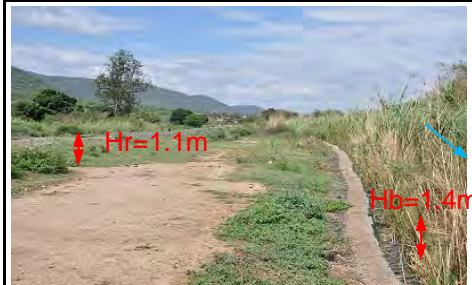
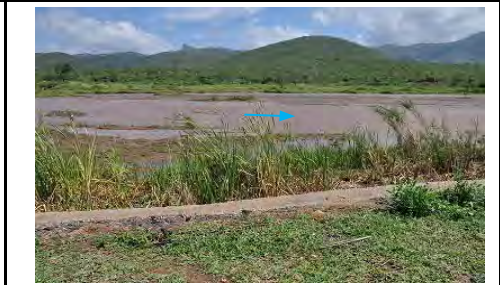
Photo Upstream **Photo Downstream**

2-18	Damaged Record, if any (year/month)	After damaged by 2010 flood, 2 steps of gabions were constructed.	
2-19	Reason of	Bank erosion	
2-20	Pattern of Riverbed	Rising of riverbed in long distance

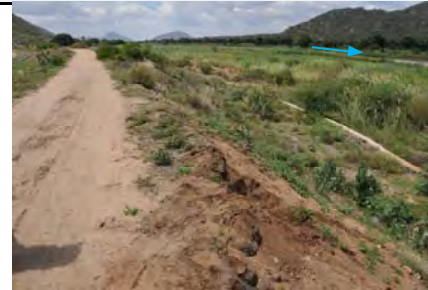
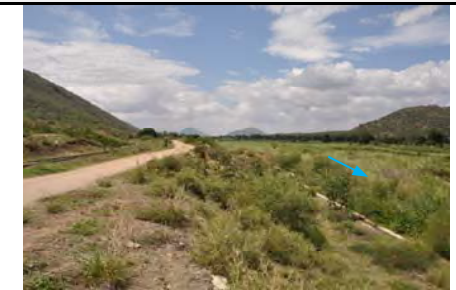
2-18	Damaged Record, if any (year/month)	Gabions (2 steps) are installed for bank protection of low water channel in the 500m section and at outlet of culvert.
2-19	Reason of	
2-20	Pattern of Riverbed

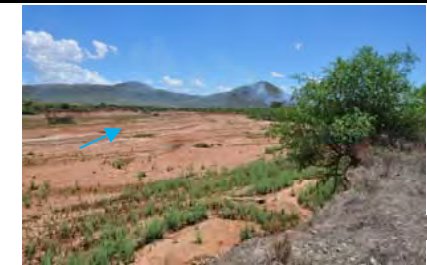
2-18	Damaged Record, if any (year/month)	Frequently damaged in the past, and diversions of track were carried out many times. 2014: bank erosion
2-19	Reason of	<u>Bank erosion</u> , Overflow, Sliding,
2-20	Pattern of Riverbed	Rising of riverbed in long distance

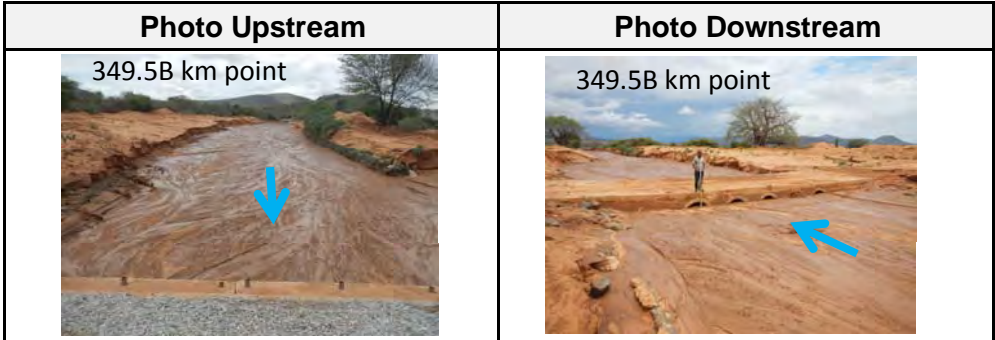
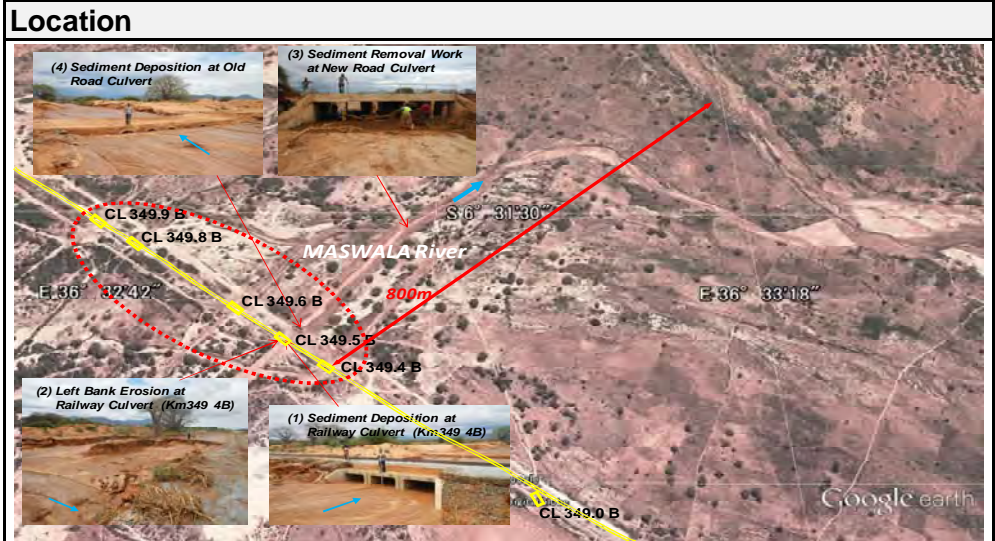
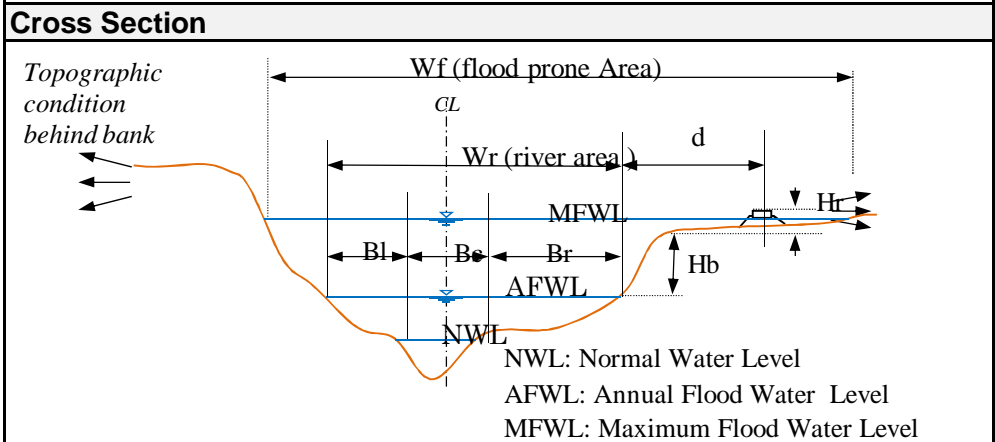
2-18	Damaged Record, if any (year/month)	Culverts of the railroad have been deposited by the sediment in the tributary MASUWALA RIVER, and river flow prevention has been occurred . The railroad bank has been scored by the	
2-19	Reason of	Flood flow overtopped railway track	
2-20	Pattern of Riverbed

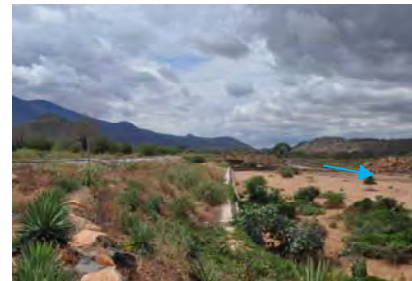
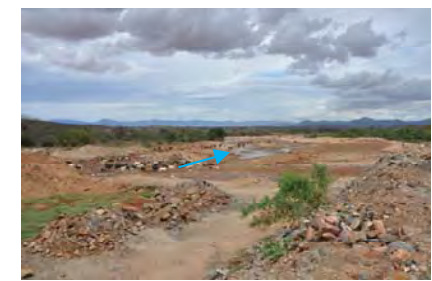
2. Characteristics of Physical Condition of River Channel			
2-1	Length of Objective Area	KM354.9-355.2	
2-2	Nos. of River	Gabion, culvert (1), bridge(1)	
2-3	River Channel Alignment	Straight, water hit area	
2-4	River Cross Section	compond	
2-5	River Width	Wf: m, Wr:300-600 m	
		Bl: m, Bc: m, Br: m	
2-6	Riverbed Slope	Gentle	
2-7	Riverbed Material	Material	Sand
2-8	River Bank	Bank Height	Hb: 4.0 - 5.3m
2-9		Side Slope	Sl: 1v: , Sr: 1v:
2-10		Vegetation	none
2-11	Estimated Flow Velocity	normal: 0 m/s, flood	m/s
2-12	Characteristic of environmental condition of river channel	Riverside forests, Sandbar, Pool, shoal, fishes, etc	
2-13	Land Use	none	
2-14	Soil Type	yellow color soil	
2-15	Topography	left: ← ,right →	
2-16	Structures/Houses, road	none	
2-17	Location of Railway	d=22mpkm355.1	
2-18	Damaged Record, if any (year/month)	After 2010 flood, gabion were insatalled. Boulders are delivered from Gulwe, and sands are extracte neare site.

2-19	Reason of	Bank erosion & overflow	
2-20	Pattern of Riverbed
