## **APPENDIX F**

### **INVENTORY SHEET OF CULVERT**

## Inventory Sheet for Culvert

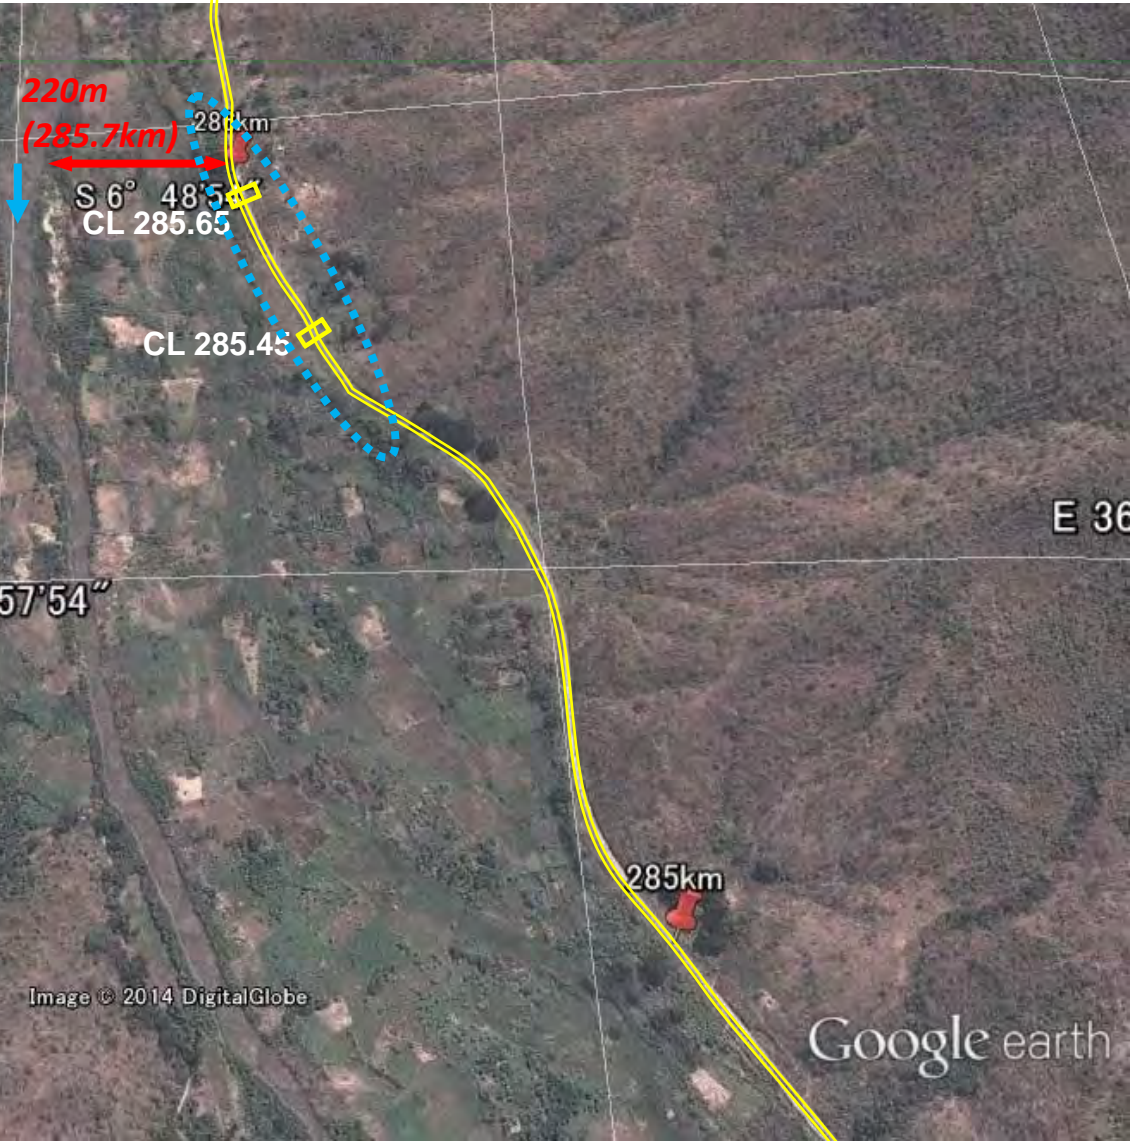
- The sediment depositions of two Culverts are slight.
- It is important to continue monitoring of deposition situation and to study a countermeasure if needed.

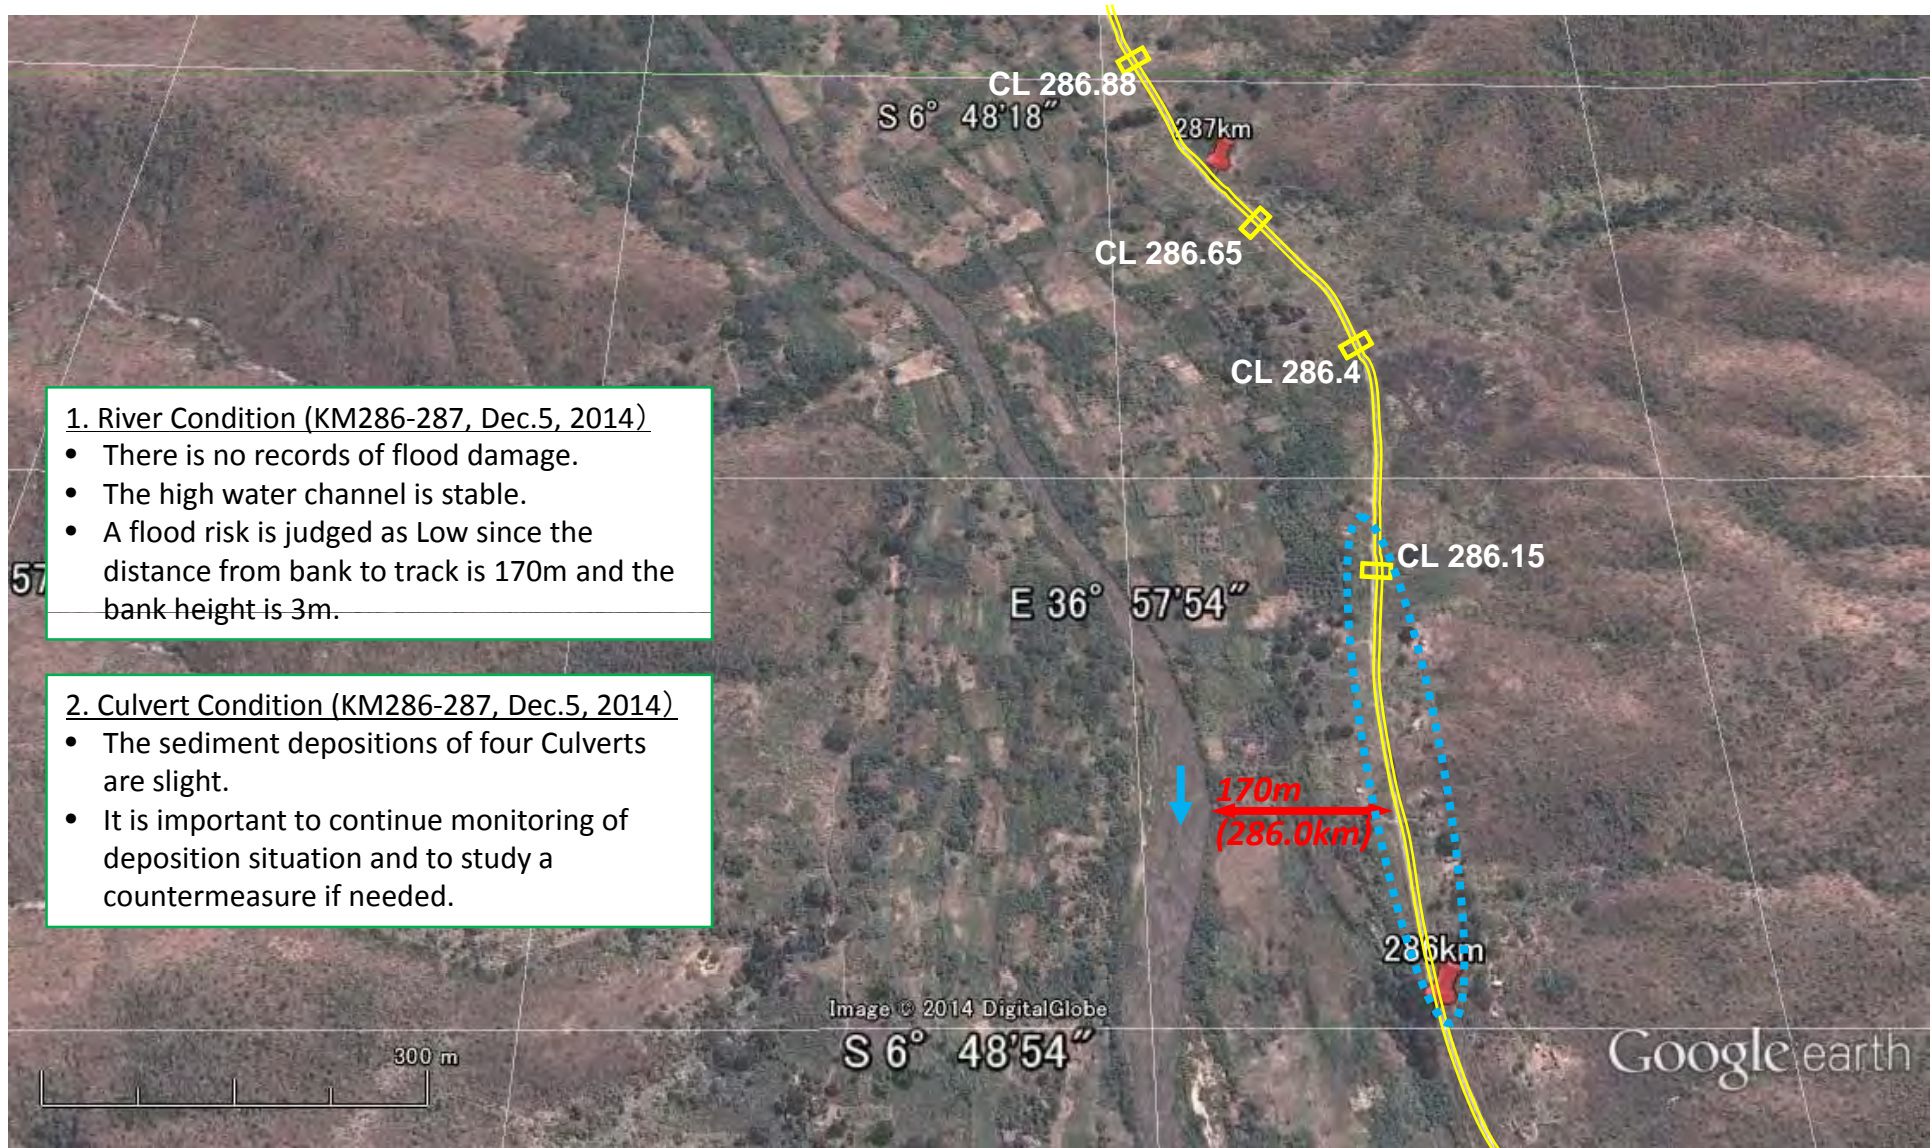
- The sediment depositions of four Culverts are slight.
- It is important to continue monitoring of deposition situation and to study a countermeasure if needed.

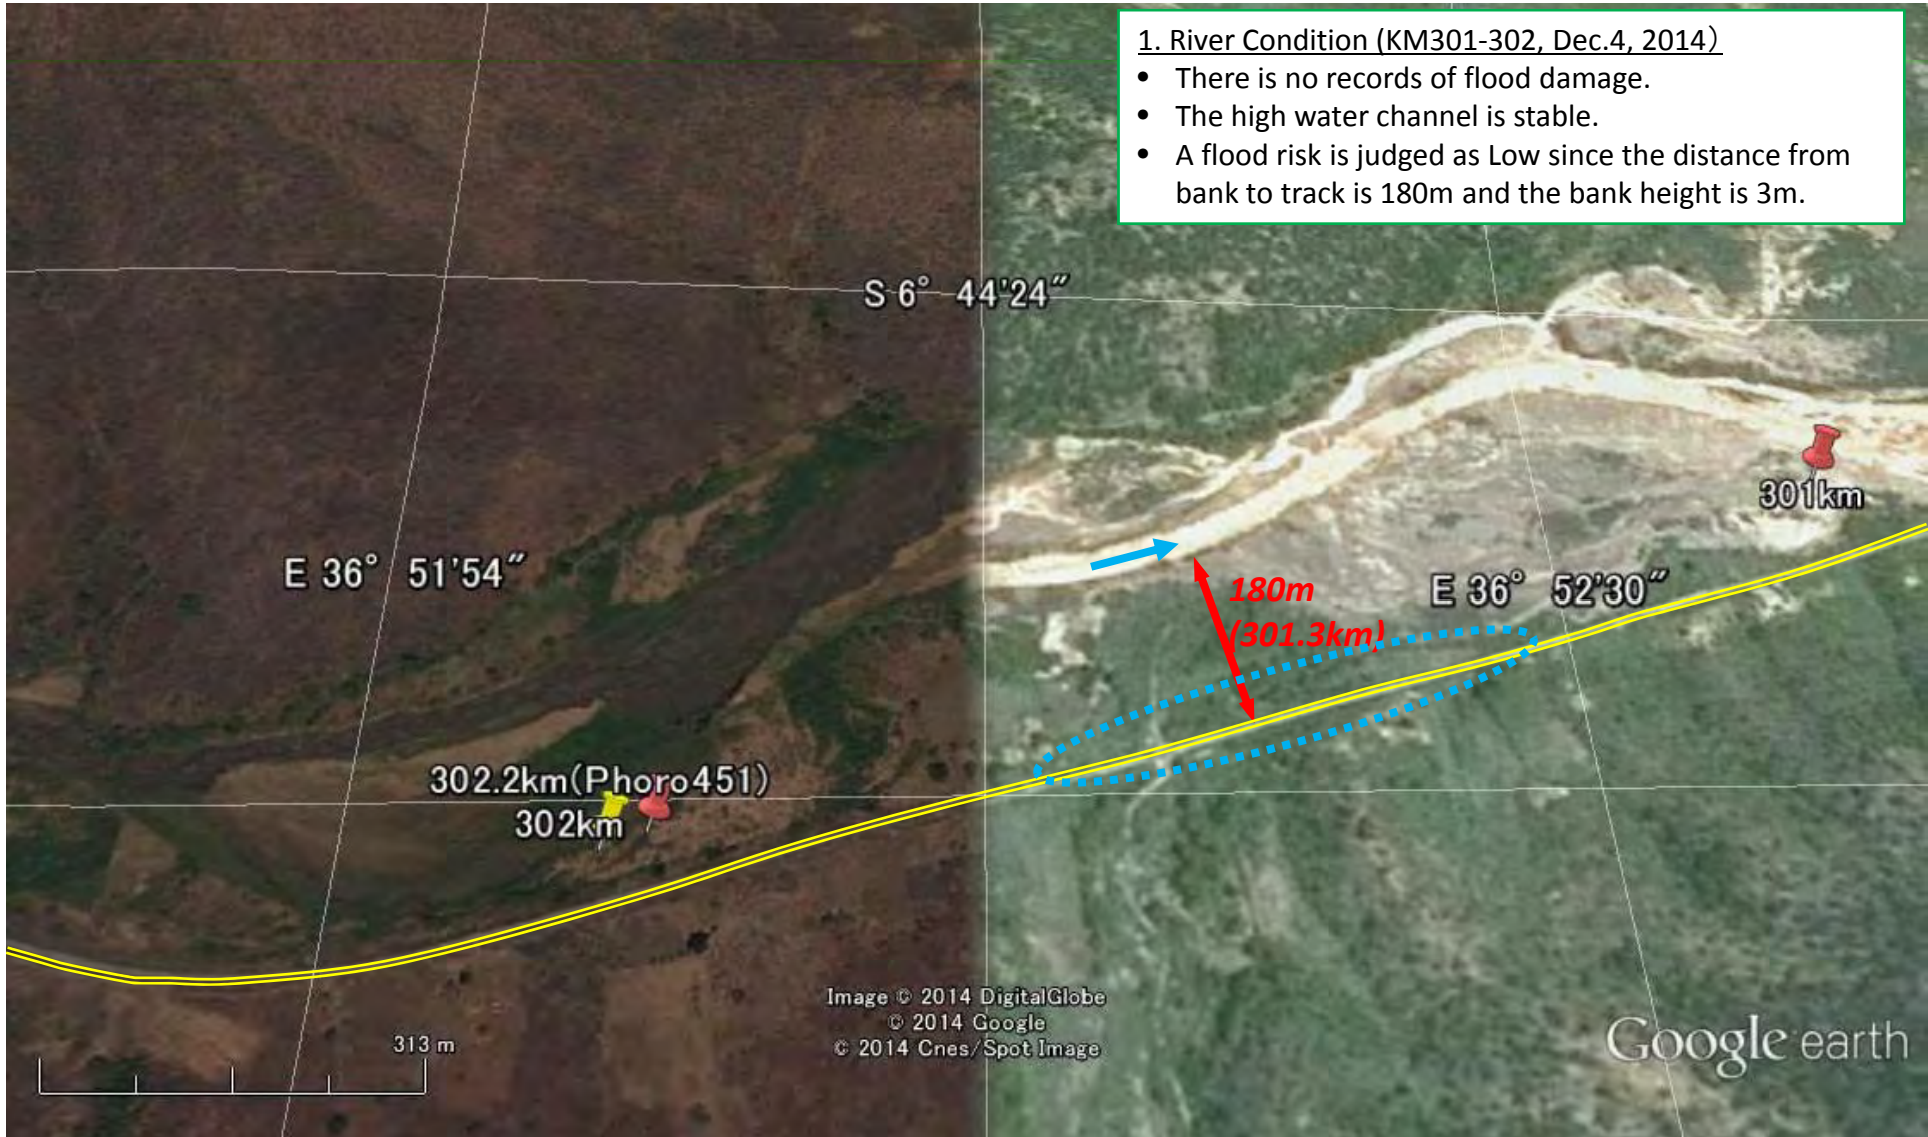
- There is no records of flood damage.
- The high water channel is stable.
- A flood risk is judged as Low since the distance from bank to track is 180m and the bank height is 3m.

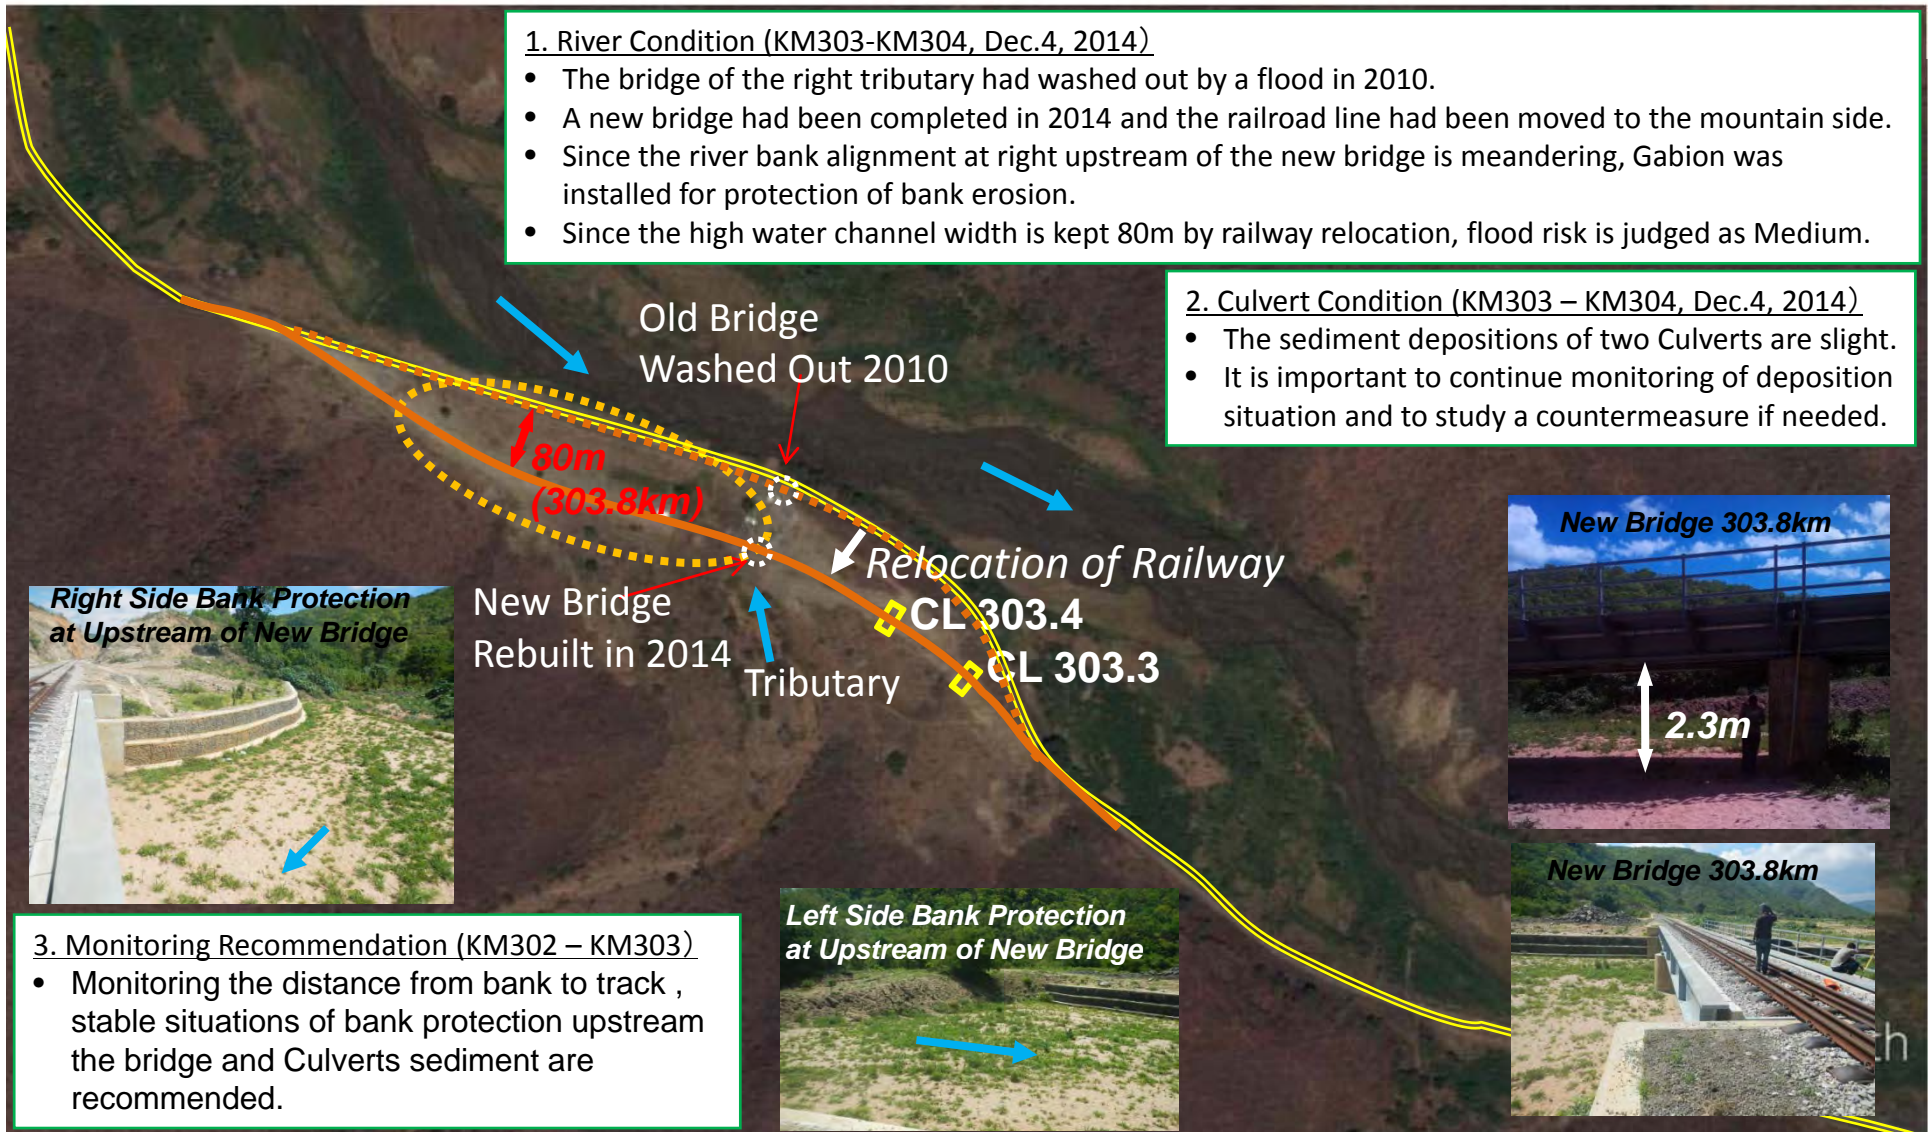
- The sediment depositions of two Culverts are slight.
- It is important to continue monitoring of deposition situation and to study a countermeasure if needed.

- 3. Monitoring Recommendation (KM302 – KM303)**
- Monitoring the distance from bank to track , stable situations of bank protection upstream the bridge and Culverts sediment are recommended.

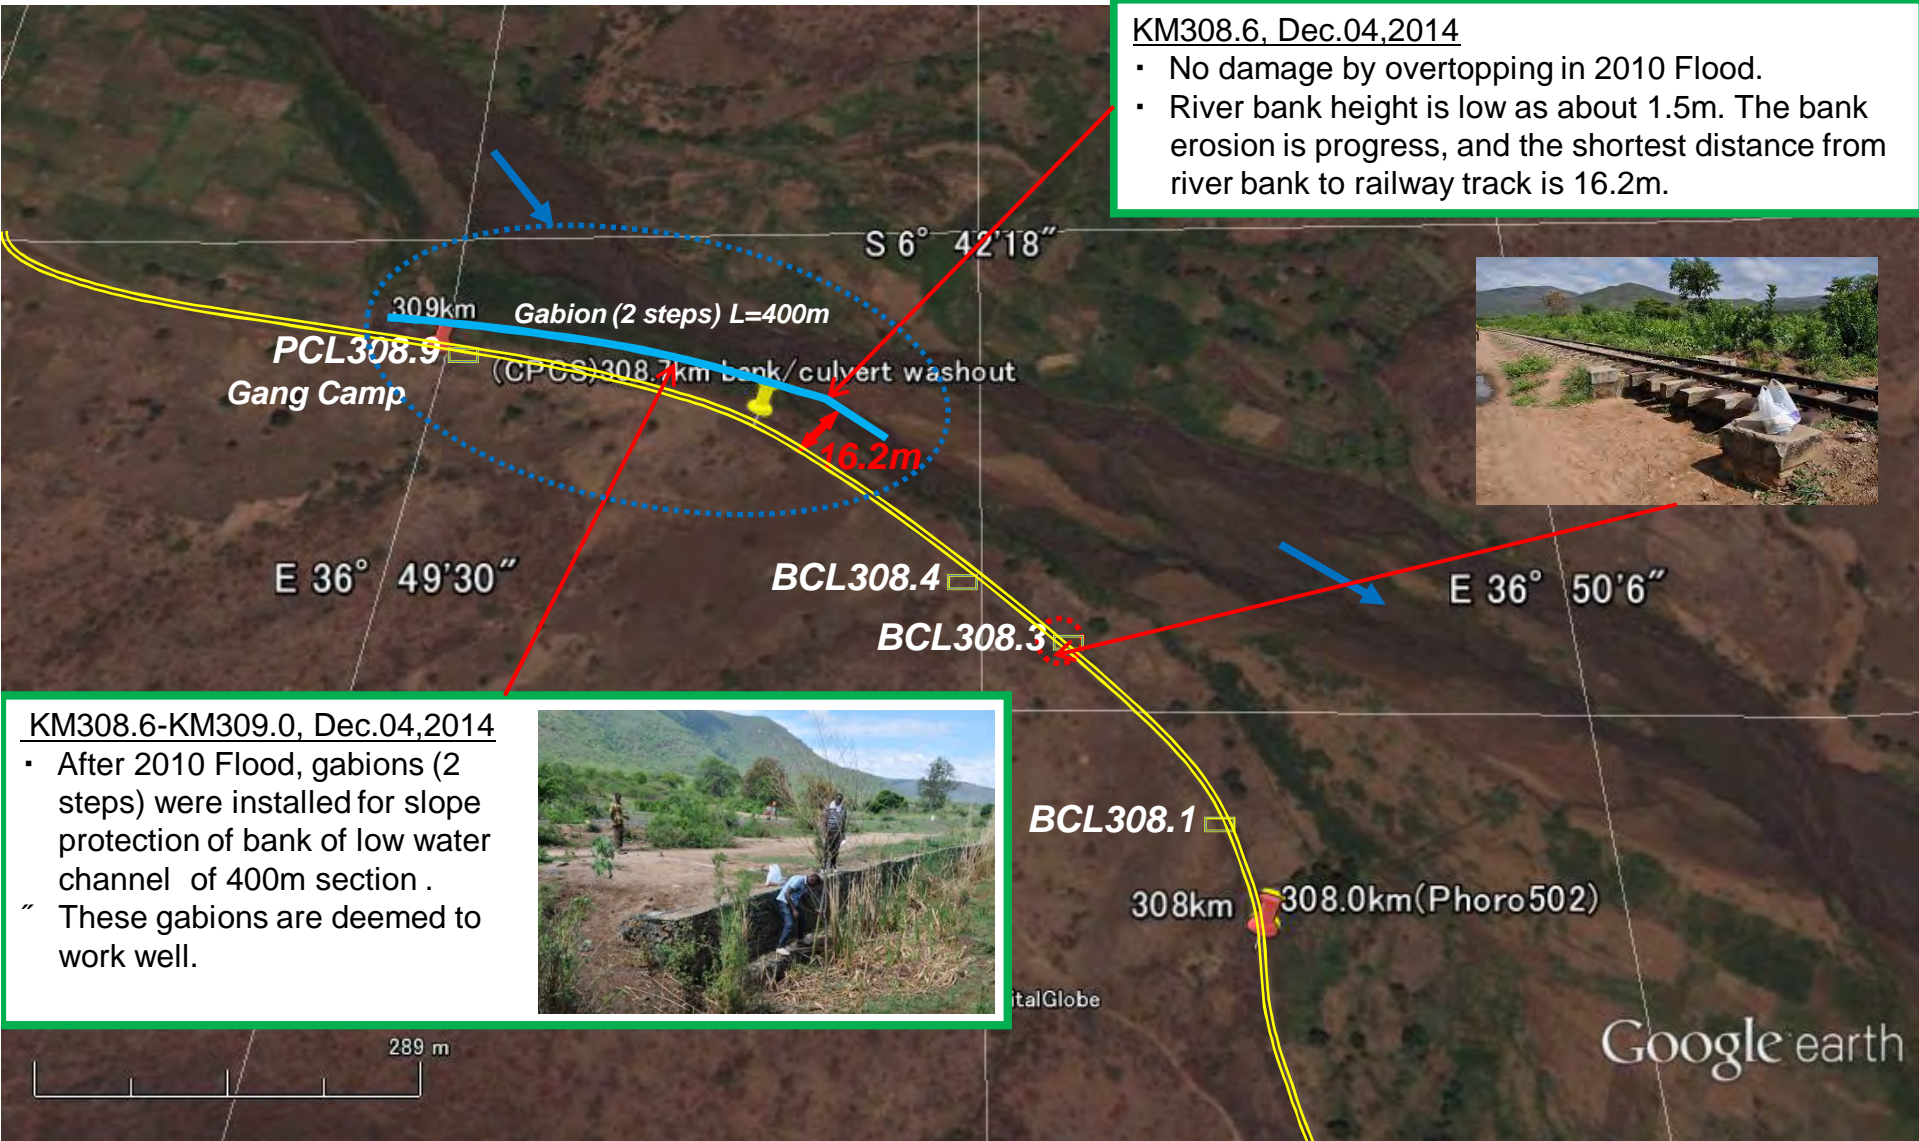
- No damage by overtopping in 2010 Flood.
- River bank height is low as about 1.5m. The bank erosion is progress, and the shortest distance from river bank to railway track is 16.2m.

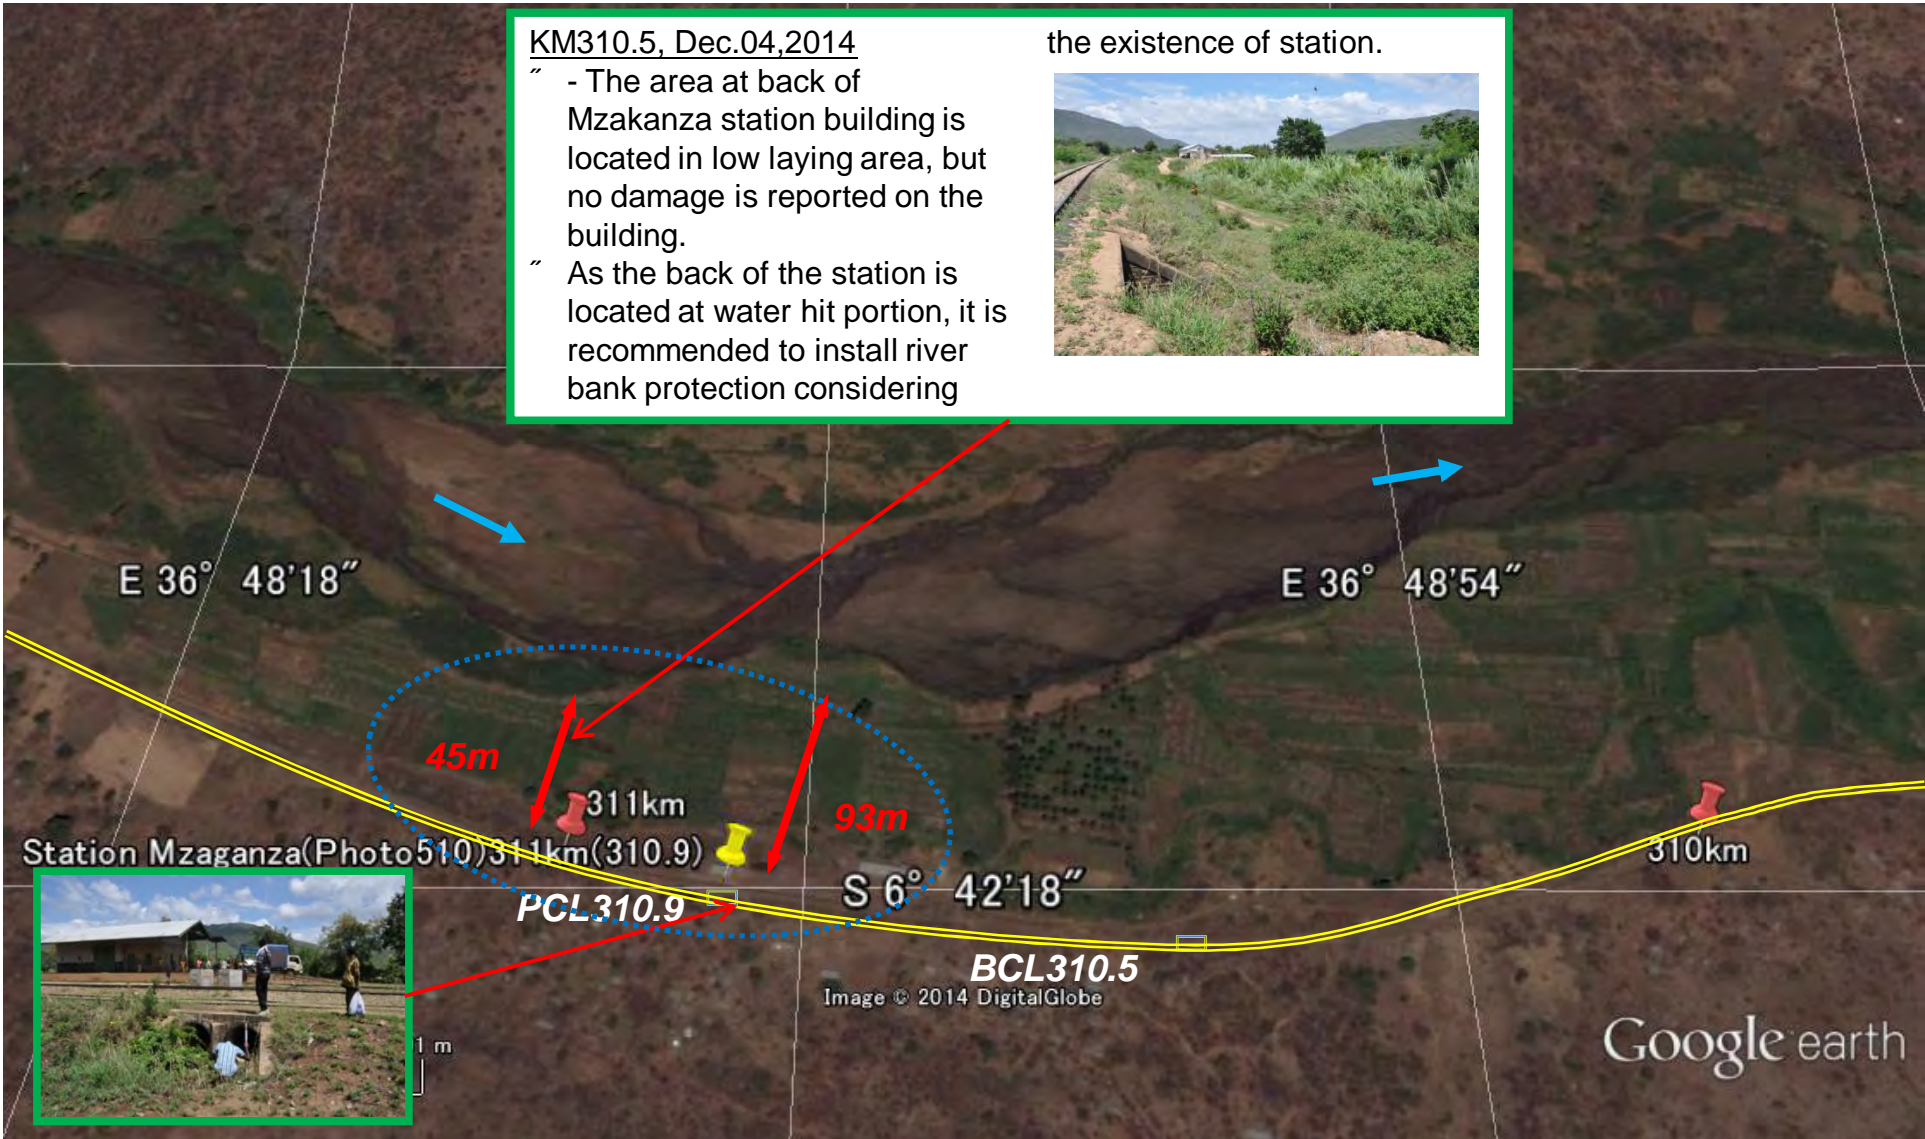
KM310.5, Dec.04,2014  
 " - The area at back of Mzaganza station building is located in low laying area, but no damage is reported on the building.  
 " As the back of the station is located at water hit portion, it is recommended to install river bank protection considering the existence of station.

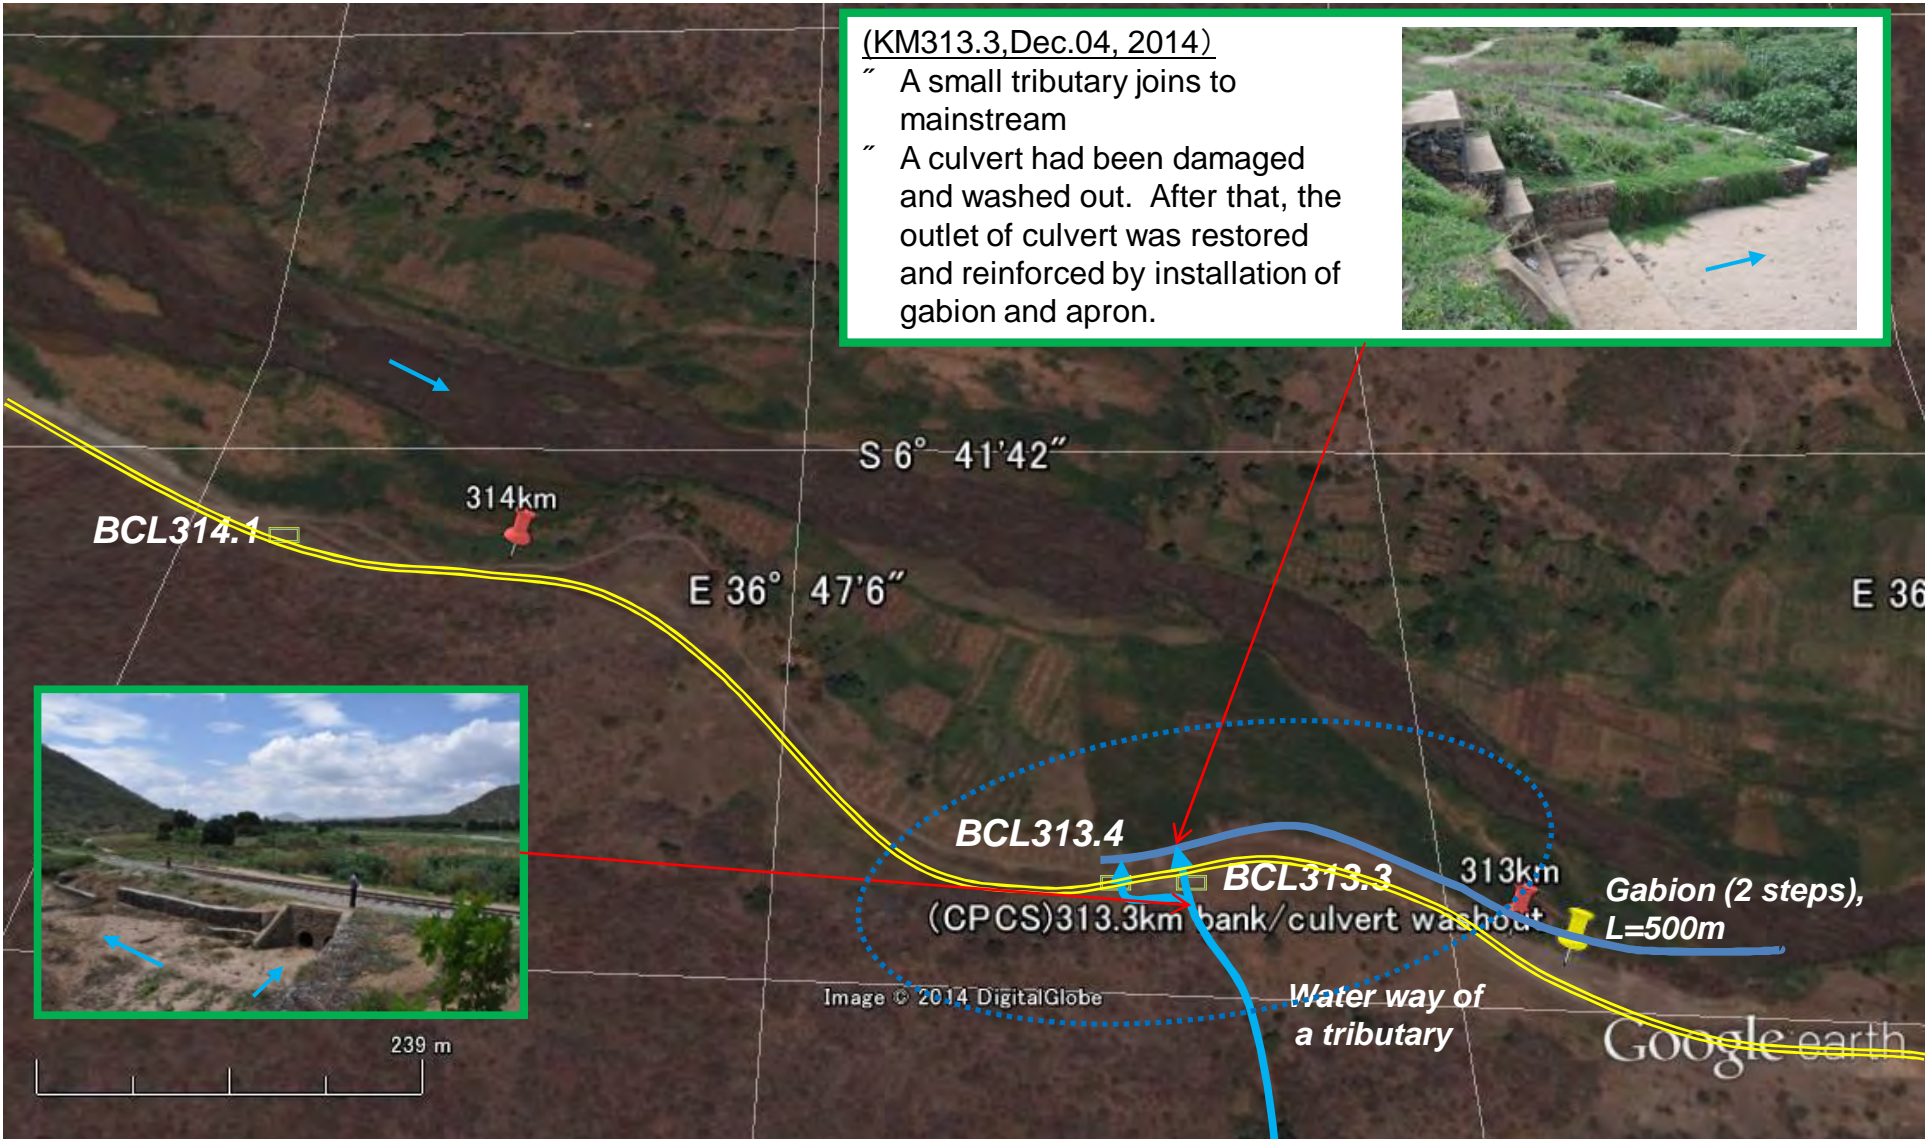
(KM313.3, Dec. 04, 2014)  
" A small tributary joins to mainstream  
" A culvert had been damaged and washed out. After that, the outlet of culvert was restored and reinforced by installation of gabion and apron.

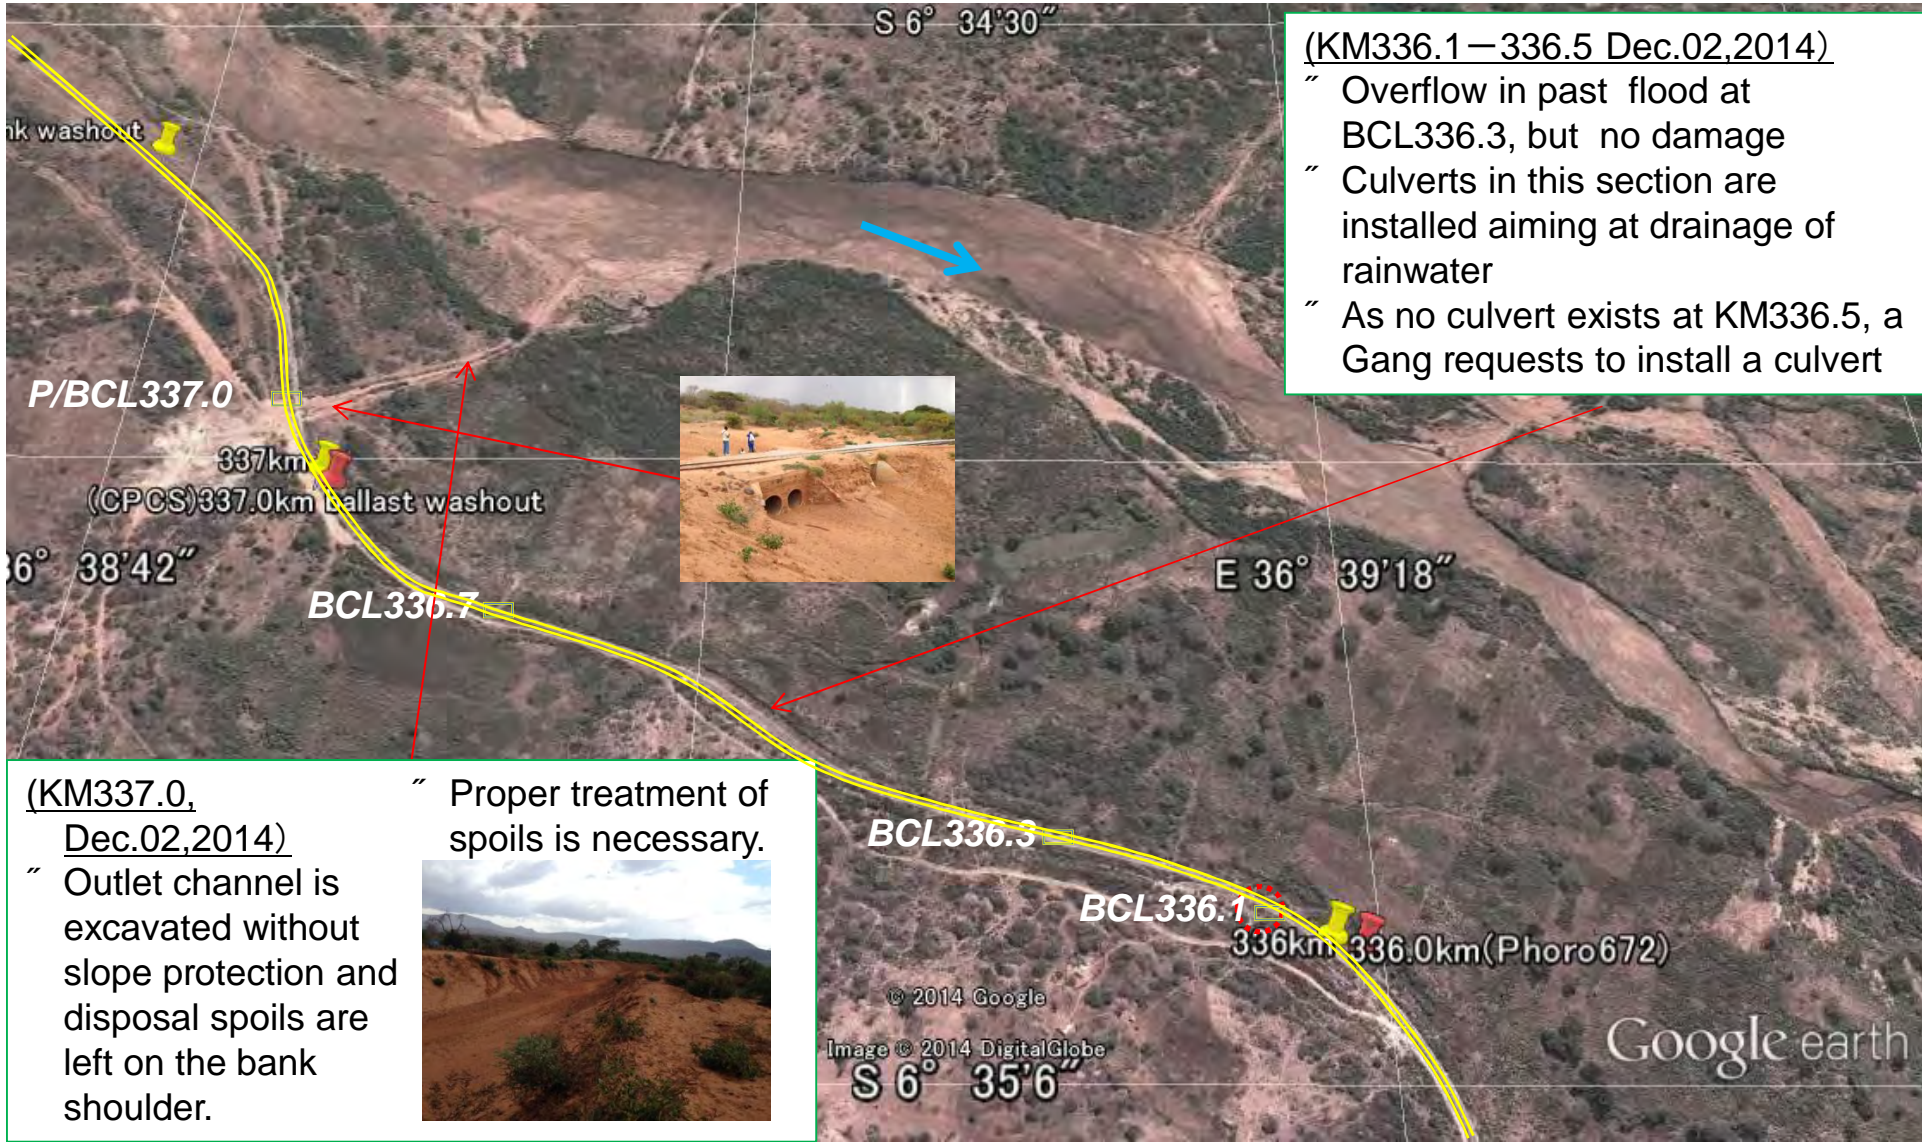
(KM336.1 – 336.5 Dec.02,2014)  
 " Overflow in past flood at BCL336.3, but no damage  
 " Culverts in this section are installed aiming at drainage of rainwater  
 " As no culvert exists at KM336.5, a Gang requests to install a culvert
