**Preparatory Survey on  
Flood Protection Measures for  
Central Railway Line  
in the United Republic of Tanzania**

**Final Report  
Volume 1: Main Text**

**July 2016**

**JAPAN INTERNATIONAL COOPERATION AGENCY**

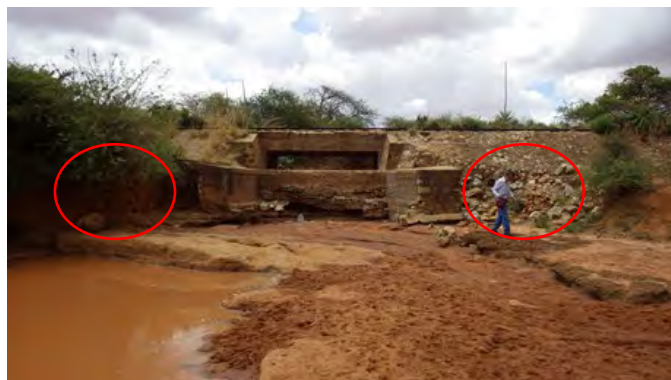
If an embankment supporting a track is destroyed, railway operations will be stopped for a long period. In the site survey, the Study Team found several places where the risk of embankment destruction is high due to erosion from running water. In many places, running water hits embankment slopes beside culverts and bridges (Source: JICA Study Team Figure 3.16). Embankment destruction may possibly occur at those places in the future.

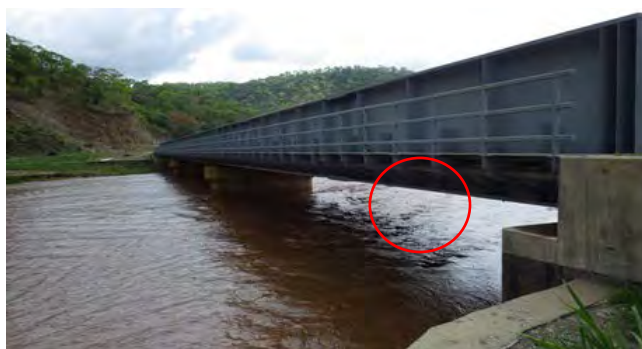
Figure 3.17 shows a small clearance between the river water level and the soffit of the bridge girder, and this presents a possibility of the bridge being washed away when water levels rise. It is necessary to confirm the height of under the girder, and high water marks will be verified in the course of future investigations.

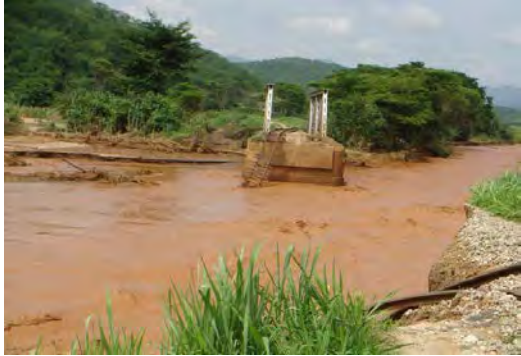
<b>Pattern 1: Flood damages from the main stream (Kinyasungwe River)</b>	
<p><b>Pattern 1-1:</b> Washaway and/or scouring of bridges foundations. An example at Km 293</p>

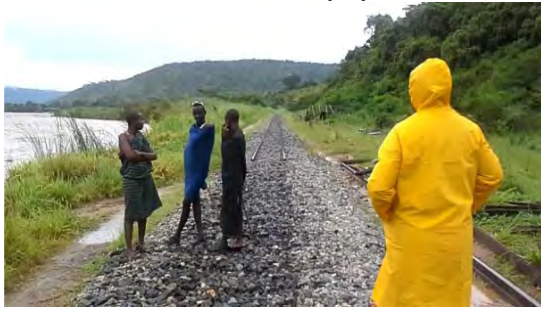
<p><b>Pattern 1-3:</b> Washaway of the track and/or water/mud flowing over the track An example at Km 302 (toward Kilosa) The track was washed away by the flood.</p>

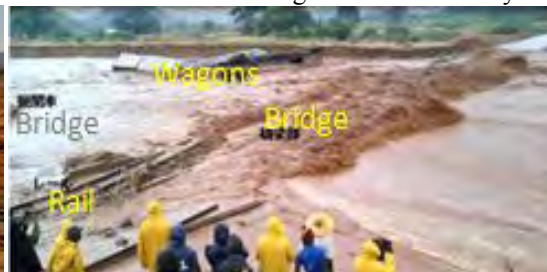
Km 349 (4B - 7C) Maswala Section  
Overtopping flood damaged the track.

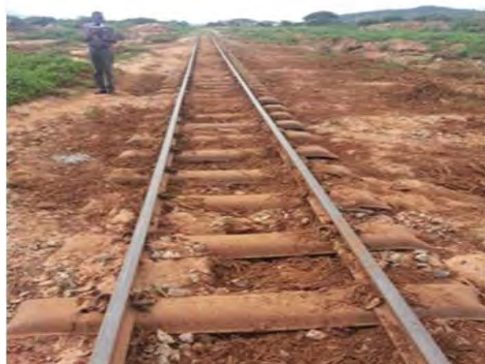
**Pattern 2-2: Damage of the track embankment**  
An example at Km 378.5

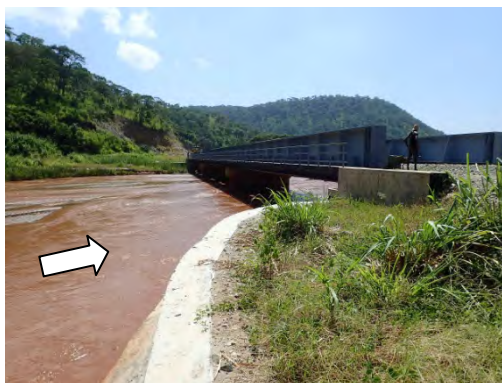
**Figure 5.9: Completed New Bridge  
at km 293**

No significant change at the section of new bridge crossing was observed upon inspection on 11 February 2015 with TRL Dodoma staff.

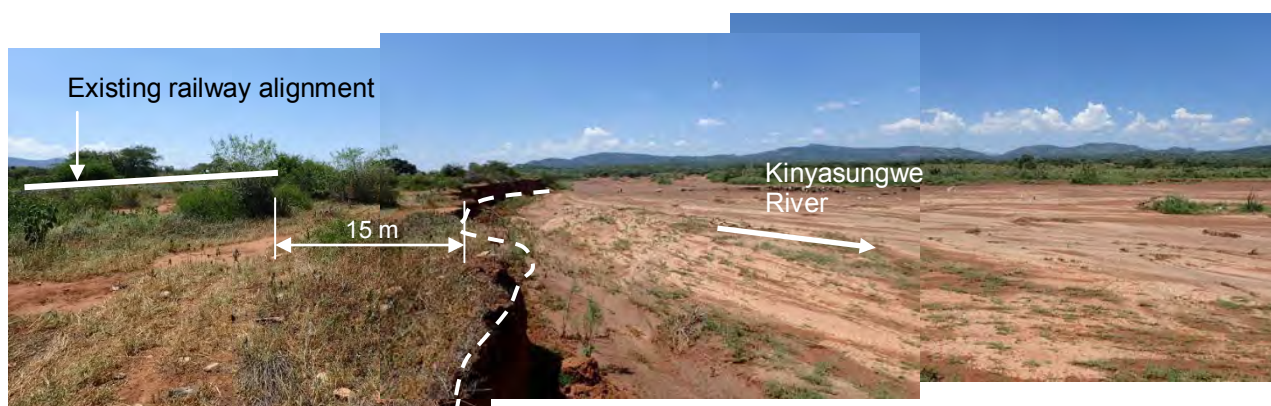
**Figure 5.15: Panoramic View toward Upstream at Km 337.4 (11 Feb. 2015)**

In December 2014, among the stretches excluding the section where restoration works were undertaken by TRL, this site was considered to be the most crucial portion susceptible to bank erosion caused by directly hitting of floodwaters. The riverbank at Km 337.4 remained at a distance of about 15 m in February 2015, as shown below:

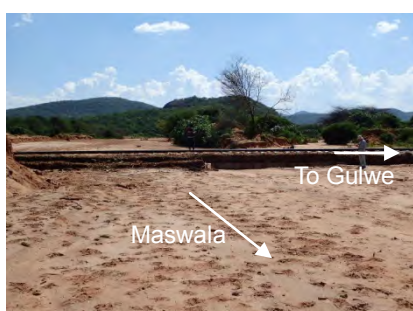
**Figure 5.16:**  
**Near CL349.5B**  
**(buried)**

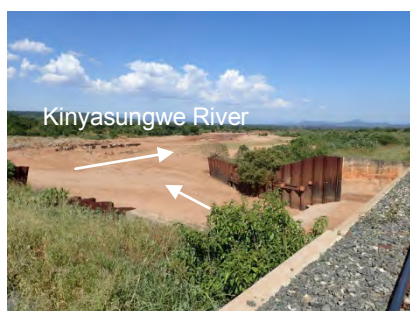
The Kidibo River meets with the Kinyasungwe River at Km 355.0. The existing railway crosses the Kidibo River just upstream of the confluence. The river channel downstream of the Kidibo is protected by steel sheet piles to protect from bank erosion at both sides. Although sediment deposition in the Kidibo River seems progressive, no serious damage to the structures can be confirmed. The span of the Kidibo Bridge is rather short compared with the river channel width of the upstream stretches. Therefore, the bridge section makes an unfavorable bottleneck and forces the water level to rise in the upstream stretch during floods. Further, since the Kidibo flows into the Kinyasungwe at almost a right-angle, channel improvements to make more smooth flow will be necessary.

**Figure 5.19:**  
**Confluence**  
**with Kinyasungwe**

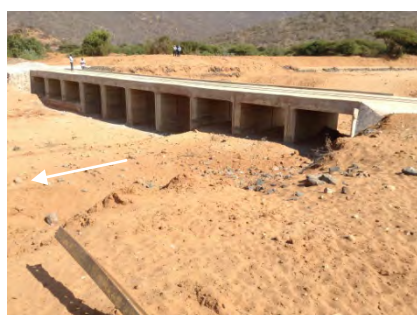
22 Jul. 2014 (1)

A serious accident happened on 28 March 2014 due to a flash flood of the Mzase River. Although the catchment area of the Mzase is rather small, huge sediment discharge brought about serious problems at this section. The following photos show the conditions of box culvert crossing the Mzase River on three different dates:
