## 7. Sediment Analysis

### 7.1 Natural Conditions

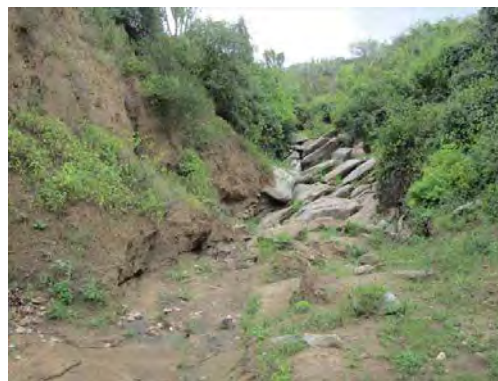
Deposition has No Structural  
Lake Deposit

Unnatural Contact with Slope

**Figure 7.16: Sediment Observed at the Kibakwe**

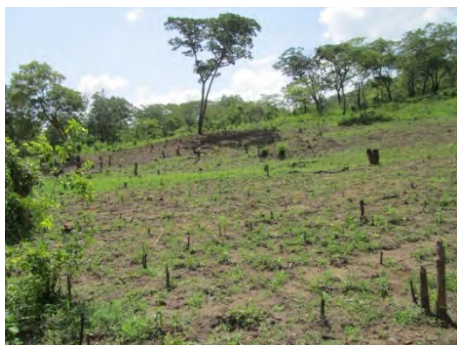
Although swidden cultivation (shifting agriculture) is conducted in places, obvious surface erosion is not observed (Figure 7.19A).

A: Swidden Cultivation (No Erosion)

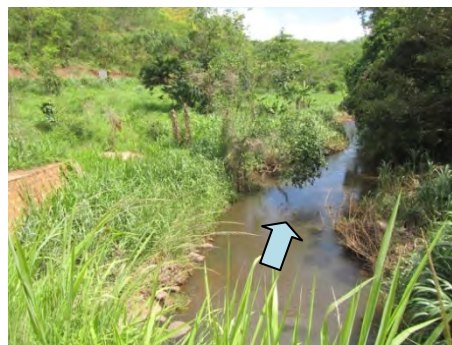
Streams in the mountain are mostly small and a slight sediment deposition is observed in the riverbed (Figure 7.19B).

B: Slight Sediment Deposition

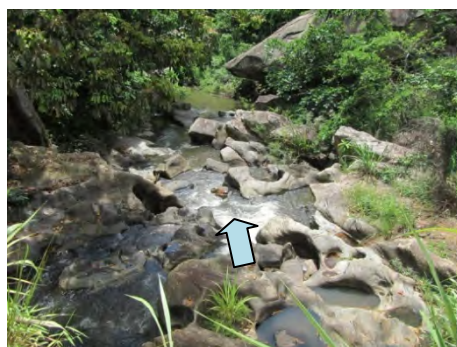
Outcrops of bedrock are observed in the riverbed and on the road cutting slopes of the Mdukwe watershed (Figure 7.20). The surface soil (topsoil) of slopes is very thin, or basically non-existent.

A: Outcrop of Bedrock (No Sediment)

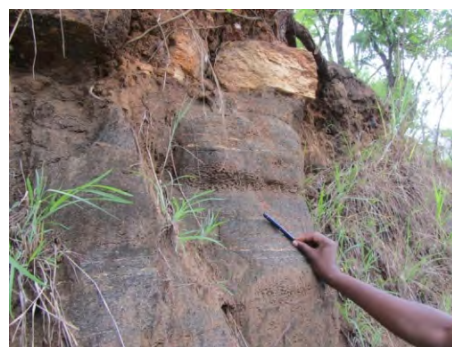
B: Outcrop of Sandstone

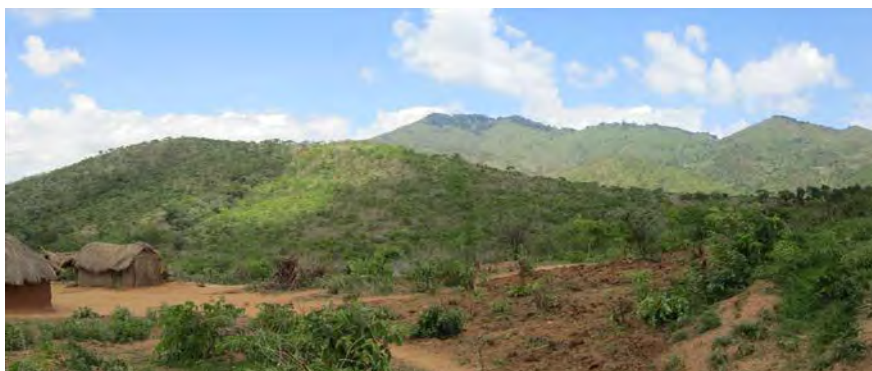
**Figure 7.21: Rounded Mountain Shape of the Watershed Boundary**

This site is located in the Lumuma watershed. The mountain shape of the watershed boundary is rounded by long-term erosion through the Quaternary. Although most of the trees in the mountains have been cut, the land surface is covered by vegetation. No slope failures are observed (Figure 7.21).

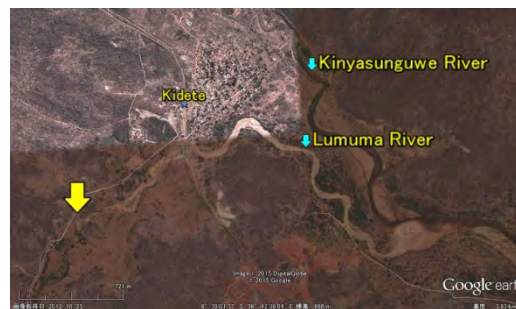
B: Remarkable Erosion  
Near River Confluence

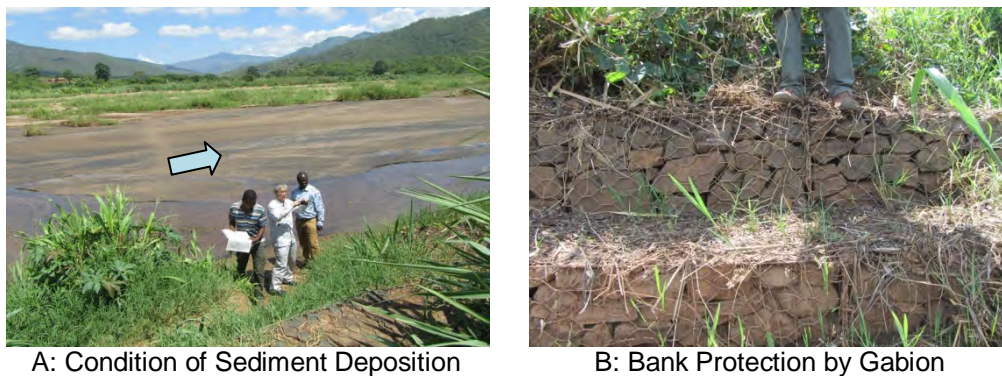
**Figure 7.24: Condition of Site Km 297.3**

This site is located at the right bank of the Mkondoa River (Km 297.3). The river width at this point is about 350 m. A great deal of sediment deposition is observed (Figure 7.24A), and gabion works are provided as bank protection (Figure 7.24B).

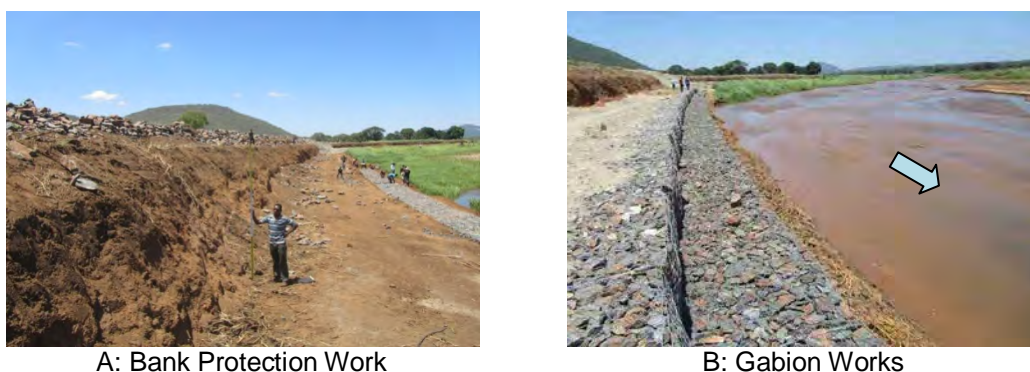
**Figure 7.25: Condition of Site Km 315.1**

This site is located at the right bank of the Mkondoa River (Km 315.1). The Mkondoa River meets the Kinyasungwe River 4.5 km upstream from this site. Riverbank erosion has been proceeding at this site (Figure 7.25A). The rate of erosion is approximately 180 meters over two years. Sediment discharge by riverbank erosion is presumed to be a supply source of sediment production in downstream areas. Bank protection works have been completed in February 2015 (Figure 7.25B).

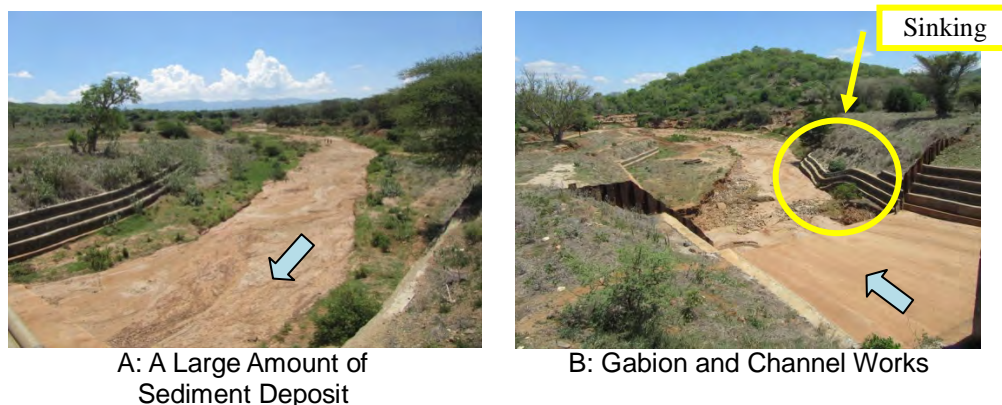
**Figure 7.26: Condition of Site Km 325.2**

This site is located downstream of the Lumuma River and near the confluence with the Kinyasungwe River (Km 325.2). The Lumuma River is a gentle river which does not have serious sediment deposition. However, remarkable riverbank erosion and sediment deposition are observed near the confluence with the Kinyasungwe River (Figure 7.26A). Sinking of revetments is observed at the downstream areas of the river channel works (Figure 7.26B).

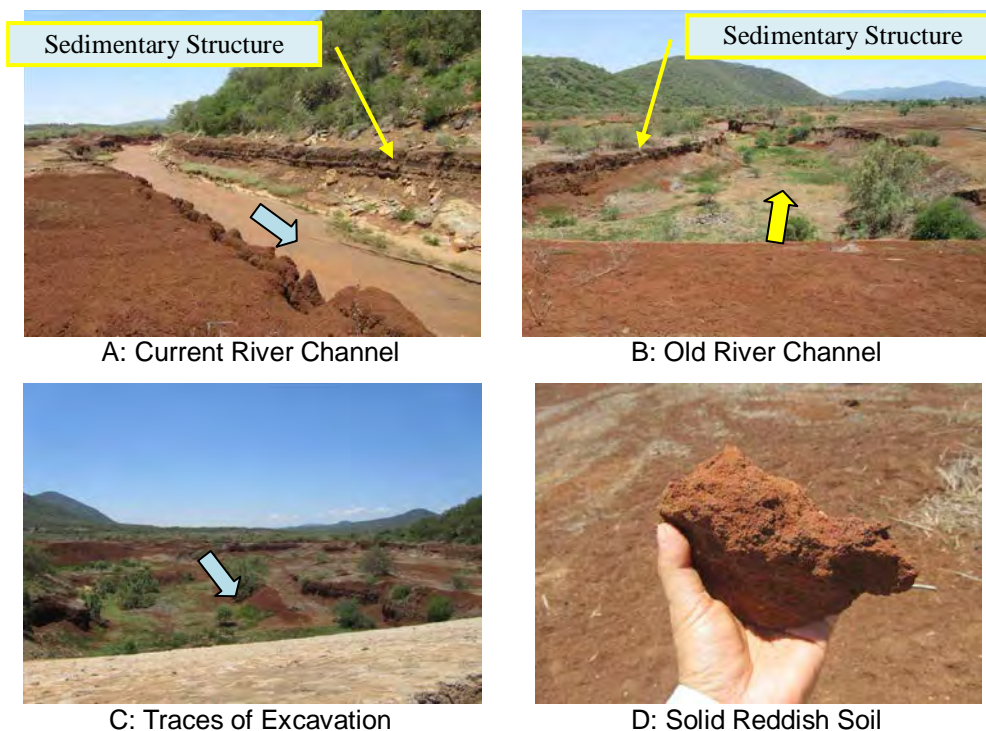
**Figure 7.27: Condition of the Kidete Dam Site**

This site is the Kidete Dam site, the construction of which is presently halted. Sediment deposition is not observed on the current riverbed (Figure 7.27A). An outcropping of bedrock is observed on the left bank. On the other hand, the old river channel remains downstream of the dam (Figure 7.27B). Additionally, the deposition of reddish soil is observed characteristically in both the upstream and downstream areas of the dam (Figure 7.27C). The deposition, which has a sedimentary structure, is observed on top of the existing reddish soil deposition (Figure 7.27D). The reddish soil deposition has a solid formation, but is not layered, indicating that the reddish soil deposition was transported all at once (a single flood event).

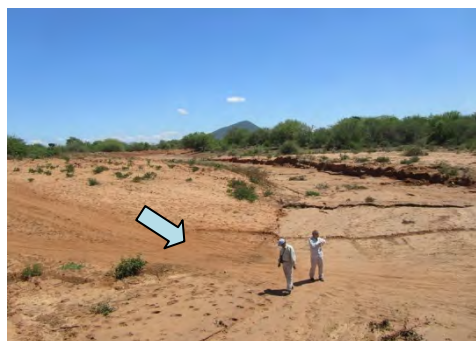
This site is located at the right bank of the Kinyasungwe River (Km 337.4). A wide river, forming a floodplain, expands in this section (Figure 7.28A). Lower terrace deposits by floods are observed along the riverbank. The material consists of sands, which are easily eroded (Figure 7.28B).

A: Sediment Deposition  
on the Wide Riverbed

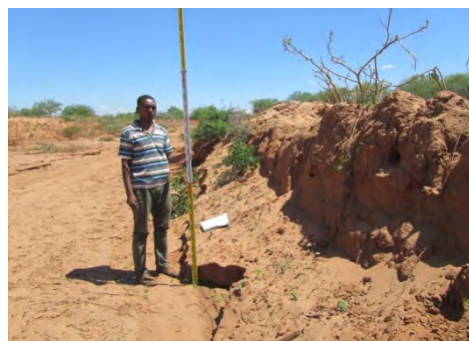
B: Lower Terrace Deposits  
along the Riverbank

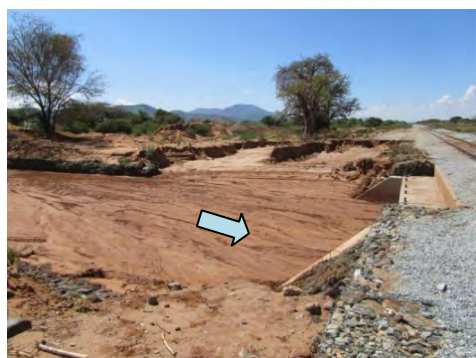
The adjacent areas of these sites are located about 1.5 km from Godegode Station. This section is located in the floodplain of the Maswala River. A great deal of sediment discharge is observed in the riverbed (Figure 7.29A). A thick deposition is spread over this area (Figure 7.29B). The box culvert of Site RW8 was open at the time of reconnaissance on 16 December 2014, but had been clogged by sediment at the reconnaissance time of 11 February 2015 (Figure 7.30A, B).

A: Condition of Remarkable Deposition  
(RW7)

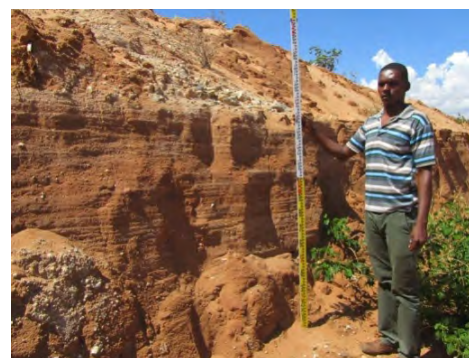
B: Deposition with Sedimentary  
Structure

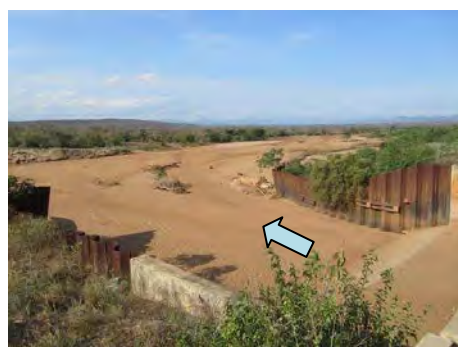
This site is located in the Kidibo River (Km 355.3), which is a right tributary of the Kinyasungwe River. Large areas of cultivated land exist in the upstream areas of the Kidibo River. Therefore, a great deal of sediment is presumed to have been flashed out from there. In this site, channel works were constructed (Figure 7.31A). A large floodplain is observed in the immediate upstream section of Site RW9, and remarkable riverbank erosion is observed along the right bank (Figure 7.31B). On the other hand, the left bank was protected by revetment works (Figure 7.31C, D).

A: Existing Channel Works  
(Condition of Confluence)

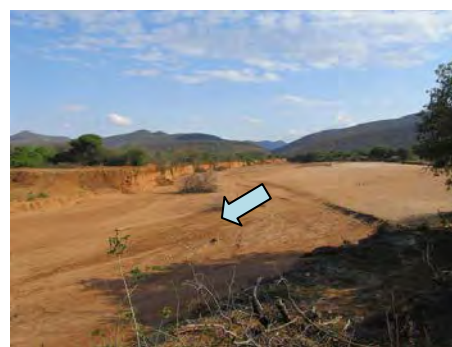
B: Remarkable Riverbank Erosion

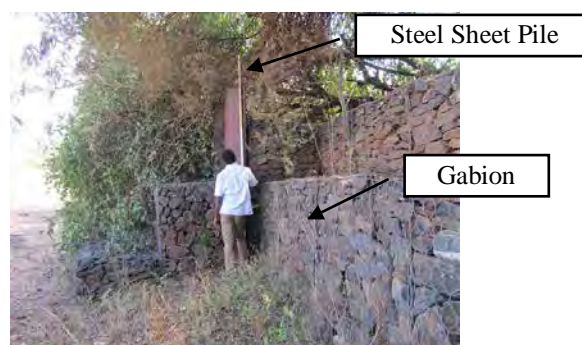
D: Revetment Works along Left Bank

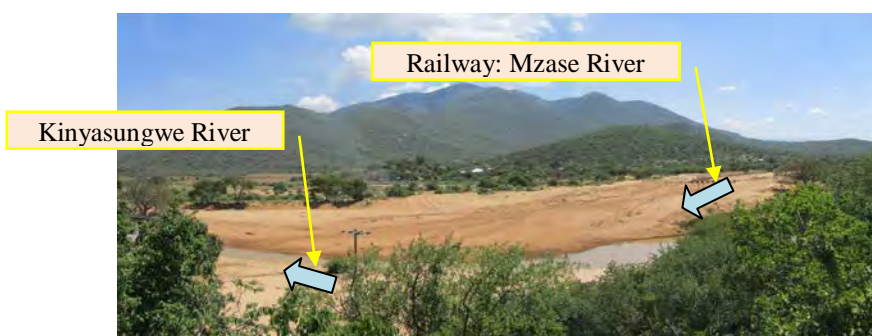
C: Sediment Deposition at the Confluence

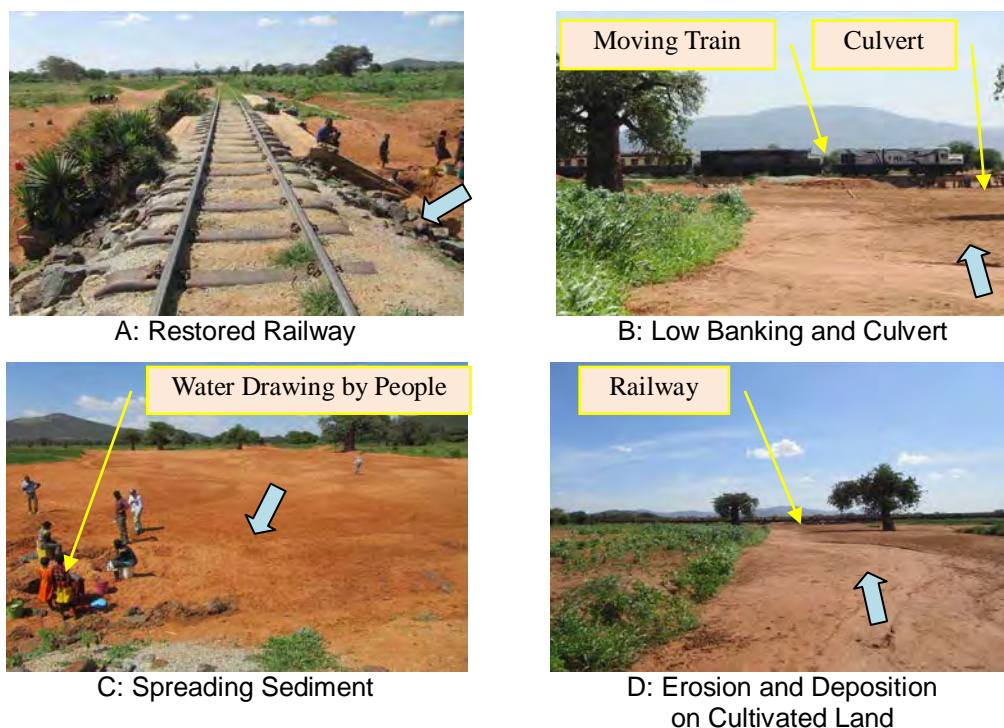
**Figure 7.34: Condition at Igandu Area**

This site is located near Igandu Station. This small watershed area has a very gentle slope. The height of the railway banking is low against the riverbed. Therefore, the bottoms of culverts should have been excavated lower than the riverbed height (Figure 7.34A, B). The opening of the culvert is too small for floodwaters to pass through. The floodwaters spread to the cultivated land due to the indistinct river channel shape and small bank height (Figure 7.34C, D). Construction of additional culverts to expand the opening underneath the railway was completed by TRL before December 2014.

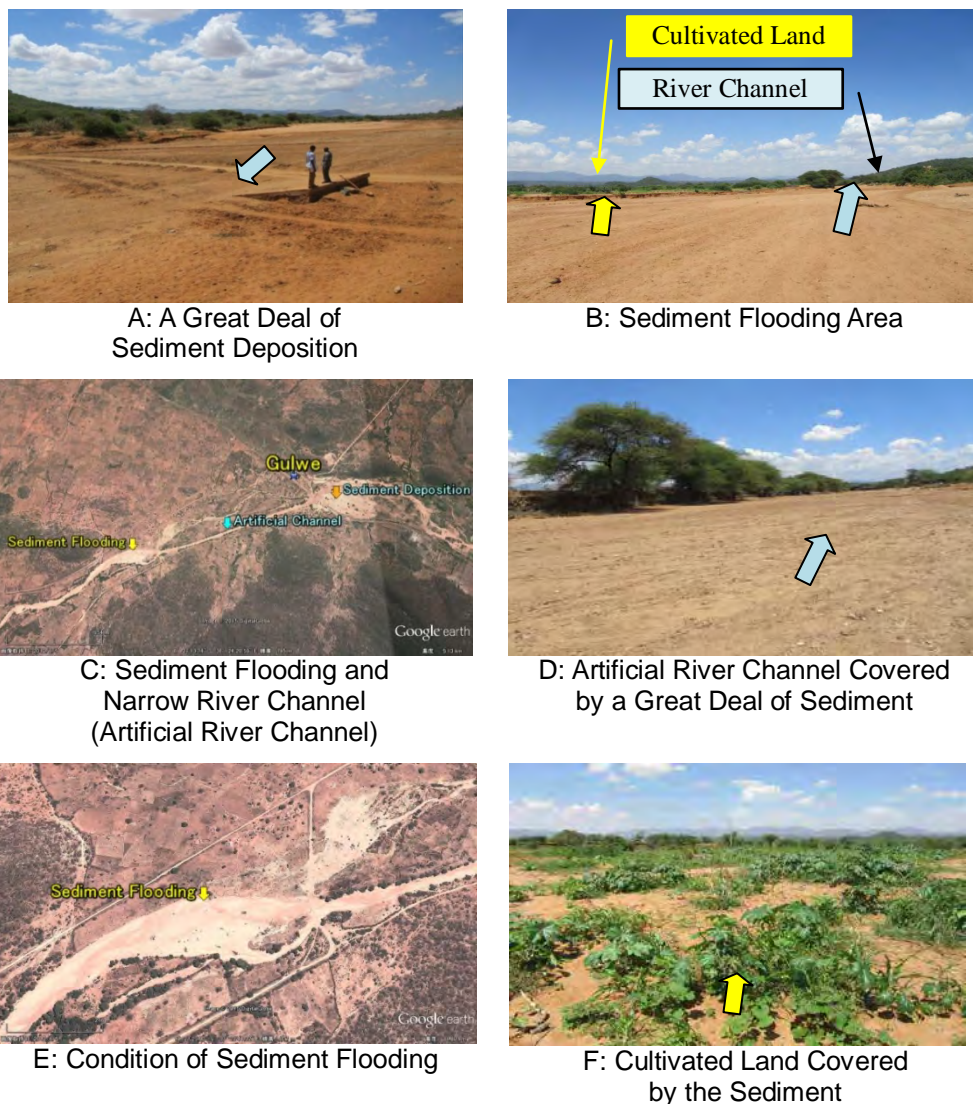
**Figure 7.35: Condition of the Mzase River near Gulwe Station**

This site is located about 1.8 km from Gulwe Station. At this site, remarkable riverbank erosion and a great deal of sediment deposition are observed (Figure 7.35A). A large sediment flooding area is observed in this area (Figure 7.35B). An artificial river channel was constructed between this site and confluence (Figure 7.35C). The river length is approximately 2.0 km. On the other hand, the riverbed of the artificial river channel has already covered by a great deal of sediment (Figure 7.35D). Therefore, this site is assumed to have become a floodplain (Figure 7.35E). In fact, the sediment discharge intruded into the cultivated lands of the adjacent village (Gulwe) during the flood on 28 March 2014 (Figure 7.35F).

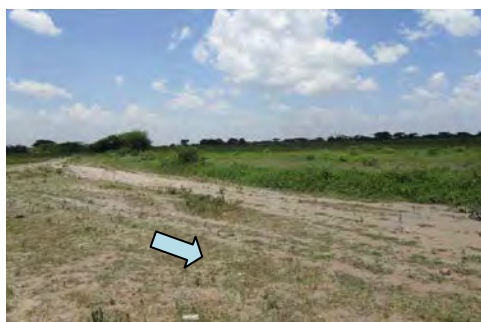
This site is located in the most upstream reaches of the Great Kinyasungwe River. The landform is almost flat (Figure 7.40A). Sediment deposition with gray color is observed on the river channel during rainfall (Figure 7.40B). The supply source of this deposition is presumed to be lake deposits or sediment transported by a huge landslide (refer to Sections 7.2.2–7.2.3). On the other hand, this river channel does not have an obvious river channel formation. This plain changes to a floodplain during rainy seasons. It is possible to verify the existence of clayey compounds in the sediment deposition by forming a “string” with the deposition by hand (Figure 7.40B). This procedure was successful at this site, and therefore, the sediment contains clayey compounds.

A: River Channel during Rainfall

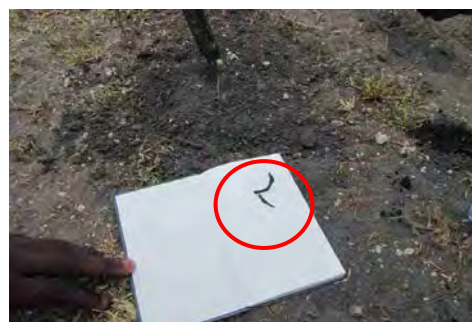
B: Sediment and String (Clay)

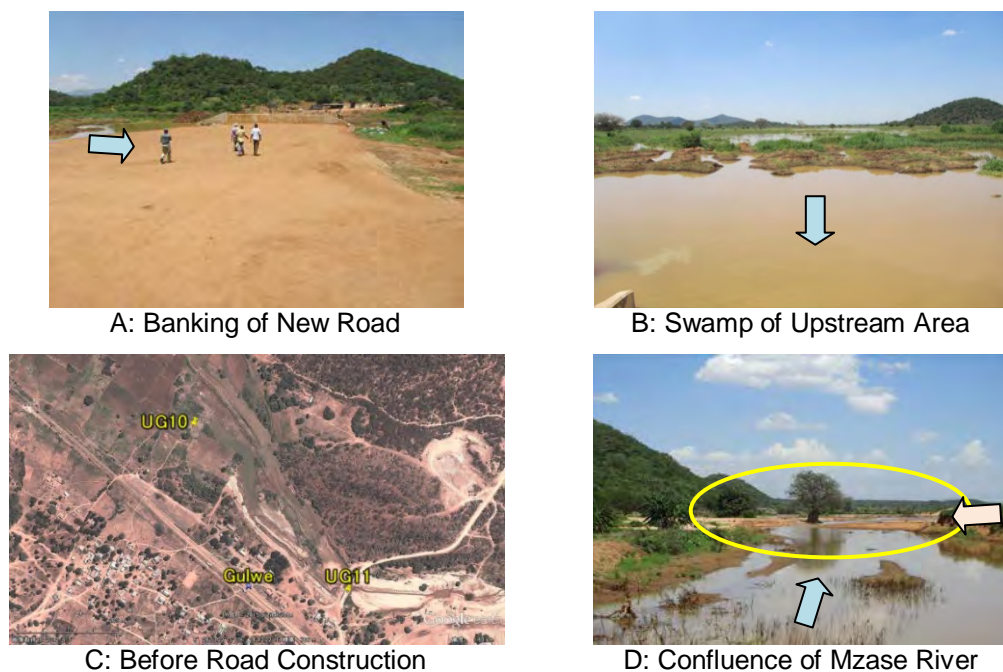
**Figure 7.49: Condition of Gulwe Site**

Site UG10 and Site UG11 are adjacent to each other, and are located upstream of Gulwe Station. At Site UG10, a new road with a road embankment has been constructed across the river (Figure 7.49A). Due to the dam effect, the road embankment creates a large swamp on the upstream side (Figure 7.49B). According to satellite photography, cultivated lands are distributed along the small streams of the Kinyasungwe River (Figure 7.49C). On the other hand, at the downstream location of Site UG11, a great deal of sediment, which flowed into the Kinyasungwe River from the Mzase River, is observed (Figure 7.49D).

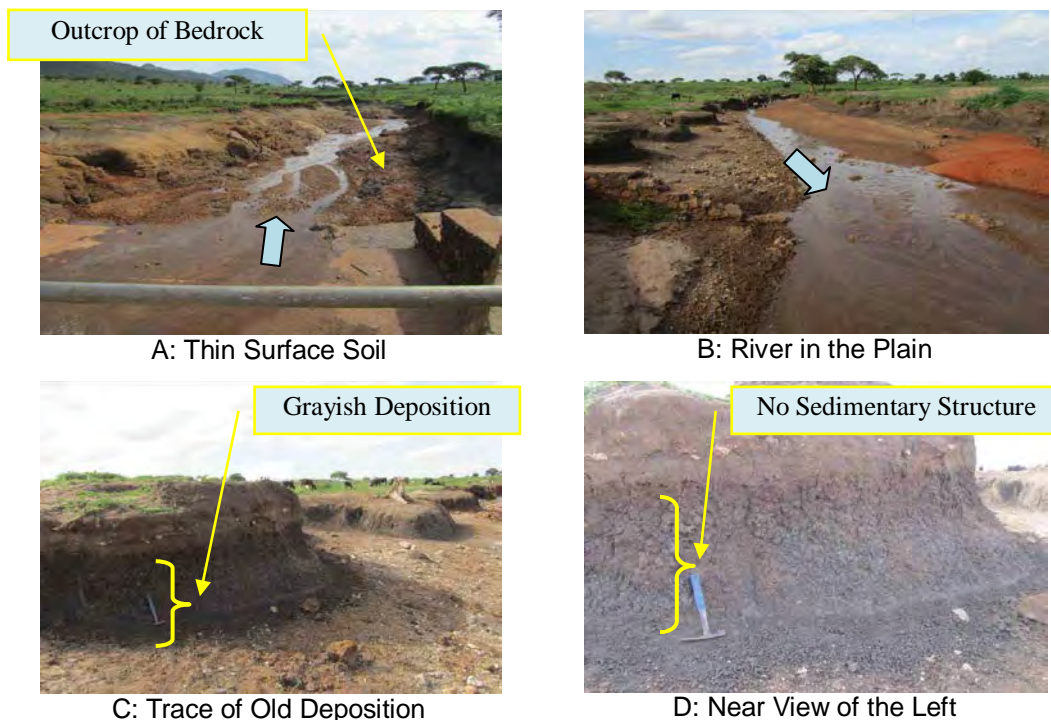
**Figure 7.54: Condition of the Northern Part of Mangweta**

This site is located at the south end of the northern area. An outcrop of bedrock is observed in the riverbed (Figure 7.54A). The layer thickness of the surface soil is relatively thin. Marked deposition, which was transported by floods, is not observed in the riverbed (Figure 7.54B). However, the bedrock around this site is covered by grayish sediment (Figure 7.54C). Because the deposition does not have sedimentary structure formed by successive floods, this deposition is presumed to have been deposited in the old age (Figure 7.54D).

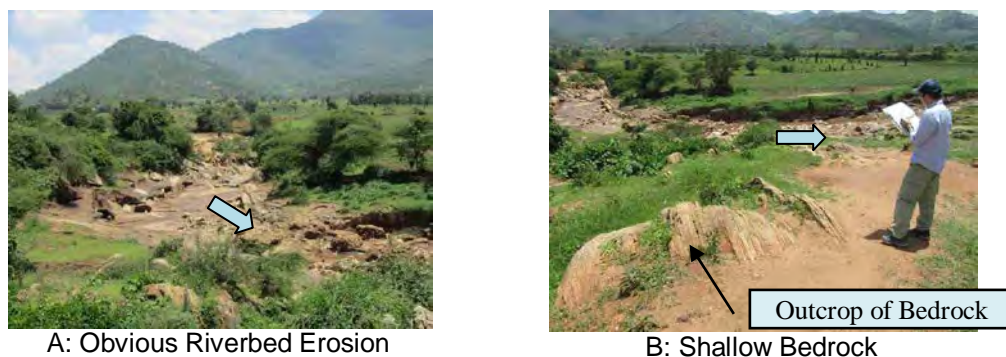
**Figure 7.55: Condition of the Middle Reaches of Mangweta**

This site is located at the boundary of the northern area and the southern area. Obvious riverbed erosion starts from this site (Figure 7.55A). Additionally, an outcrop of bedrock is distributed around this site (Figure 7.55B).

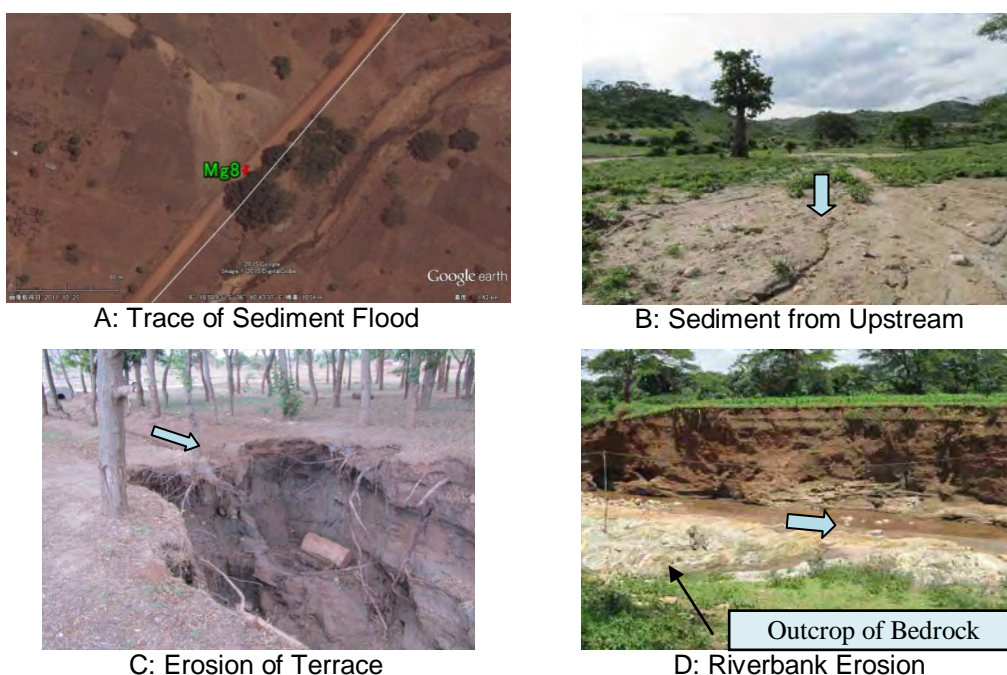
**Figure 7.56: Condition of the Middle Reaches of Mangweta**

This site is located at the north end of the southern area. The sediment discharge from the mountain side is the characteristic phenomenon (Figure 7.56A). However, evidence of slope failure is not observed on the mountain slope. Therefore, the discharged sediment is presumed to have been supplied from adjacent cultivated lands (Figure 7.56B). Additionally, a great deal of flood flow from the mountain causes the remarkable erosion on the right bank side (Figure 7.56C).

Steep cliffs which were formed by floods are observed along both riverbanks along the mainstream (Figure 7.56D). Additionally, thick sediment deposition is observed at both sides of the riverbank on the bedrock. This thick deposition is assumed to be the deposition which had been formed in the old age.

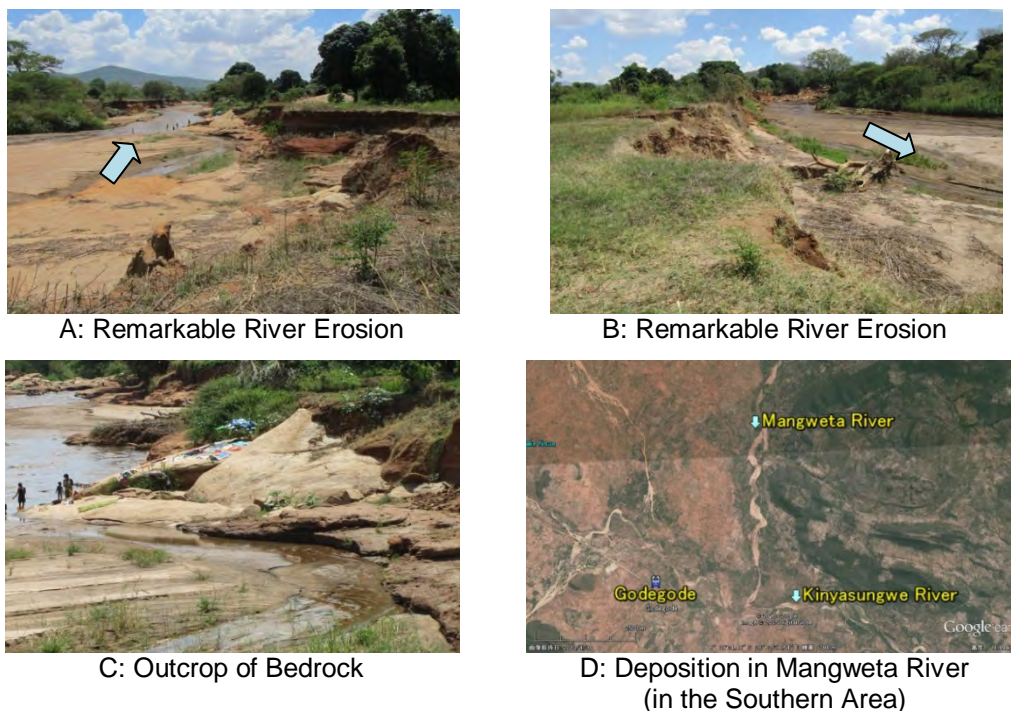
**Figure 7.57: Condition of the Middle Reaches of Mangweta**

This site is located in the middle reaches of the southern area. Remarkable river erosion is observed on both riverbanks, as in Site Ma8 (Figure 7.57A, B). An outcrop is observed in the riverbed (Figure 7.57C). Additionally, a thin deposition is observed partly in the riverbed. According to satellite photography, obvious deposition is distributed in the section from the downstream of site Ma9 up to the confluence (Figure 7.57D). The deposition in this section is presumed to be a source of supply to the Kinyasungwe River.

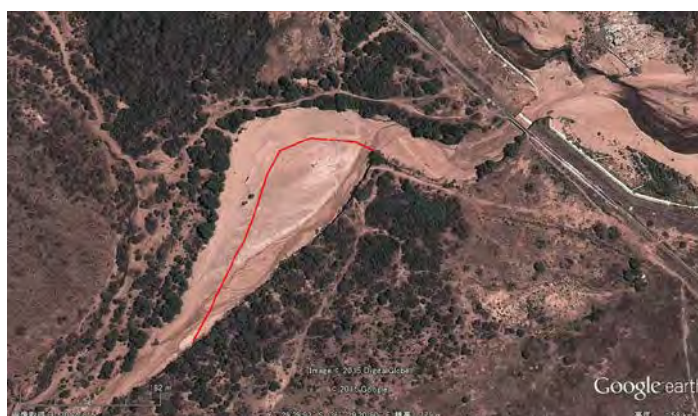
However, in fact, the right bank was eroded remarkably even after this series of countermeasures, as shown in Figure 7.81A. The quantity of eroded sediment is estimated to be at least about 105,000 m<sup>3</sup> (21,000 m<sup>2</sup> by 5 m). The average erosion width is estimated to be about 4.7 m (21,000 m<sup>3</sup> / 300 m / 15 years = 4.7 m). This phenomenon is presumed to be due to a series of countermeasures. Therefore, it is strongly recommended that a re-examination of the flow cross-section of the river channel works should be conducted.

A: Old Right Bank (Red Line)

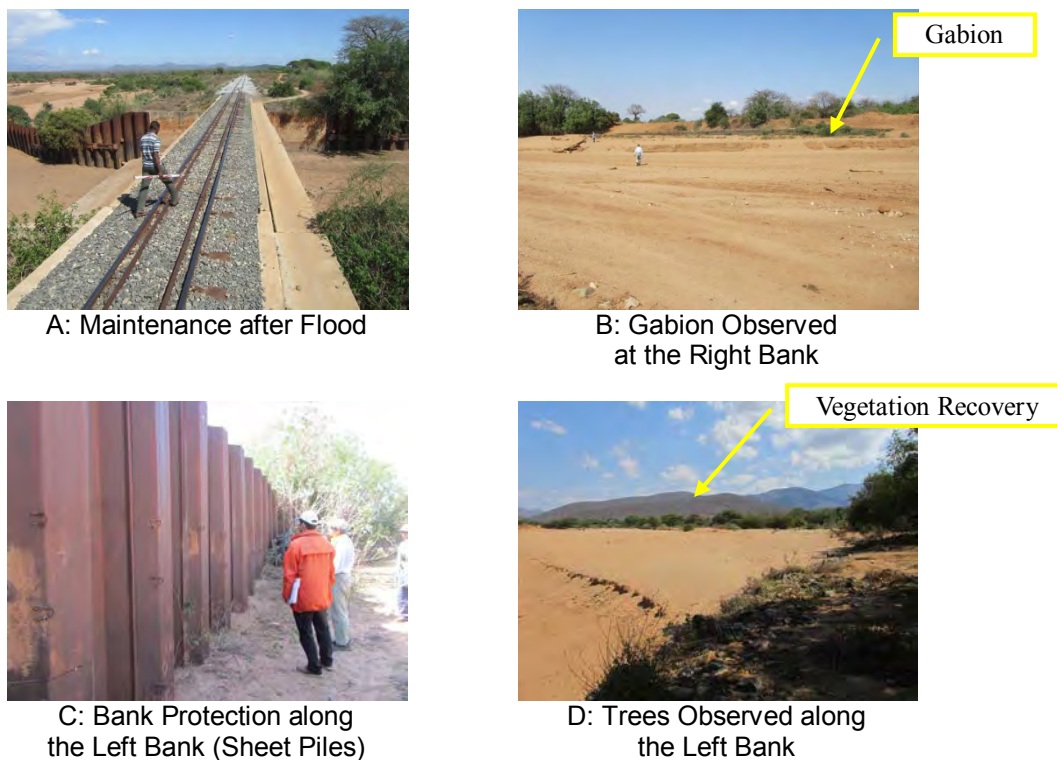
**Figure 7.82: Current River Conditions and Bank Protection (Kidibo)**

Figure 7.82 shows the current river conditions. Figure 7.82A shows the condition of maintenance after the flood. Figure 7.82B and C shows the existing bank protection. Some vegetation recovery is observed along the left bank (Figure 7.82D), showing that recent river erosion has not occurred along the left bank.
