**Preparatory Survey on  
Flood Protection Measures for  
Central Railway Line  
in the United Republic of Tanzania**

**Final Report  
Volume 2: Appendices**

### **RECORDS OF FLOODS IN KILOSA–DODOMA SECTION 2011–2014**

# **THE TEMPORARY URGENT PROTECTION WORK AND OUTLINE OF THE SITE CONDITIONS AT MASWALA AND KIDIBO IN DECEMBER 2014**

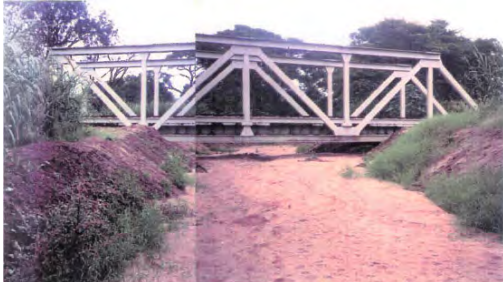
Location	Activities	Photos, Maps, etc.
<p>Km 288 Mkadage Bridge</p>	<p>➤ Problems:</p> <ul style="list-style-type: none"> <li>• Due to siltation, the bridge blocked the river.</li> </ul> <p>➤ Countermeasure:</p> <ul style="list-style-type: none"> <li>• Demolition of the old center pier &amp; abutments currently buried under the existing bridge deck</li> <li>• Excavation and re-alignment of the river channel over 625m length</li> </ul> <p>(Comments by JICA Study Team) It is recommended to re-conduct the excavation and re-alignment of the river channel.</p>	<p>Year 1997 (Toward downstream)</p>

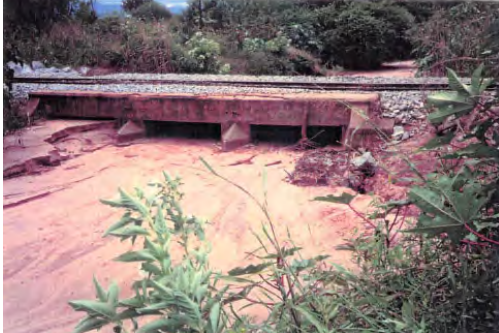
<p>Km 349/4b, 4c Maswala Cross Drainage</p>	<p>➤ Problems:</p> <ul style="list-style-type: none"> <li>• Inadequate Cross drainage (culverts) under the railway</li> </ul> <p>➤ Countermeasure:</p> <ul style="list-style-type: none"> <li>• Track raising by 1.25 m</li> <li>• Provision of 9 nr 2.0 x 2.0 precast Culverts</li> <li>• Minor stream training and protection works</li> <li>• Demolition the existing culverts</li> <li>• Excavation in river channels</li> <li>• Gabion works, etc.</li> </ul> <p>(Comments by JICA Study Team) Currently, flood waters still go over the railway, when it rains at the mountain side. It is recommended to conduct sustainable countermeasures, such as a relocation of the railway toward the mountain side.</p>	<p>Year 1997 (Toward downstream)</p>

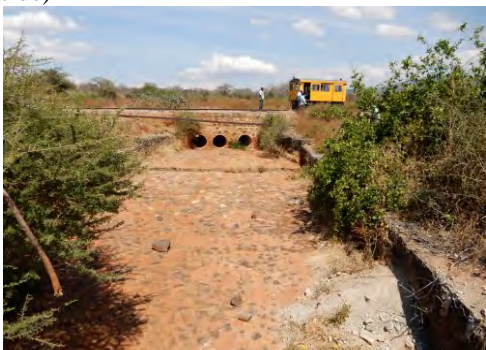
Location	Activities	Photos, Maps, etc.
	4) Km 345.6 and Km 346: Inadequate Cross Drainage Capacity	4) Km 346.1: Dec.2014 (Toward mountain side)

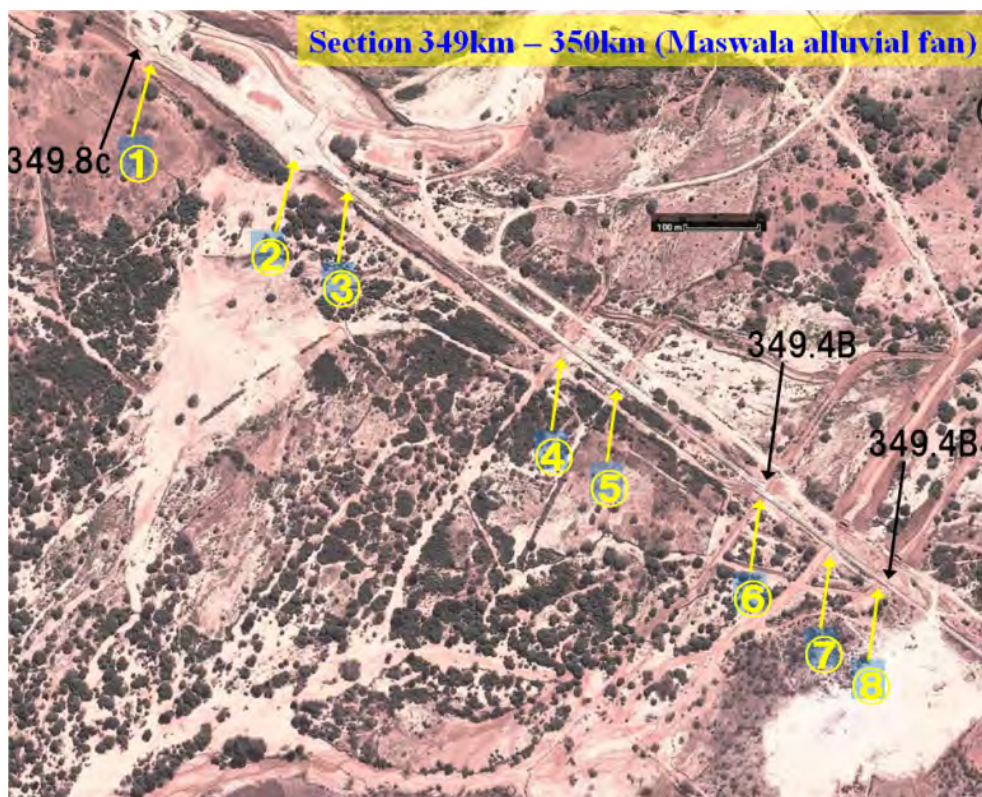
### Km 349–Km 349.8c (Maswala River Section)

This section is the alluvial fan of the Maswala River, where the track has been damage at almost all culvert locations in this section every rainy season due to inadequate cross drainage.

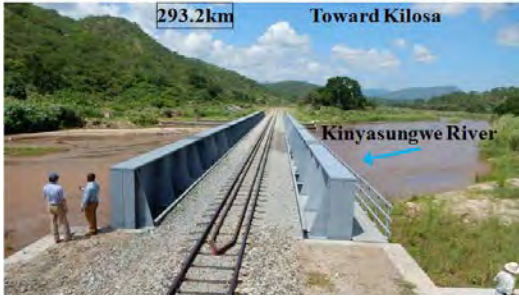
Location	Pattern of Damage	Temporary Remedial Works in the past	Distance between track and river * <sup>1</sup>	Difference of elevation between track and river * <sup>2</sup>	Photos of the section	Possible Flood Protection Measures	Priority for Flood Protection
Km 293.6	<ul style="list-style-type: none"> <li>• Pattern 1-1, 1-2</li> </ul>	<ul style="list-style-type: none"> <li>• A new bridge with a longer span was constructed (2014), as the old bridge was washed away in 2010.</li> <li>• Gabion works</li> </ul>		2.0 m

<p>293.2km Toward Kilosa Kinyasungwe River</p>	<ul style="list-style-type: none"> <li>• Expansion of the bridge</li> <li>• Additional gabion works to protect the riverbank</li> <li>• Sustainable excavation of the riverbed</li> </ul>	Medium
Km 293.6– Km 294.4	<ul style="list-style-type: none"> <li>• Pattern 1-3</li> </ul>		6 m–80 m	2.0 m

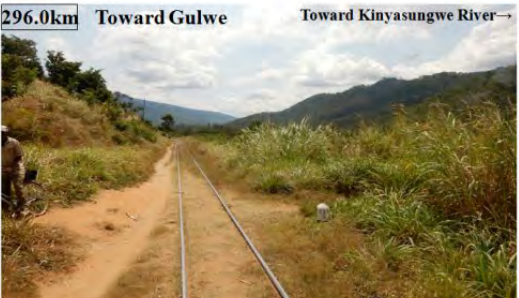
Km 294.4– Km 297.1	<ul style="list-style-type: none"> <li>• Pattern 1-3</li> </ul>	<ul style="list-style-type: none"> <li>• Restoration of the washed- away track</li> </ul>	130 m–400 m	2.0 m

<p>296.0km Toward Gulwe Toward Kinyasungwe River →</p>	<ul style="list-style-type: none"> <li>• Track raising by embankment</li> <li>• Protection from the erosion of the riverbank, etc.</li> </ul>	Medium

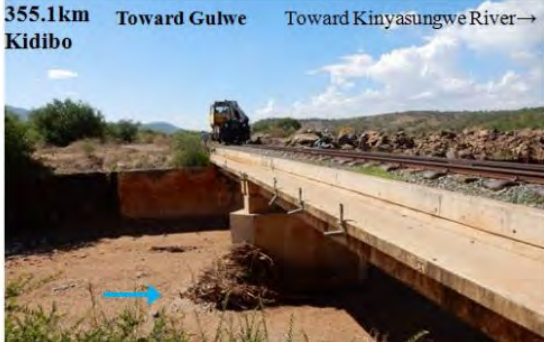
<ul style="list-style-type: none"> <li>• Improvement of cross-drainage</li> </ul>	Low
Km 355.1 Mafugusa River Kidibo Bridge	<ul style="list-style-type: none"> <li>• Pattern 2-1, 2-2</li> </ul>	<ul style="list-style-type: none"> <li>• Re-routing the Mafugusa River</li> <li>• Excavation in the river channel and forming embankment</li> <li>• Sheet piling with anchor bolts to protect the riverbanks</li> <li>• Gabion works</li> </ul>	30 m	4.5 m	<p>355.1km    Toward Gulwe    Toward Kinyasungwe River→ Kidibo</p>

<ul style="list-style-type: none"> <li>• Re-routing the track</li> <li>• Track raising</li> <li>• Protection from the erosion of the tributary bank, etc.</li> <li>• Improvement of cross-drainage</li> <li>• Sustainable excavation of the stream channel crossing the track</li> </ul>	Medium

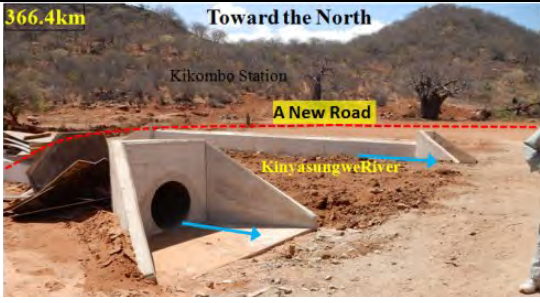
<ul style="list-style-type: none"> <li>Protection of the track against the flood. (Note) Due to the new road bridge with very much inadequate drainage, the track will be flooded</li> </ul>	Medium
