Inventory Sheet for River/Channel

Station: From KM305 to KM306 **Sheet No.: CH- KM 305**

1. General			
1-1	Name of Inspector	T. Kawaguchi ,, Hussein , Abiud	
1-2	Organization of Inspector	River Group D	
1-3	Date/Time of Inspection	Dec. 4, 2014	
1-4	Location	Lat	6° 43' 38" 05"
1-5		Long	36° 50' 33" 85"

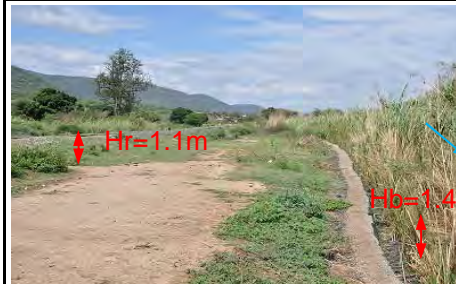
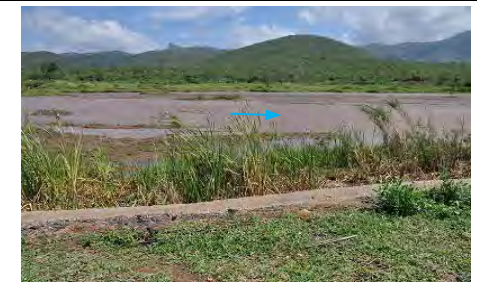
Station: From KM308-KM309 **Sheet No.: CH-308**

2-18	Damaged Record, if any (year/month)	After damaged by 2010 flood, 2 steps of gabions were constructed.	
2-19	Reason of	Bank erosion	
2-20	Pattern of Riverbed	Rising of riverbed in long distance

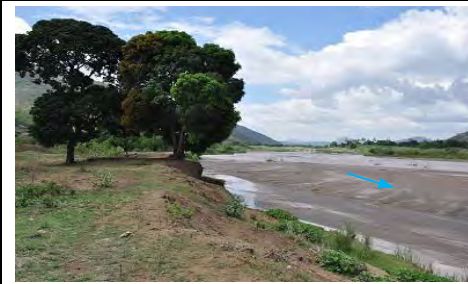
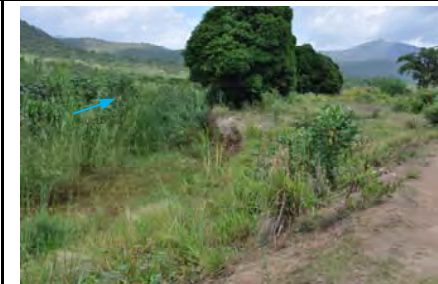
Station: From KM312.1 to 312.4 **Sheet No.: CH-312.1**

2-18	Damaged Record, if any (year/month)	Progress of erosion to railway side
2-19	Reason of	bank erosion
2-20	Pattern of Riverbed

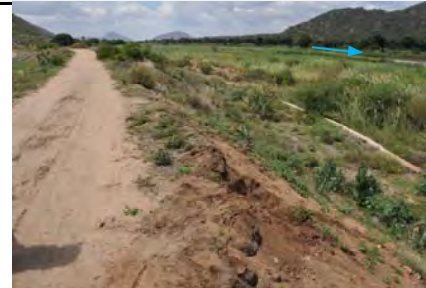
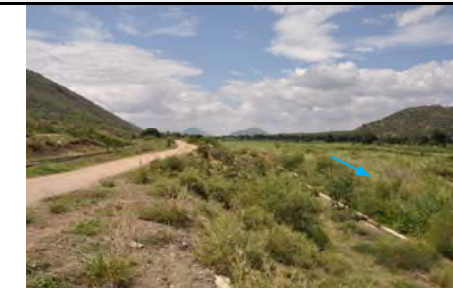
Station: From KM312.8 to 313.3 **Sheet No.: CH-312.8**

2-18	Damaged Record, if any (year/month)	Gabions (2 steps) are installed for bank protection of low water channel in the 500m section and at outlet of culvert.
2-19	Reason of	
2-20	Pattern of Riverbed

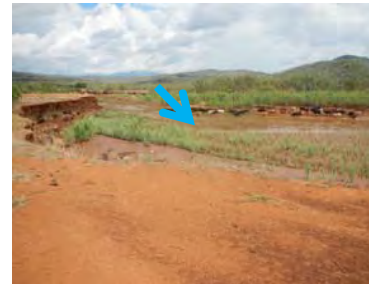
Station: From KM327 to KM328 **Sheet No.: CH- KM 327**

2-18	Damaged Record, if any (year/month)	Notable riverbank corrosion has been occurred at 327.95 km point of the water colliding front. About 50m corrosion has been advancing during two years and a half between present
2-19	Reason of	Bank Erosion
2-20	Pattern of Riverbed

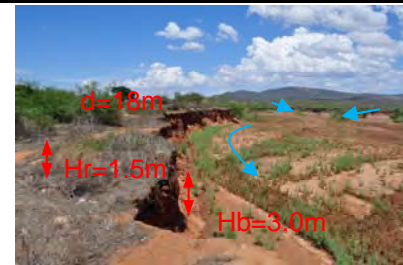
Station: From KM337 to KM338 **Sheet No.: CH-337**

2-18	Damaged Record, if any (year/month)	Frequently damaged in the past, and diversions of track were carried out many times. 2014: bank erosion
2-19	Reason of	Bank erosion , Overflow, Sliding,
2-20	Pattern of Riverbed	Rising of riverbed in long distance

- At present, serious bank erosion is observed in this section.
- Height of river bank is 4.5m and the shortest distance from river bank to railway track is 18 m.
- There is a possibility to be damaged during next rainy season.
- It is recommended to conduct an urgent measure in the section between Km337.2 and Km337.7.

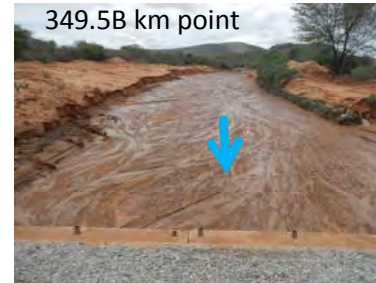
Station: From KM349.4B to KM349.9B **Sheet No.: CH- KM 349.4B**

2-18	Damaged Record, if any (year/month)	Culverts of the railroad have been deposited by the sediment in the tributary MASUWALA RIVER, and river flow prevention has been occurred . The railroad bank has been scored by the
2-19	Reason of	Flood flow overtopped railway track
2-20	Pattern of Riverbed

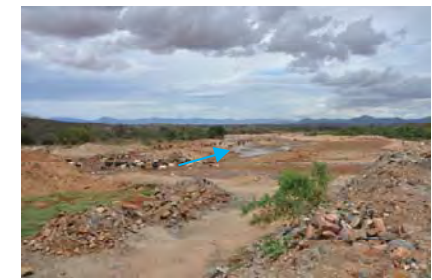
Station: From KM355.1		Sheet No.: CH-355.1	
1. General			
1-1	Name of Inspector	T.Fukuda, Mr. Kido, Mr. Philipo	
1-2	Organization of Inspector	Team B	
1-3	Date/Time of Inspection	Dec. 2, 2014 1325	
1-4	Location	Lat	
1-5		Long

2. Characteristics of Physical Condition of River Channel			
2-1	Length of Objective Area	KM354.9-355.2	
2-2	Nos. of River	Gabion, culvert (1), bridge(1)	
2-3	River Channel Alignment	Straight, water hit area	
2-4	River Cross Section	compond	
2-5	River Width	Wf: m, Wr:300-600 m	
		Bl: m, Bc: m, Br: m	
2-6	Riverbed Slope	Gentle	
2-7	Riverbed Material	Material	Sand
2-8	River Bank	Bank Height	Hb: 4.0 - 5.3m
2-9		Side Slope	Sl: 1v: , Sr: 1v:
2-10		Vegetation	none
2-11	Estimated Flow Velocity	normal: 0 m/s, flood	m/s
2-12	Characteristic of environmental condition of river channel	Riverside forests, Sandbar, Pool, shoal, fishes, etc	
2-13	Land Use	none	
2-14	Soil Type	yellow color soil	
2-15	Topography	left: ← ,right →	
2-16	Structures/Houses, road	none	
2-17	Location of Railway	d=22mpkm355.1	
2-18	Damaged Record, if any (year/month)	After 2010 flood, gabion were insatalled. Boulders are delivered from Gulwe, and sands are extracte neare site.

2-19	Reason of	Bank erosion & overflow	
2-20	Pattern of Riverbed
