## **APPENDIX F**

### **INVENTORY SHEET OF CULVERT**

## Inventory Sheet for Culvert

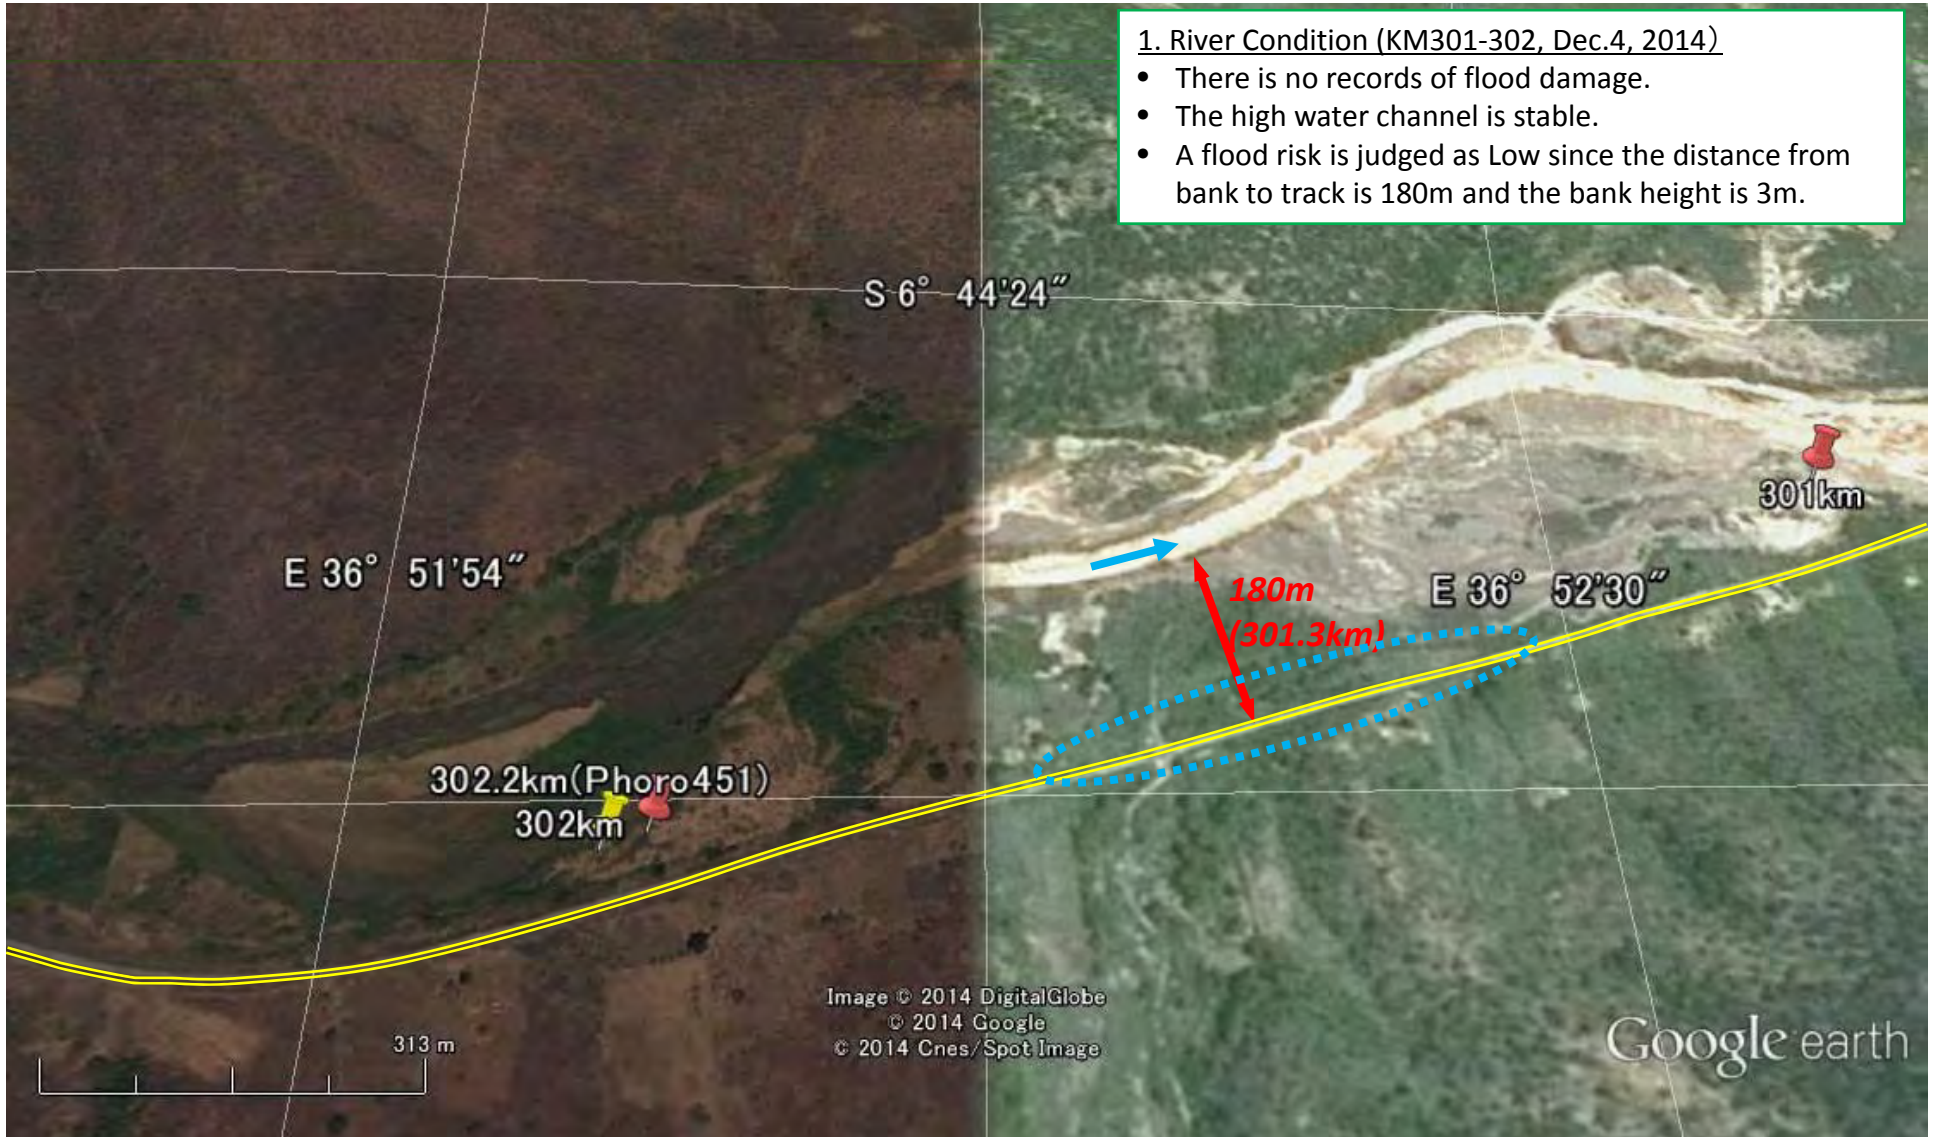
- There is no records of flood damage.
- The high water channel is stable.
- A flood risk is judged as Low since the distance from bank to track is 180m and the bank height is 3m.

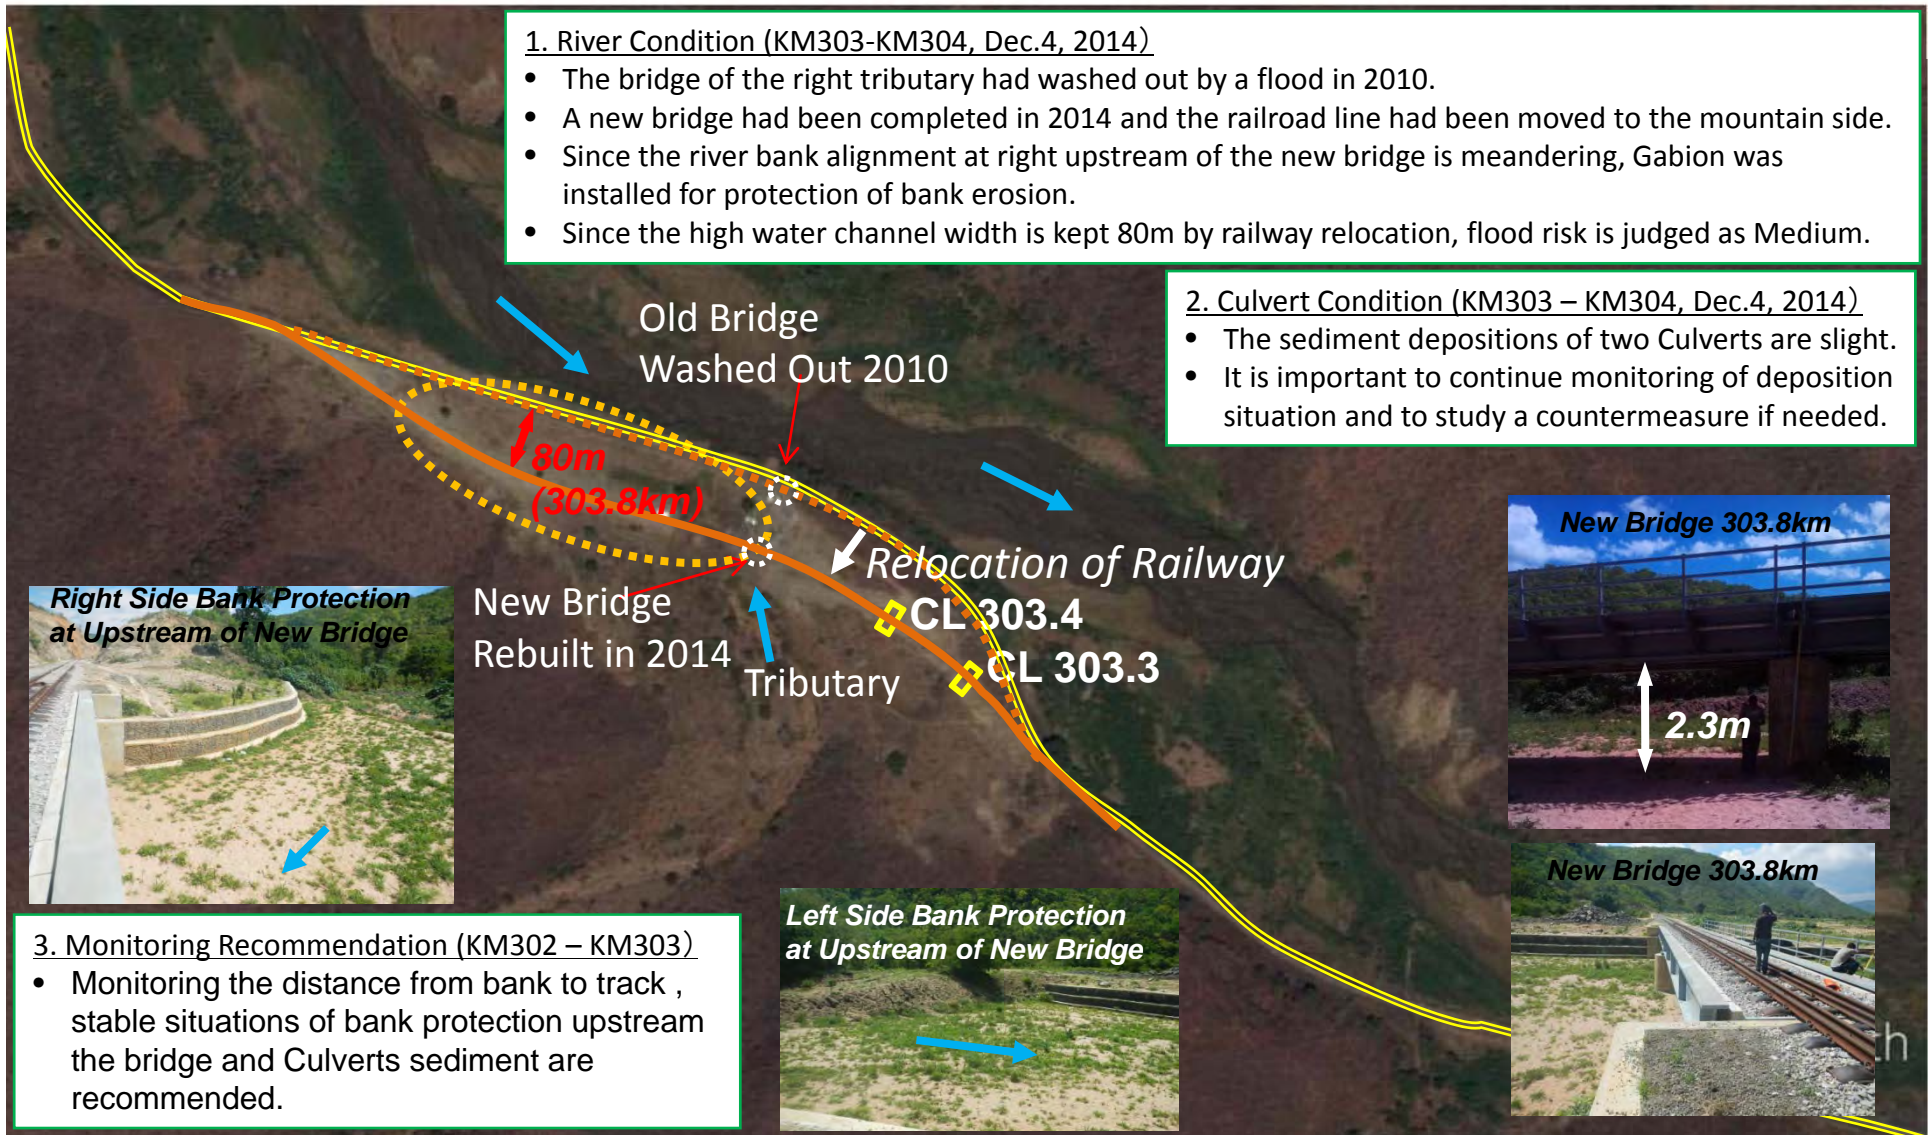
- The sediment depositions of two Culverts are slight.
- It is important to continue monitoring of deposition situation and to study a countermeasure if needed.

- 3. Monitoring Recommendation (KM302 – KM303)**
- Monitoring the distance from bank to track , stable situations of bank protection upstream the bridge and Culverts sediment are recommended.

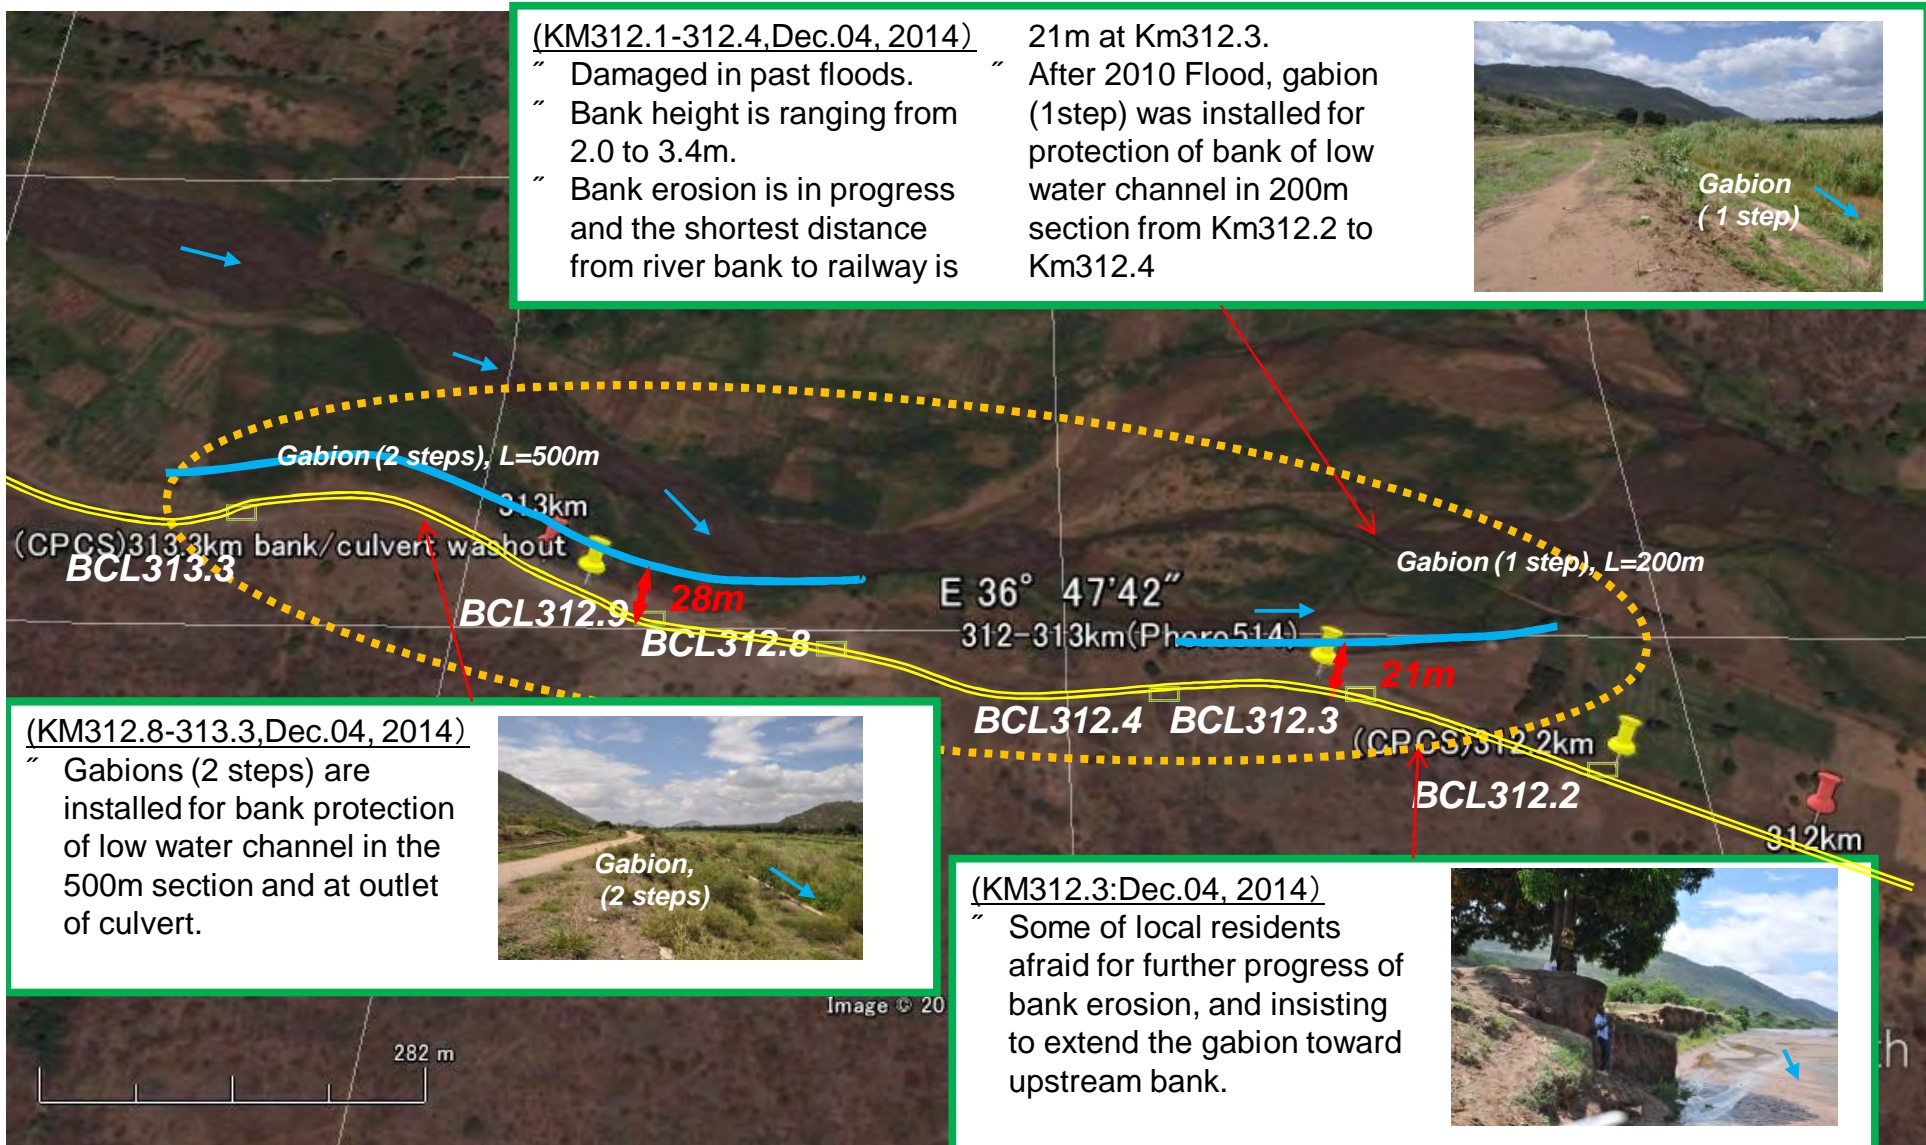
(KM312.1-312.4, Dec.04, 2014)  
 " Damaged in past floods.  
 " Bank height is ranging from 2.0 to 3.4m.  
 " Bank erosion is in progress and the shortest distance from river bank to railway is

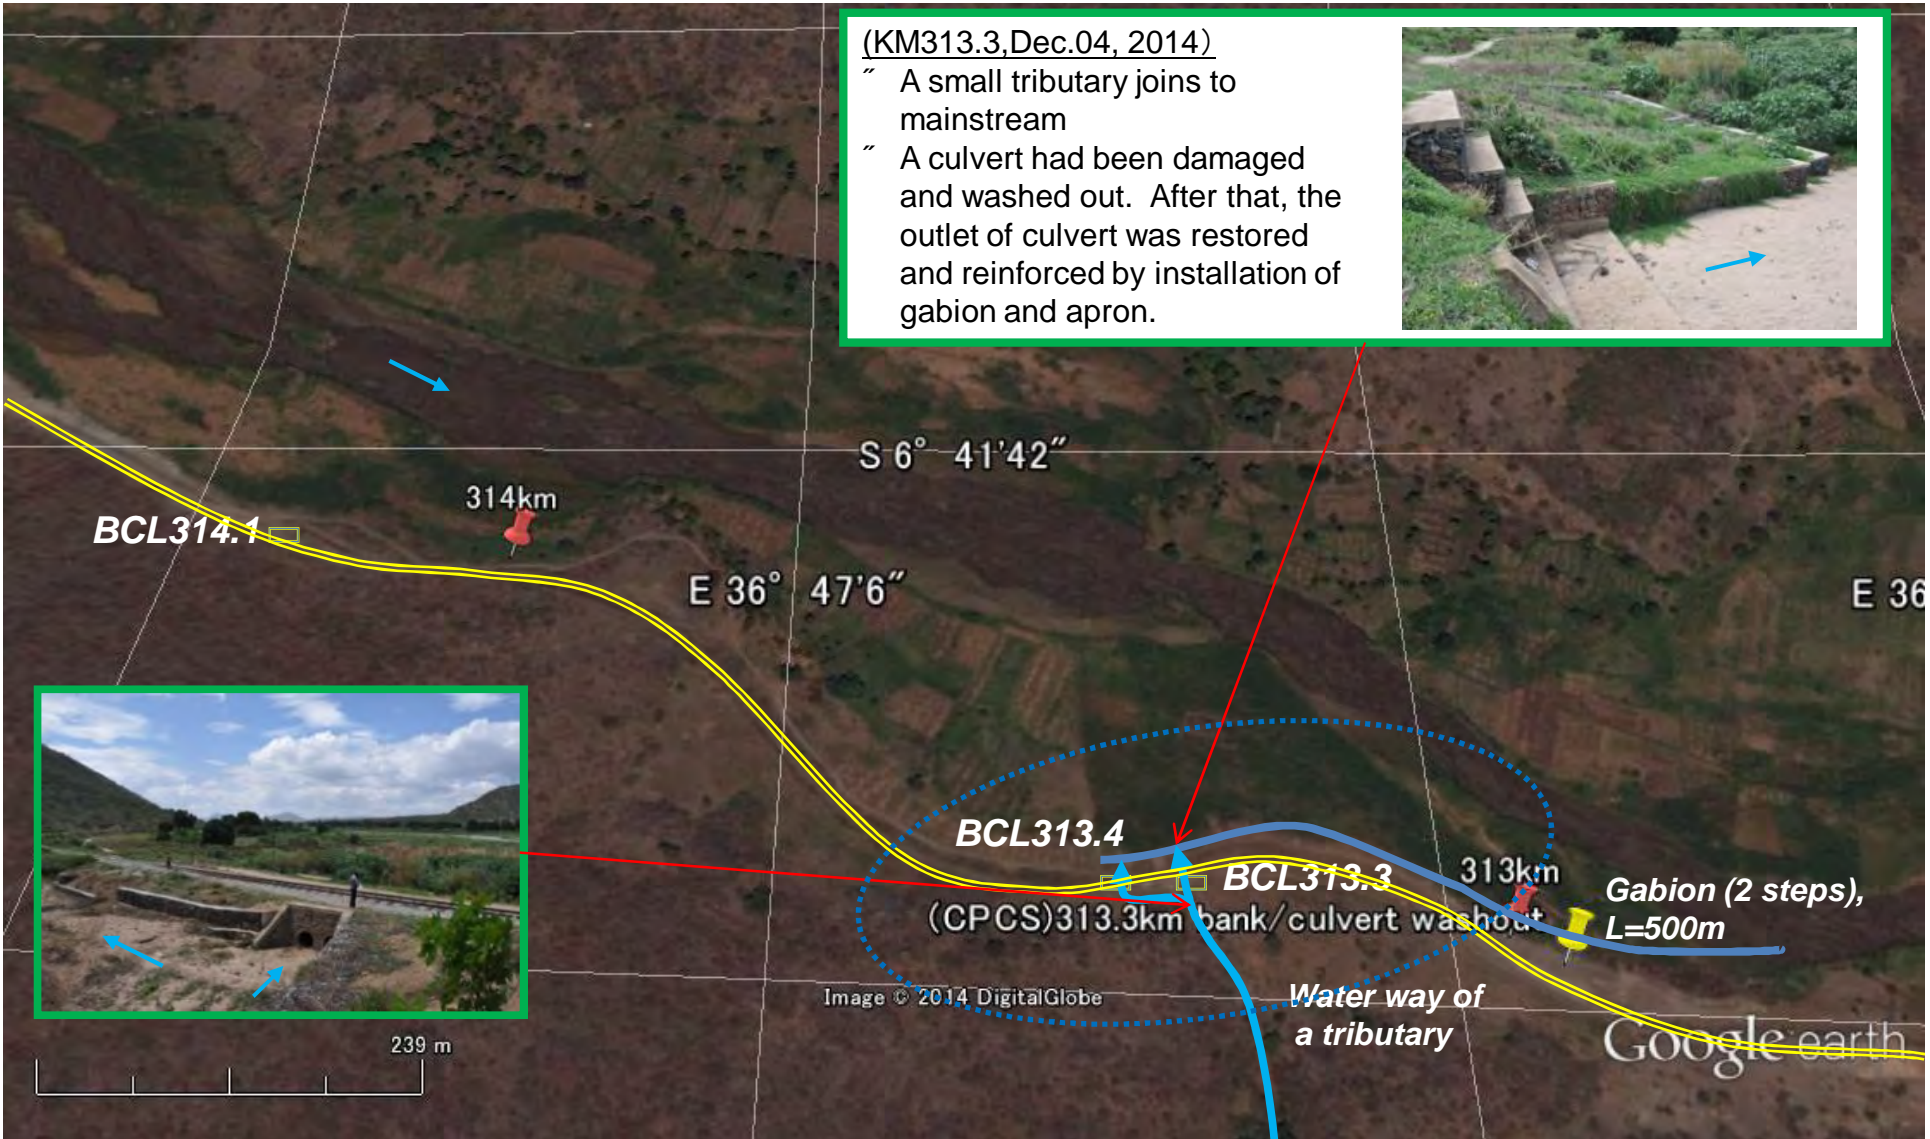
- ~ A small tributary joins to mainstream
- ~ A culvert had been damaged and washed out. After that, the outlet of culvert was restored and reinforced by installation of gabion and apron.

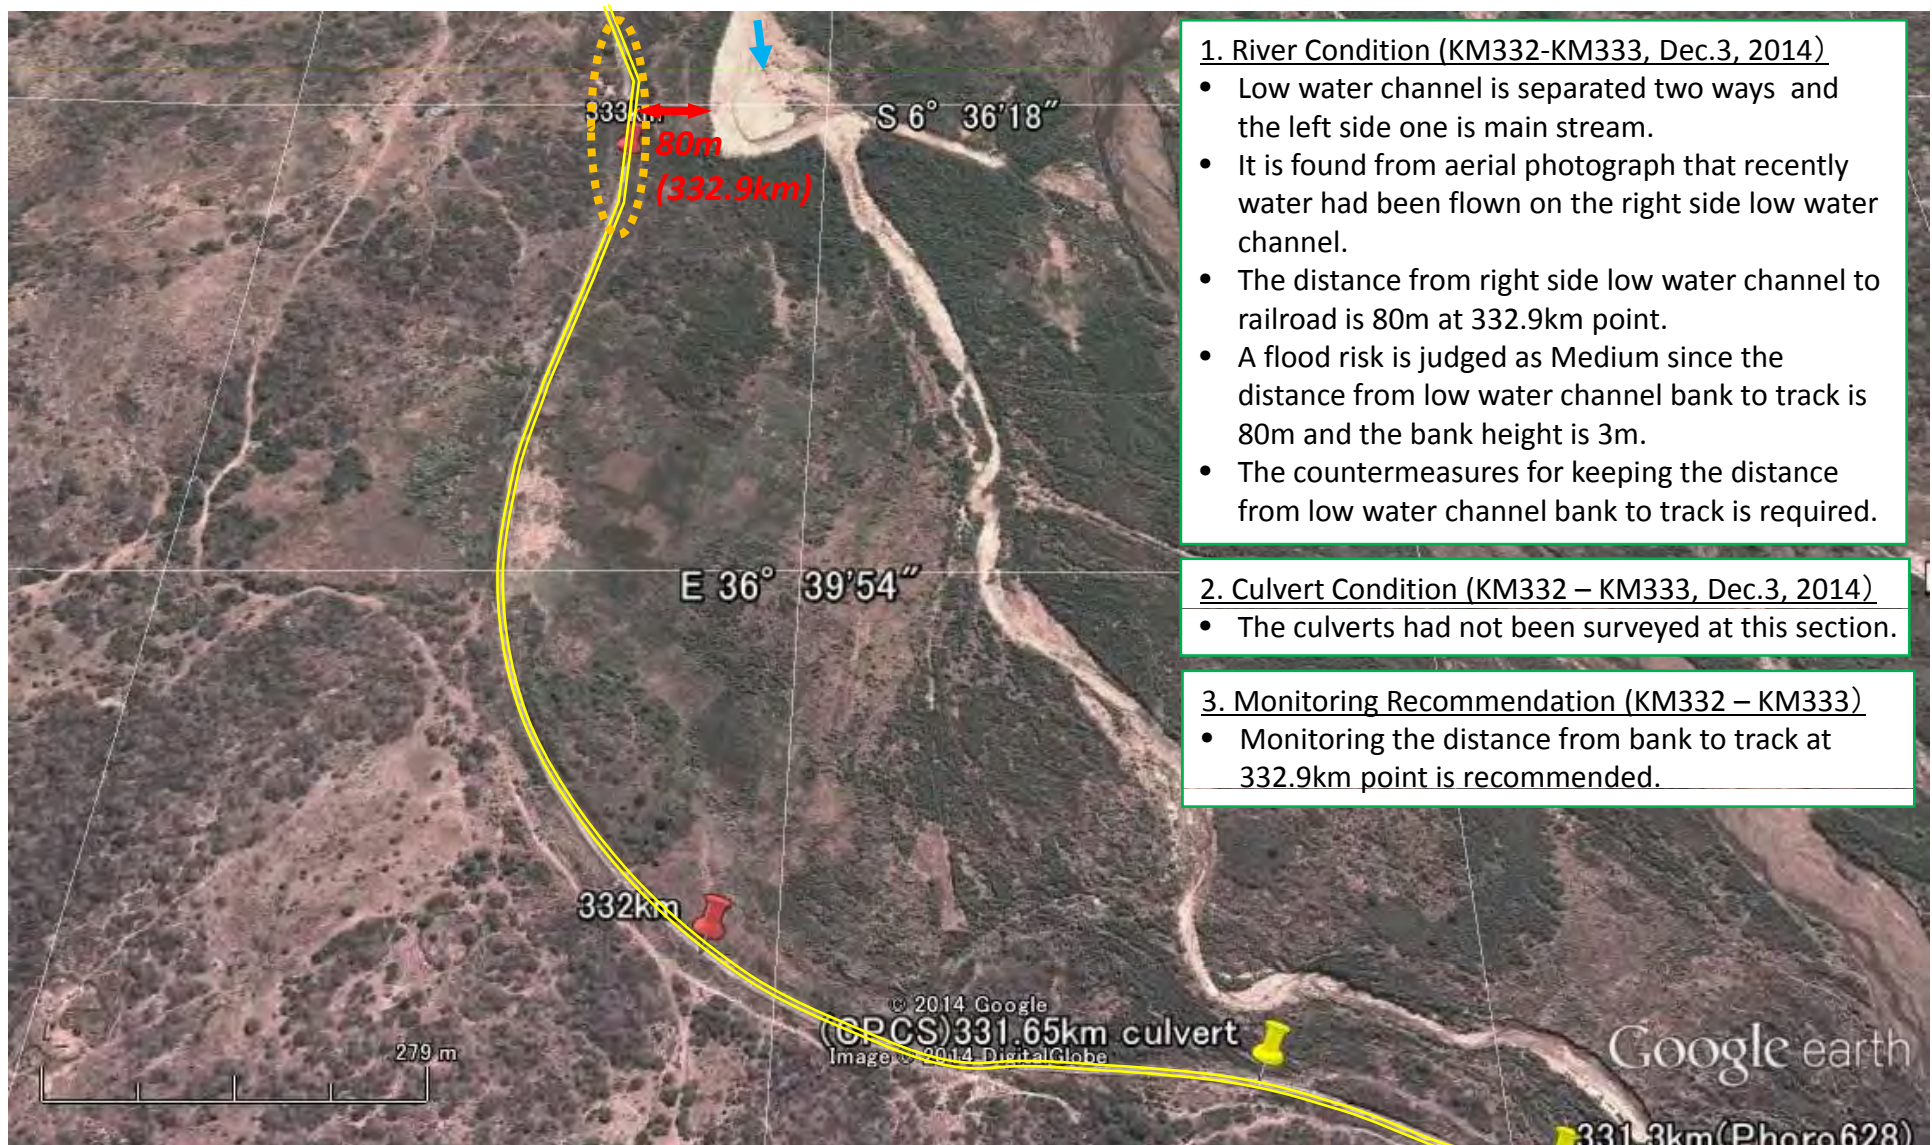
1. River Condition (KM332-KM333, Dec.3, 2014)
- Low water channel is separated two ways and the left side one is main stream.
  - It is found from aerial photograph that recently water had been flown on the right side low water channel.
  - The distance from right side low water channel to railroad is 80m at 332.9km point.
  - A flood risk is judged as Medium since the distance from low water channel bank to track is 80m and the bank height is 3m.
  - The countermeasures for keeping the distance from low water channel bank to track is required.
