Chapter 3 Field Investigations

3.1 Basin Overview (Helicopter Survey)

3.2 River Survey

Chapter 4 Summary of Present Conditions and Issues of Flood Control and Basin Management in Nadi River

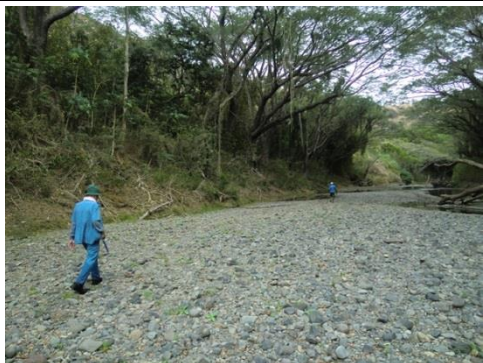
<p>Up-stream of Nadi River Mountain-Burning Events (P-09)</p>	<p>Sedimentation on River-bed of Namosi River Up-stream (P-013)</p>

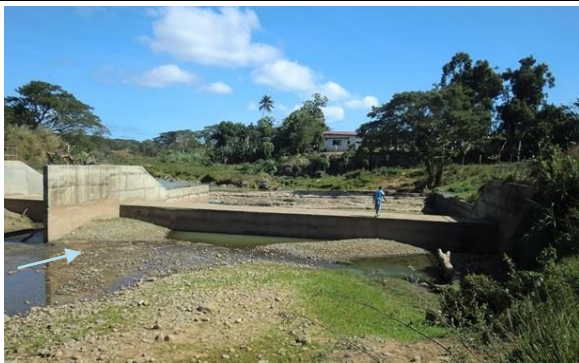
At five (5) kilo-meters from confluence, and ten (10) kilo-meters from confluence, there were retention dams. The apron of the retention dam at upper stream was left collapsed. This collapse was caused by the flood of 2012 (see Figure 3-2, and P-14, P-15).

<p>River-bed of Nadi River up-stream (P-10)</p>	<p>Retention Dam at Nawaka River (5km :P-14)</p>

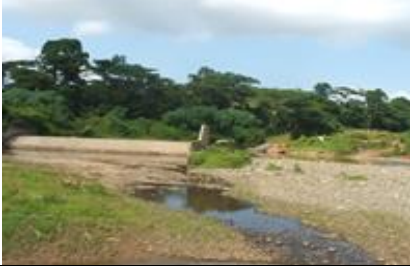
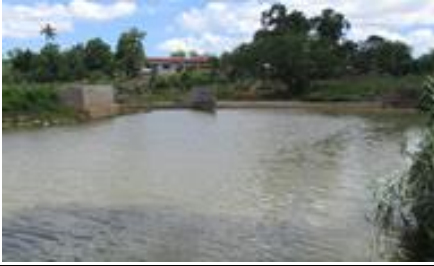
The damage situation of the river structures in the March 2012 flood is shown in Picture 4-2. A part of plans regarding the rehabilitation situation of Namulomulo Dam in the Namosi River is kept and is shown in Appendix-2.

Vatutu Dam in the Nawaka River after the March 2012 flood	Vatutu Dam in the Nawaka River after the rehabilitation

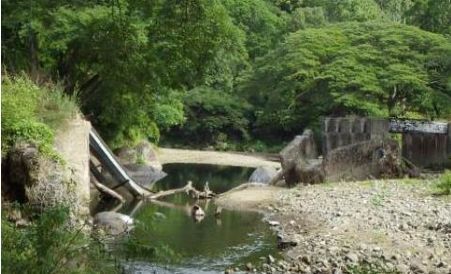
Wreckage of the damaged bridge in the Nadi River at Natawa Village (as of 2014, year of damage is unknown)	Wreckage of the damaged Qeleloa Bridge in the Nawaka River (as of 2014, year of damage is unknown)
