Data Collection Survey on Urban Building Safety in the People's Republic of Bangladesh

Final Report (Appendices)

JAPAN INTERNATIONAL COOPERATION AGENCY (JICA)

Preliminary inspection sheet for the seismic capacity of a building

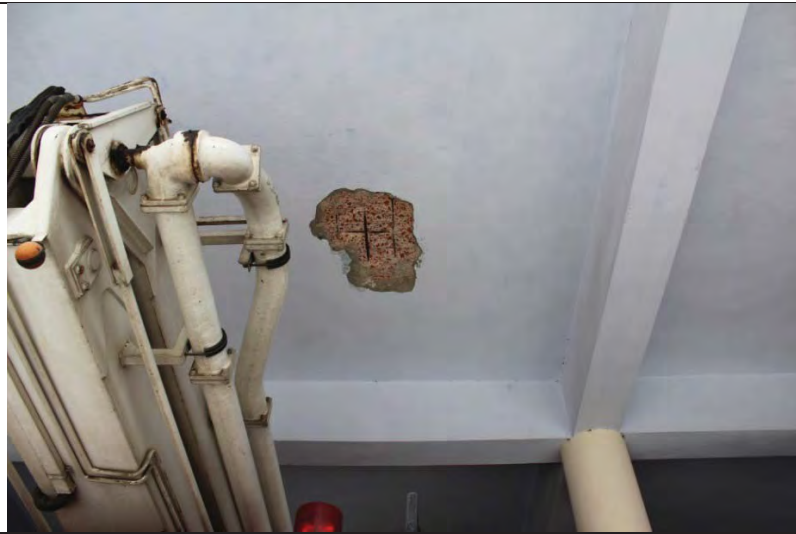
Corrosion of rebar

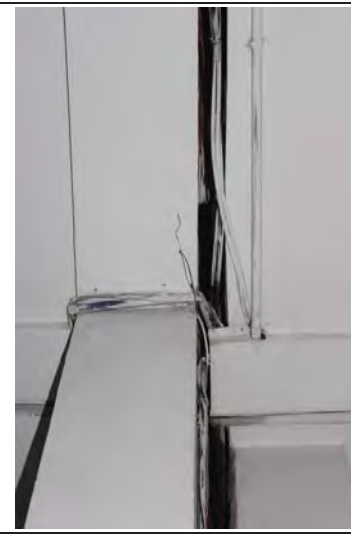
Narrow expansion-joint

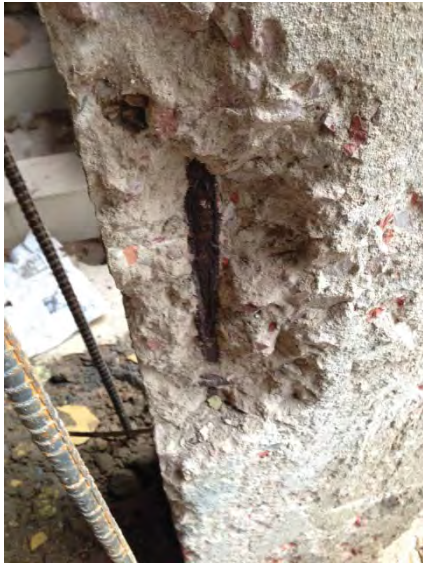
Corrosion of existing main reinforcing-bar in columns

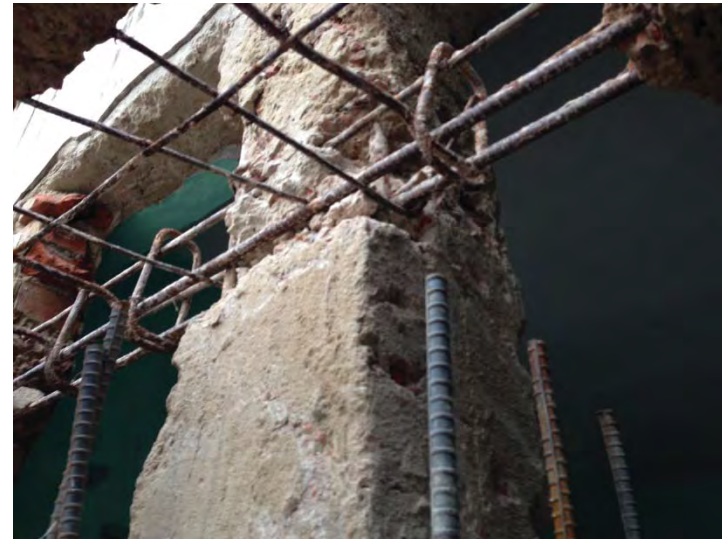
Reinforcing-bar arrangement in existing beam

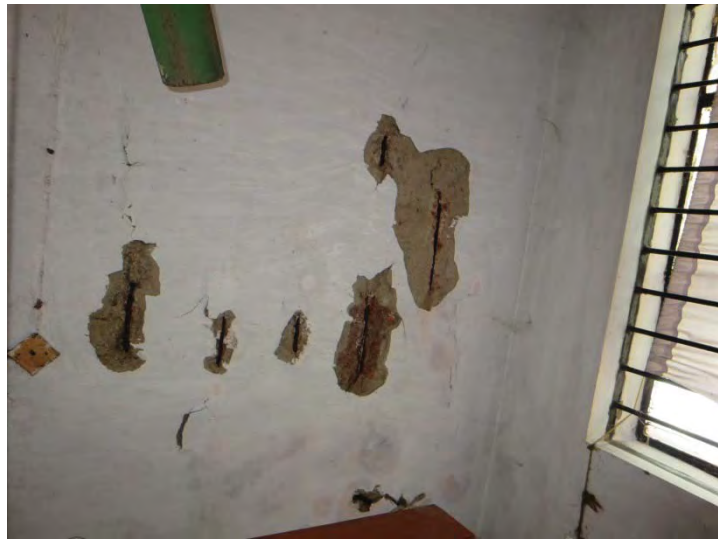
Corrosion of reinforcing-bar in existing slab

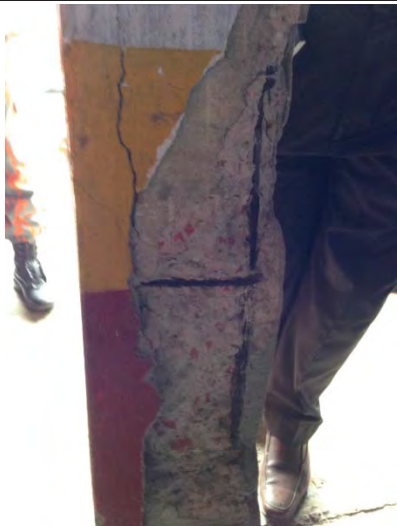
Deterioration(cracking, rusting, deflection and others)	<input type="checkbox"/> None <input checked="" type="checkbox"/> Existent : Corrosion of existing main reinforcing-bar in columns	
Irregular structure (Mass, Torsion, Weak/Soft story)	<input checked="" type="checkbox"/> None <input type="checkbox"/> Existent : -	
Constraints on seismic retrofit work	-	
Additional facilities/Fence	-	
Others	BUET owns land.	
Comments		
Approval of BUET is necessary to rebuild this fire station, because BUET owns land.

Corrosion of existing main reinforcing-bar in columns

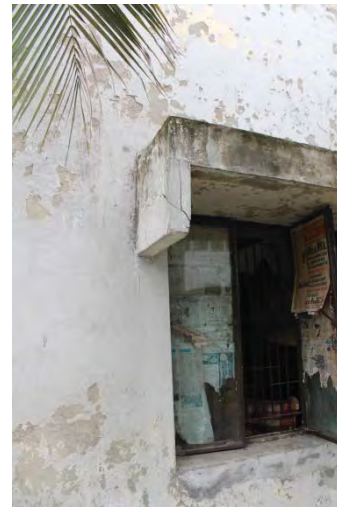
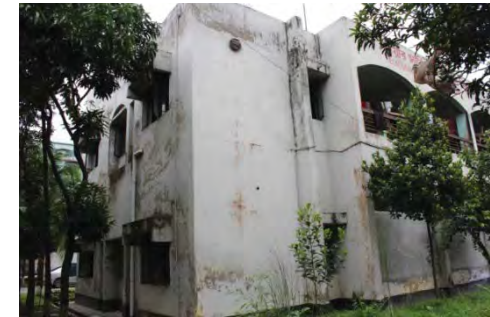
Outline information	
Name	⑫Savar EPZ (Type A)
Location	-
Occupation	<input checked="" type="checkbox"/> Fire station <input type="checkbox"/> School <input type="checkbox"/> Hospital <input type="checkbox"/> Others ()
Structural type	<input checked="" type="checkbox"/> RC <input type="checkbox"/> BRICK <input type="checkbox"/> RC+BRICK <input type="checkbox"/> Others
Foundation structural type	<input checked="" type="checkbox"/> Pile(- m) <input type="checkbox"/> Spread <input type="checkbox"/> Unknown
Number of stories	3-story
Year of completion	1997(Duration:17years)
Total floor/building area	671.19 m ² , 285 m ²
Surrounding terrain	-
Additional facilities	<input type="checkbox"/> None <input checked="" type="checkbox"/> Existent (Garage)
Fence	<input checked="" type="checkbox"/> None <input type="checkbox"/> Existent
Inspection results	
Deterioration(cracking, rusting, deflection and others)	<input type="checkbox"/> None <input checked="" type="checkbox"/> Existent :Cracking

Deterioration(Crack)

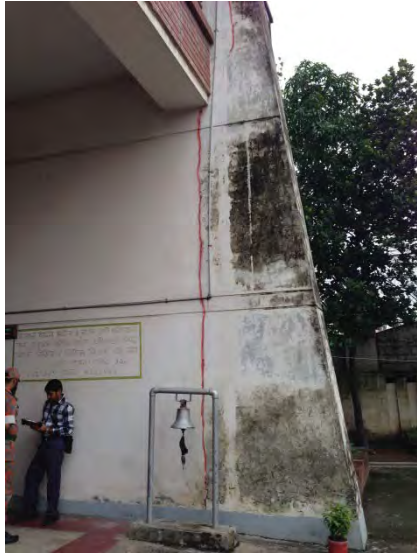
Outline information	
Name	⑭ Baridhara (Type B)
Location	-
Occupation	<input checked="" type="checkbox"/> Fire station <input type="checkbox"/> School <input type="checkbox"/> Hospital <input type="checkbox"/> Others ()
Structural type	<input type="checkbox"/> RC <input type="checkbox"/> BRICK <input checked="" type="checkbox"/> RC+BRICK <input type="checkbox"/> Others
Foundation structural type	<input type="checkbox"/> Pile(m) <input checked="" type="checkbox"/> Spread <input type="checkbox"/> Unknown
Number of stories	2-story
Year of completion	2004(Duration:10years)
Total floor/building area	Unknown/282 m ²
Surrounding terrain	-
Additional facilities	<input type="checkbox"/> None <input checked="" type="checkbox"/> Existent (Family quarter, etc.)
Fence	<input type="checkbox"/> None <input checked="" type="checkbox"/> Existent (Height is 1.5m)
Inspection results	
Deterioration(cracking, rusting, deflection and others)	<input type="checkbox"/> None <input checked="" type="checkbox"/> Existent : Cracking with settlement of building.

Cracking with settlement of building

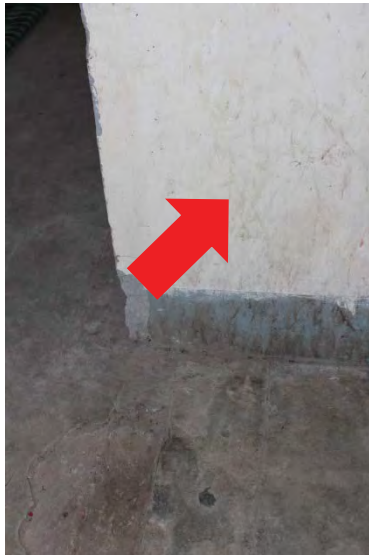
Deterioration(cracking, rusting, deflection and others)	<input type="checkbox"/> None <input checked="" type="checkbox"/> Existent :Cracking
Irregular structure (Mass, Torsion, Weak/Soft story)	<input checked="" type="checkbox"/> None <input type="checkbox"/> Existent:
Constraints on seismic retrofit work	-
Additional facilities/Fence	-
Others	Three story building with expansions (small intervals)

Situation of deterioration

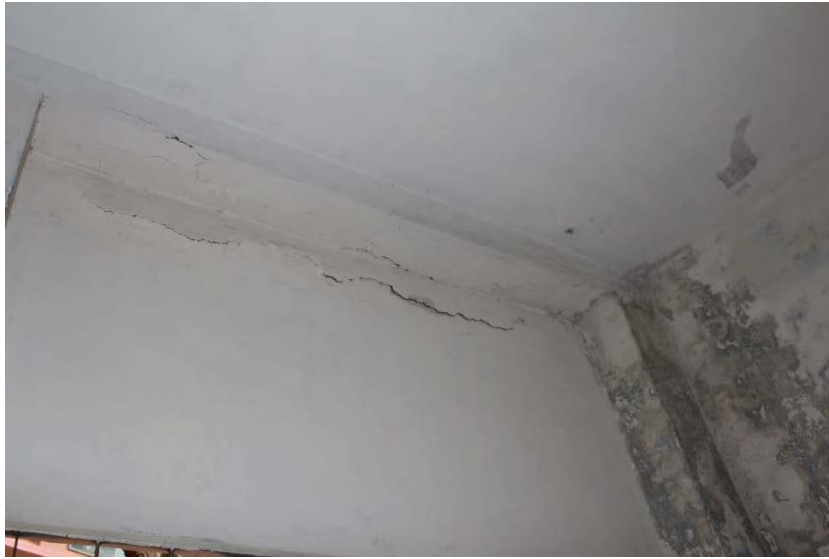
Deterioration(cracking, rusting, deflection and others)	<input type="checkbox"/> None <input checked="" type="checkbox"/> Existent : Corrosion of existing reinforcing-bar in beams
Irregular structure (Mass, Torsion, Weak/Soft story)	<input type="checkbox"/> None <input checked="" type="checkbox"/> Existent: Irregular plan, Frame is ununiformity.
Constraints on seismic retrofit work	-
Additional facilities/Fence	-
Others	-

Corrosion of existing reinforcing-bar in beams

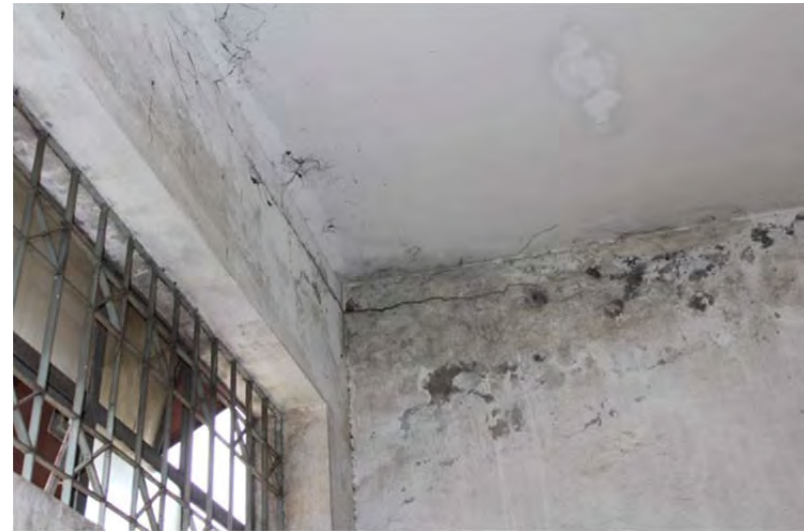
Corrosion of existing reinforcing-bar in beams
