エジプト国
橋梁設計（スエズ運河架橋建設計画
カウンターパート研修）
フォローアップ協力（調査）

調査報告書

平成 28 年 10 月
（2016 年）

独立行政法人
国際協力機構（JICA）

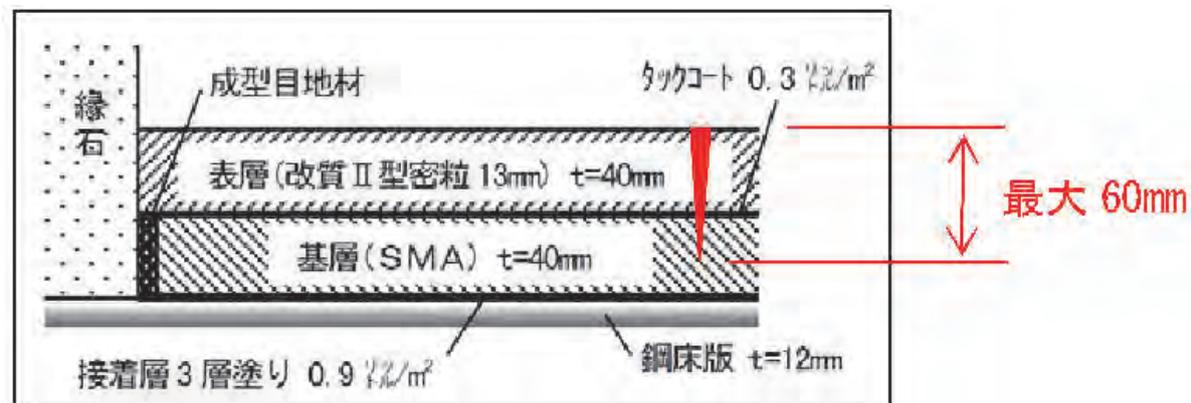
クラック範囲、幅は、2011年5月の調査時より広がった印象を受けた。また、ポットホールが発生、クラック幅、深さの進行など、明らかな損傷の進行が確認された。

図1.2.2 クラック調査(最大クラック深さ6cmを確認)

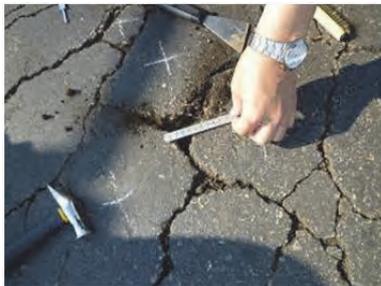
舗装のクラック（2012年調査）

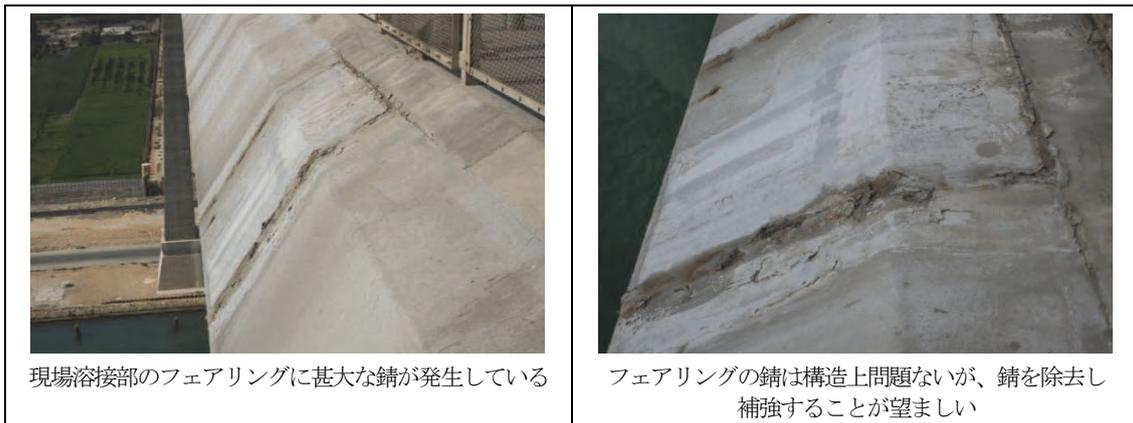
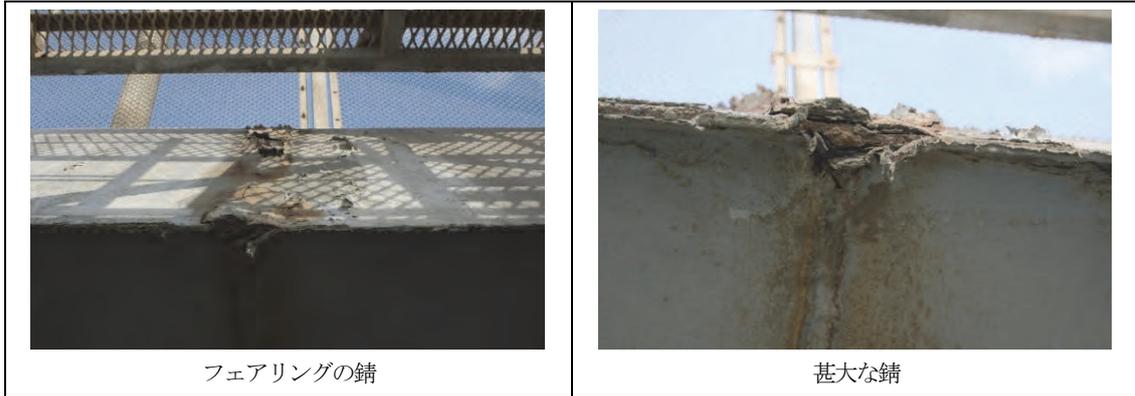
ただし、以下の写真に示すように南側の外側フェアリングに大きな損傷が確認された。フェアリングは構造部材でないため橋の安全性にかかわるものではないが、早急に錆を除去し、補強することを提案する。

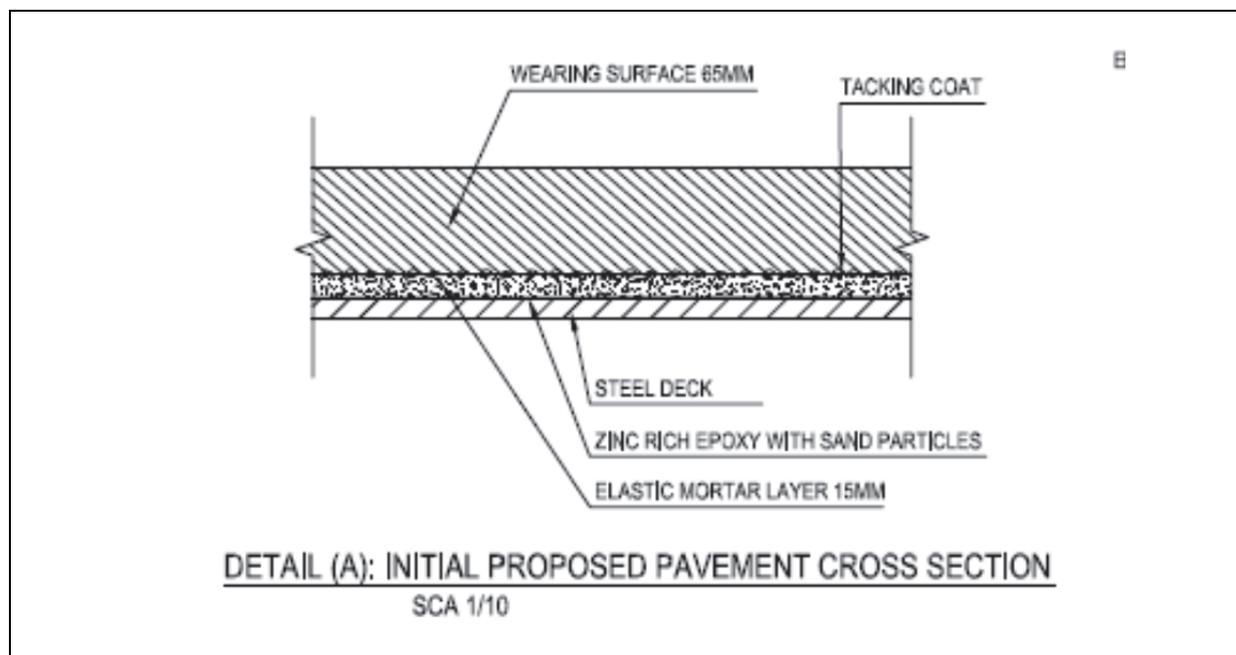
図 2.2.1 GARBLT 提案の舗装

GARBLT 提案の舗装については、日本での実績がないため、スエズ運河橋に用いることが適切か、調査チームは判断できない。しかしながら、Masara 橋での実績を考慮すると、GARBLT の責任で実施することにあえて、反対はしない。

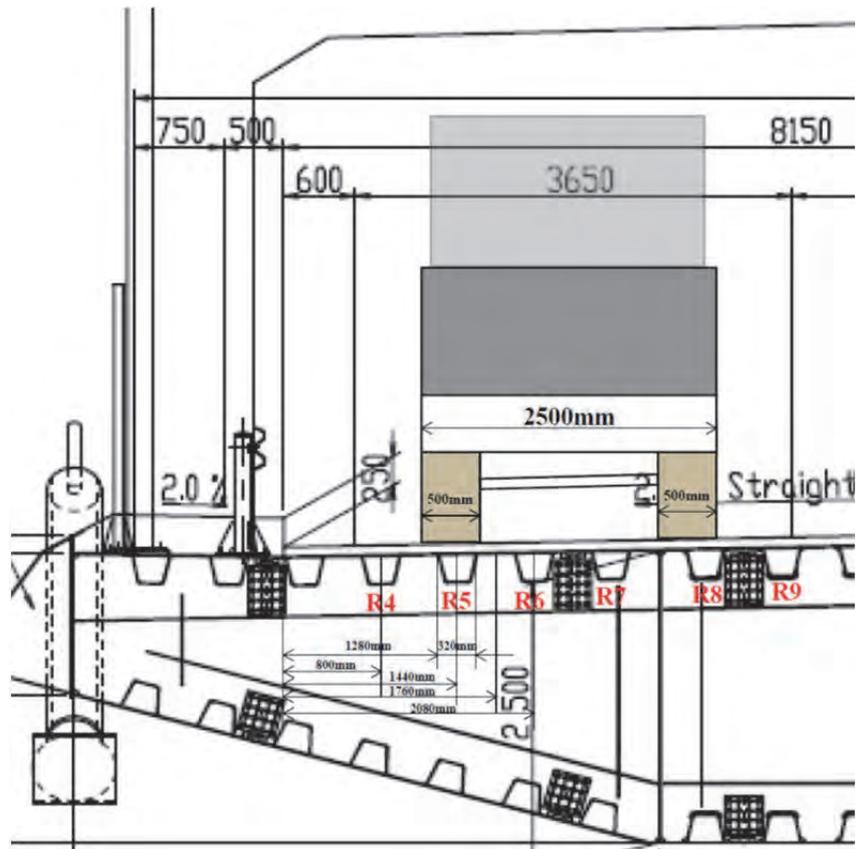
図 2.3.1 路肩から、U リブ中央またはU リブ間中央までの距離

図 2.3.1、2.3.2 に示すように舗装クラックは、概ねタイヤの通過位置と一致する。また、舗装クラックはUリブ内の中央または2つのUリブの間で発生している。この事は、舗装クラックが補強のリブプレートのない鋼床版の上面で発生していることを示す。これは、2012年調査の報告書にも記載されている。

舗装クラックは、Uリブ内の中央、および2つのUリブの間の無補剛位置にて、鋼床版の変形によって生じていると推察される。

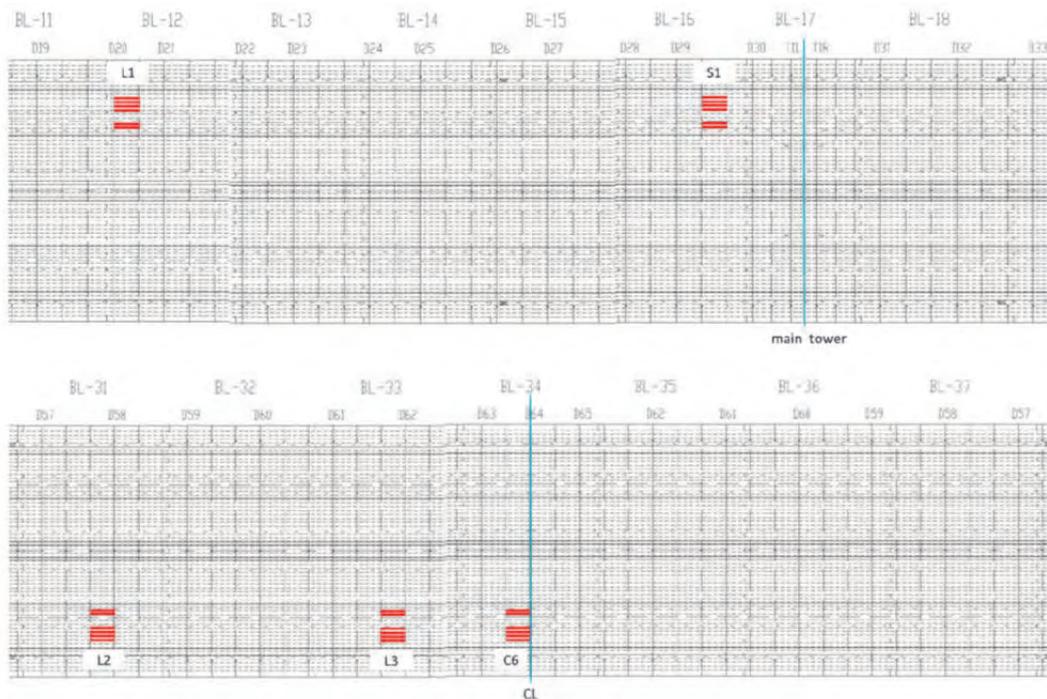
図 2.3.4 2012年調査のL1, S1, L2, L3, C6の位置

調査チームは箱桁内に入り、2012年に調査された図2.3.4の5か所の調査を行った。もしクラックが確認されれば、これは2012年以降に発生したことになる。R6とR5を中心に調査を行ったが、疲労クラック発生兆候となるペンキの割れは認められなかった。

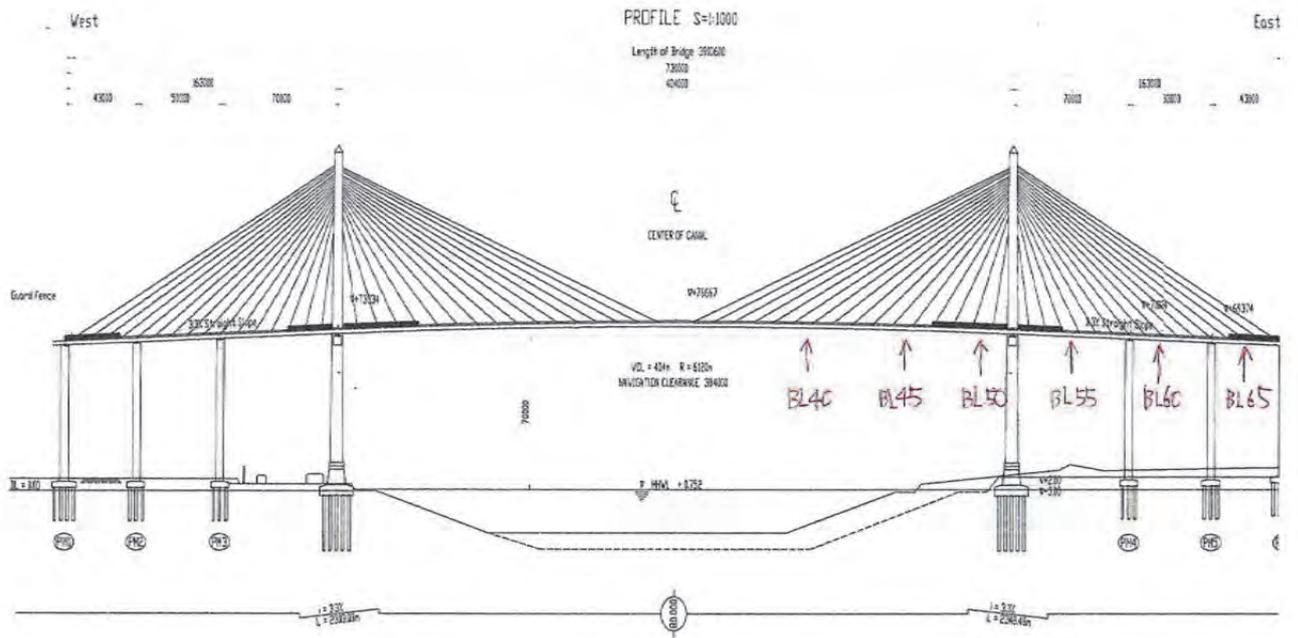
図 3.2.3 調査位置

箱桁内部で疲労クラックの調査を行った。図 3.2.3 に示す、BL 40 から BL 65 を調査した。主に北側、南側の R8 の U リブまわりを調査した。結果、疲労クラック発生の兆候となるペンキの割れは認められなかった。

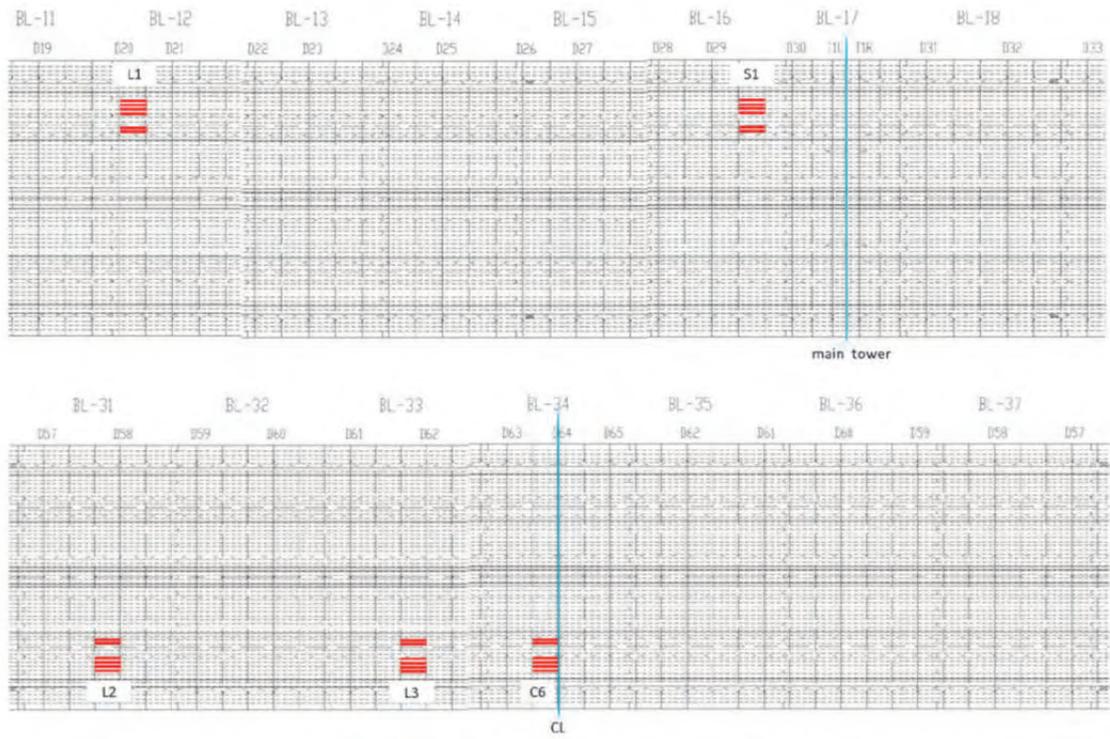
图2 2012年調査L1, S1, L2、L3位置

調査チームは箱桁内に入り、2012年に調査された図2.3.4の5か所の調査を行った。もしクラックが確認できれば、これは2012年以降に発生したことになる。R6とR5を中心に調査を行ったが、疲労クラック発生の兆候となるペンキの割れは認められなかった。

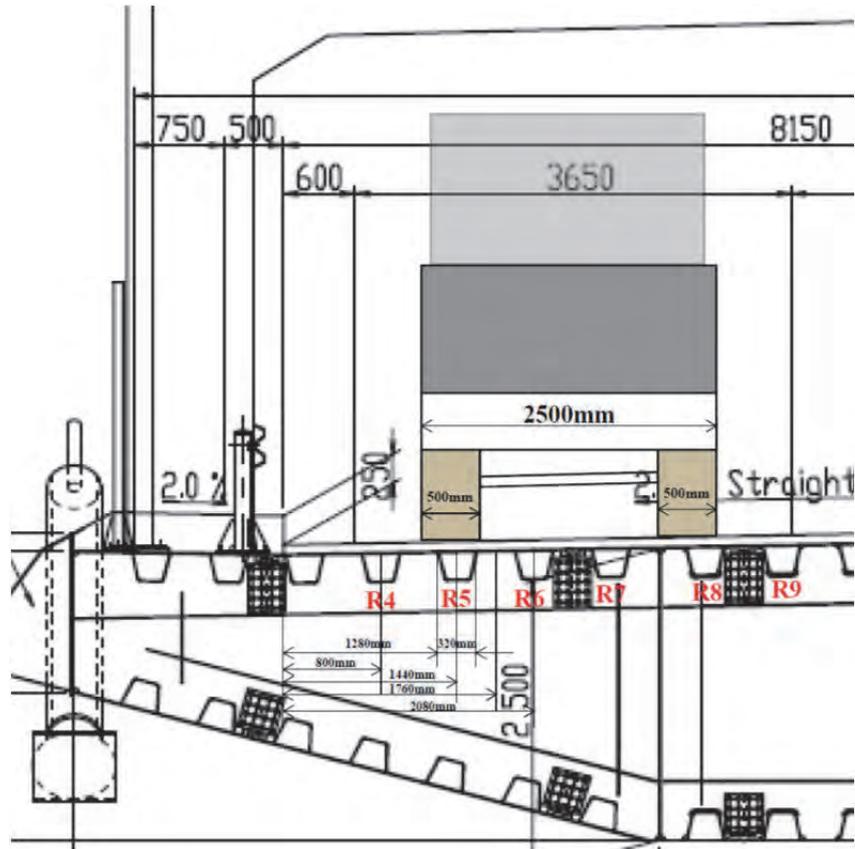
図1 地覆端からUリブ中央およびUリブ間中央までの距離

図 1、2 に示すように舗装クラックは、概ねタイヤの通過位置と一致する。また、舗装クラックは U リブ内の中央または 2 つの U リブの間で発生している。この事は、舗装クラックが補強のリブプレートのない鋼床版の上で発生していることを示す。これは、2012 年調査の報告書にも記載されている。

舗装クラックは、U リブ内の中央、および 2 つの U リブの間の無補剛位置にて、鋼床版の変形によって生じていると推察される。

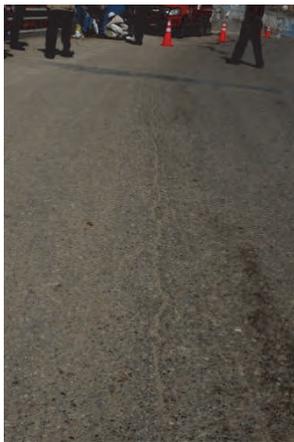
9. Cracks on the pavement. These cracks seem to correspond to the position of two panel connection, because two panels can move independently to some extent.

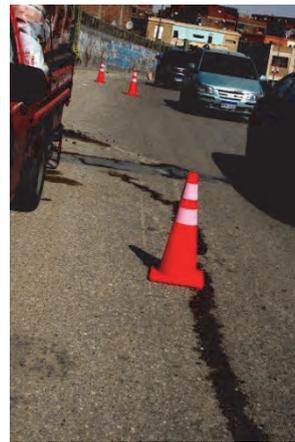
10. Cracks on the pavement. These cracks seem to correspond to the position of two panel connection.

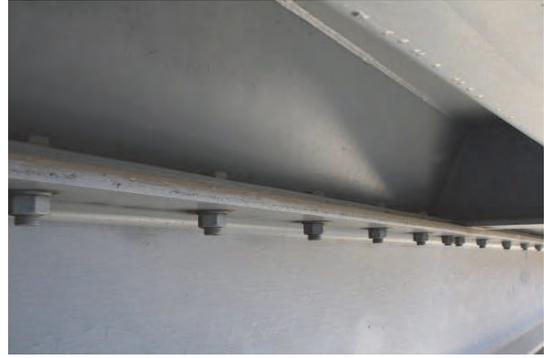
12. Inclined plate above the longitudinal beam. The structure is well-designed. No sign of fatigue cracks were found.

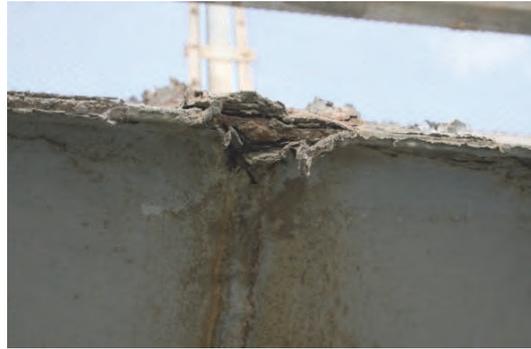
10. 大きな錆による損傷

ただし、写真に示すように南側の外側フェアリングに大きな損傷が確認された。フェアリングは構造部材でないため橋の安全性にかかわるものではないが、早急に錆を除去し、補強することを提案する。

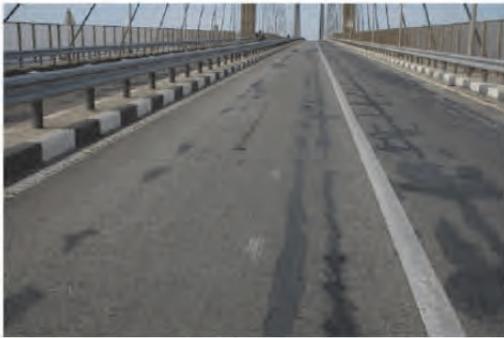
1. East side of the bridge and north lanes. Looking towards West on Overtaking Lane. Line repairs of pavements are visible.

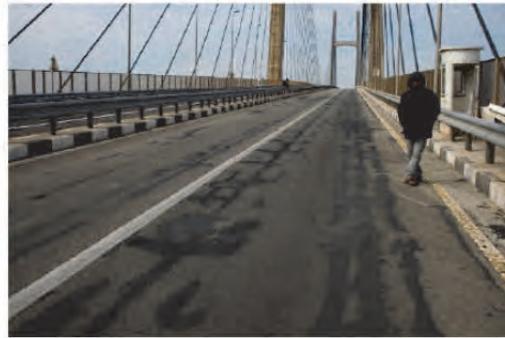
2. Driving Lane and 5 lines of pavement repair are visible. These lines correspond to the center of the U-ribs or the center of two adjacent U-ribs. This will be explained in detail, later.

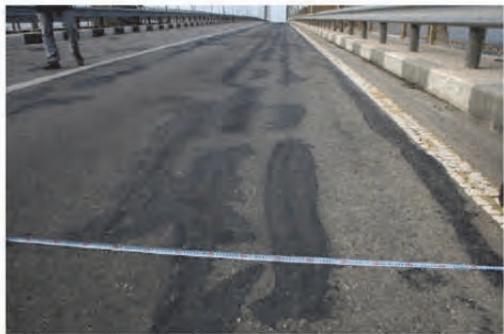
3. In this area, a repair line near the right white line, which is at the center of R4, is visible. But over this line, tires do not run so often and the reason of the crack formation is unclear.

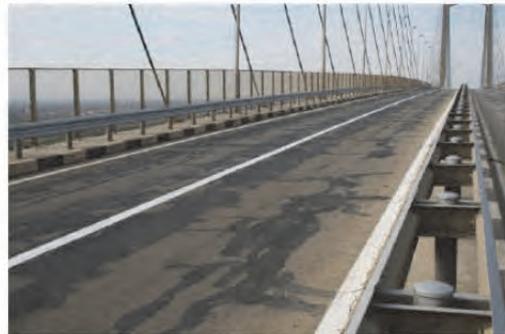
4. On the south lane, the pavement crack over R4 U-rib is not formed.

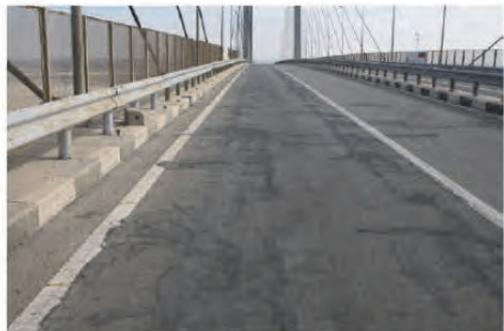
5. Near the bridge center, a crack line over R4 is not formed.

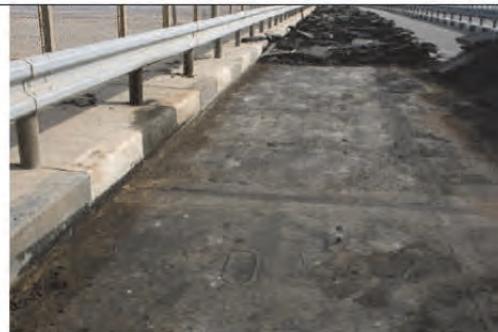
6. Near the tower, pavement materials were removed and the starving horse is visible. A temporary hand hole is between R4 and R5.

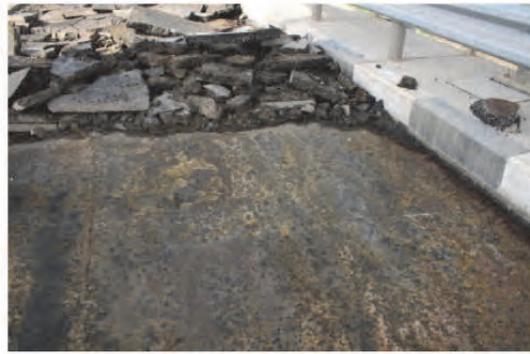
8. Corroded area near the west tower. This may be worst corroded.

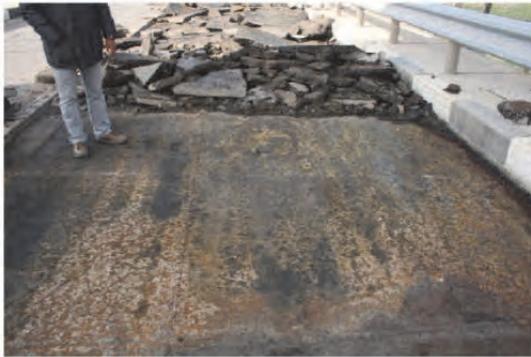
9. Corrosion near the west tower and on the North Lane.

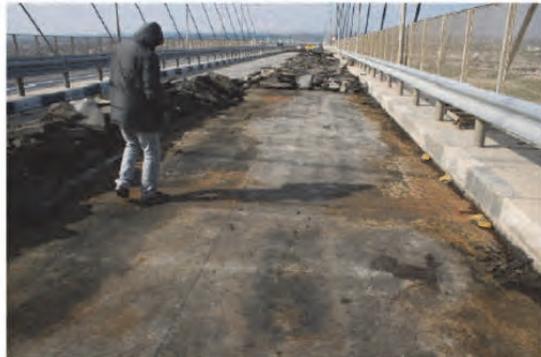
10. The corroded areas are on both sides which are below the cracked pavement areas. The center area is healthier.

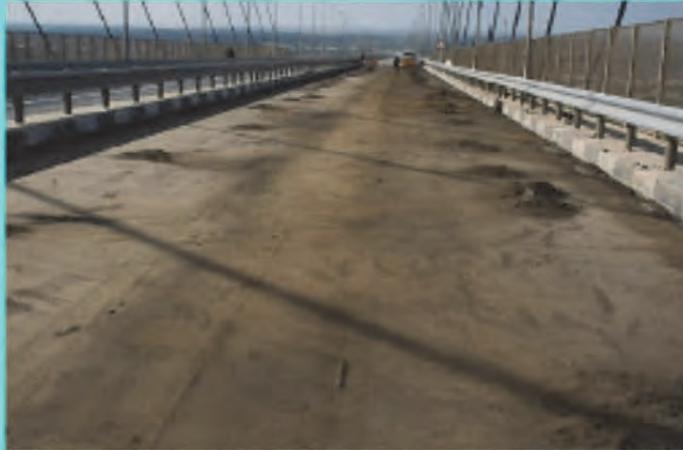
Lines of rust were not found. A line of rust can indicate the existence of penetrated fatigue crack initiated from inside of the deck plate. Non-existence of lines of rust does not assure non-existence of fatigue cracks inside. Fatigue cracks around U-shaped rib under deck plate need to be checked. White areas above are generally healthy. Red areas are rusty to some extent. Both ends of the road surface and the center are often rusty. The average reduction of thickness is not large.

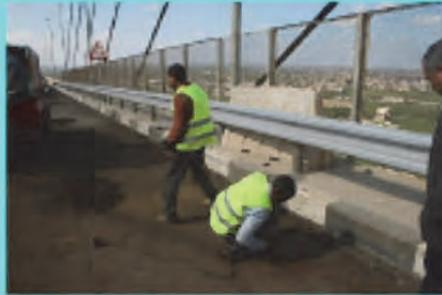
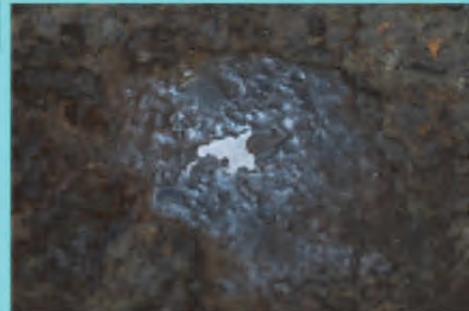
Measurement of Extra1, Rustiest spot

Thickness 11.21mm

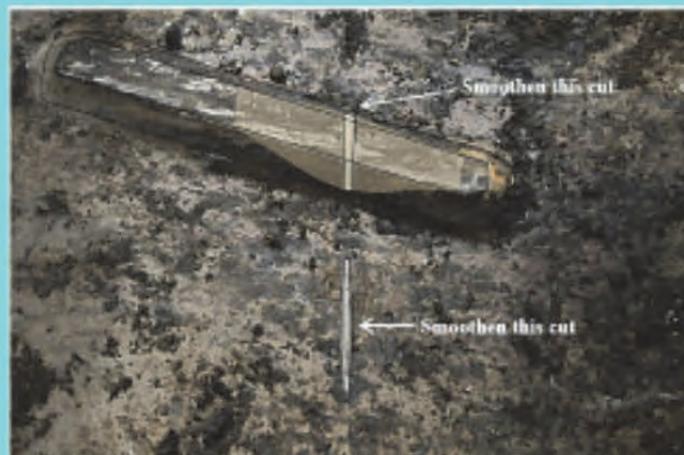
When the thickness was measured, two small cuts on the remaining of the lifting piece and the deck plate were found. It was requested to smoothen the cuts at the site, but SAMCO engineer proposed to do so later because a smaller grinder was easy to do so. This kind of cut should be avoided as far as possible.

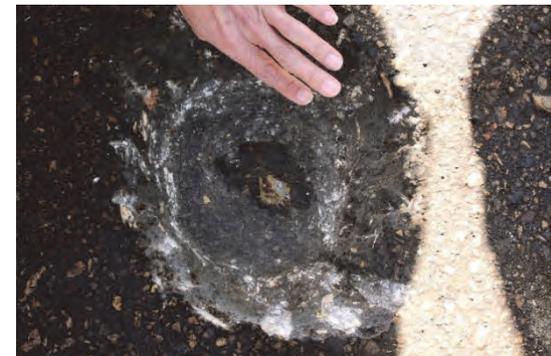
4. Condition of pavement was quite good and no rust was observed on the deck surface. The yellow color shows the Zinc Chromate. Hexavalent(+6) Chrome is toxic but Trivalent(+3) Chrome is not.
