**FOLLOW-UP COOPERATION STUDY  
ON  
THE BRIDGE DESIGN  
(COUNTERPART TRAINING FOR THE SUEZ  
CANAL BRIDGE PROJECT)**

**FINAL REPORT**

**JAPAN INTERNATIONAL COOPERATION AGENCY**

**ORIENTAL CONSULTANTS GLOBAL CO., LTD.  
CHODAI CO., LTD.**

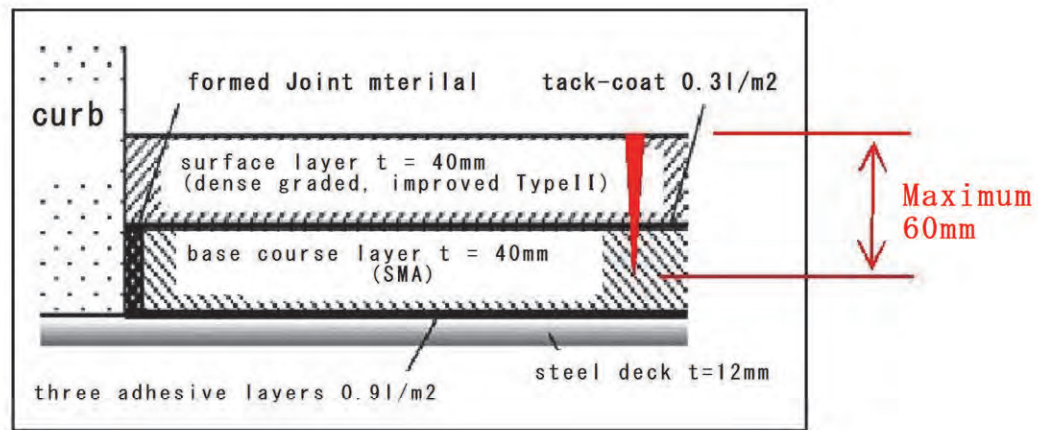
The Survey Team conducted an investigation on damage conditions of the pavement in August 2011. The area and the width of cracks had increased since the survey in May 2011. In addition, the progress of damage to the pavement, such as the occurrence of potholes and the crack width and depth increases were confirmed.

Figure 1.2.2 Cracks Survey ( Maximum crack depth 60 mm was confirmed)

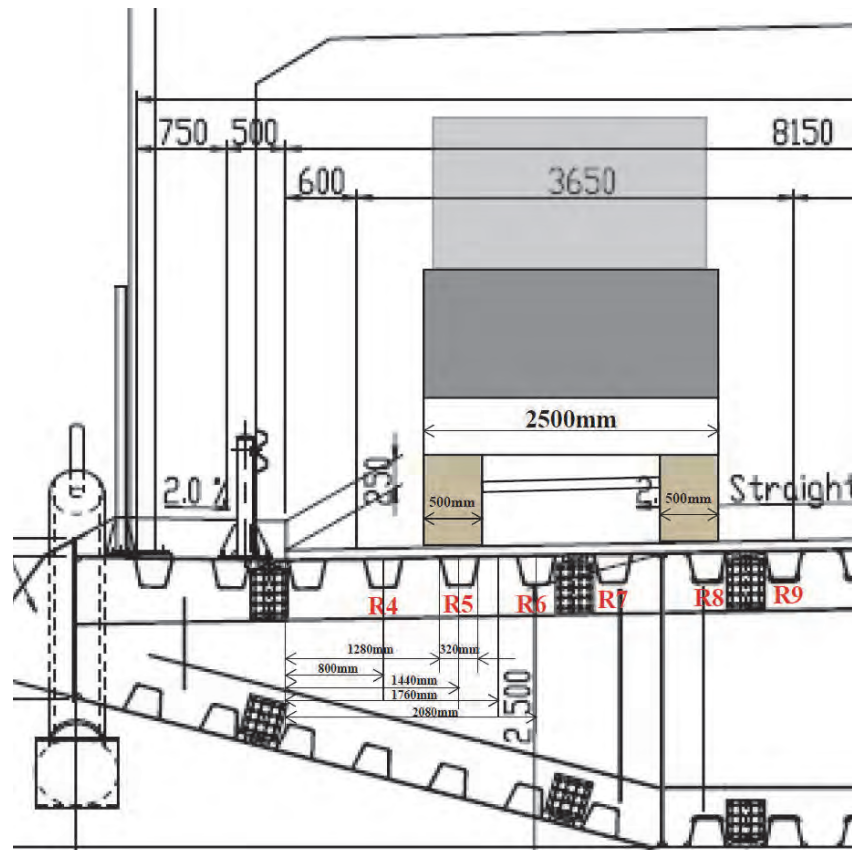
Fig.2.3.1 Distance from Curb to Center of U-ribs or to Center between Two adjacent U-ribs

As shown in Fig.2.3.1 & 2.3.2, pavement cracks roughly correspond to the tire passing lines. Also the pavement cracks correspond to the positions of the center of U-ribs, or the center of two adjacent U-ribs. This means that the pavement cracks occur over the plates under which no reinforcing ribs exist. This can be seen from the report of 2012, too.

Pavement cracks may have been caused by the deformation of the steel deck plates over an empty space of the U-rib or an empty space between two adjacent U-ribs.

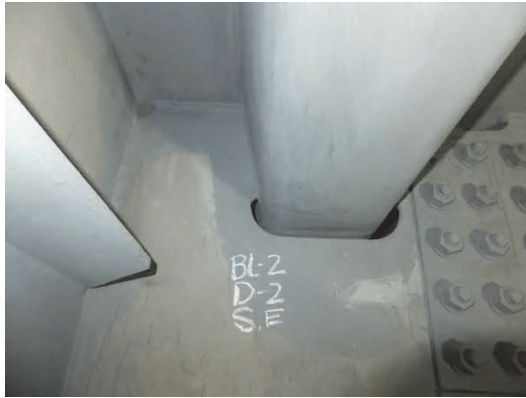
R8 and D2 diaphragm, East face.

The Study Team again inspected inside of the box girder, especially R8 U-rib areas. The inspected area is the west side span and half of center span. As a result, no paint cracks nor fatigue cracks were found.

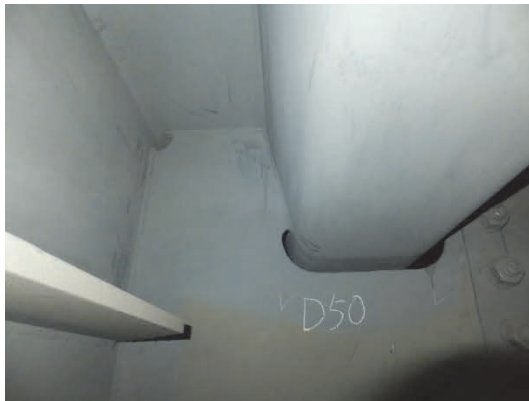
D50 diaphragm, east face. No cracks.

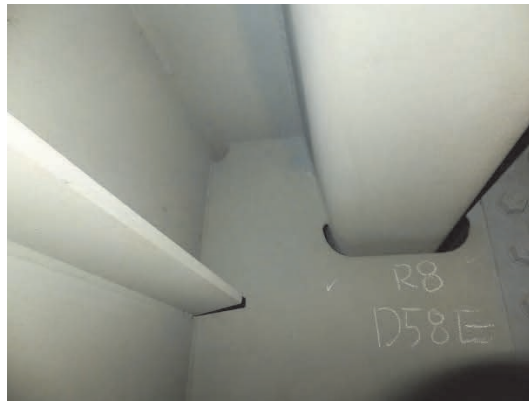
D58 diaphragm, east face. No cracks.  
Above this area, pavement cracks exist.

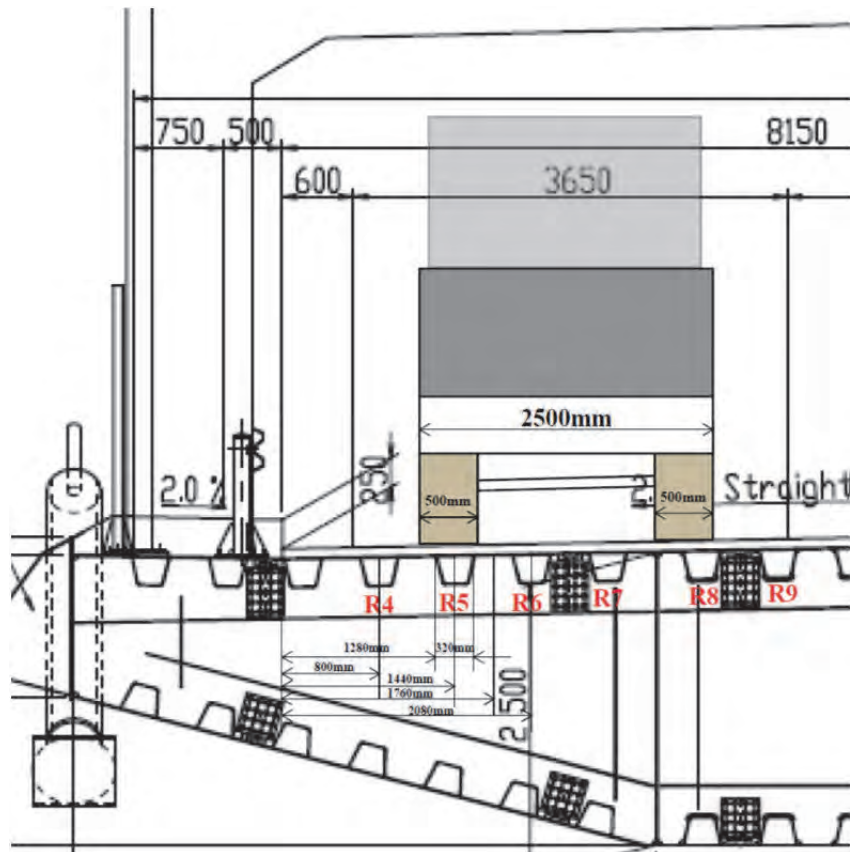
Fig.1 Distance from Curb to Center of U-ribs or to Center between Two adjacent U-ribs

The cracks may have been caused by the deformation of the steel deck plates over an empty space of the U-rib or an empty space between two adjacent U-ribs.

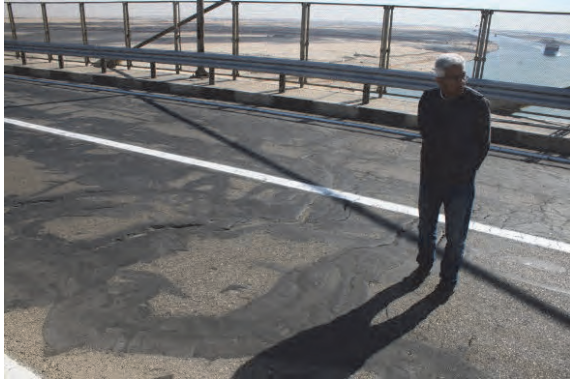
1. This is the same photo of 28th Day Report. Large cracks at center of center span on South Lane near 3rd cable from the longest west side cable. It seems the pavement is flowing. The reason is unclear. 3rd cable is fixed near D58 Diaphragm. The inside around D58 was examined.

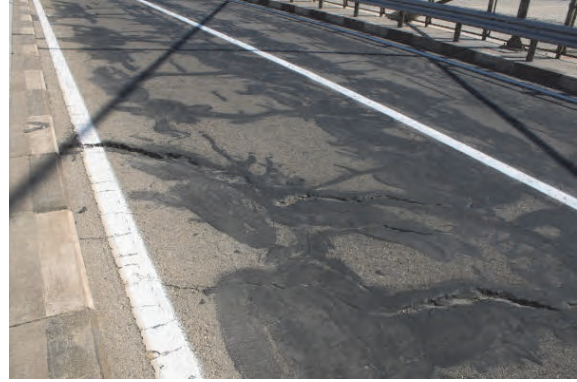
2. This is the same photo as Photo 1 from 28th Day Report. The same large cracks as Photo 1.

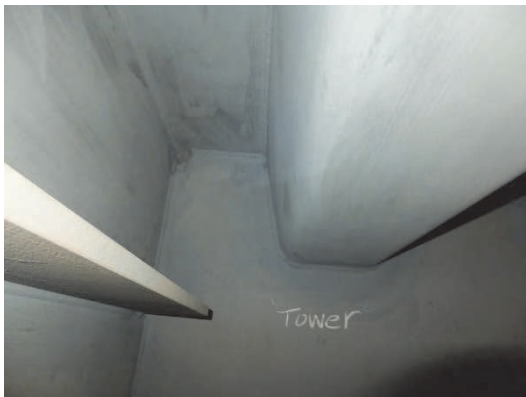
3. Only south side R8 U-rib is shown. D30, East face at Tower. No paint cracks were found.

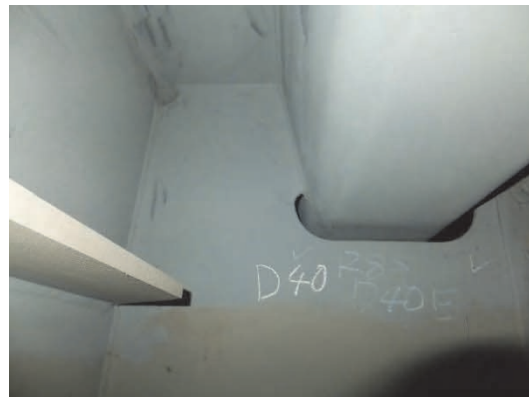
4. D40 diaphragm, east face. No cracks.

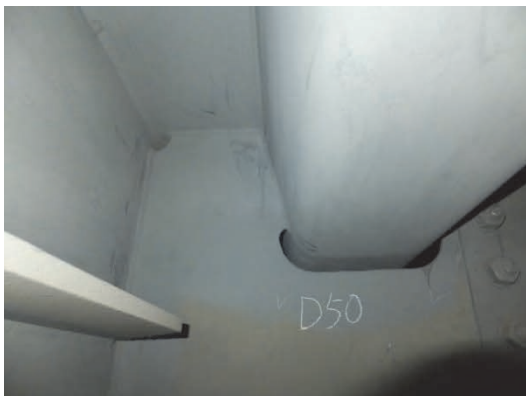
5. D50 diaphragm, east face. No cracks.

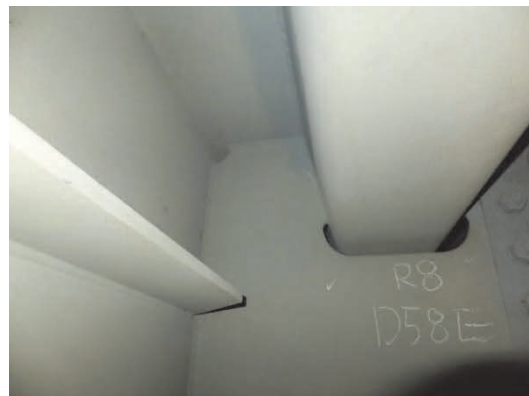
6. D58 diaphragm, east face. No cracks. Above this area, pavement cracks exist.

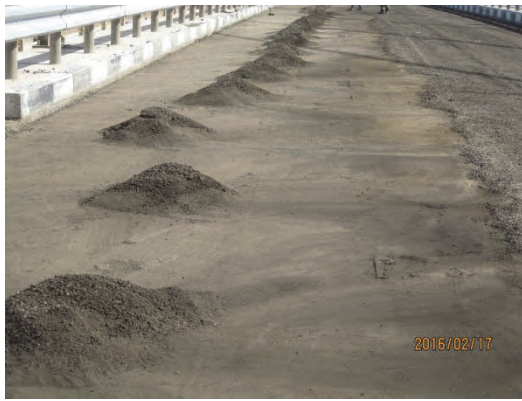
A line of rust can indicate the existence of penetrated fatigue crack from inside of the deck plate. So the checking of a line of rust is very important. Lines of rust were not found.

1. Surface after removal of pavement.

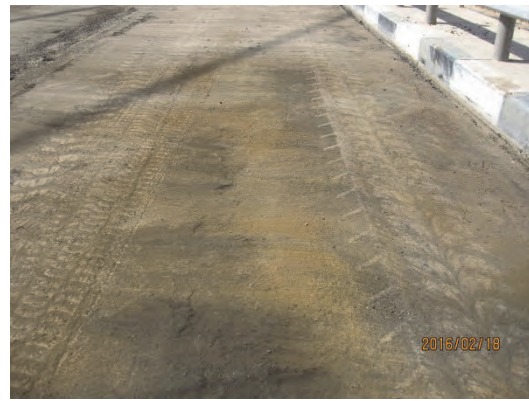
2. Corrosion of the surface East side (North lane)

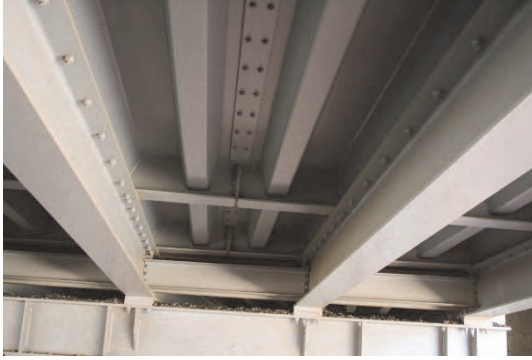
11. U-ribs and adjacent U-ribs directly above the longitudinal beam and consisting of two inclined plates.

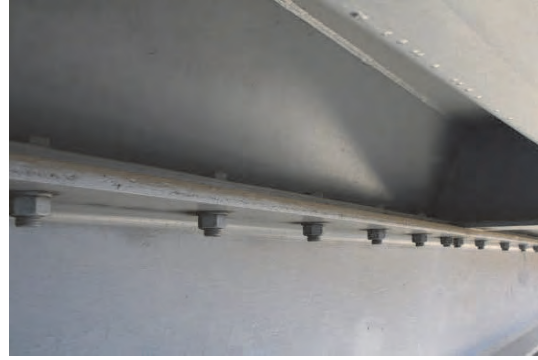
12. Inclined plate above the longitudinal beam. The structure is well-designed. No sign of fatigue cracks were found.

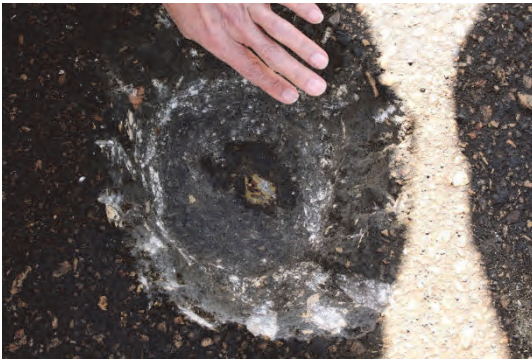
15. Condition of pavement was quite good and no rust was observed on the deck surface. The yellow color shows the Zinc Chromate. Hexavalent(+6) Chrome is toxic but Trivalent(+3) Chrome is not.

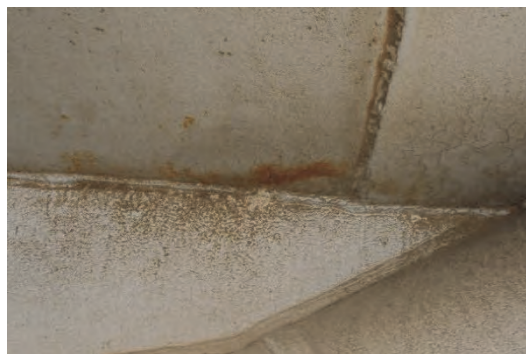
3. Some rust near pipe fixing structure.

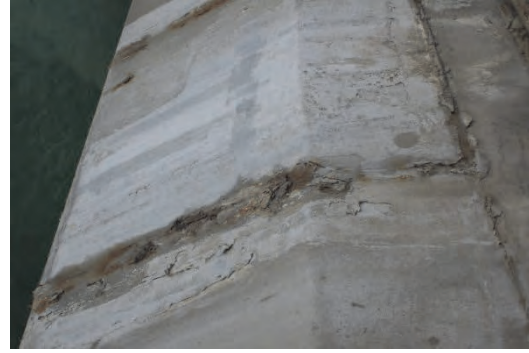
8. Corrosion. The fairing is not a structural member but it is better to remove the rust and repaint immediately.

The condition of the bridge deck is good partly because of the scarce rain, the good paint, etc. But one severe corrosion was found. It is on the fairing. The fairing is not a structural member so that the bridge will not collapse even if a small part of the fairing disappeared. But it is strongly recommended to remove the rust and repaint the surface immediately. Although it seems that the engineers do not inspect the bridge so often, they know the places of rust very well.

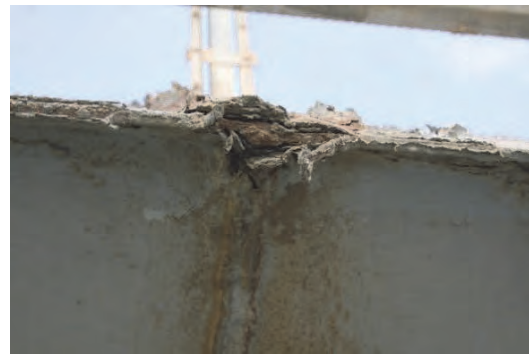
10. Severe corrosion

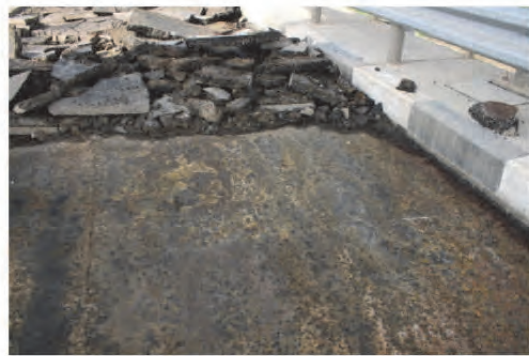
8. Corroded area near the west tower. This may be worst corroded.

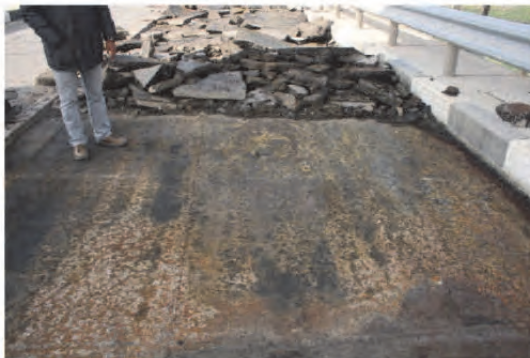
9. Corrosion near the west tower and on the North Lane.

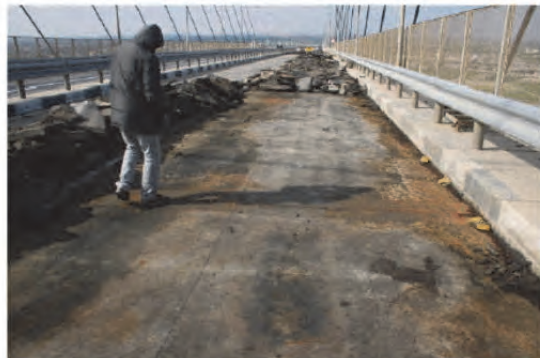
10. The corroded areas are on both sides which are below the cracked pavement areas. The center area is healthier.

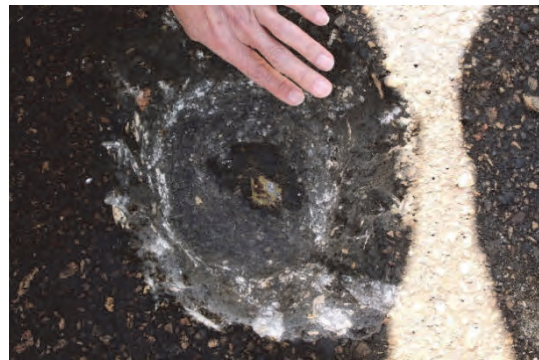
4. Condition of pavement was quite good and no rust was observed on the deck surface. The yellow color shows the Zinc Chromate. Hexavalent(+6) Chrome is toxic but Trivalent(+3) Chrome is not.
