**PREPARATORY SURVEY
ON
HYDROPOWER PLANTS REHABILITATION PROJECT
IN
THE REPUBLIC OF THE UNION OF MYANMAR**

FINAL REPORT

November 2016

Japan International Cooperation Agency

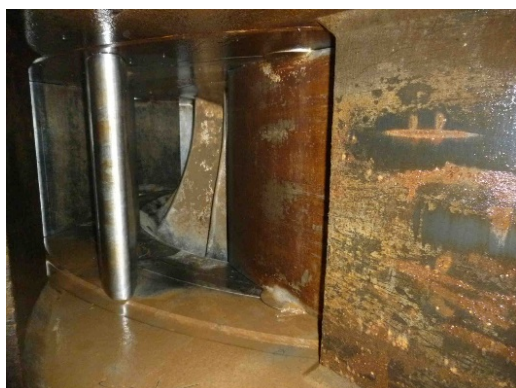
(1) from the out-side of Guide Vanes

The inside portions of the guide vane pitch circle and runner vane surfaces (only pressure side) are in good condition and no apparent problems. (Photo 4.1-2 (1))

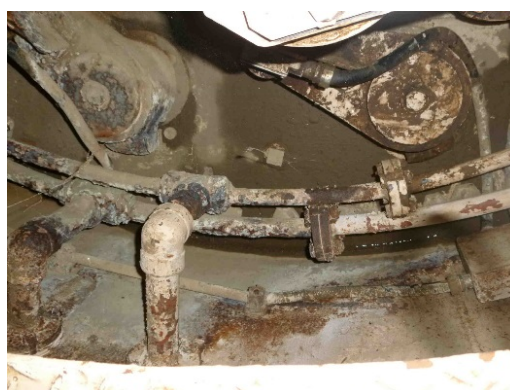
There are deeply rusted portions on the surface of water distribution pipes of each unit. It may become the cause of eroded holes and water leakage in the future. (Photo 4.1-6 (2))

(2) Eroded water piping

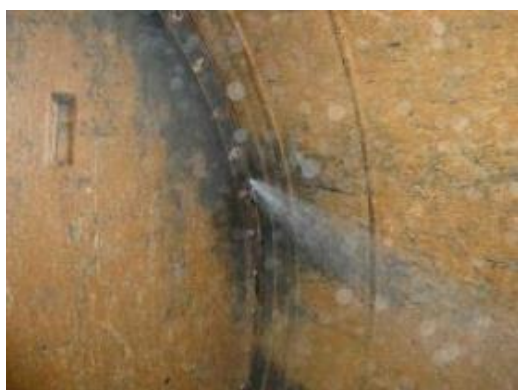
In general, the water seal is in good condition. However, there are slight water leakage points due to the partial damage of sealing packing. Water is leaked splashing at unit-#1 and dropping at unit-#2. (Photo 4.1-7)

(1) Splashing water leakage (unit #1)

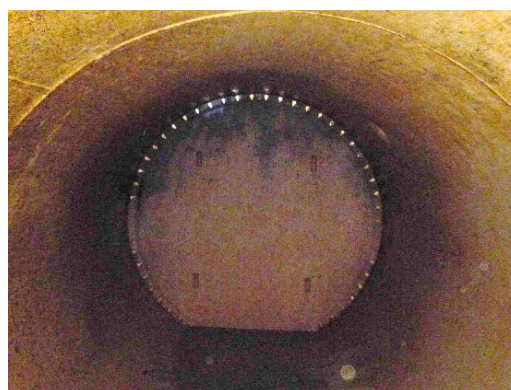
(2) Drop-like water leakage (unit #2)

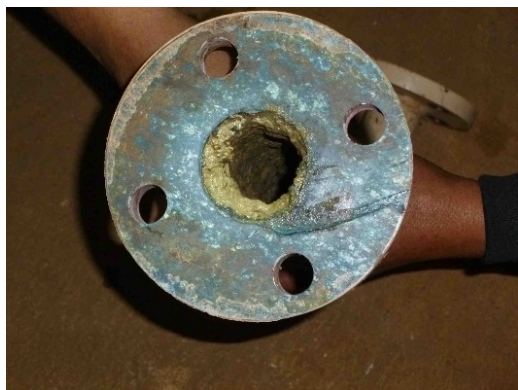
(1) Rust and mud accumulation in the water piping (near strainers)

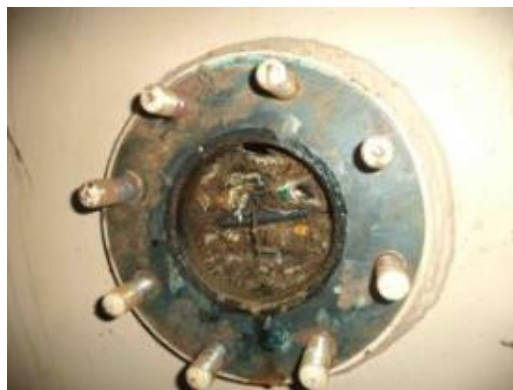
(2) Foreign Materials at the intake of cooling water piping

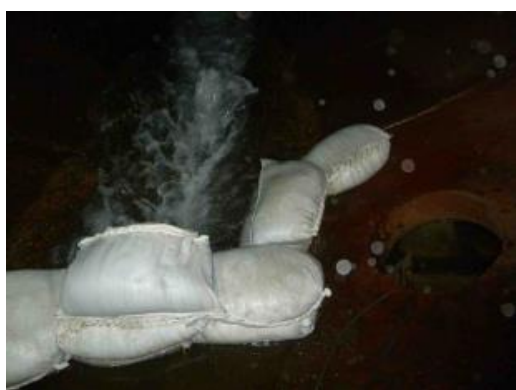
(1) Water leakage of unit #2

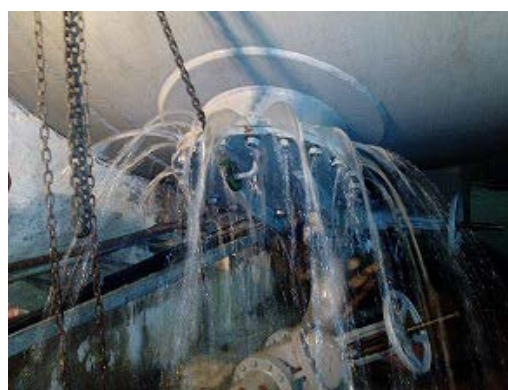
(2) Water leakage of unit #1

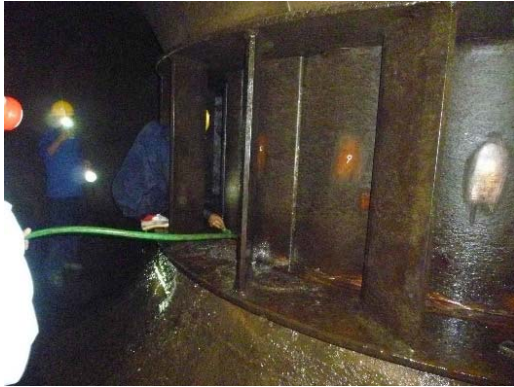
(1) External view of Guide vanes

Gaps at the upper and lower portion of guide vanes are measured. The measured gaps are averagely 2.0 - 3.0mm. This value extremely exceeds the design value of 0.5mm. There are much less sand abrasions at the surface of facing plates of upper and lower cover portion. It is necessary to adjust the guide vane gaps at the upper and lower portion during future overhaul work.

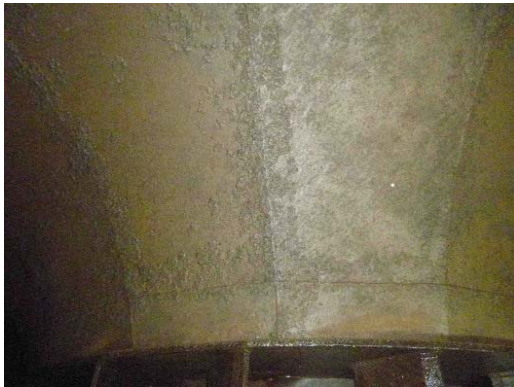
There are many blisters due to the rusty knobs on the inner surface of casing. It is necessary to execute scouring rust, cleaning and coating the surface (Photo 4.1-18).

(1) Blisters on casing surface

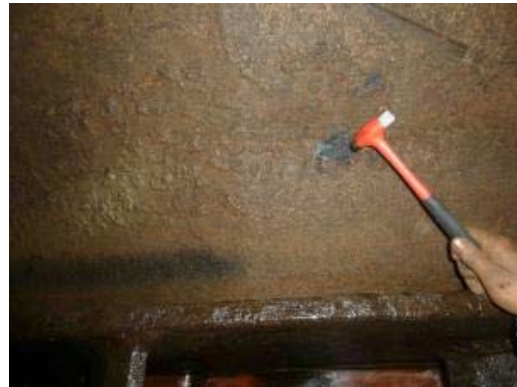
(2) Hammering check of rusty portion

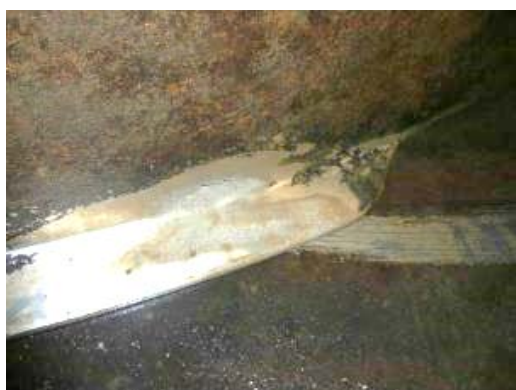
(1) Portions eroded by cavitation

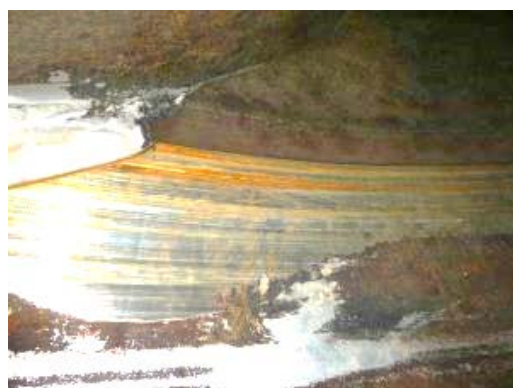
- c) Gaps between the outer periphery of runner vanes and the inner surface of the discharge ring are measured. Gaps of the vane have the values of minimum 0.6mm and maximum 5.3mm. This variation is remarkably large. It is supposed that aging of overall equipment has been developed. It is necessary to adjust these gaps in the future. (Photo 4.1-19 (3)).
- d) Circumferential abrasion signatures are observed at a portion of the inner face of the discharge ring. However the relation with the large variation of runner vane gaps mentioned in 3) is not clear. (Photo 4.1-19 (4)).

(4) Abrasion signatures

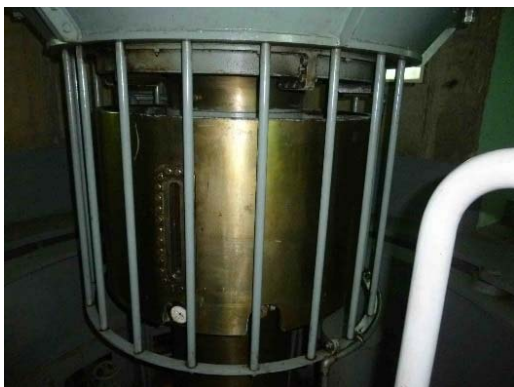
(1) Oil tank on turbine shaft

Indication of the oil gauge (sight glass) of the rotating oil tank equipped at the upper turbine shaft cannot be checked due to the grim of deteriorated oil by aging (both unit). (Photo 4.1-21 (1))

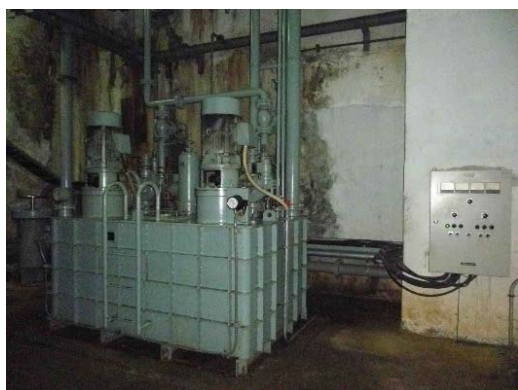
(1) Oil sump tank set

Total function of the oil sump tank set is decreased due to the deterioration of unloader valves on the tank and all electrical components/devices including the local control panel.

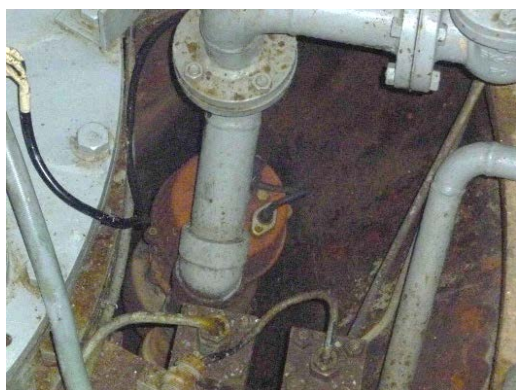
(1) Drainage pump on head cover (2 pumps/unit)

One of two pumps is in trouble at both units. The remaining pump is predicted to be in aging and deteriorated conditions.

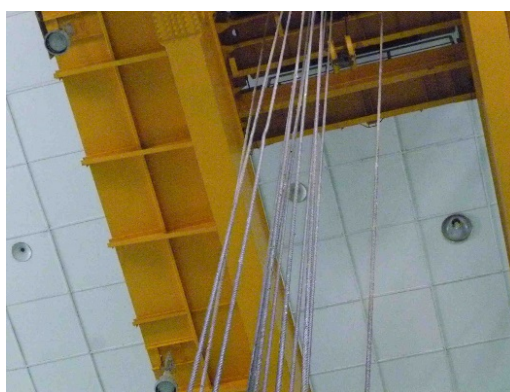
(3) Damage(kink) of main lifting wire

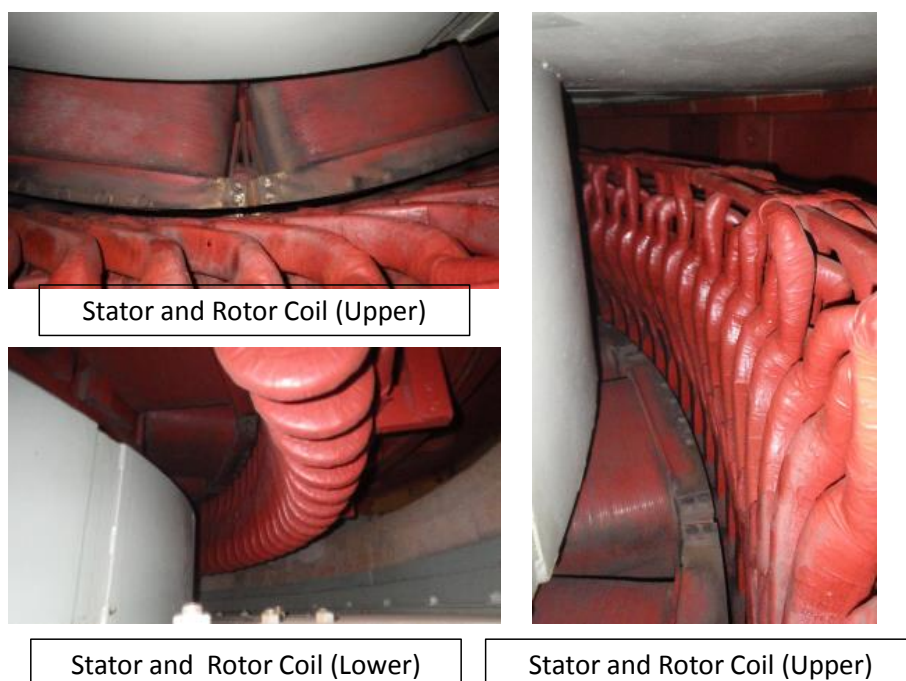
Photo 5.1-1 Stator and Rotor Coil

There are no abnormal apparent symptoms except dust-coats at the surface of stator and rotor coils. However, the decrease of insulation function is assumed due to the aging deterioration (Photo 5.1-1).

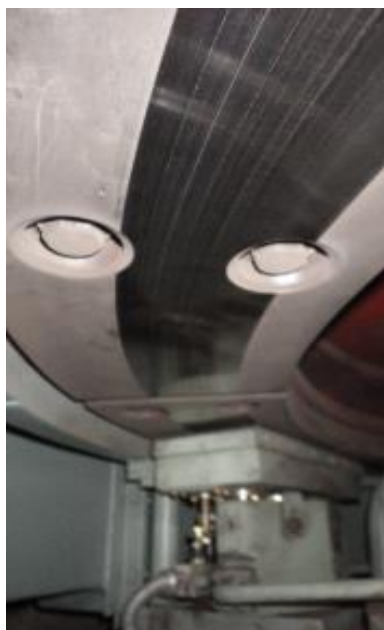
Brake ring is damaged by the slide scaring. Decrease of the reliability due to the deterioration of braking control equipment may cause the burning accident of bearing in the shutdown procedures of turbine and generators (Photo 5.1-4).

Sliding Scarring of Brake Ring

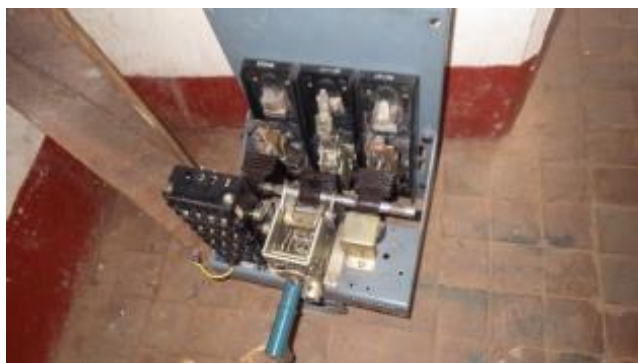
Damaged FCB

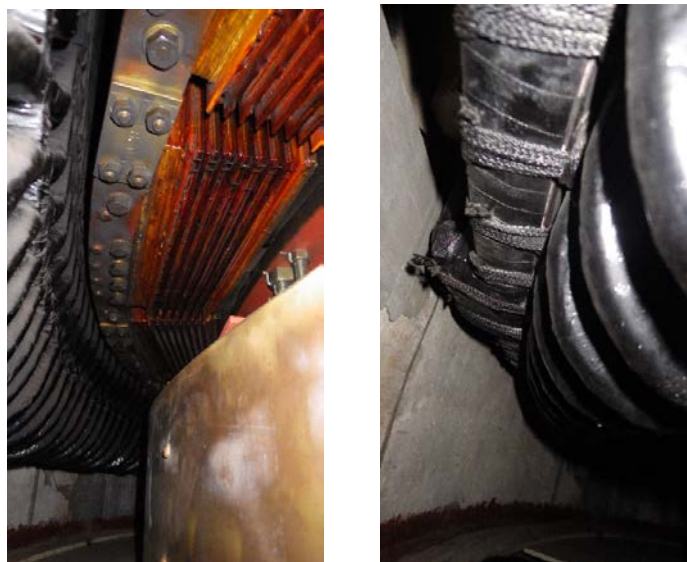
Photo 5.1-11 Stator and Rotor Coil

Defective appearances are not observed by the visual inspection except the dust coating on the surface of stator and rotor coils (Photo 5.1-11).

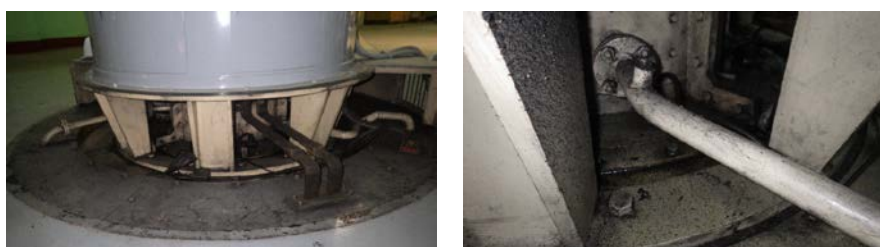
There is oil leakage at the upper bracket from oil tank of the upper bearing and at the lower bracket from oil tank of the lower bearing (Photo 5.1-12).

Oil Leakage at Upper Bracket

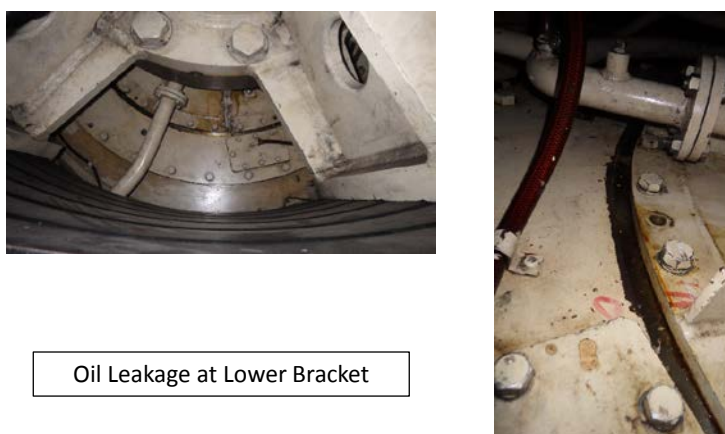
Oil Leakage at Lower Bracket

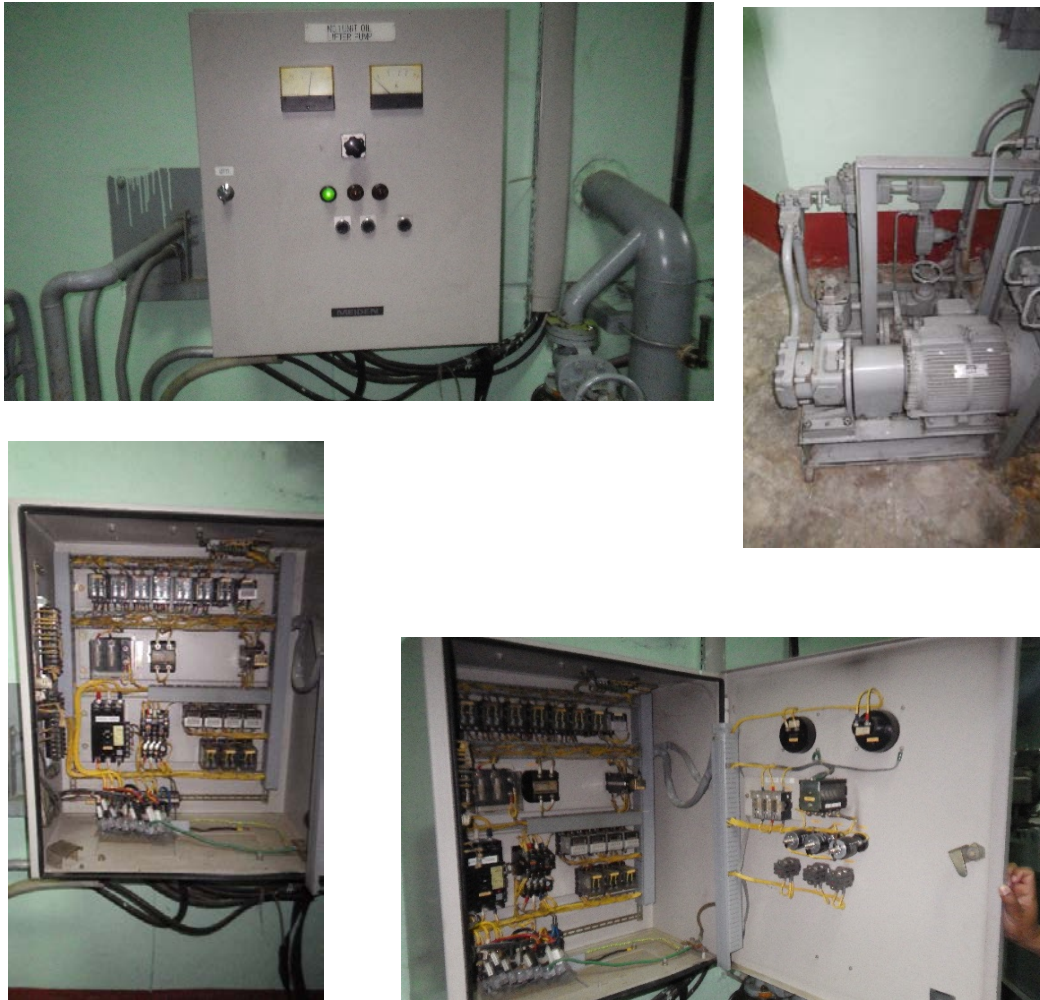
Photo 5.1-17 Oil Lifter

In past, the oil lifter was clogged. Reliability is supposed to decrease due to the deterioration of the main body of equipment and control equipment. It may cause the burning accident of thrust bearing in the starting and stopping process of turbine and generator (Photo 5.1-17).

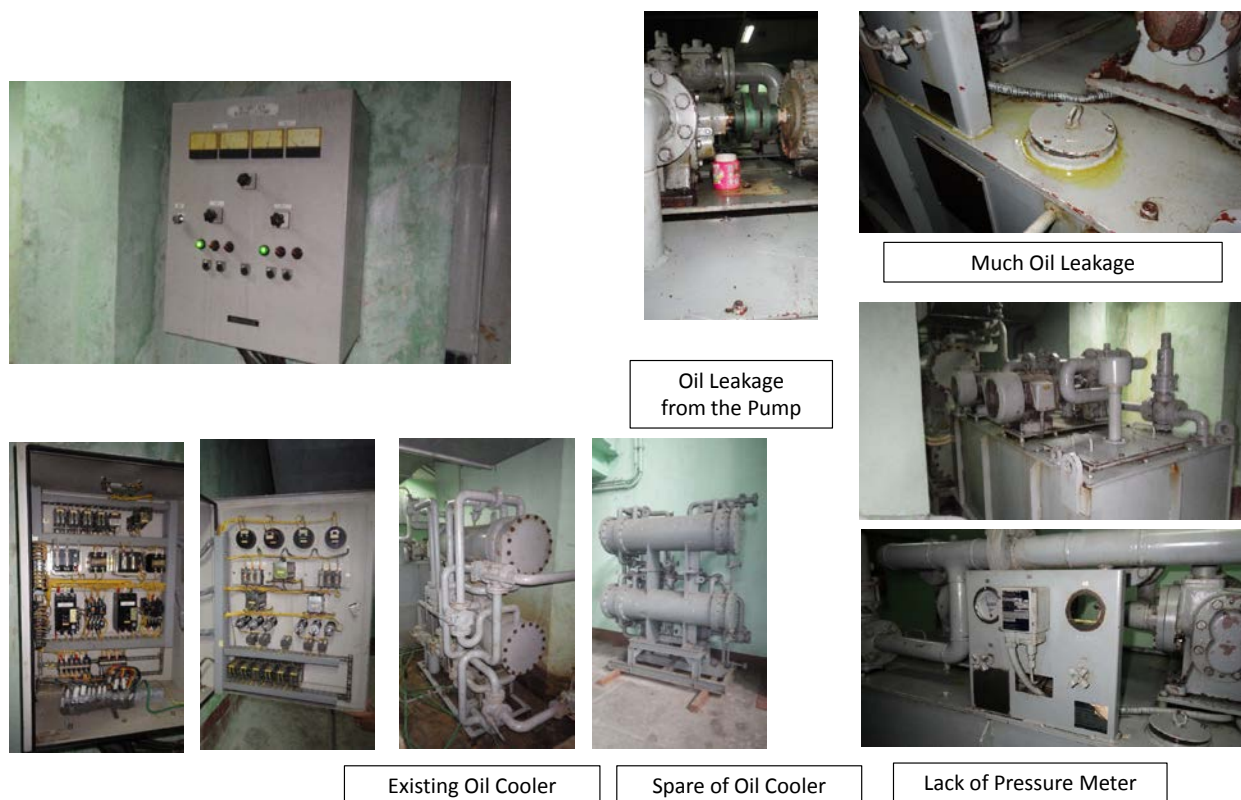
Photo 5.1-18 Lubricating Oil Cooling Unit

Vibration of electronic pump occurs in the lubricating oil cooling unit (1 of 2 system in both Unit). There is much oil leakage from the pump. Regarding the Unit-1, the pump pressure meter is lost. Reliability is supposed to decrease due to the deterioration of the electric pump and control equipment. It may cause burning accidents of turbine and generator due to the temperature rising of all bearings (Photo 5.1-18).

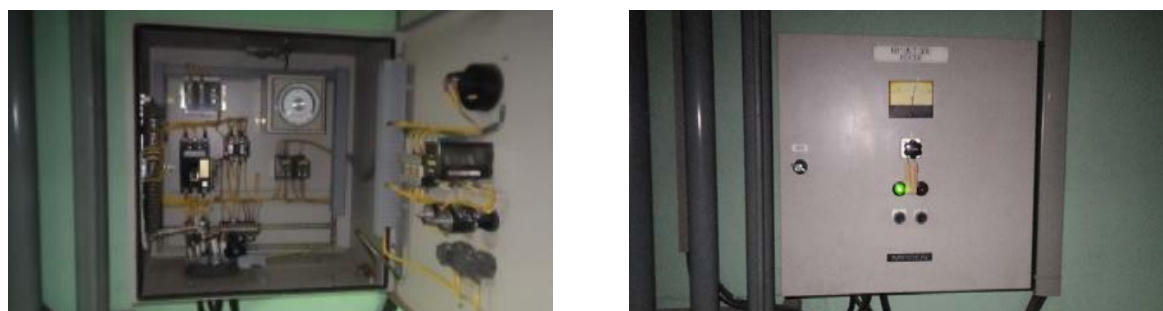
Photo 5.1-19 Generator Heater

Reliability is supposed to decrease due to the deterioration of the control system for generator heater (Photo 5.1-19).

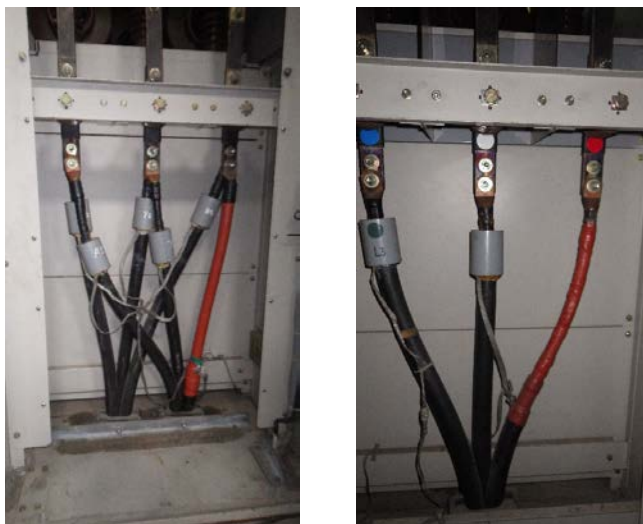
Photo 5.1-23 Repair of 11kV Power Cable

Insulating repair works of LTC-3 11kV power cable in Unit-1 (A phase to main transformer and C phase to 11kV switchgear) had been implemented due to the accident (Photo 5.1-23).

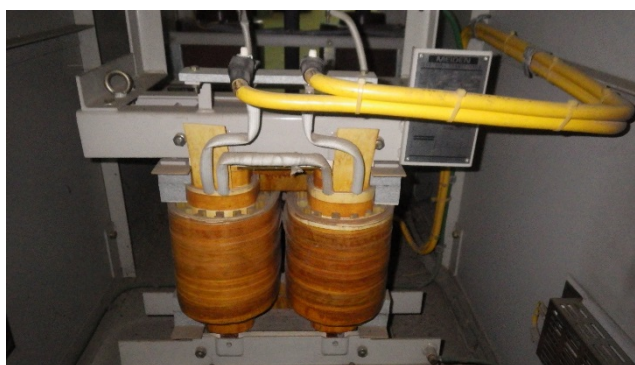
Photo 5.1-24

The neutral grounding transformer is dry type. The reliability is supposed to decrease due to the deterioration (Photo 5.1-24).

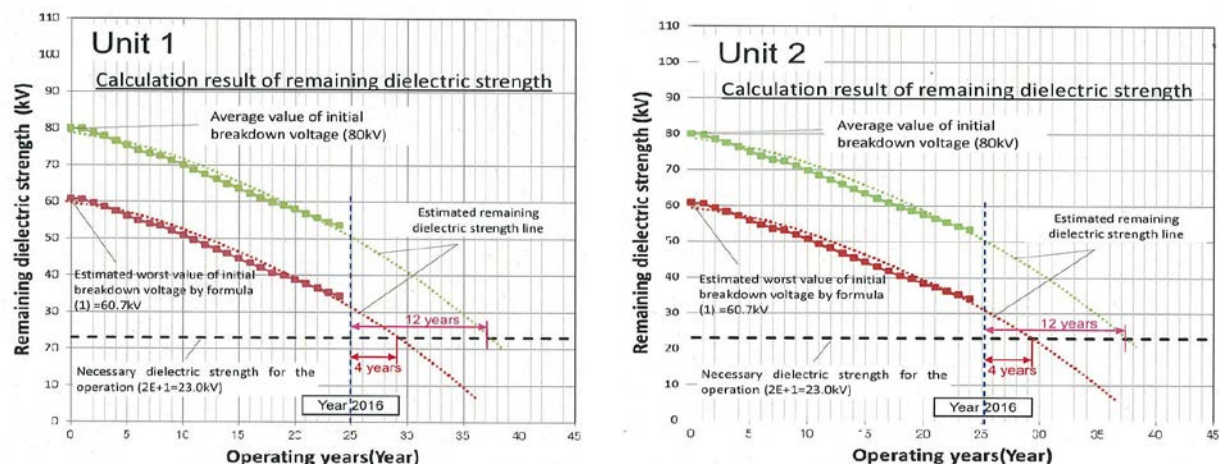
The remaining lifetime of Unit 1 and Unit 2 are estimated to be approximately four (4) years in worst case. The Consultant strongly recommend rewinding stator coil of both units in the earliest opportunity.

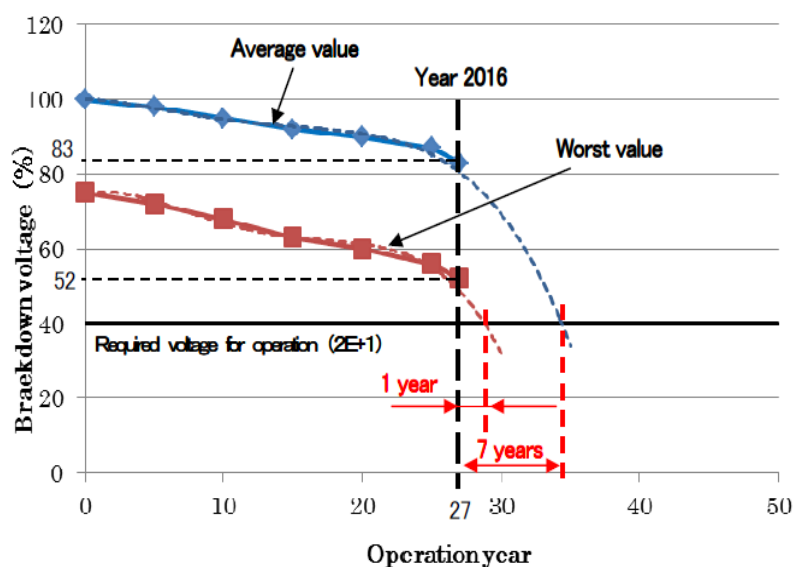
The remaining lifetime of Unit 1 and Unit 2 are estimated to be approximately one (1) year in worst case. The Consultant strongly recommend rewinding stator coil of both units in the earliest opportunity.
