CHAPTER 16

ENVIRONMENTAL AND SOCIAL CONSIDERATIONS

16.2 Environmental Baseline Conditions of the Project Area-1 Baluchaung No.1 Hydropower Plant

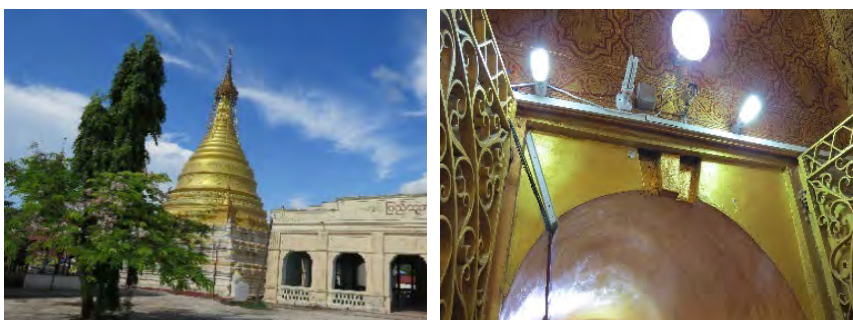
Photo 16.3-1 Ku-tho-daw Pagoda

Ku-tho-daw Pagoda, inside which two bricks missing in the ceiling while construction

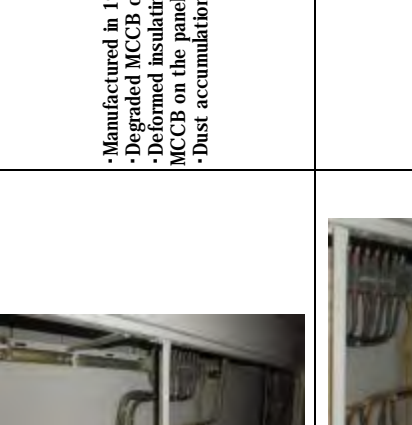
<ul style="list-style-type: none"> - Manufactured in 1988 (28 year-old) - Degraded MCCB on the panel - Deformed insulating rubber on MCCB on the panel - Dust accumulation
HDC 2

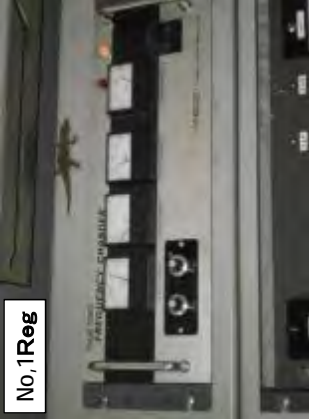
No.2Reg

No.1Reg	<ul style="list-style-type: none"> -Manufactured in 1988 (28 year-old) -Small animal in Gov-Reg Panel -Replaced No.1 power unit (in 1994) -No spare part for detecting unit
Reg 2

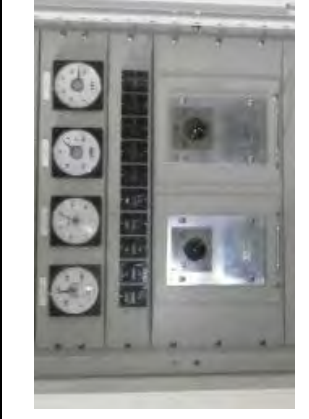
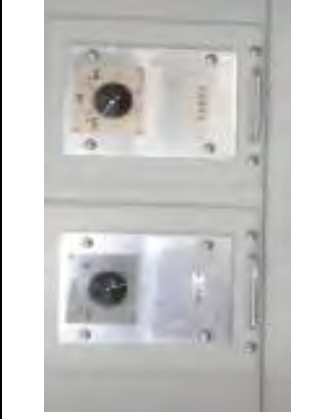
<ul style="list-style-type: none"> -Regulators of variable resistor, exceeding the durable life -Mechanical indicators exceeding the durable life
Reg 3

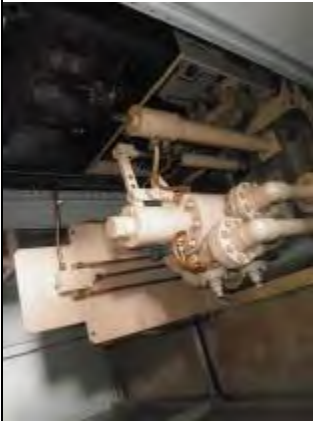
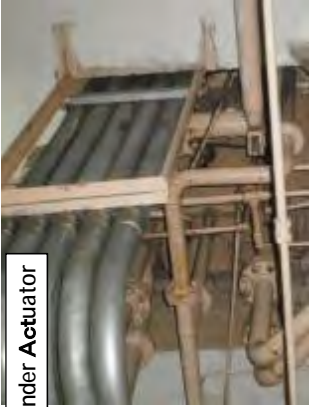
No.1 Act	<ul style="list-style-type: none"> -Grease adhering to the operation unit in actuator panel -Deterioration of operating oil
Act 2

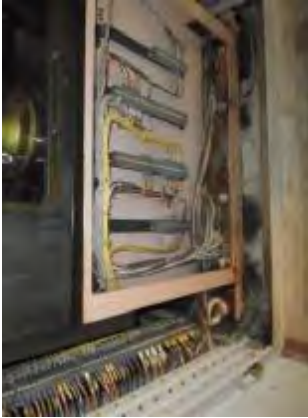
Servomotor Side	<ul style="list-style-type: none"> -No maintenance record of coupling and return units in actuator panel after COD
Act 3

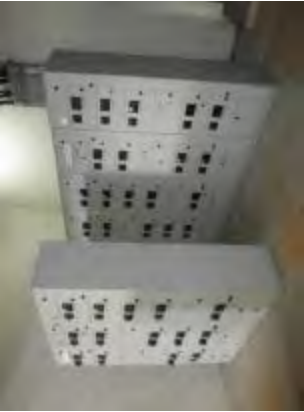
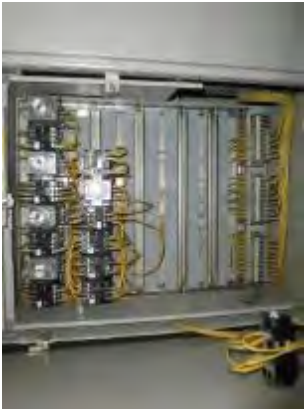
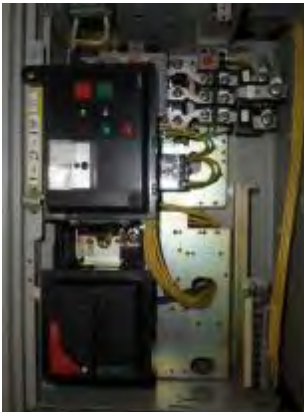
<ul style="list-style-type: none"> - Manufactured in 1988 (28 year-old) - Aging degradation of timer, auxiliary relay, MCCB and switches. - Dust accumulation on the machines and wirings
C/C 2

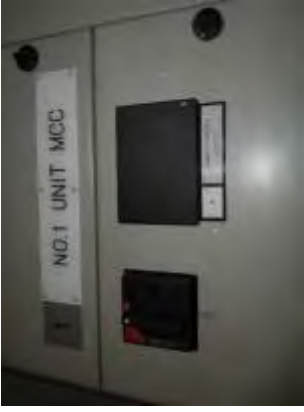
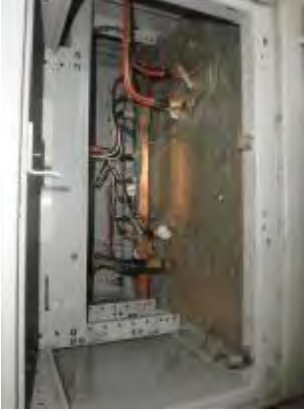
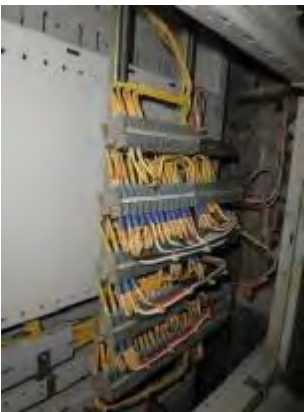
<ul style="list-style-type: none"> - Manufactured in 1988 (28 year-old) - Rust on the terminal - No terminal cover - Dust accumulation on the machines and wirings
C/C 3

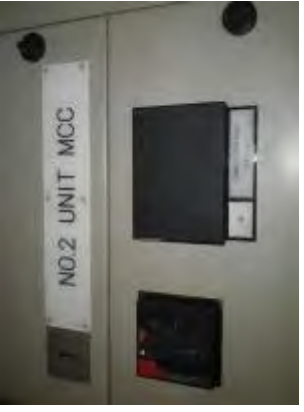
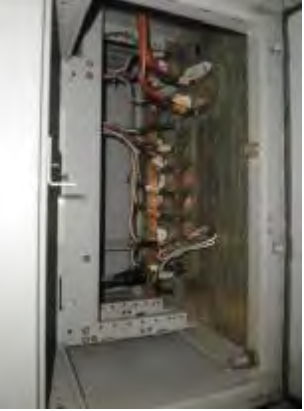
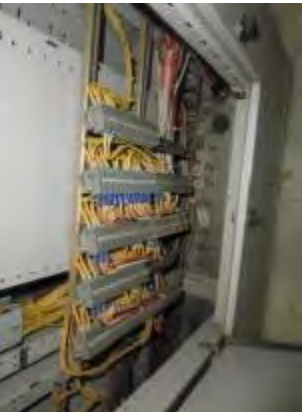
<ul style="list-style-type: none"> - Manufactured in 1988 (28 year-old) - Rust on the terminal - No terminal cover - Dust accumulation on the machines and wirings
C/C 4

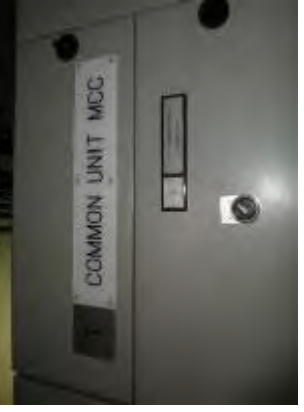
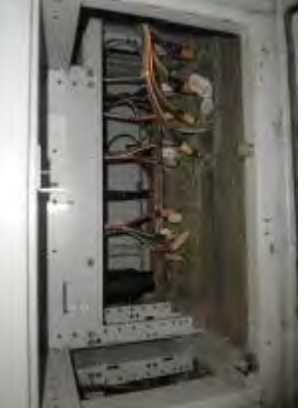
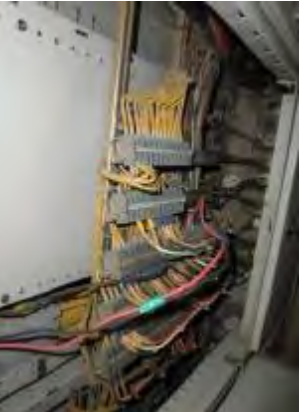
<ul style="list-style-type: none"> - Manufactured in 1988 (28 year-old) - Rust on the terminal - No terminal cover - Dust accumulation on the machines and wirings

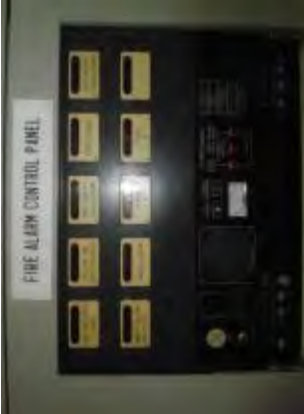
<ul style="list-style-type: none"> -Manufactured in 1987 (29 year-old) -No maintenance record after COD -Aging degradation -The connection to central control center is unknown.
FAL 3

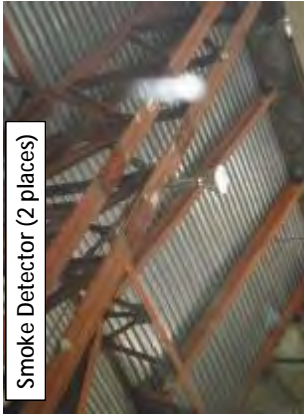
<ul style="list-style-type: none"> -Manufactured in 1987 (29 year-old) -No maintenance record after COD -Aging degradation
FAL 4

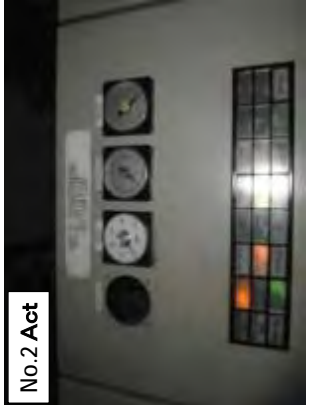
No. 1 Act

No. 2 Act	<p>Governor Actuator Panel</p> <ul style="list-style-type: none"> -Manufactured in 1985 (31 year-old) -Removed power meter because of failure -Incorrect value indicated by speed meter at the position "0"
Act 2

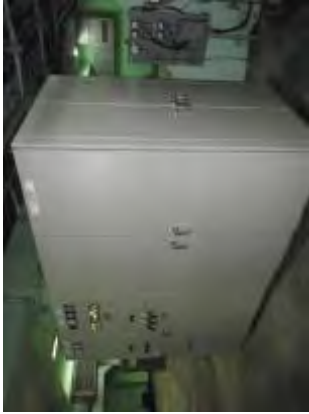
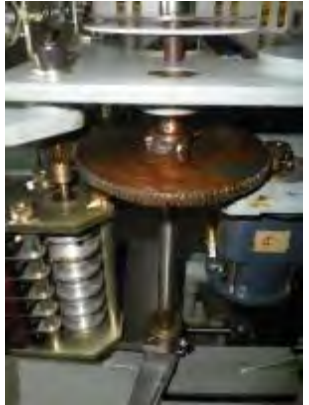
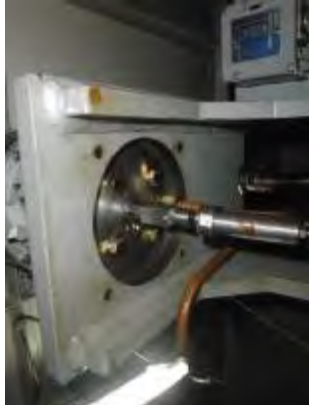
<p>Governor Actuator Panel</p> <ul style="list-style-type: none"> -Grease adhering to the operation unit in actuator panel -Oil leakage -Degraded operation oil
Act 3

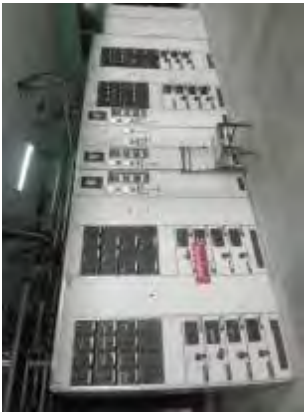
FEEDER-1 FEEDER-2 FEEDER-7 FEEDER-8	  FEEDER-1 FEEDER-2 FEEDER-7 FEEDER-8	Auxiliary control center (C/C) -Manufactured in 1985 (31 year-old) -Aging degradation of MCCB, timer, switches and auxiliary relays -Dust accumulation
C/C 2

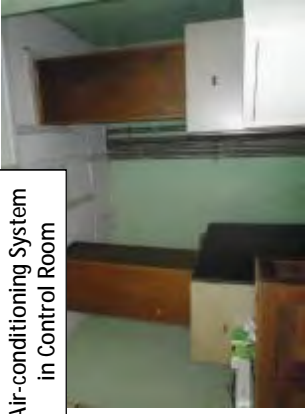
<p>Air-conditioner (2 units) -Manufactured in 1985 (31 year-old) -Dust accumulation -Both are broken.</p>
AC 2	<p>Control Panel</p>

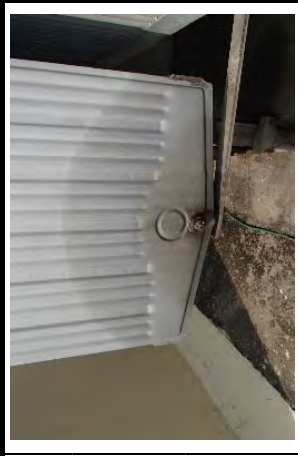
<p>S-15</p> <p>132/11kV Main Tr.</p> <p>Oil leak at radiator</p>

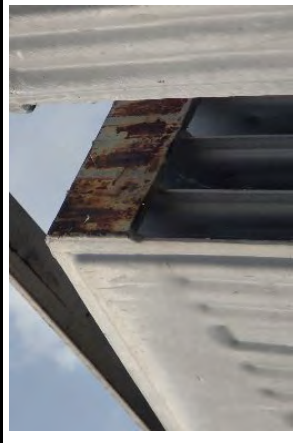
<p>S-16</p> <p>132/11kV Main Tr.</p> <p>Rust of radiator</p>
