ムンバイ市跨線橋架替えプロジェクト説明資料

Data Collection Survey on Road/Railway Bridge Sector

Explanatory Material of Reconstruction Project of ROBs in Mumbai

**August 2016
Mumbai**

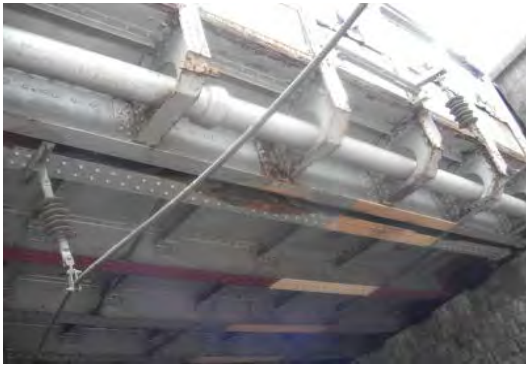
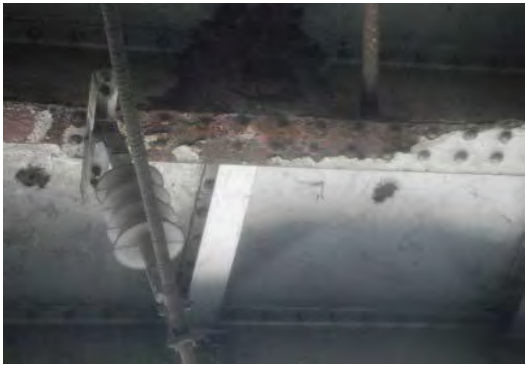
Object Member	Steel I-Girder
Kind of Damage	Rusting
Sketch or Photo	<div style="display: flex; justify-content: space-around;">

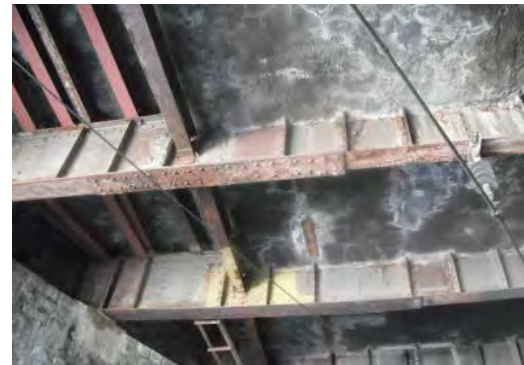
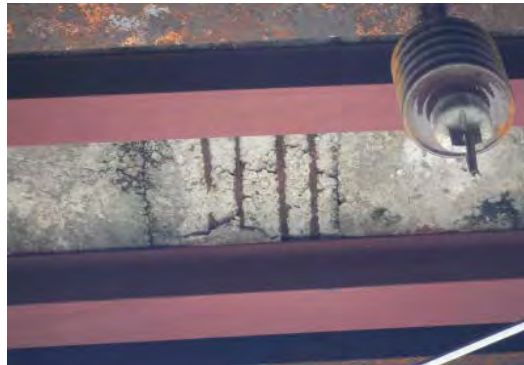
Object Member	RC Slub
Kind of Damage	Spalling and exposed Rebar
Sketch or Photo

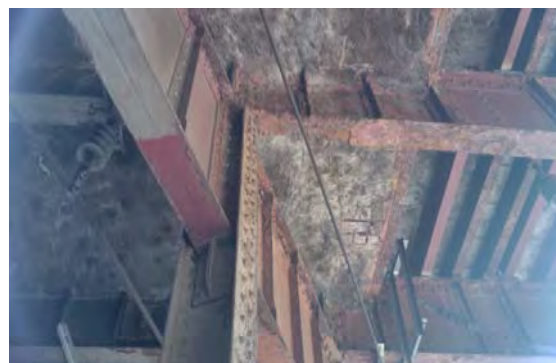
Object Member	Concrete Base
Kind of Damage	Cracking and spalling
Sketch or Photo

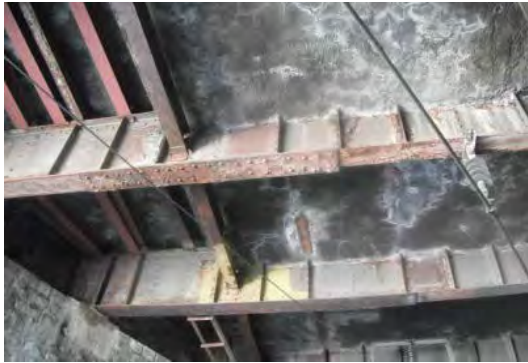
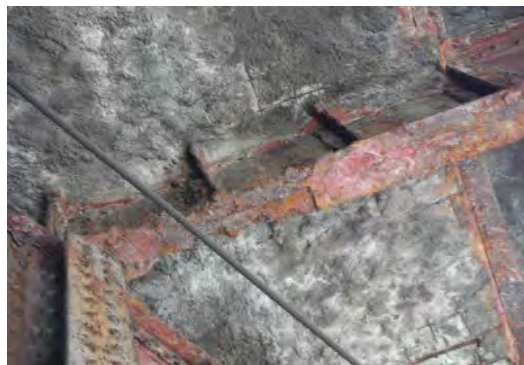
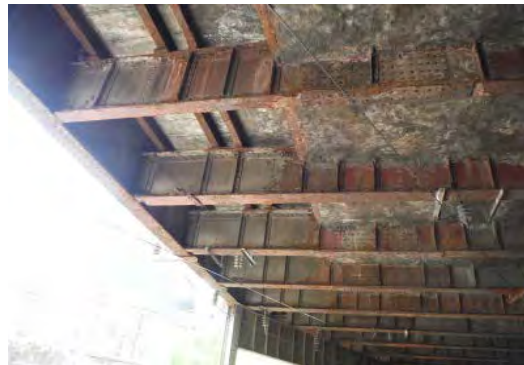
Object Member	Cross Bream
Kind of Damage	Runsting
Sketch or Photo

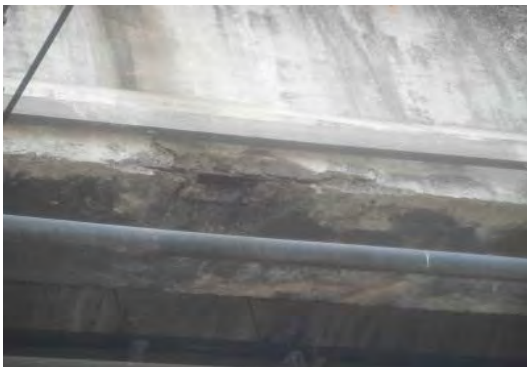
Object Member	PC I-Girder and RC slab
Kind of Damage	Spalling
Sketch or Photo

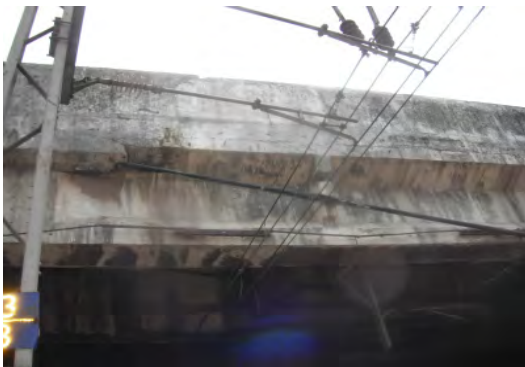
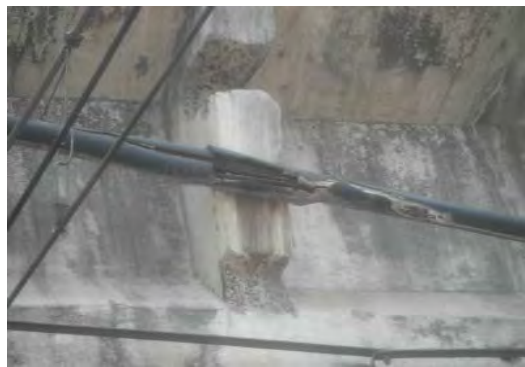
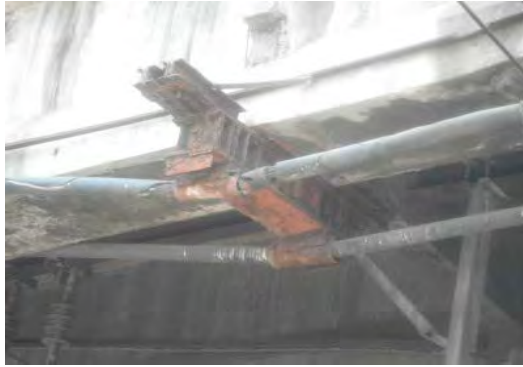
Object Member	PC cable
Kind of Damage	Fracture
Sketch or Photo

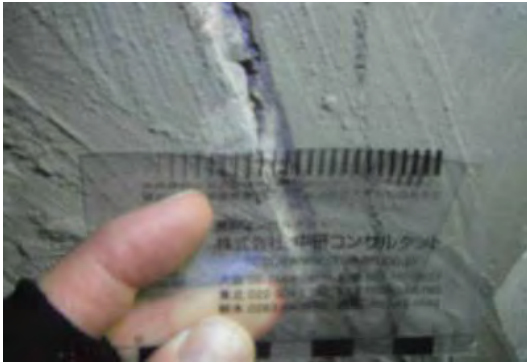
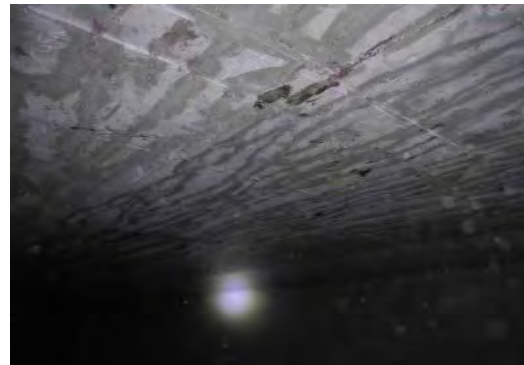
Object Member	Deck Slab
Kind of Damage	Repair Work for Cracking
Sketch or Photo

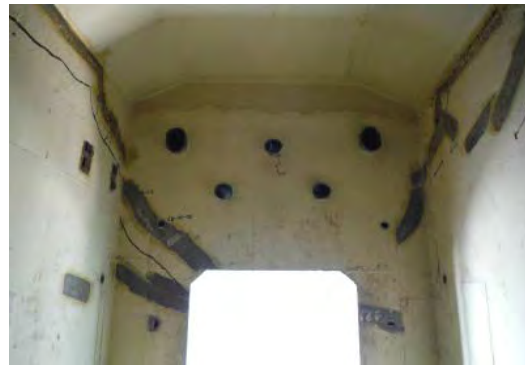
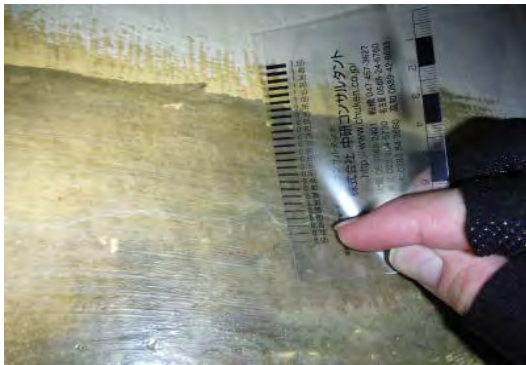
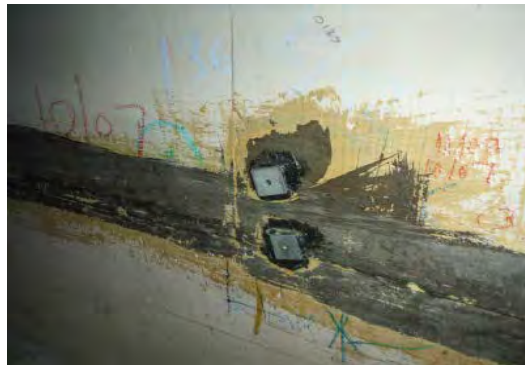
Object Member	PSC Box Girder
Kind of Damage	Horizontal and Inclined Cracks in Web
Sketch or Photo

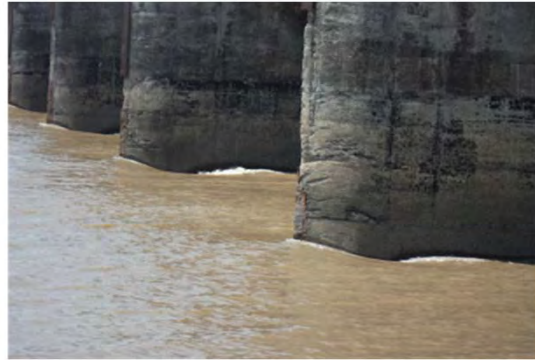
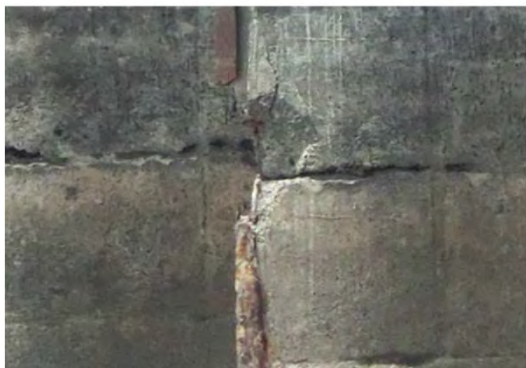
Object Member	Pier
Kind of Damage	Cracking
Sketch or Photo

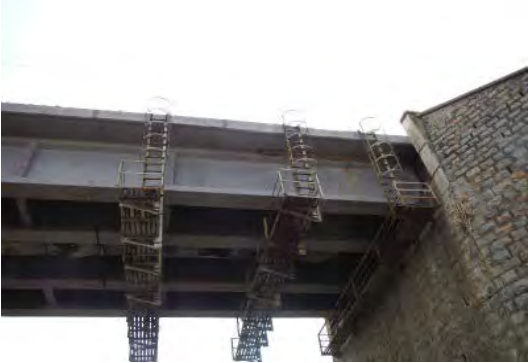
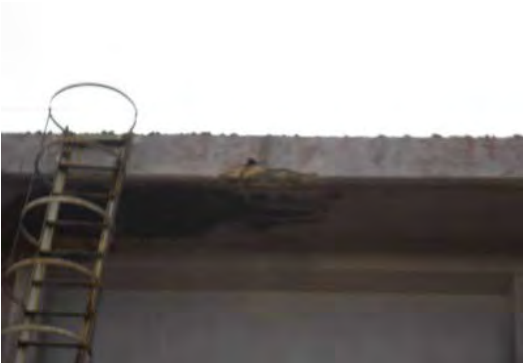
Object Member	Prestressed I-Girders
Kind of Damage	Cracking
Sketch or Photo	<div style="display: flex; justify-content: space-around; align-items: flex-start;"> <div style="width: 45%;">
