APPENDIX 6

Damaged Bridge Survey Record Managed by Western Railway

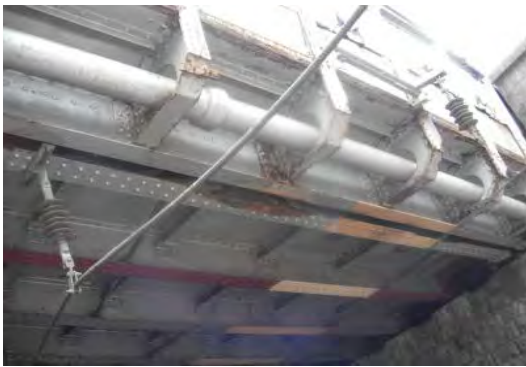
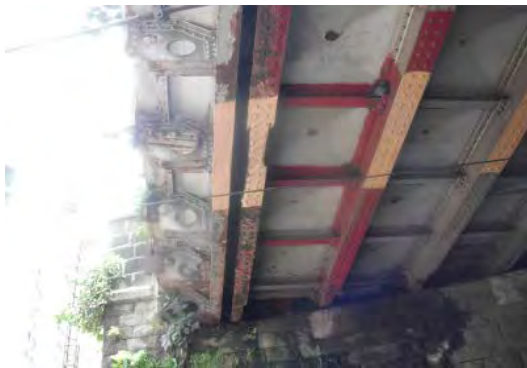
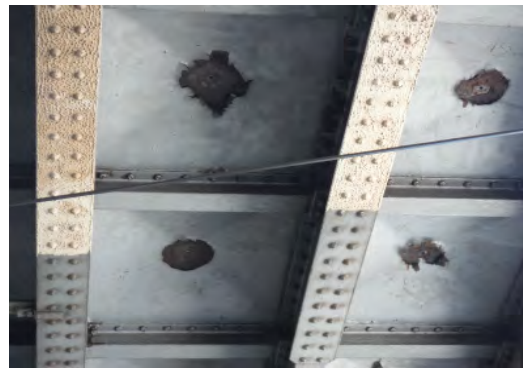
Object Member	Steel I-Girder
Kind of Damage	Rusting
Sketch or Photo

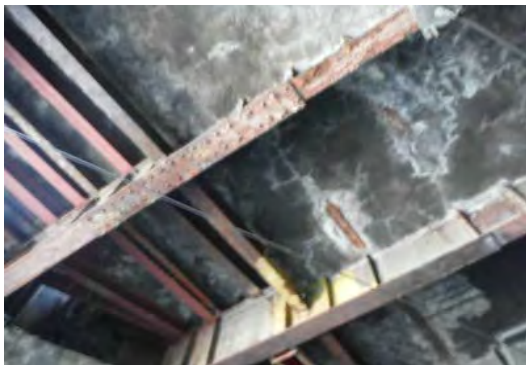
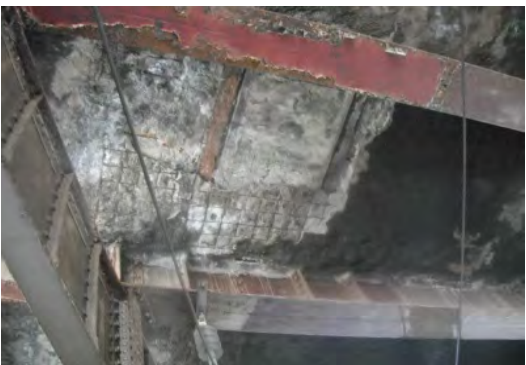
Object Member	RC Slub
Kind of Damage	Spalling and exposed Rebar
Sketch or Photo

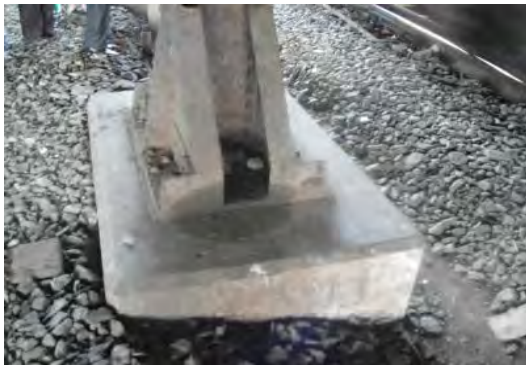
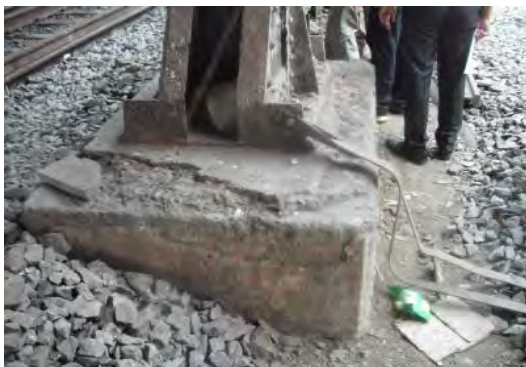
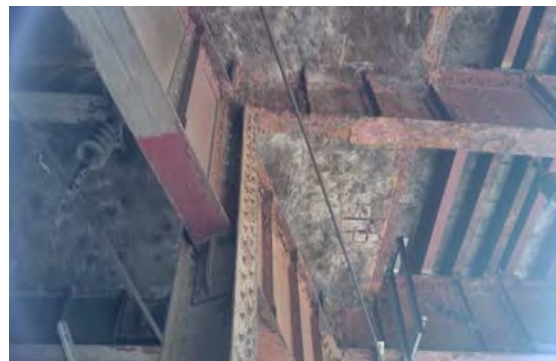
Object Member	Concrete Base
Kind of Damage	Cracking and spalling
Sketch or Photo

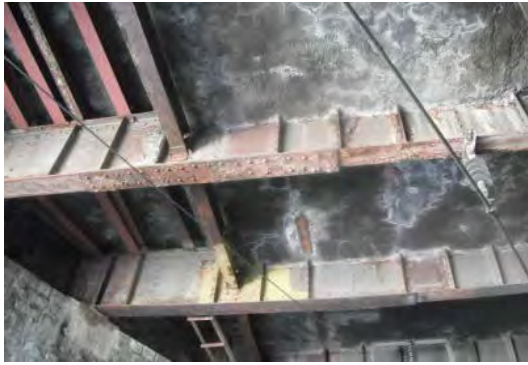
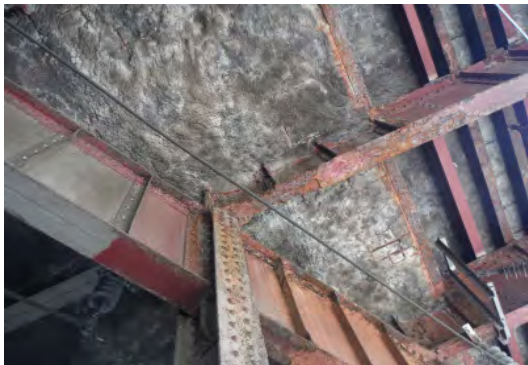
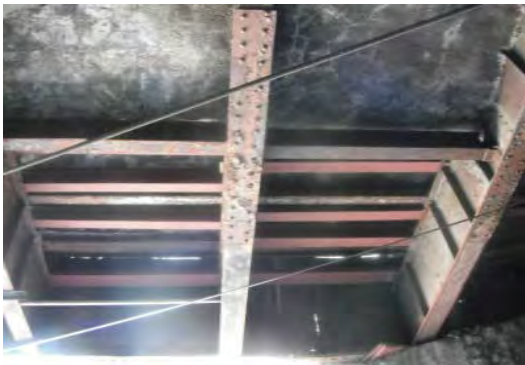
Object Member	Cross Bream
Kind of Damage	Runsting
Sketch or Photo

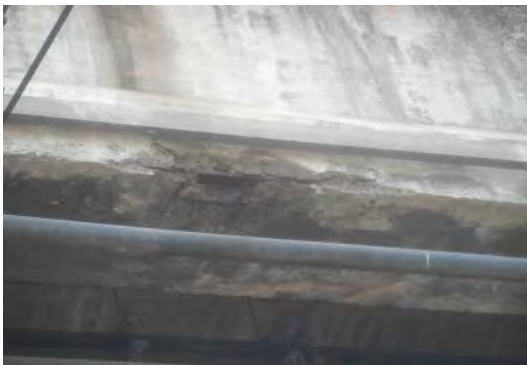
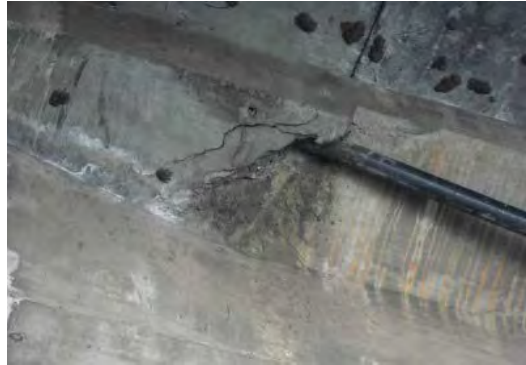
Object Member	PC I-Girder and RC slab
Kind of Damage	Spalling
Sketch or Photo

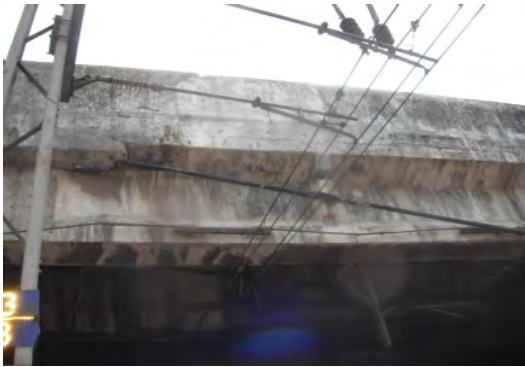
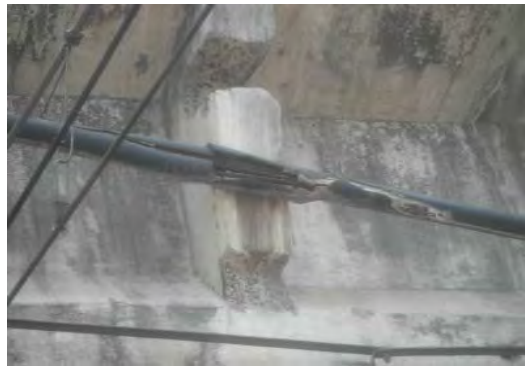
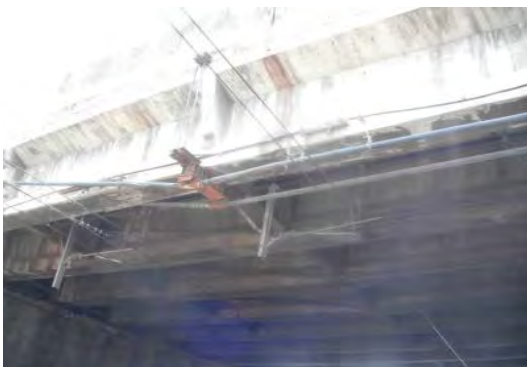
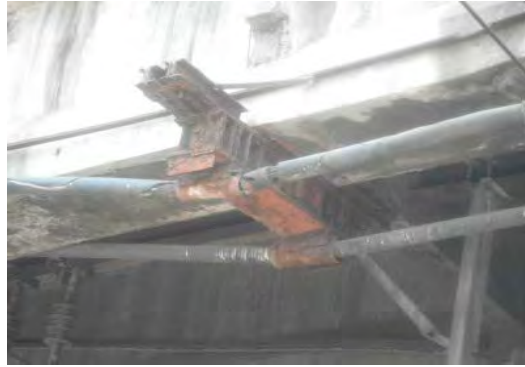
Object Member	PC cable
Kind of Damage	Fracture
Sketch or Photo

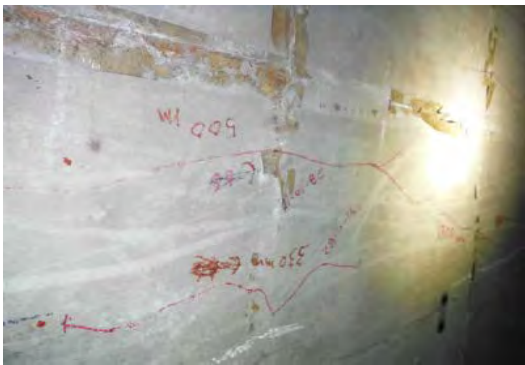
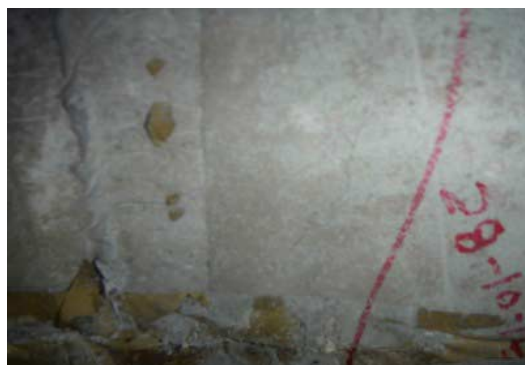
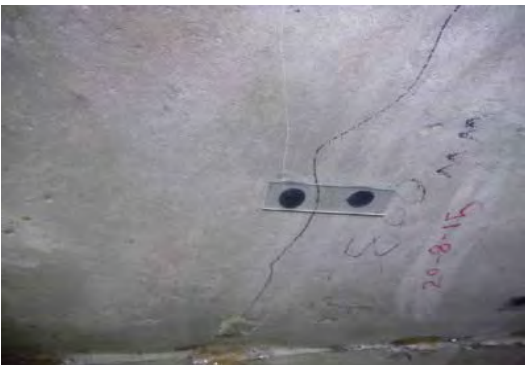
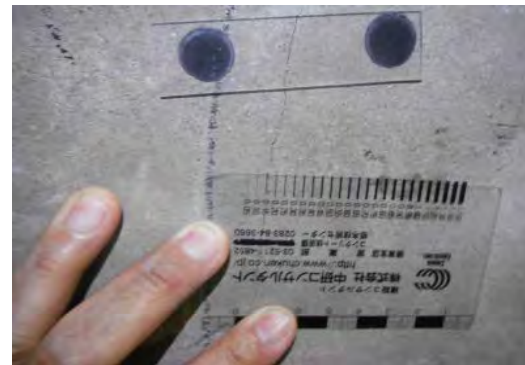
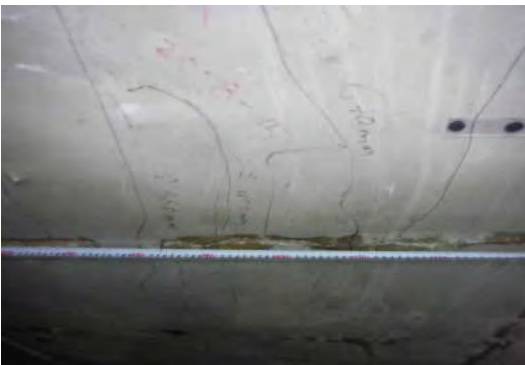
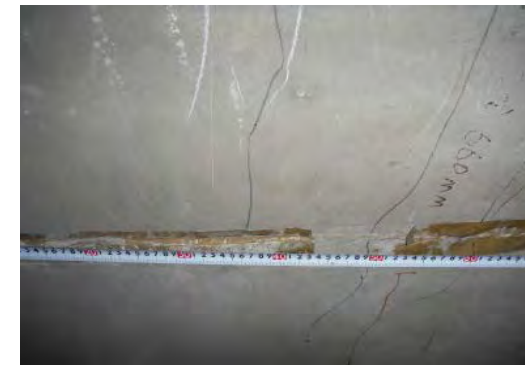
Object Member	PSC Box
Kind of Damage	Cracking
Sketch or Photo

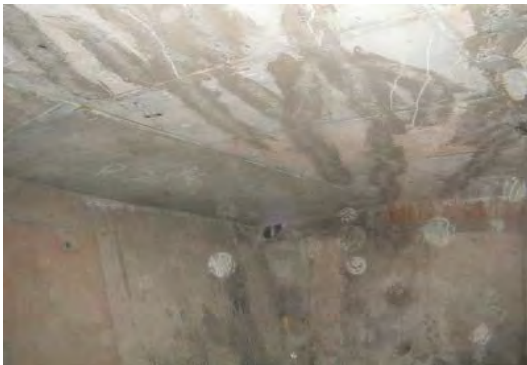
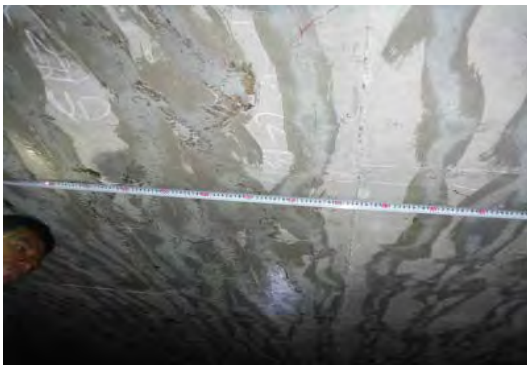
Object Member	Deck Slab
Kind of Damage	Repair Work for Cracking
Sketch or Photo

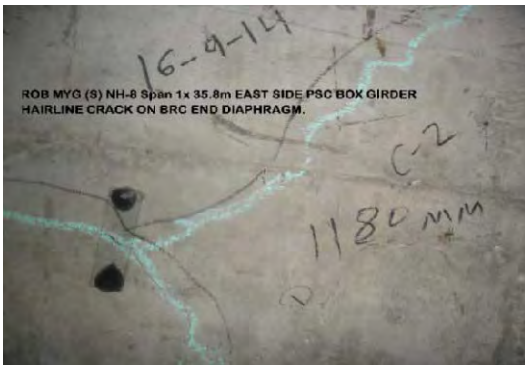
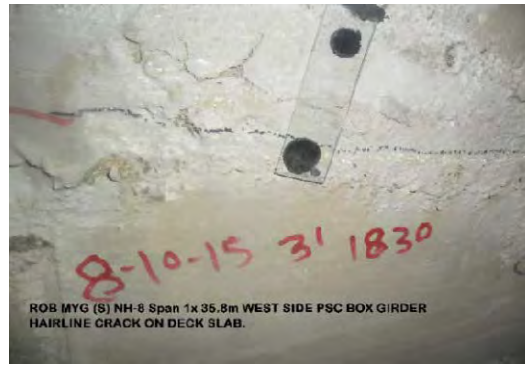
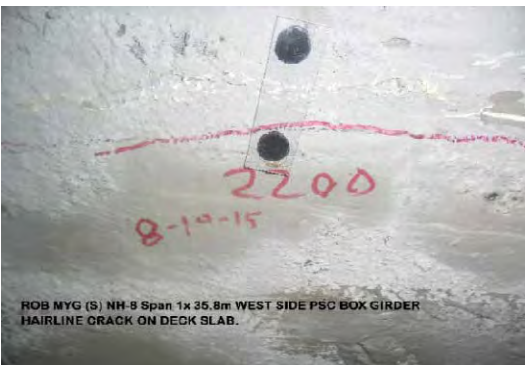
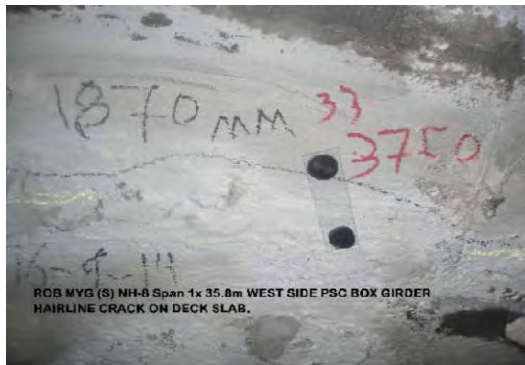
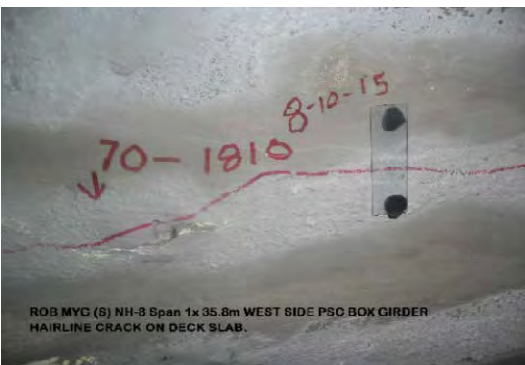
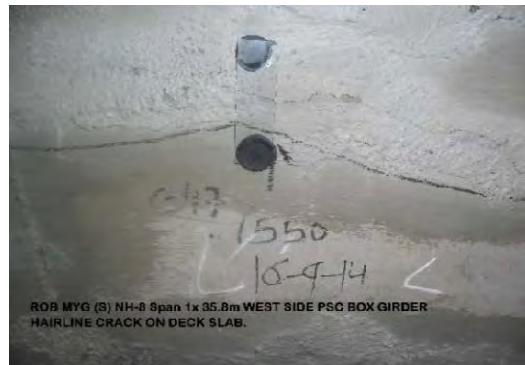
Object Member	Deck Slab
Kind of Damage	Cracking
Sketch or Photo

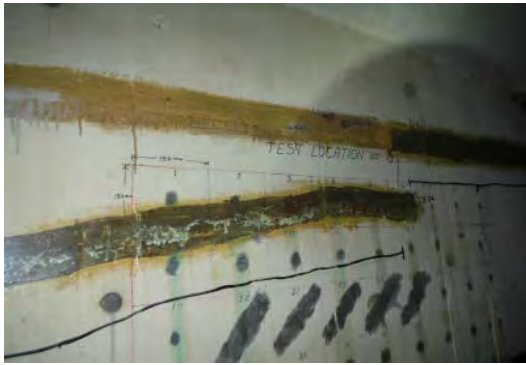
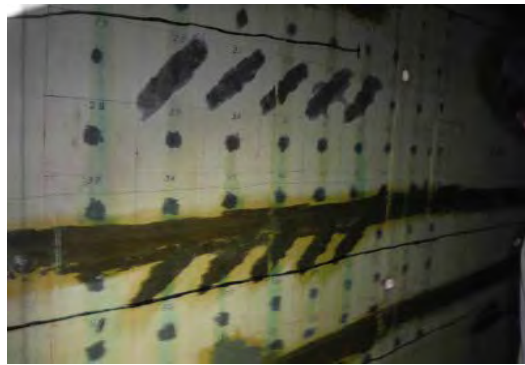
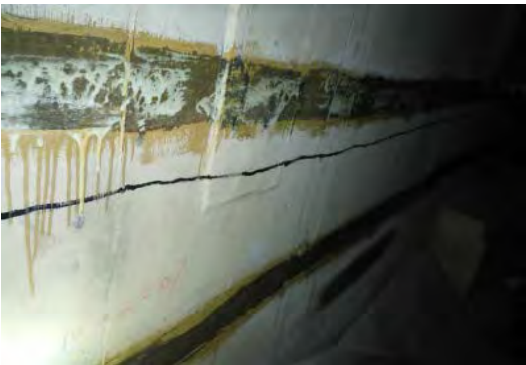
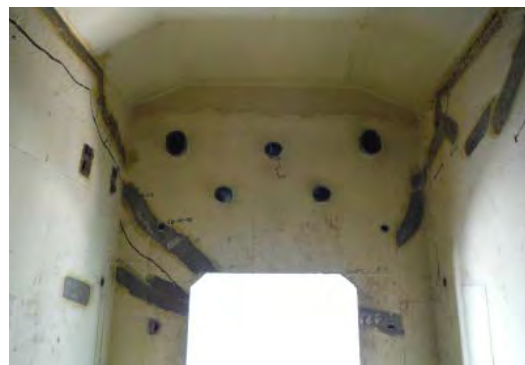
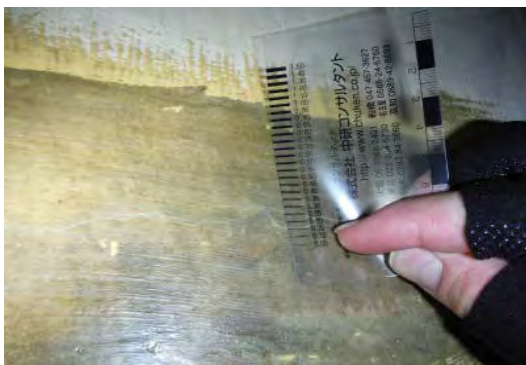
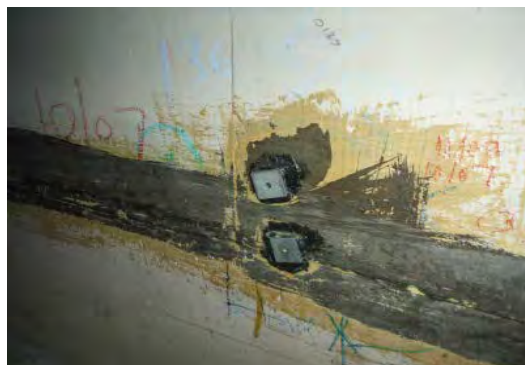
Object Member	PSC Box Girder
Kind of Damage	Horizontal and Inclined Cracks in Web
Sketch or Photo

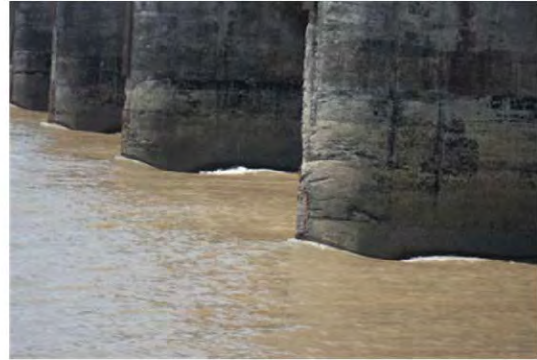
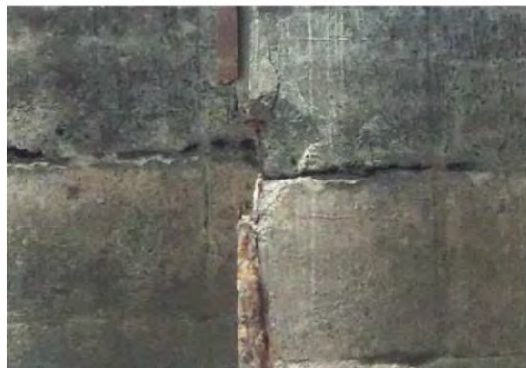
Object Member	Pier
Kind of Damage	Cracking
Sketch or Photo

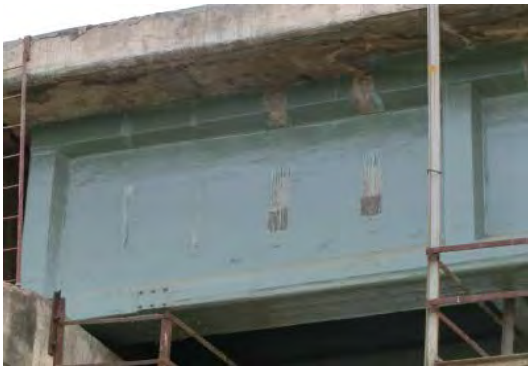
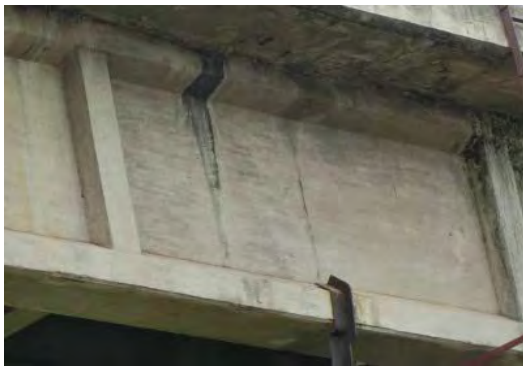
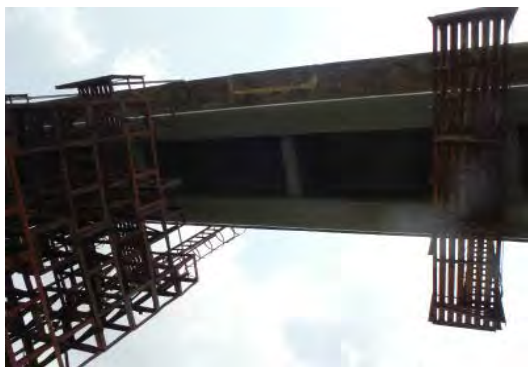
Object Member	Prestressed I-Girder
Kind of Damage	After Repairing CFRP, Now in Good Condition
Sketch or Photo

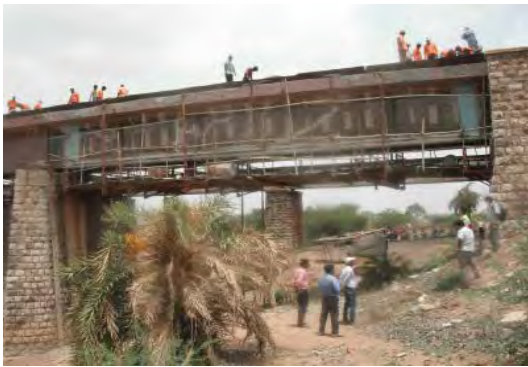
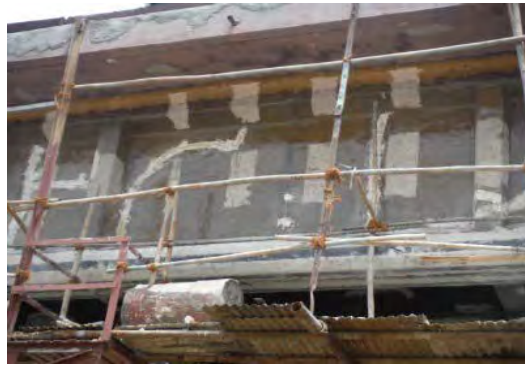
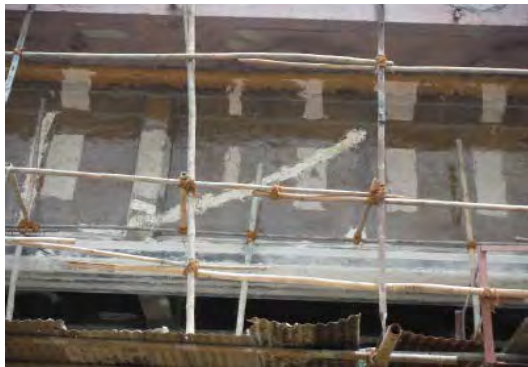
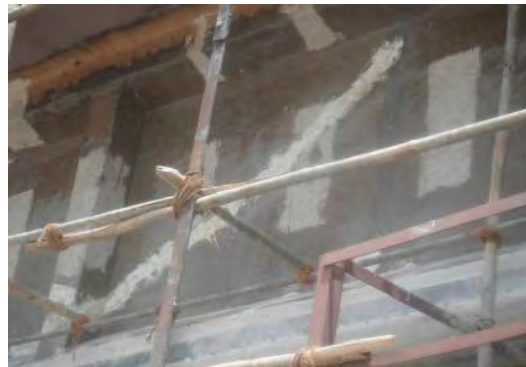
Object Member	Prestressed I-Girders
Kind of Damage	After Repairing CFRP, Now in Good Condition
Sketch or Photo

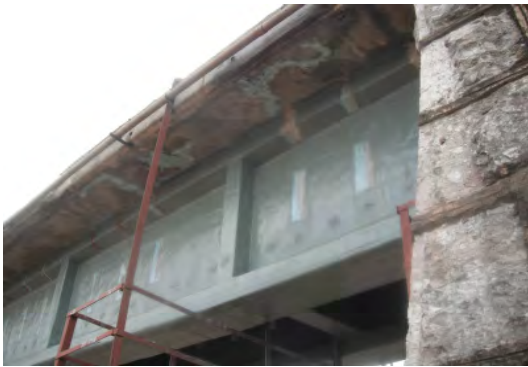
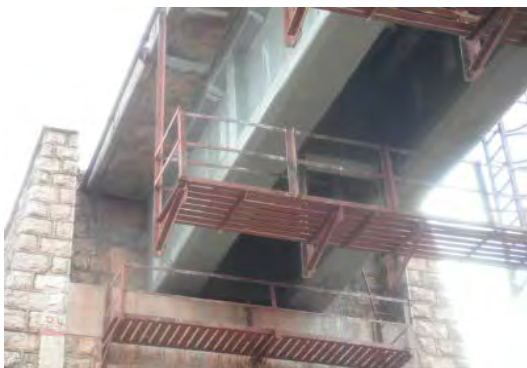
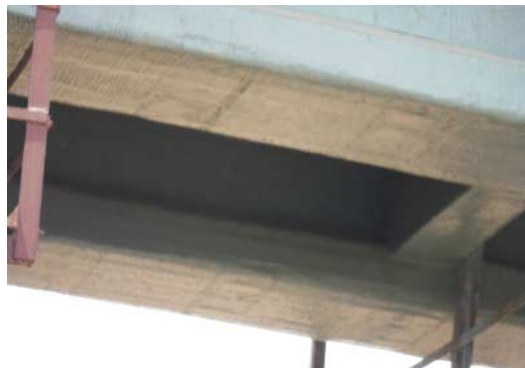
Object Member	Prestressed I-Girders
Kind of Damage	After Repairing CFRP, Now in Good Condition
Sketch or Photo

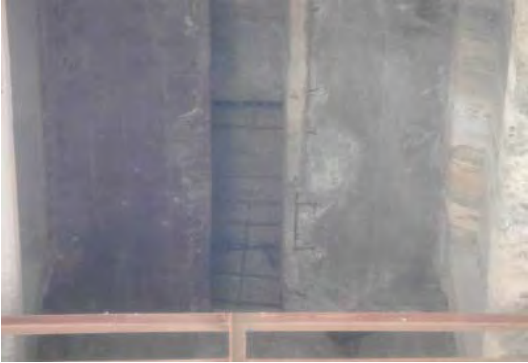
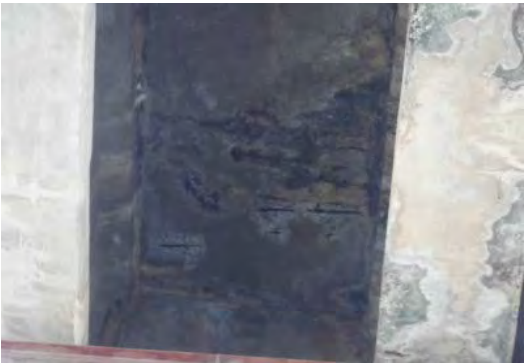
Object Member	Prestressed I-Girders
Kind of Damage	Cracking
Sketch or Photo	<div style="display: flex; flex-wrap: wrap; justify-content: space-around;">

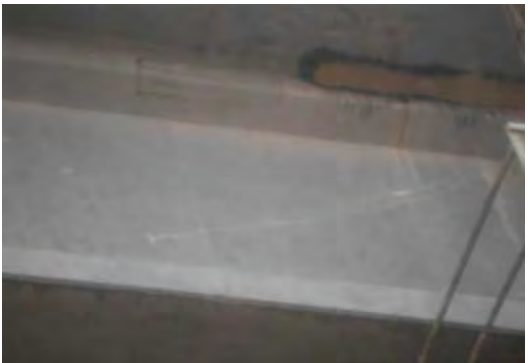
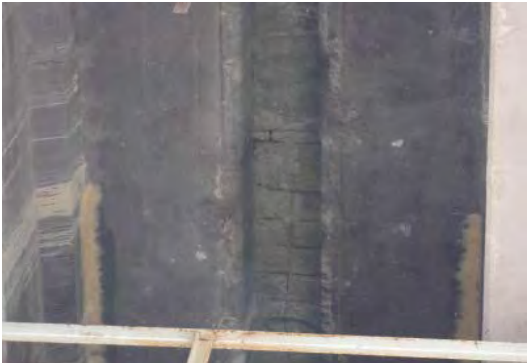
Object Member	Prestressed I-Girders
Kind of Damage	Cracking
Sketch or Photo	<div style="display: flex; justify-content: space-around; align-items: flex-start;"> <div style="width: 45%;">
