Original Data Sheet by  
RGSB  
in Beni-Suef

**Data Sheet for the minor Structure**      **From 1/ For intake,**  
**Regulator, Tail escape**

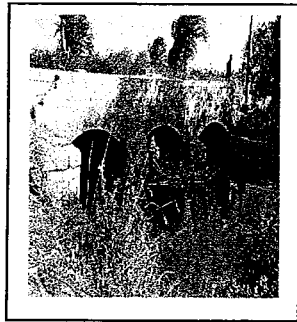
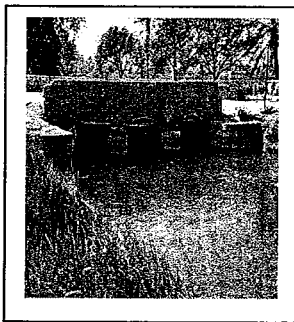
8) Down stream water level EL (m)			27.50
9) How ofen the maintenance /every half year or 1 year.. nothing .. etc			1 YEAR
10) Please write remarks , if any			n

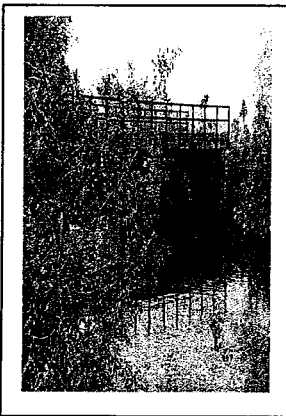
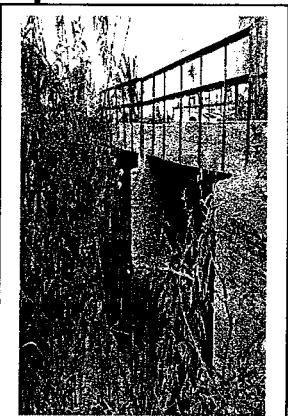
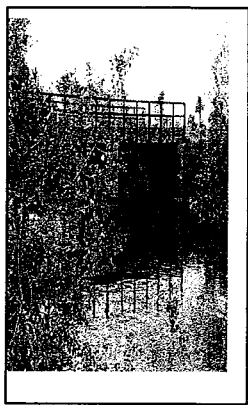
6) Width of down stream of the canal (m)	5.00		
7) Up stream water level EL (m)	27.25		
8) Down stream water level EL (m)	27.25		
9) How ofen the maintenance /every half year or 1 year.. nothing .. etc	1 YEAR

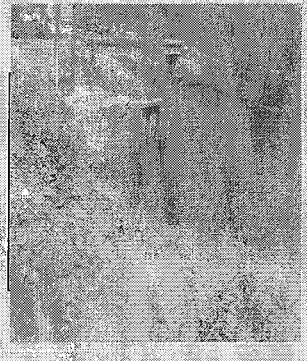
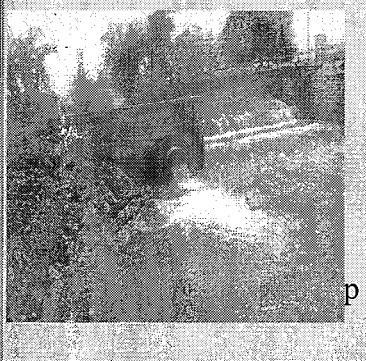
6) Bed level EL(m)	24.00		
7) Gate type / Wood , Steal, Others, Nothing	N		
8) Structure condition /Excellent, Good , Bad , Already Expire	Good		
9) Gate condition / Excellent, Good , Bad , Already Expire	N

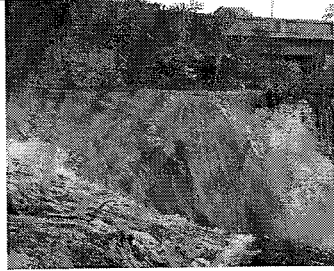
10. Cost of necessary works for improvement			10000000 LE
11. Contents of the necessary works for improvement		Replace all the Structure	
12. Existing problems of the structure		Old str.

3) Crest L(m)	-16.50	4) Crest Width (m)	-
5) max.Water L (m)	3.54	6) Bed level d.s (m)	-24.50
7) Structure condition / Excellent , Good , Bad , Already Expire			Already Expire

10) Please write remarks , if any		The Structure is very danger and we have 2 pump station	
15. Picture	Front	Top	Side or Behind

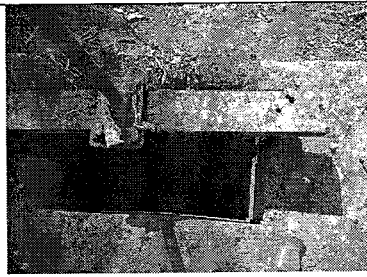
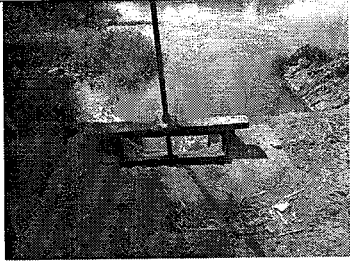
10. Cost of necessary works for improvement			3000000 LE
11. Contents of the necessary works for improvement		Replace all the Structure	
12. Existing problems of the structure		Old str. And very narrow intake

1) Height (m)	3.00	2) Width (m)	1.00
3) Depth (m)	2.50	4) Number of Vent	1.00 for each intake
5) Water EL (m)	23.5	6) Bed level EL (m)	20.80
7) Structure condition / Excellent , Good , Bad , Already Expire			Bad

8) Gate type / Wood , Steal , Others , Nothing			Steal
9) Gate condition / Excellent , Good , Bad , Already Expire			Good
10) Please write remarks , if any		This canal has a2 intake and we must delete one of them and this inke has meny cables (telef. Elec.and many pipe )	
TABLE B. IF structure is Pipe line Culvert and Siphon , Aqueduct

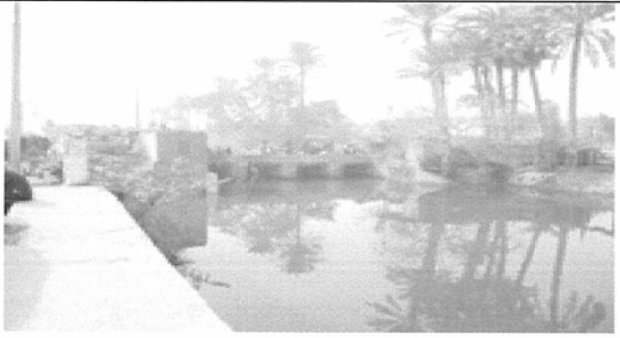
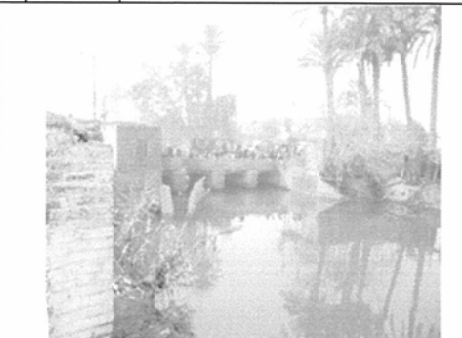
8)Gate type /Wood , Steal , Others , Nothing			Steal
9)Gate condition / Excellent , Good , Bad , Already Expire			Bad,
10)Please write remarks , if any

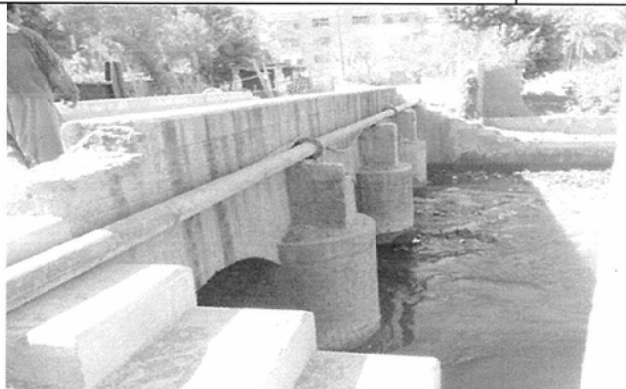
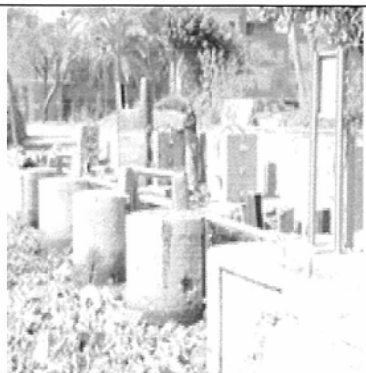
8)Gate type /Wood , Steal , Others , Nothing			Steal
9)Gate condition / Excellent , Good , Bad , Already Expire			Bad,
10)Please write remarks , if any

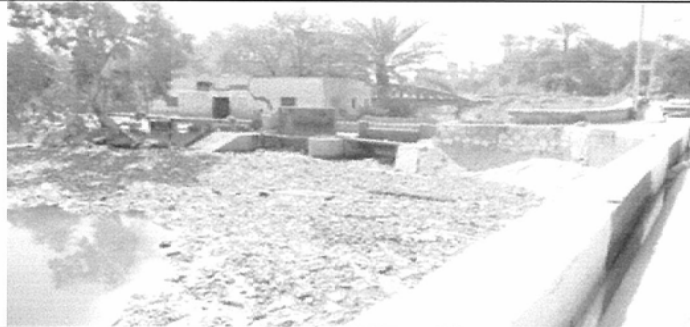
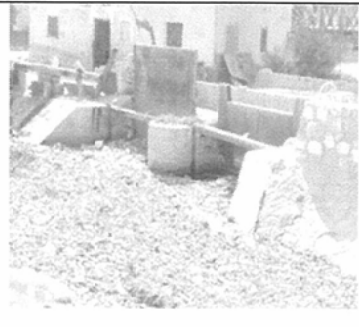
8)Gate type /Wood , Steal , Others , Nothing		Steal	
9)Gate condition / Excellent , Good , Bad , Already Expire		Bad,	
10)Please write remarks , if any

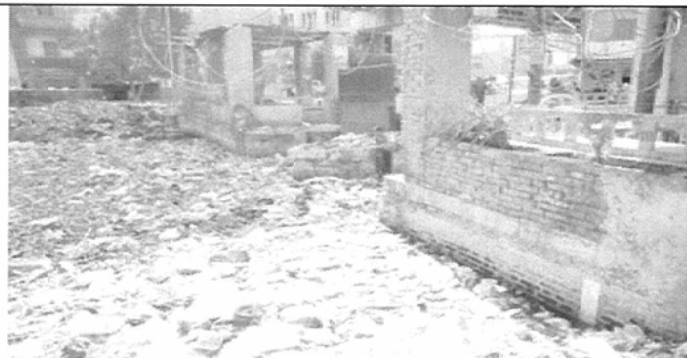
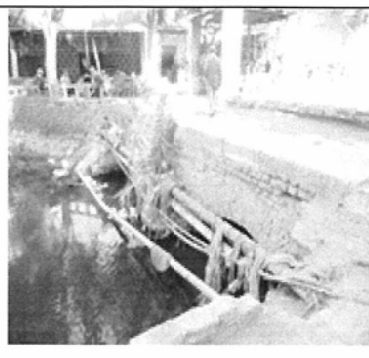
8)Gate type /Wood , Steal , Others , Nothing			Steal
9)Gate condition / Excellent , Good , Bad , Already Expire			Bad,
10)Please write remarks , if any
