Republic of Mauritius
Landslide Management Unit: LMU, Ministry of Public
Infrastructure and Land Transport: MPI

TECHNICAL COOPERATION PROJECT : LANDSLIDE ADVISER FOR MAURITIUS

FINAL REPORT

February 2018

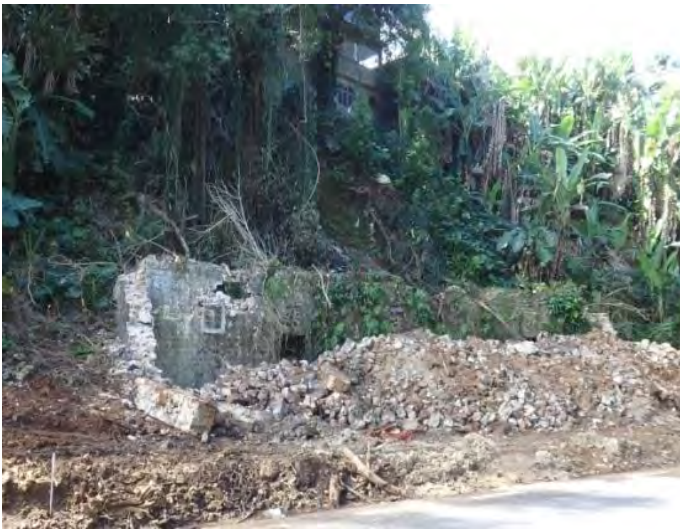
The slope in which a retaining wall (1.5 m high) is to be applied, Batelage

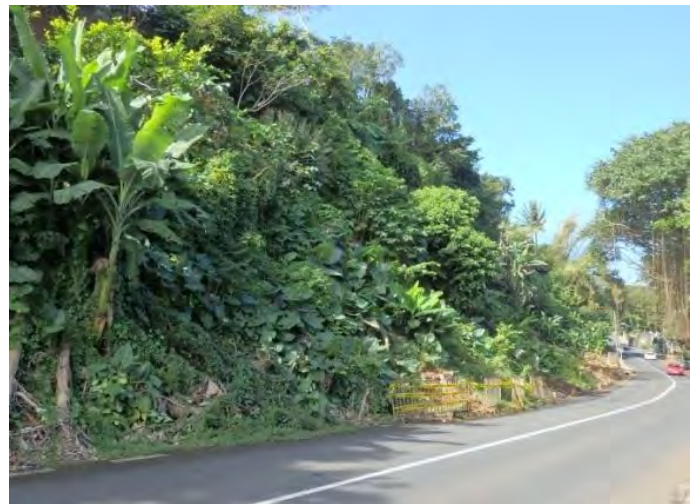
The slope at middle of the road in which a crib wall is to be applied, Batelage

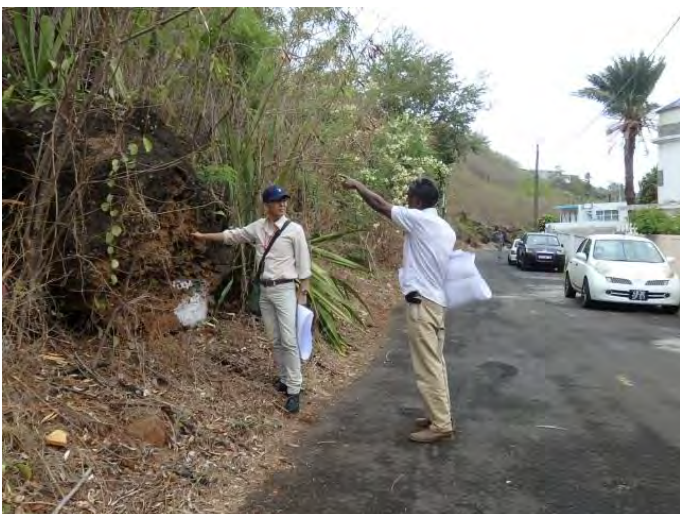
Site study of slope failure and rockfall, Hermitage

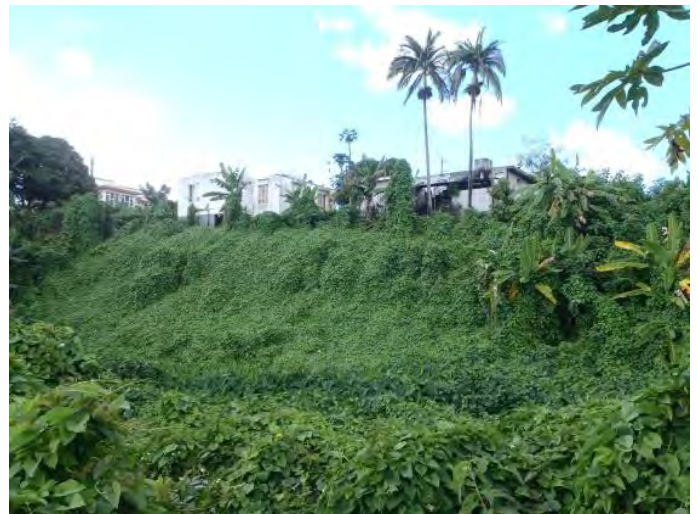
The investigation spot where two houses sit near the scarp, Camp Garreau, Flacq

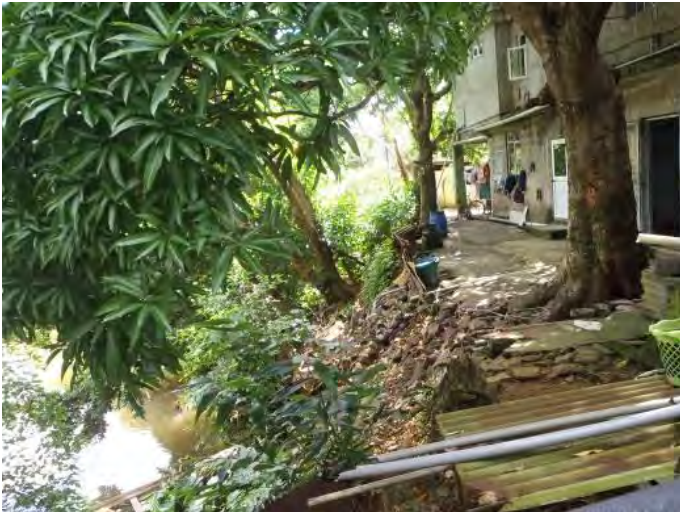
Current condition of the site with slope failure and river erosion, Kewal Nagar Belle Rive

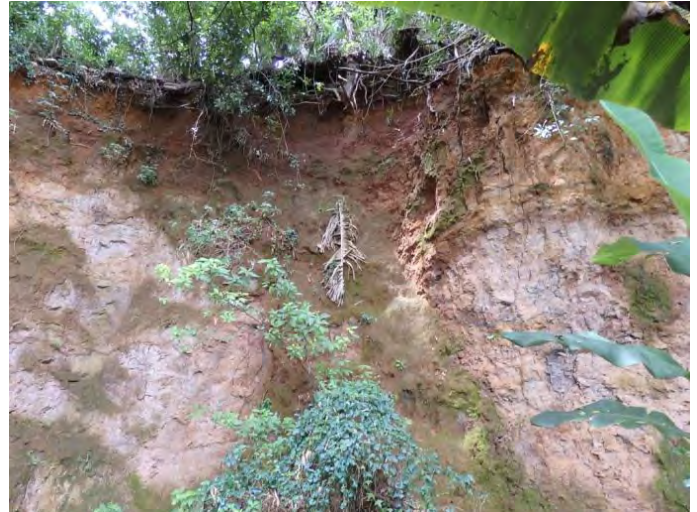
Cut slope failure, Pilot Bel Air

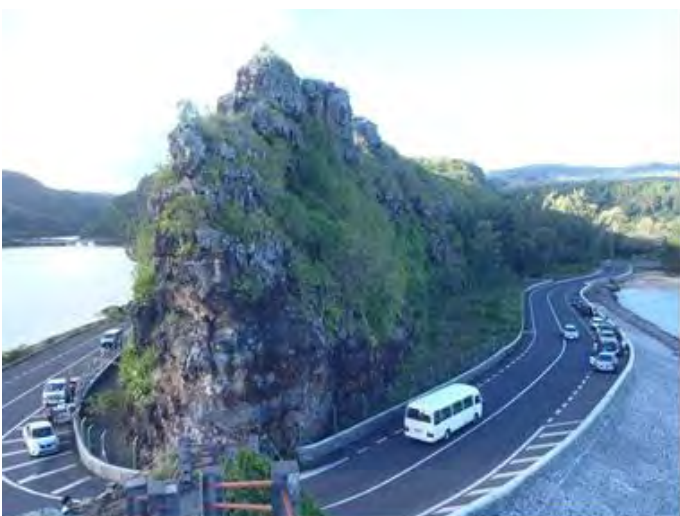
Rock fall, Maconde

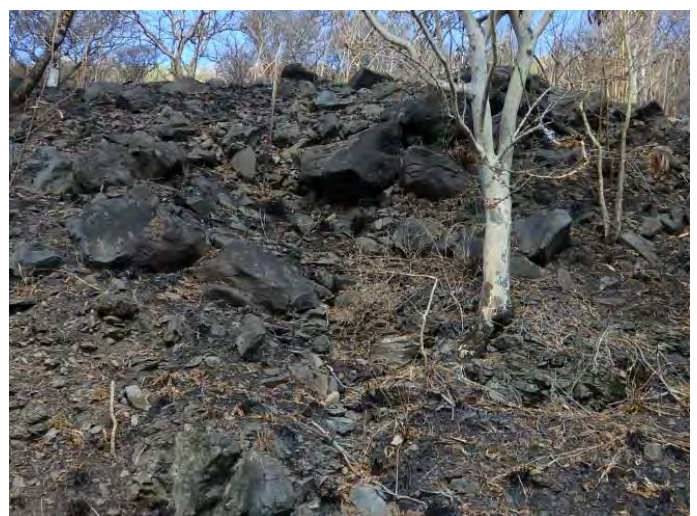
Unstable rocks, Signal Mountain

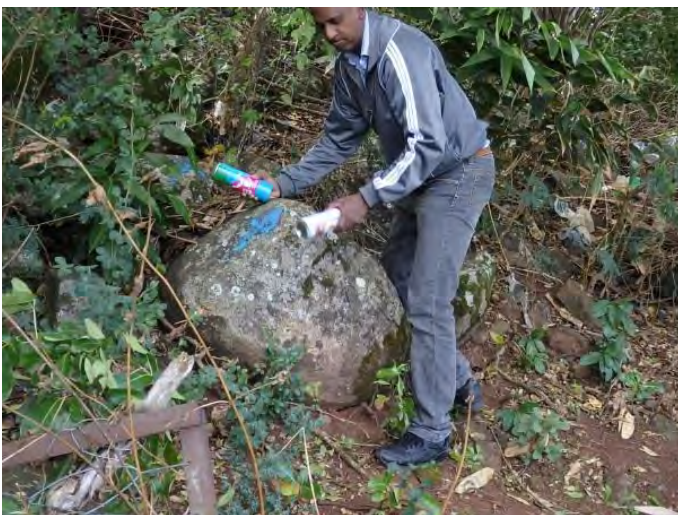
Consideration of measures (blue spray: stabilisation), Ruisseau Des Creoles

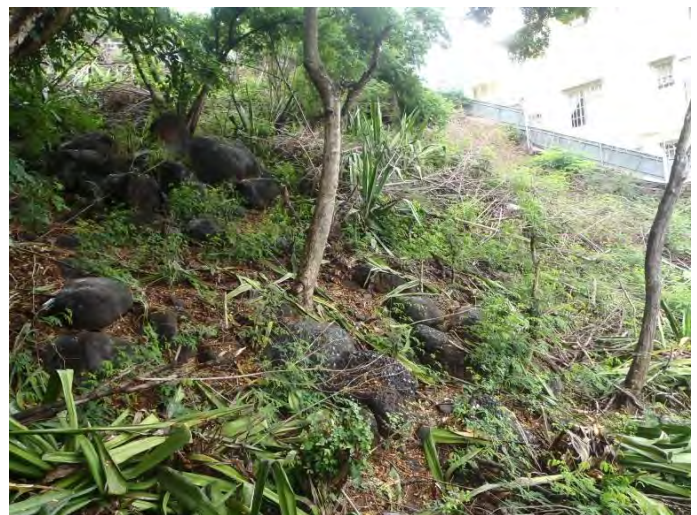
Unstable boulders on the steep slope, Coromandel

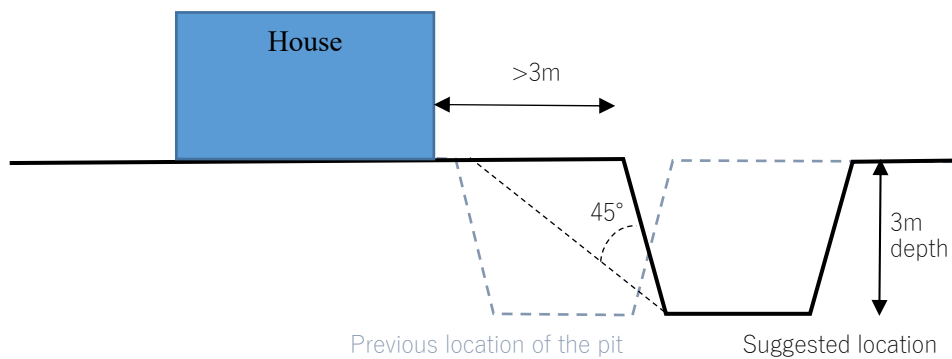
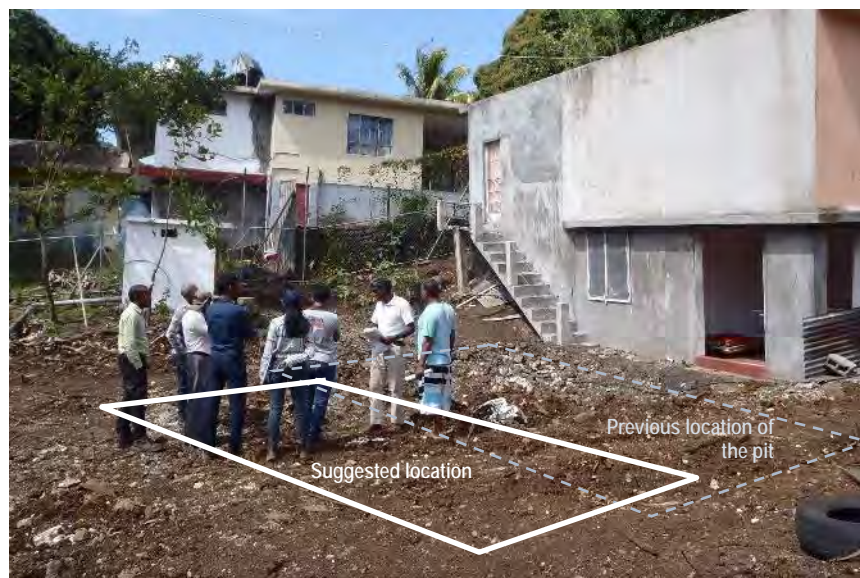
Figure 1 Suggested location of excavation near the house (Source: JET)

Photo 1 Suggested location of excavation near the house (Source: JET)

- ✓ The impact of the excavation must not extend to the house.
- ✓ In this case, the distance from the house to the pit should be more than 3 m.

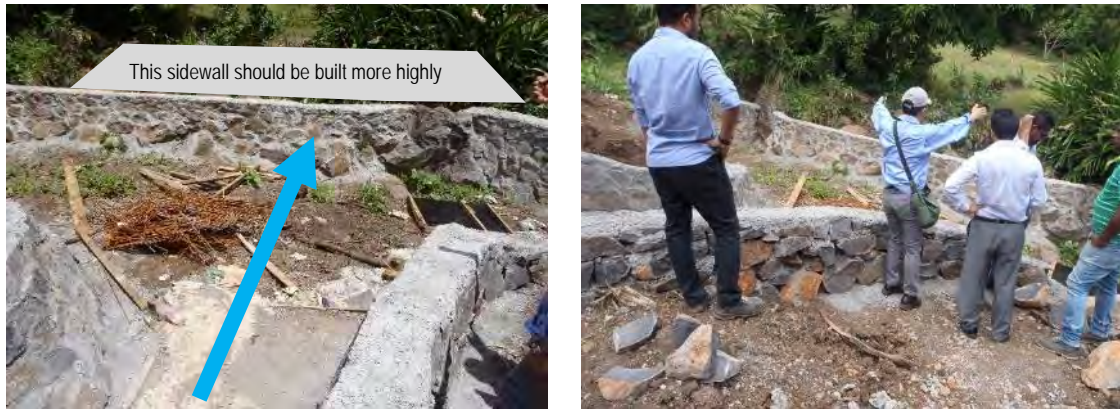
Figure 2 Bend (near BR-6) of New Channel, NCH1, needing building up (Source: JET)

JICA expert suggested that the side wall at a bend (near BR-6) of the New Channel, NCH1, should be built higher than the current height to prevent scattering of the water.

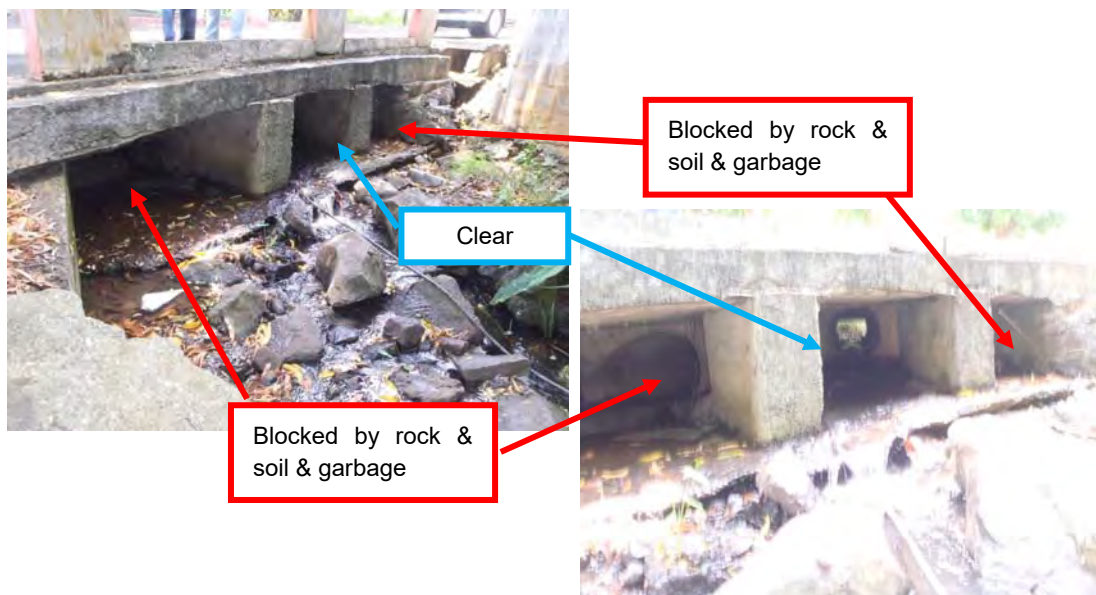
CH-3 末端の道路を横断している既存のカルバートの能力が不十分なため、以下の処置を推薦する。

Figure 3 Current condition of the existing Calvert crossing the road

既存カルバートは、排水能力を確保するために橋に変更されるべきです。橋の建設までの暫定的な処置として、直ぐに既存カルバートを掃除するべきです。

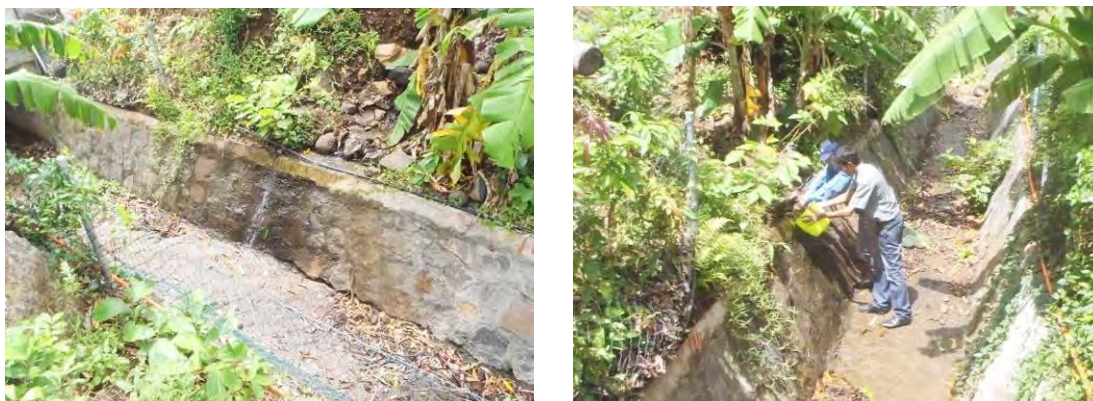
The flow of this surface water was 26.4 litres a minute (refer to table 1).

Photo 1 Surface water near bridge Br-1 (Source: JET)
