Work plan for evaluation of the landslide countermeasure in Chitrakoot

Slope inventory

MPI and JET have visited 18 sites of slope failures, rock falls, and debris flows, and surveyed the current conditions of each slope during this project. As a result of the investigation of the 18 sites, slope investigation sheets and a slope inventory were made by MPI and JET.

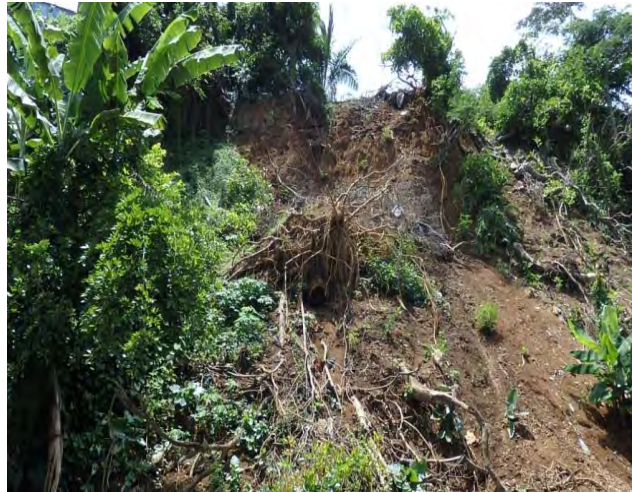
Photo-1 Full view. Scarps of the slope failure. After discussion between LMU and JET, structural slope protection were designed.

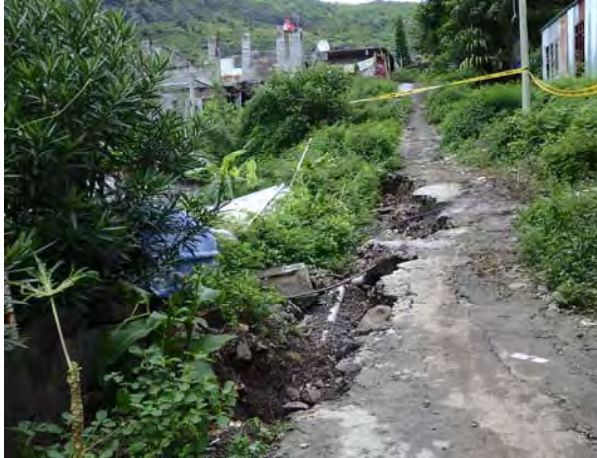
Photo-1 Full view. Long term rain water infiltrated through the road surface and the earth fill was saturated. The flash flood did not flow into the damaged part. That indicates after flash flood, the wall and road were collapsed.
No leakage was observed from the sewage pipe.

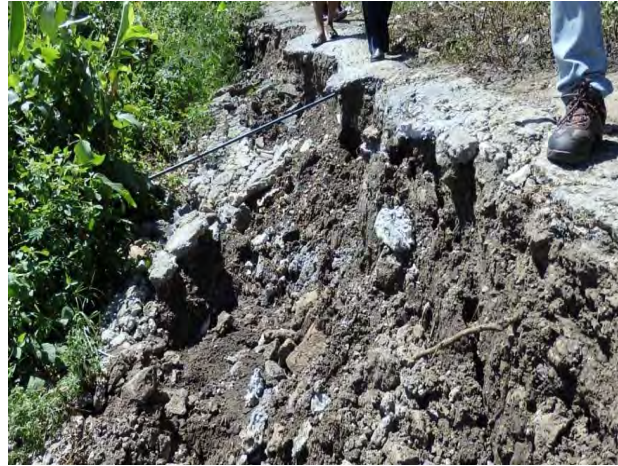
Photo-2 17m long, 3m wide and 0.5m deep collapse of the road

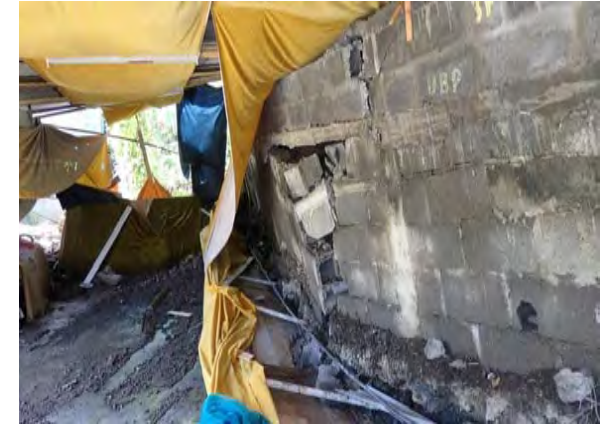
Photo-3 Damage of the concrete block wall of the mosque. The wall was inclined by lack of strength. The base of the wall was pushed up.

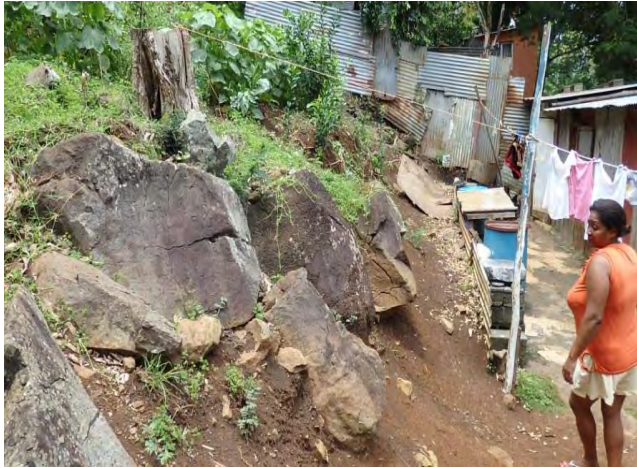
Photo-1 Rock exposed behind the houses in Ruisseau de Creoles.

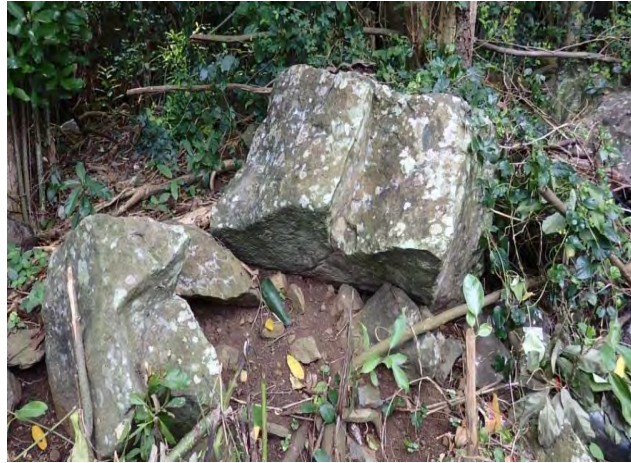
Photo-2 1m to 1.5m diameter rock are observed on the slope

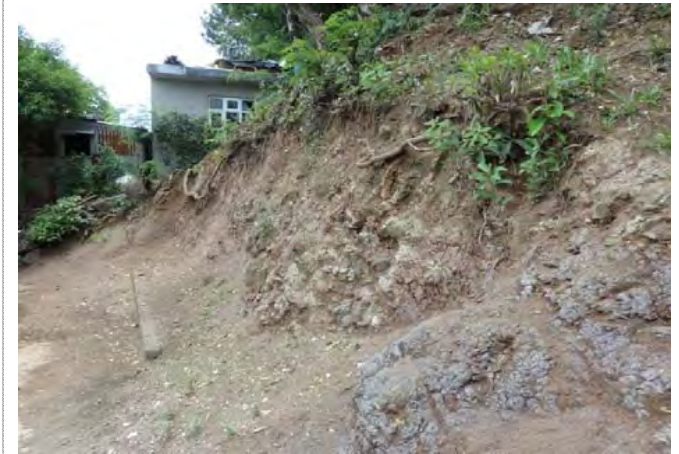
Photo-3 Cut slope become unstable.

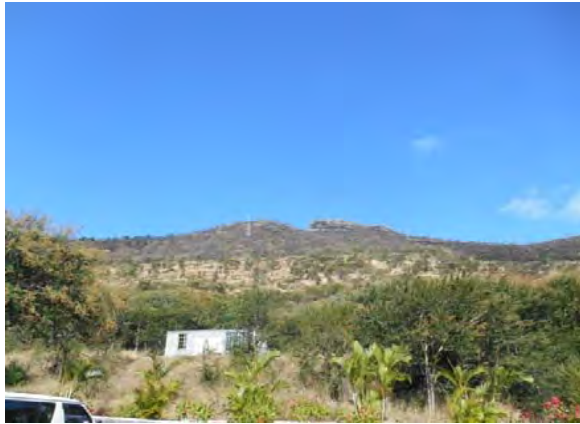
Photo-1 Full view from lowest part. All section of the road is on the slope. Wide area is burned by wild fire.

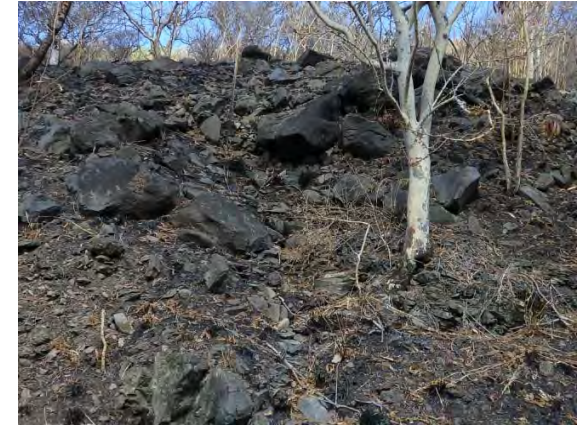
Photo-3 Slightly cut slope. Many unstable rocks can be seen. No barrier exists on the slope to the road.

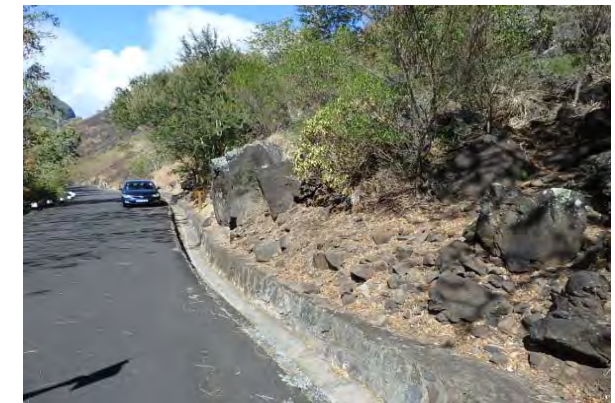
Photo-6 Rolling stones are fell into the drainage.

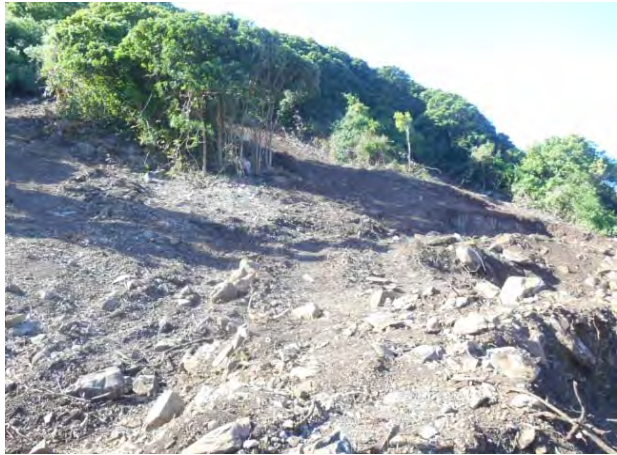
Photo-1 Upper slope of development area. Trees are all cut and muddy surface is exposed.

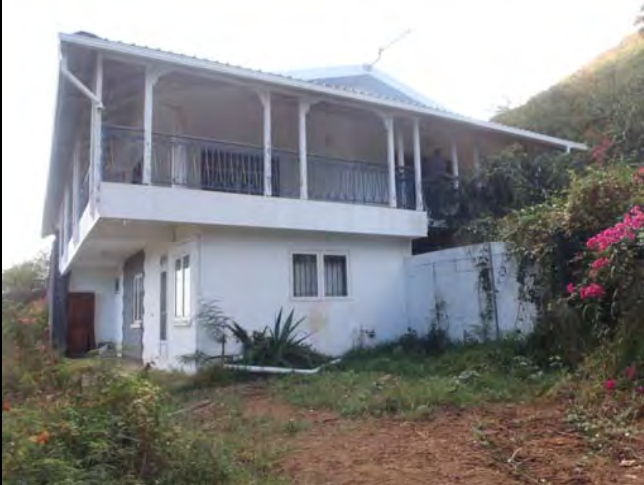
Excising House
Damage by landslide is not found on the existing building.

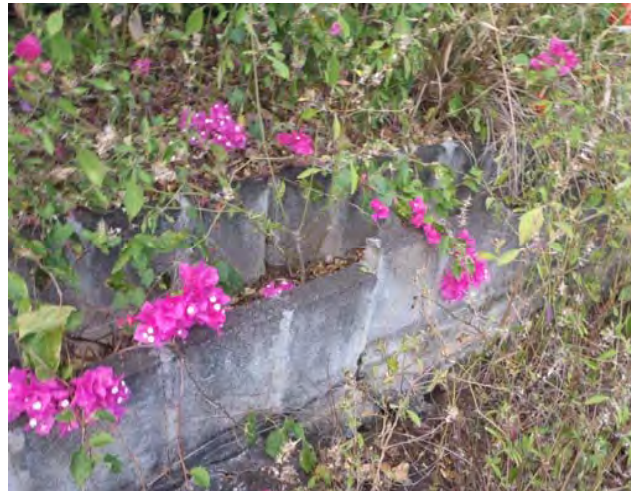
Excising Drainage
The existing drainage need to be repaired.

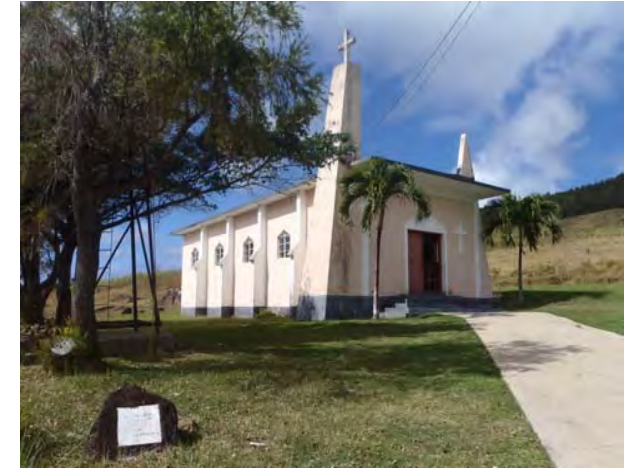
Excising Building (Church)
No damage by landslide is found on this land, on the existing building (church).

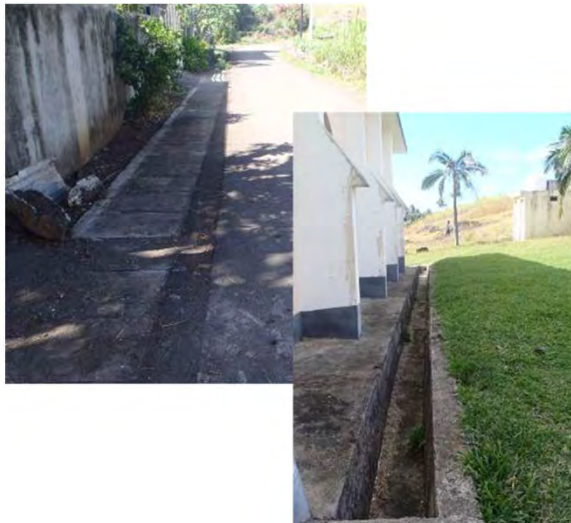
Existing Drainage of Road Side & Around Church
No damage by landslide is found on the existing open drains.

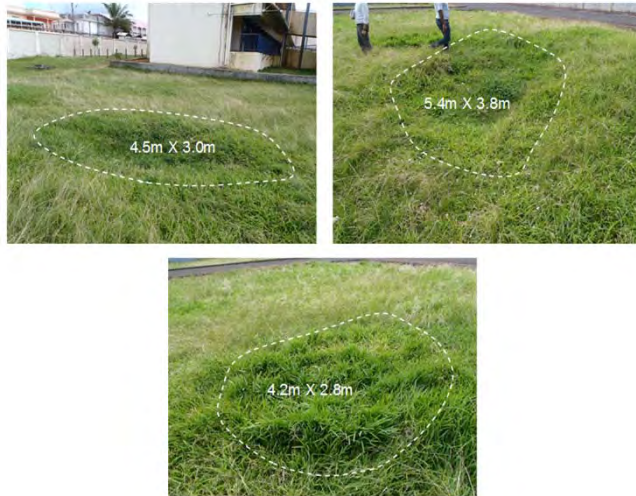
Current condition of three depressions in the green area
