# ミャンマー国 ヤンゴン・マンダレー鉄道整備事業 フェーズⅡ準備調査

ファイナルレポート (公開版)

独立行政法人 国際協力機構(JICA)

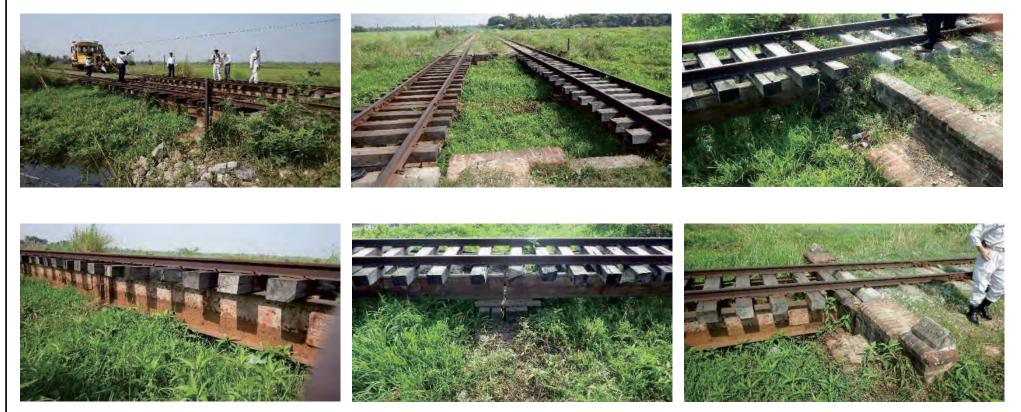
Investigation Record for Bridge on Yangon - Mandalay Trunk Line (26.Apr.)										
Bridge No. [Name (UP or DN)]	291 [ (UP & DN)]	Mileage	181 / 14 -

- Steel Deck Plate Girder (UP & DN)
- $-10(ft) \times 3(span) = 30(ft) (UP \& DN)$
- Design Live Load: unknown (UP), axle load 13 t (DN)
- Railway ties are inserted in bearing point of abutments and piers of up & down line. It is considered to be a countermeasure against settlement of substructure.
- Outflow of back soil and ballasts is observed at an abutment.
- The bodies of abutments and piers are unable to be visually observed due to settlement or sediment.
- Dirt and corrosion are observed over a main girder. Also, traces of submergence is observed from bottom flange to middle of a web.

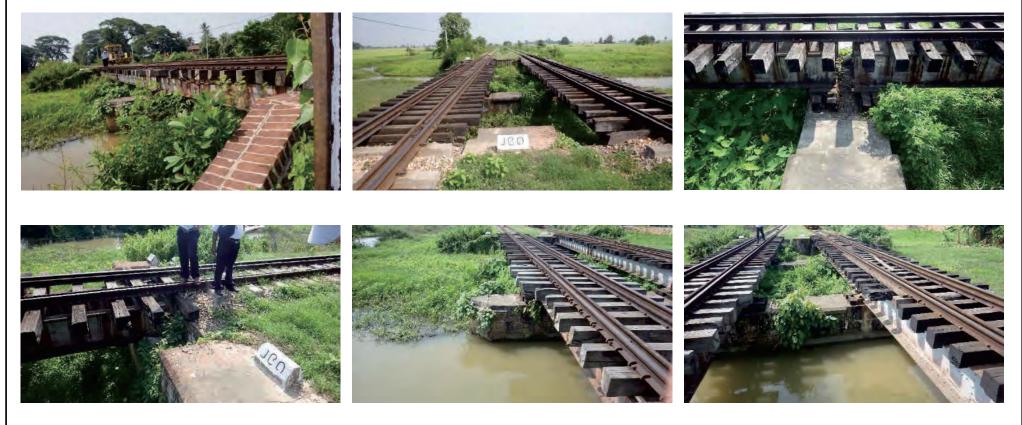
Investigation Record for Bridge on Yangon - Mandalay Trunk Line (26.Apr.)											
Bridge No. [Name (UP or DN)]	298 [ (UP & DN)]	Mileage	184 / 14 -

- Steel Deck Plate Girder (UP & DN)
- $-20(ft) \times 3(span) = 60(ft) (UP \& DN)$
- Design Live Load: unknown (UP), axle load 13 t (DN)
- Railway ties are inserted in bearing point of abutments and piers of up & down line. It is considered to be a countermeasure against settlement of substructure.
- Outflow of back soil and ballasts is observed at an abutment.
- Aged deterioration, such as cracks at joint of bricks, chipped bricks, and dirt, is observed over abutments and piers. However, a great damage is not observed.
- Dirt and corrosion are observed over a main girder.

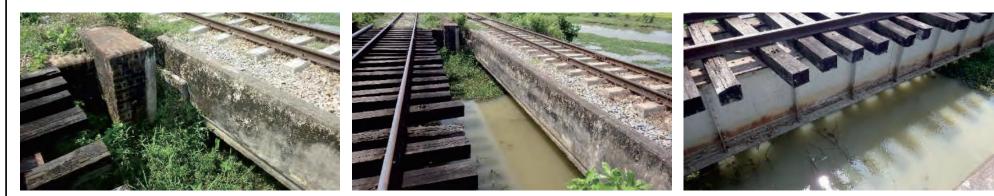
Investigation Record for Bridge on Yangon - Mandalay Trunk Line (26.Apr.)				
Bridge No. [Name (UP or DN)]	301 [ (UP & DN)]	Mileage	187 / 10 -	
- the		The states		
			C. Martine C.

- Prestressed Concrete Girder (UP), Steel Deck Plate Girder (DN)

- 40(ft) (UP & DN)

- Outflow of back soil is observed at an abutment. Also, the bearing part is unable to be visually observed due to outflow of soil.

- Aged deterioration, such as cracks of joint of bricks, chipped bricks, and dirt, is observed over abutments and piers. However, a great damage is not obseved.

- Dirt and corrosion are observed over a steel main girder. Also, trace of submergence is observed from bottom flange to lower part of a web.

- At concrete main girder, dirt on surface due to aging, and concrete honeycomb due to construction failure, are observed.

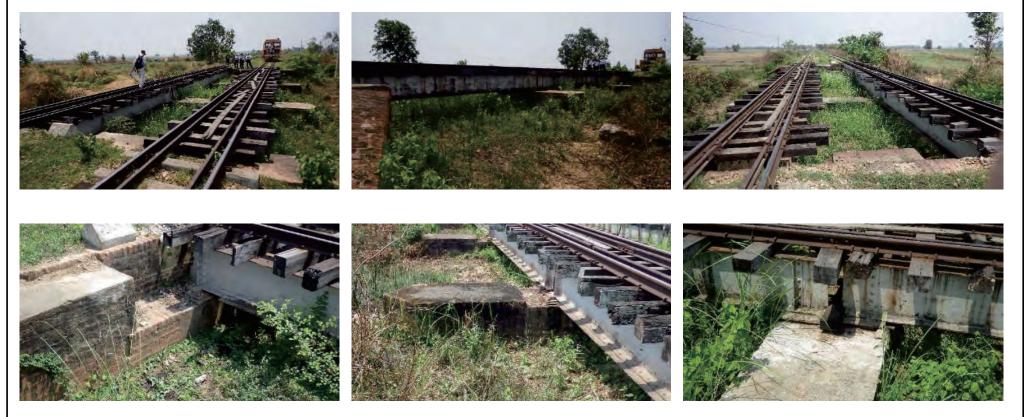
Investigation Record for Bridge on Yangon - Mandalay Trunk Line (26.Apr.)			
Bridge No. [Name (UP or DN)]	320 A [ (UP & DN)]	Mileage	197 / 3 -

- Steel Deck Plate Girder (UP & DN)
- $-20(ft) \times 3(span) = 60(ft) (UP \& DN)$
- Design Live Load: axle load 13 t (UP), unknown (DN)
- Design Live Load. axie load 15 t (UP), unknown (DN) - Wooden lumber is inserted in bearing point of abutments and piers of up & down lines. It is considered to be a countermeasure against settlement of substructure.
- Outflow of ballasts at the back is observed at an abutment.
- Aged deterioration, such as cracks of joint of bricks, chipped bricks, and dirt, is observed over abutments and piers. However, a great damage is not obseved.
- Dirt and corrosion are observed over a main girder.
- Wooden lumber is inserted at joint gap of main girders whose purpose might be to prevent girders from hitting each other due to its lateral movement.

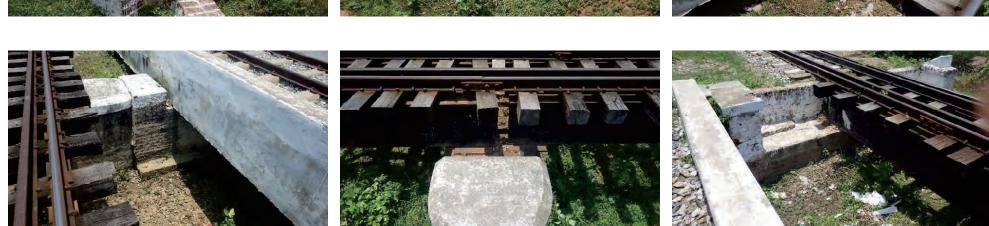
Investigation Record for Bridge on Yangon - Mandalay Trunk Line (27.Apr.)				
Bridge No. [Name (UP or DN)]	523 [ (UP & DN)]	Mileage	282 / 21 -

- Steel Deck Plate Girder (UP), Reinforced Concrete Girder (DN)

$-20(ft) \times 4(span) = 80(ft)$

- Design Live Load: axle load 13 t (UP), unknown (DN)
- Outflow of back soil and ballasts is observed at abutments.
- Aged deterioration, such as cracks at joint of bricks, chipped bricks, and dirt, is observed over abutments and piers. However, a great damage is not observed.
- Dirt and corrosion are observed over a main steel girder.

- At a concrete main girder, dirt on surface due to aging is observed. Deterioration condition of girder body is unable to be visually observed because it is covered by mortar.

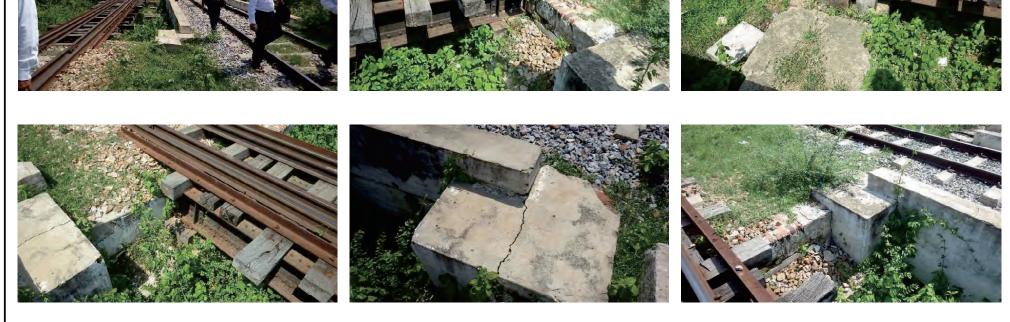
Investigation	Investigation Record for Bridge on Yangon - Mandalay Trunk Line (27.Apr.)			
Bridge No. [Name (UP or DN)]	573 [ (UP & DN)]	Mileage	297 / 24 -

- Reinforced Concrete Girder (UP), Steel Deck Plate Girder (DN)
- $-20(ft) \times 3(span) = 60(ft) (UP \& DN)$
- Design Live Load: unknown (UP & DN)
- Outflow of back soil and ballasts is observed at an abutment.
- Wooden sleepers are inserted in bearing point of abutments and piers of down line (steel girder). It is considered to be a countermeasure against settlement of substructure.
- Cracks are observed at side wall of parapet at an abutment of up line (concrete girder).
- Damage on parapet section, which might be caused by collision with girder, is observed.
- Dirt and corrosion are observed over a main steel girder.
