## **APPENDIX 5.9**

# **Existing station Building Conditions**

## Investigation of Station Building

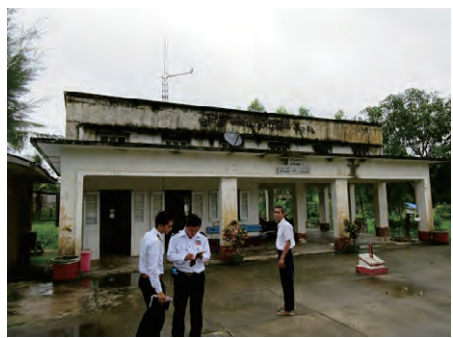
Station No.	39	Line Name	Yangon – Mandalay Line	Date of Survey	5/7/2017		
Station Name	KYEDAW						
Existing Station Building	Kilopost	276.5	Mileage	171.75			
	Access Road	<input checked="" type="radio"/> Yes <input type="radio"/> No	Age of Building	Over 50 years			
	Story of Building	( 1 ) Story Building	Total Floor Area	About 109 m <sup>2</sup>			
	Type of Main Structure (Check <input type="radio"/> )	<input checked="" type="radio"/> Brick with RC • Wood • Other(    )	Finish Material	Roof	<input checked="" type="radio"/> Corrugated Steel sheet • Roof Tiles • RC • Asbestos Fibre Cement		
	Other Structure	Wall		<input checked="" type="radio"/> Brick <input type="radio"/> Wood	Wall	<input checked="" type="radio"/> Paint	
		Column		<input checked="" type="radio"/> Brick <input type="radio"/> Wood	Column	<input checked="" type="radio"/> Paint	
		Beam		Wood <input checked="" type="radio"/> RC <input type="radio"/> Steel	Floor	<input checked="" type="radio"/> Concrete    • Wood

Electric system (Check <input type="radio"/> )	<input checked="" type="radio"/> Retract from outside • Solar System • Generator	Water Supply (Check <input type="radio"/> )	<input checked="" type="radio"/> Water Well (    ) • Waterwork • None			
	Condition of Main Structure	Main Damage Type & Rank*		Condition of Finish Material	Main Damage Type & Rank*		
		D	<input checked="" type="radio"/> Crack (10 mm) • Settlement • Inclination		D	<input checked="" type="radio"/> Water Leak <input checked="" type="radio"/> Peel Off (Roof, Ceiling, Wall, Colum )	
General Evaluation	• Usual <input checked="" type="radio"/> Poor • Severe	Remarks	No passenger and freight. No toilet. 1 cable room and 1 generator room.				
Photograph

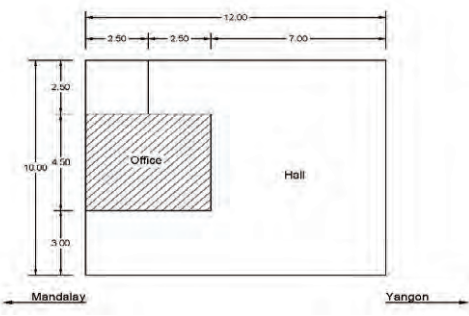
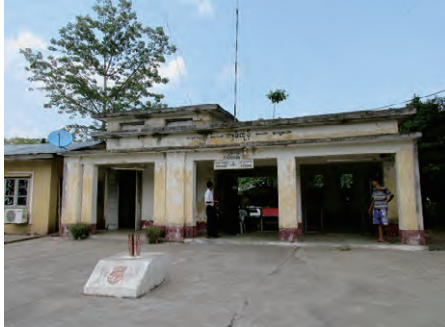
Station No.	40	Line Name	Yangon – Mandalay Line	Date of Survy	17/5/2017		
Station Name	KYUNGON						
Existing Station Building	Kilopost	282.5	Mileage	175.5			
	Access Road	<input checked="" type="radio"/> Yes <input type="radio"/> No	Age of Building	Over 100 years			
	Story of Building	( 1 ) Story Building	Total Floor Area	About 120 m <sup>2</sup>			
	Type of Main Structure (Check <input type="radio"/> )	<input checked="" type="radio"/> Brick with RC • Wood • Other(    )	Finish Material	Roof	<ul style="list-style-type: none"> <li>• Corrugated Steel sheet</li> <li>• Roof Tiles</li> <li><input checked="" type="radio"/> RC</li> <li>• Asbestos Fibre Cement</li> </ul>		
	Other Structure	Wall		<input checked="" type="radio"/> Brick <input type="radio"/> Wood	Wall	<input checked="" type="radio"/> Paint	
		Column		<input checked="" type="radio"/> Brick <input type="radio"/> Wood	Column	<input checked="" type="radio"/> Paint

Beam		Wood <input checked="" type="radio"/> RC <input type="radio"/> Steel	Floor	<input checked="" type="radio"/> Concrete with Brick <input type="radio"/> Wood	
	Electric system (Check <input type="radio"/> )	<input checked="" type="radio"/> Retract from outside • Solar System • Generator	Water Supply (Check <input type="radio"/> )	<ul style="list-style-type: none"> <li>• Water Well (    )</li> <li>• Waterwork</li> <li><input checked="" type="radio"/> None</li> </ul>			
	Condition of Main Structure	Main Damage Type & Rank*		Condition of Finish Material	Main Damage Type & Rank*		
		D	<input checked="" type="radio"/> Crack (5 mm) • Settlement • Inclination		D	<input checked="" type="radio"/> Water Leak <input checked="" type="radio"/> Peel Off (Roof, Ceiling, Wall, Colum )	
General Evaluation	<ul style="list-style-type: none"> <li>• Usual</li> <li><input checked="" type="radio"/> Poor</li> <li>• Severe</li> </ul>	Remarks	No passenger and freight. No toilet and tube well. 1 cable room and 1 generator room.

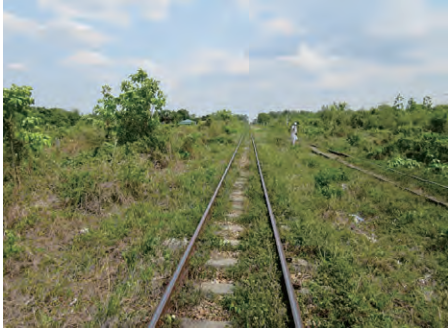
Condition of Main Structure	Main Damage Type & Rank*		Condition of Finish Material	Main Damage Type & Rank*		
			<ul style="list-style-type: none"> <li>▪ Crack ( mm)</li> <li>▪ Settlement</li> <li>▪ Inclination</li> </ul>			<ul style="list-style-type: none"> <li>▪ Water Leak</li> <li>▪ Peel Off (Roof, Ceiling, Wall, Colum )</li> </ul>	
General Evaluation	<ul style="list-style-type: none"> <li>▪ Usual</li> <li>▪ Poor</li> <li>▪ Severe</li> </ul>		Remarks	Dismantled in 1994.			
Photograph

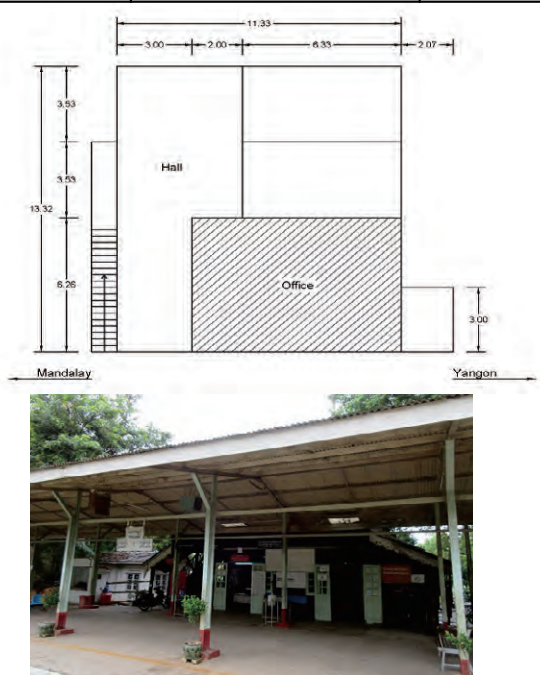
Electric system (Check <input type="radio"/> )	<input checked="" type="radio"/> Retract from outside <input type="radio"/> Solar System <input type="radio"/> Generator		Water Supply (Check <input type="radio"/> )	<input type="radio"/> Water Well (    ) <input type="radio"/> Waterwork <input checked="" type="radio"/> None		
	Condition of Main Structure	Main Damage Type & Rank*		Condition of Finish Material	Main Damage Type & Rank*		
		D	<input type="checkbox"/> Crack (    mm) <input type="checkbox"/> Settlement <input type="checkbox"/> Inclination		D	<input checked="" type="radio"/> Water Leak <input checked="" type="radio"/> Peel Off (Roof, Ceiling, Wall, Colum )	
General Evaluation	<input type="checkbox"/> Usual <input checked="" type="radio"/> Poor <input type="checkbox"/> Severe		Remarks	About 70 passengers/day and no freight.No toilet and tube well.1 cable rm, 1 generator rm and 1 store rm.

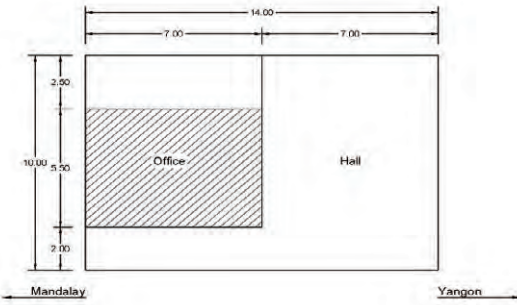
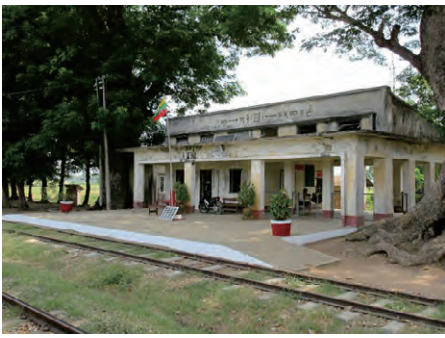
Condition of Main Structure	Main Damage Type & Rank*		Condition of Finish Material	Main Damage Type & Rank*		
		F	<input checked="" type="radio"/> Crack ( 10mm) • Settlement • Inclination		D	<input checked="" type="radio"/> Water Leak <input checked="" type="radio"/> Peel Off (Roof, Ceiling, Wall, Colum )	
General Evaluation	• Usual • Poor <input checked="" type="radio"/> Severe		Remarks	No toilet room.1 cable room and 1 generator room.Tube well for staff.Train: Upline 1stop/day Dline 1stop/day.			
Photograph

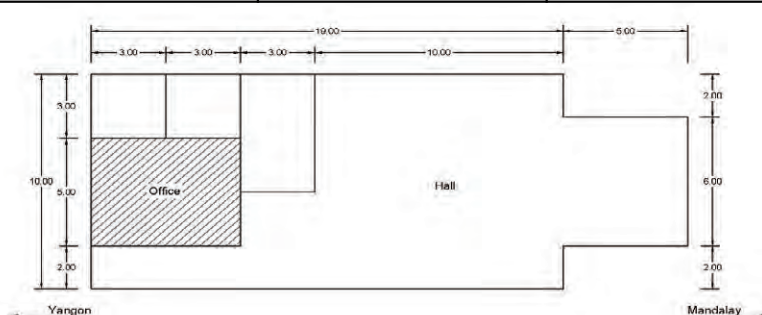
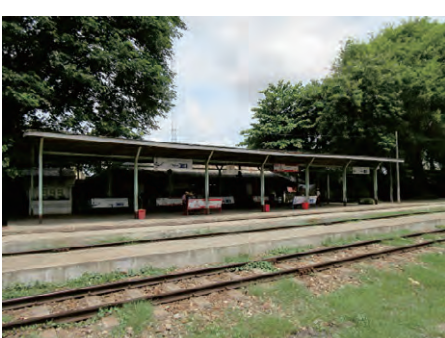
Electric system (Check <input type="radio"/> )	<input checked="" type="radio"/> Retract from outside <input type="radio"/> Solar System <input type="radio"/> Generator		Water Supply (Check <input type="radio"/> )	<input type="radio"/> Water Well (    ) <input type="radio"/> Waterwork <input checked="" type="radio"/> None		
	Condition of Main Structure	Main Damage Type & Rank*		Condition of Finish Material	Main Damage Type & Rank*		
		D	<input type="radio"/> Crack ( mm) <input type="radio"/> Settlement <input type="radio"/> Inclination <input checked="" type="radio"/> Break column		B	<input type="radio"/> Water Leak <input type="radio"/> Peel Off (Roof, Ceiling, Wall, Colum )	
General Evaluation	<input type="radio"/> Usual <input checked="" type="radio"/> Poor <input type="radio"/> Severe		Remarks	No toilet room.			
Photograph

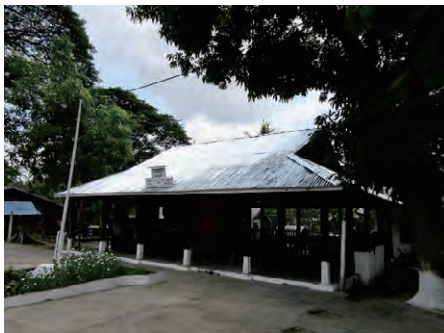
Electric system (Check <input type="radio"/> )	<input checked="" type="radio"/> Retract from outside <input type="radio"/> Solar System <input type="radio"/> Generator		Water Supply (Check <input type="radio"/> )	<input type="radio"/> Water Well (    ) <input type="radio"/> Waterwork <input type="radio"/> None		
	Condition of Main Structure	Main Damage Type & Rank*		Condition of Finish Material	Main Damage Type & Rank*		
		<b>B</b>	<input type="radio"/> Crack (    mm) <input type="radio"/> Settlement <input type="radio"/> Inclination		<b>B</b>	<input type="radio"/> Water Leak <input type="radio"/> Peel Off (Roof, Ceiling, Wall, Colum )	
General Evaluation	<input checked="" type="radio"/> Usual <input type="radio"/> Poor <input type="radio"/> Severe		Remarks	No toilet room.			
Photograph

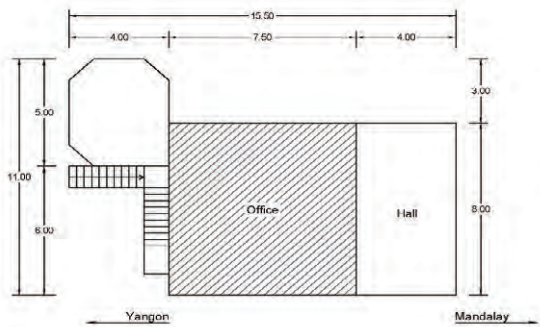
Electric system (Check <input type="radio"/> )	<input checked="" type="radio"/> Retract from outside • Solar System • Generator		Water Supply (Check <input type="radio"/> )	• Water Well (    ) • Waterwork <input checked="" type="radio"/> None			
	Condition of Main Structure	Main Damage Type & Rank*			Condition of Finish Material		Main Damage Type & Rank*	
		D	• Crack (    mm) • Settlement • Inclination		D		<input checked="" type="radio"/> Water Leak <input checked="" type="radio"/> Peel Off (Roof, Ceiling, Wall, Colum )	
General Evaluation	• Usual <input checked="" type="radio"/> Poor • Severe		Remarks		No toilet room(Only staff).			
Photograph

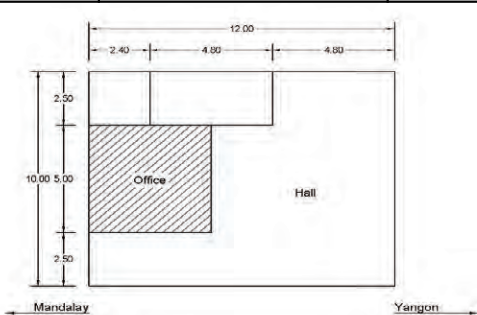
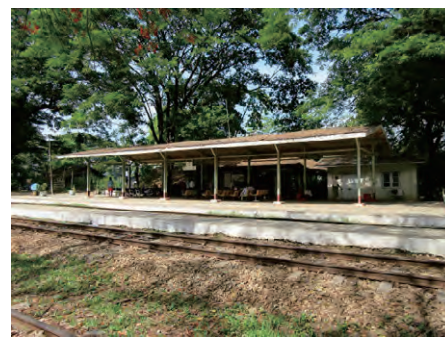
Electric system (Check <input type="radio"/> )	<ul style="list-style-type: none"> <li><input checked="" type="radio"/> Retract from outside</li> <li>▪ Solar System</li> <li>▪ Generator</li> </ul>		Water Supply (Check <input type="radio"/> )	<ul style="list-style-type: none"> <li>▪ Water Well (    )</li> <li>▪ Waterwork</li> <li><input checked="" type="radio"/> None</li> </ul>		
	Condition of Main Structure	Main Damage Type & Rank*		Condition of Finish Material	Main Damage Type & Rank*		
		F	<ul style="list-style-type: none"> <li><input checked="" type="radio"/> Crack (30mm)</li> <li>▪ Settlement</li> <li>▪ Inclination</li> </ul>		C	<ul style="list-style-type: none"> <li><input checked="" type="radio"/> Water Leak</li> <li>▪ Peel Off (Roof, Ceiling, Wall, Colum )</li> </ul>	
General Evaluation	<ul style="list-style-type: none"> <li>▪ Usual</li> <li>▪ Poor</li> <li><input checked="" type="radio"/> Severe</li> </ul>		Remarks	No toilet room.

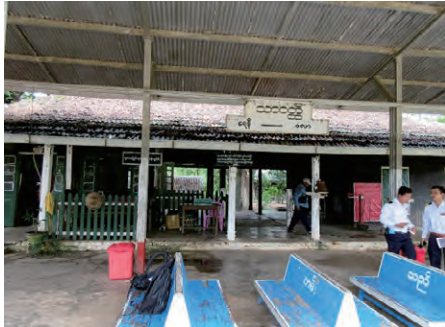
Electric system (Check <input type="radio"/> )	<ul style="list-style-type: none"> <li><input checked="" type="radio"/> Retract from outside</li> <li>▪ Solar System</li> <li>▪ Generator</li> </ul>		Water Supply (Check <input type="radio"/> )	<ul style="list-style-type: none"> <li><input checked="" type="radio"/> Water Well ( Mortar )</li> <li>▪ Waterwork</li> <li>▪ None</li> </ul>		
	Condition of Main Structure	Main Damage Type & Rank*			Condition of Finish Material	Main Damage Type & Rank*	
		F	<ul style="list-style-type: none"> <li><input checked="" type="radio"/> Crack (10mm)</li> <li><input type="radio"/> Settlement</li> <li><input type="radio"/> Inclination</li> </ul>			C	<ul style="list-style-type: none"> <li><input checked="" type="radio"/> Water Leak</li> <li><input checked="" type="radio"/> Peel Off (Roof, Ceiling, Wall, Colum )</li> </ul>
General Evaluation	<ul style="list-style-type: none"> <li>▪ Usual</li> <li>▪ Poor</li> <li><input checked="" type="radio"/> Severe</li> </ul>		Remarks	No toilet room. About 7 passengers/day and a little freight(sometime).

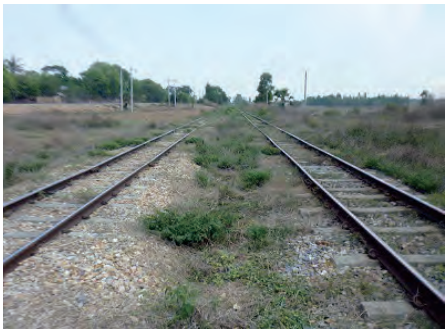
Condition of Main Structure	Main Damage Type & Rank*		Condition of Finish Material	Main Damage Type & Rank*		
			<ul style="list-style-type: none"> <li>▪ Crack ( mm)</li> <li>▪ Settlement</li> <li>▪ Inclination</li> </ul>			<ul style="list-style-type: none"> <li>▪ Water Leak</li> <li>▪ Peel Off (Roof, Ceiling, Wall, Colum )</li> </ul>	
General Evaluation	<ul style="list-style-type: none"> <li>▪ Usual</li> <li>▪ Poor</li> <li>▪ Severe</li> </ul>		Remarks	Dismantled.			
Photograph

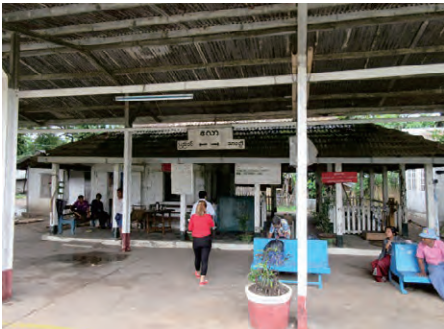
Beam	<input checked="" type="radio"/> Wood    RC    Steel		Floor	<input checked="" type="radio"/> Concrete    • Wood	
	Electric system (Check <input type="radio"/> )	<ul style="list-style-type: none"> <li><input checked="" type="radio"/> Retract from outside</li> <li>• Solar System</li> <li>• Generator</li> </ul>		Water Supply (Check <input type="radio"/> )	<ul style="list-style-type: none"> <li><input checked="" type="radio"/> Water Well ( Mortar )</li> <li>• Waterwork</li> <li>• None</li> </ul>		
	Condition of Main Structure	Main Damage Type & Rank*			Condition of Finish Material	Main Damage Type & Rank*	
		D	<ul style="list-style-type: none"> <li><input checked="" type="radio"/> Crack (10mm)</li> <li>• Settlement</li> <li>• Inclination</li> </ul>			D	<ul style="list-style-type: none"> <li><input checked="" type="radio"/> Water Leak</li> <li><input checked="" type="radio"/> Peel Off (Roof, Ceiling, Wall, Colum )</li> </ul>

General Evaluation	<ul style="list-style-type: none"> <li>• Usual</li> <li><input checked="" type="radio"/> Poor</li> <li>• Severe</li> </ul>		Remarks	No toilet room. About 70 passengers/day and a little freight(sometime). 1 cable and 1 generator			
Photograph

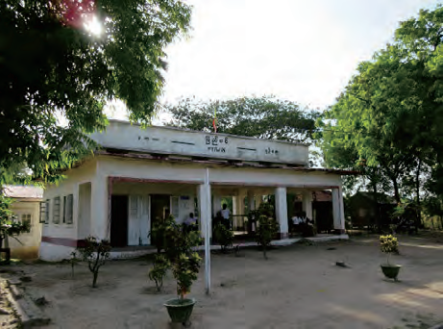
Condition of Main Structure	Main Damage Type & Rank*		Condition of Finish Material	Main Damage Type & Rank*		
		F	<input checked="" type="radio"/> Crack (10mm) <input checked="" type="radio"/> Settlement • Inclination		D	<input checked="" type="radio"/> Water Leak <input checked="" type="radio"/> Peel Off (Roof, Ceiling, Wall, Colum )	
General Evaluation	• Usual • Poor <input checked="" type="radio"/> Severe		Remarks	No toilet room.			
Photograph

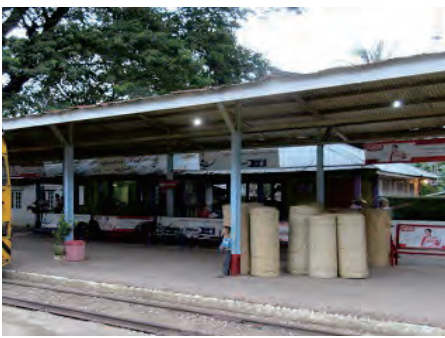
Beam	<input checked="" type="radio"/> Wood <input type="radio"/> RC <input type="radio"/> Steel		Floor	<input checked="" type="radio"/> Concrete <input type="radio"/> Wood	
	Electric system (Check <input type="radio"/> )	<input checked="" type="radio"/> Retract from outside <input type="radio"/> Solar System <input type="radio"/> Generator		Water Supply (Check <input type="radio"/> )	<input checked="" type="radio"/> Water Well ( Tube ) <input type="radio"/> Waterwork <input type="radio"/> None		
	Condition of Main Structure	Main Damage Type & Rank*			Main Damage Type & Rank*		
		D	<input checked="" type="radio"/> Crack (6mm) <input checked="" type="radio"/> Settlement <input type="radio"/> Inclination		C	<input checked="" type="radio"/> Water Leak <input type="radio"/> Peel Off (Roof, Ceiling, Wall, Colum )	
General Evaluation	<input type="radio"/> Usual <input checked="" type="radio"/> Poor <input type="radio"/> Severe		Remarks	About 100 passengers/day and freight(sometime). No toilet. 1 cable room and 1 store

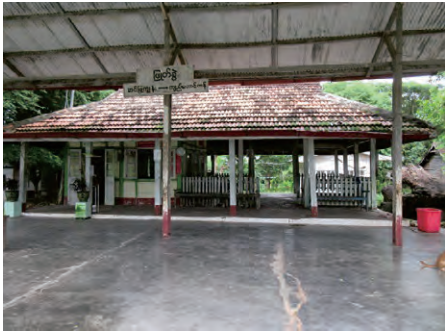
Beam		<input checked="" type="radio"/> Wood <input type="radio"/> RC <input type="radio"/> Steel	Floor	<input checked="" type="radio"/> Concrete    • Wood	
	Electric system (Check <input type="radio"/> )	<ul style="list-style-type: none"> <li><input checked="" type="radio"/> Retract from outside</li> <li>• Solar System</li> <li>• Generator</li> </ul>	Water Supply (Check <input type="radio"/> )	<ul style="list-style-type: none"> <li>• Water Well (            )</li> <li>• Waterwork</li> <li><input checked="" type="radio"/> None</li> </ul>			
	Condition of Main Structure	Main Damage Type & Rank*		Condition of Finish Material	Main Damage Type & Rank*		
		F	<ul style="list-style-type: none"> <li><input checked="" type="radio"/> Crack (10mm)</li> <li><input checked="" type="radio"/> Settlement</li> <li><input checked="" type="radio"/> Inclination 5°</li> </ul>		D	<ul style="list-style-type: none"> <li><input checked="" type="radio"/> Water Leak</li> <li><input checked="" type="radio"/> Peel Off (Roof, Ceiling, Wall, Colum )</li> </ul>

General Evaluation	<ul style="list-style-type: none"> <li>• Usual</li> <li>• Poor</li> <li><input checked="" type="radio"/> Severe</li> </ul>	Remarks	About 40 passengers/day and no freight. No toilet. 1 cable and 1 generator				
Photograph

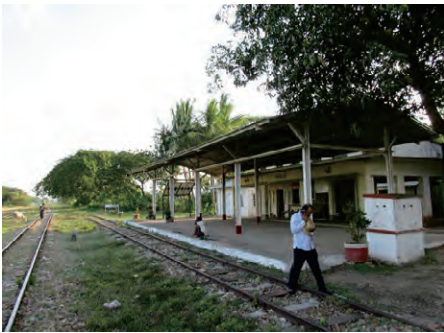
Electric system (Check <input type="radio"/> )	• Retract from outside <input checked="" type="radio"/> Solar System • Generator	Water Supply (Check <input type="radio"/> )	• Water Well (    ) • Waterwork <input checked="" type="radio"/> None			
	Condition of Main Structure	Main Damage Type & Rank*		Condition of Finish Material	Main Damage Type & Rank*		
		F	<input checked="" type="radio"/> Crack (10mm) • Settlement • Inclination		D	<input checked="" type="radio"/> Water Leak <input checked="" type="radio"/> Peel Off (Roof, Ceiling, Wall, Colum )	
General Evaluation	• Usual • Poor <input checked="" type="radio"/> Severe		Remarks	No toilet.			
Photograph

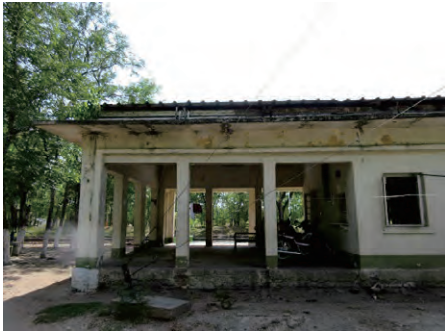
Electric system (Check <input type="radio"/> )	<input checked="" type="radio"/> Retract from outside • Solar System • Generator	Water Supply (Check <input type="radio"/> )	<input checked="" type="radio"/> Water Well (    ) • Waterwork • None			
	Condition of Main Structure	Main Damage Type & Rank*		Condition of Finish Material	Main Damage Type & Rank*		
		F	<input checked="" type="radio"/> Crack ( 50mm) • Settlement • Inclination		C	<input checked="" type="radio"/> Water Leak • Peel Off (Roof, Ceiling, Wall, Colum )	
General Evaluation	• Usual • Poor <input checked="" type="radio"/> Severe		Remarks	No toilet.			
Photograph

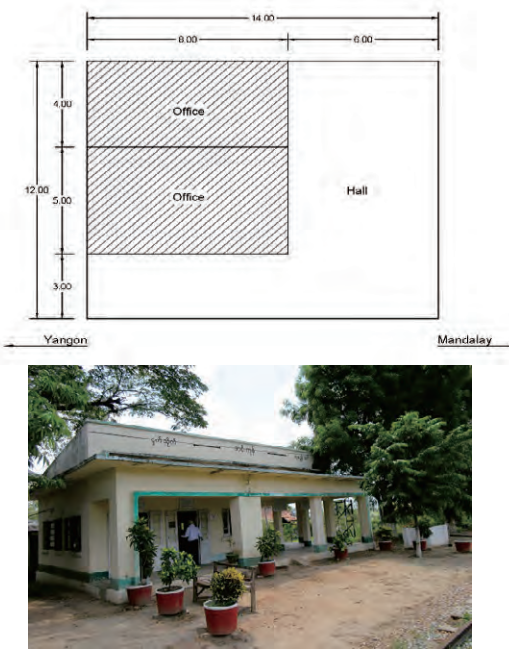
Electric system (Check <input type="radio"/> )	• Retract from outside <input checked="" type="radio"/> Solar System • Generator	Water Supply (Check <input type="radio"/> )	<input checked="" type="radio"/> Water Well (    ) • Waterwork • None			
	Condition of Main Structure	Main Damage Type & Rank*		Condition of Finish Material	Main Damage Type & Rank*		
		F	<input checked="" type="radio"/> Crack (10 mm) <input checked="" type="radio"/> Settlement • Inclination		D	<input checked="" type="radio"/> Water Leak <input checked="" type="radio"/> Peel Off (Roof, Ceiling, Wall, Colum )	
General Evaluation	• Usual • Poor <input checked="" type="radio"/> Severe	Remarks	No toilet.				
Photograph

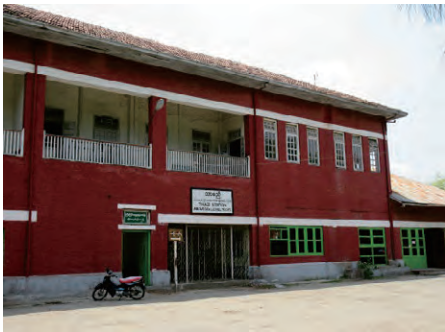
Beam		<input checked="" type="radio"/> Wood <input type="radio"/> RC <input checked="" type="radio"/> Steel	Floor	<input checked="" type="radio"/> Concrete <input type="radio"/> Wood	
	Electric system (Check <input type="radio"/> )	<input checked="" type="radio"/> Retract from outside <input type="radio"/> Solar System <input type="radio"/> Generator	Water Supply (Check <input type="radio"/> )	<input checked="" type="radio"/> Water Well (                    ) <input type="radio"/> Waterwork <input type="radio"/> None			
	Condition of Main Structure	Main Damage Type & Rank*		Condition of Finish Material	Main Damage Type & Rank*		
		F	<input checked="" type="radio"/> Crack ( 10mm) <input type="radio"/> Settlement <input type="radio"/> Inclination		C	<input checked="" type="radio"/> Water Leak <input type="radio"/> Peel Off (Roof, Ceiling, Wall, Colum )	
General Evaluation	<input type="radio"/> Usual <input type="radio"/> Poor <input checked="" type="radio"/> Severe		Remarks

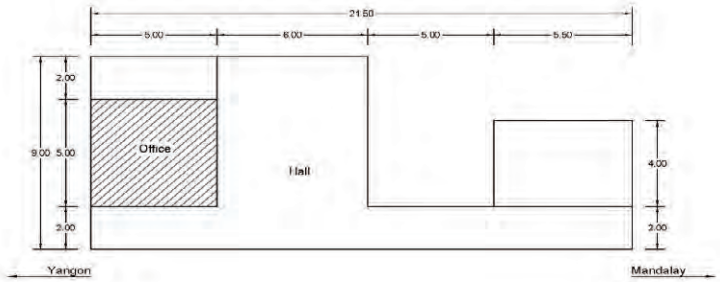
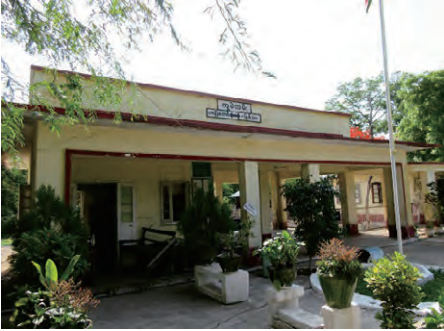
Electric system (Check <input type="radio"/> )	<input checked="" type="radio"/> Retract from outside • Solar System • Generator	Water Supply (Check <input type="radio"/> )	• Water Well (    ) • Waterwork <input checked="" type="radio"/> None			
	Condition of Main Structure	Main Damage Type & Rank*		Condition of Finish Material	Main Damage Type & Rank*		
		F	<input checked="" type="radio"/> Crack (15mm) • Settlement • Inclination		C	<input checked="" type="radio"/> Water Leak • Peel Off (Roof, Ceiling, Wall, Colum )	
General Evaluation	• Usual • Poor <input checked="" type="radio"/> Severe		Remarks	No toilet.			
Photograph

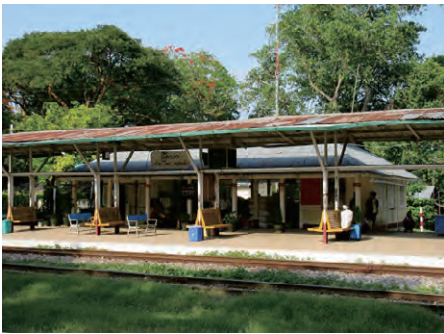
Beam		<input checked="" type="radio"/> Wood <input type="radio"/> RC <input type="radio"/> Steel	Floor	<input checked="" type="radio"/> Concrete <input type="radio"/> Wood	
	Electric system (Check <input type="radio"/> )	<input checked="" type="radio"/> Retract from outside <input type="radio"/> Solar System <input type="radio"/> Generator	Water Supply (Check <input type="radio"/> )	<input checked="" type="radio"/> Water Well ( Pump ) <input type="radio"/> Waterwork <input type="radio"/> None			
	Condition of Main Structure	Main Damage Type & Rank*		Condition of Finish Material	Main Damage Type & Rank*		
		D	<input checked="" type="radio"/> Crack ( 10mm ) <input type="radio"/> Settlement <input type="radio"/> Inclination		B	<input type="radio"/> Water Leak <input type="radio"/> Peel Off ( Roof, Ceiling, Wall, Colum )	
General Evaluation	<input type="radio"/> Usual <input checked="" type="radio"/> Poor <input type="radio"/> Severe		Remarks	No toilet.
