## **APPENDIX 5.9**

### **Existing station Building Conditions**

## Investigation of Station Building

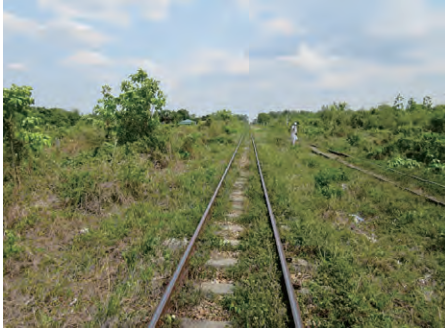
Station No.	41	Line Name	Yangon – Mandalay Line	Date of Survey	17/5/2017		
Station Name	KAYTUMADI						
Existing Station Building	Kilopost	290.5		Mileage	180.5		
	Access Road	Yes	No	Age of Building			
	Story of Building	( ) Story Building		Total Floor Area	About m <sup>2</sup>		
	Type of Main Structure (Check <input type="checkbox"/> )	<ul style="list-style-type: none"> <li>▪ Brick with RC</li> <li>▪ Wood</li> <li>▪ Other( )</li> </ul>		Finish Material	Roof	<ul style="list-style-type: none"> <li>▪ Corrugated Steel sheet</li> <li>▪ Roof Tiles</li> <li>▪ RC</li> <li>▪ Asbestos Fibre Cement</li> </ul>	
	Other Structure	Wall	Brick		Wood	Wall	▪ Paint
		Column	Brick		Wood	Column	▪ Paint
		Beam	Wood		RC	Steel	Floor
	Electric system (Check <input type="checkbox"/> )	<ul style="list-style-type: none"> <li>▪ Retract from outside</li> <li>▪ Solar System</li> <li>▪ Generator</li> </ul>		Water Supply (Check <input type="checkbox"/> )	<ul style="list-style-type: none"> <li>▪ Water Well ( )</li> <li>▪ Waterwork</li> <li>▪ None</li> </ul>

Condition of Main Structure	Main Damage Type & Rank*		Condition of Finish Material	Main Damage Type & Rank*		
			<ul style="list-style-type: none"> <li>▪ Crack ( mm)</li> <li>▪ Settlement</li> <li>▪ Inclination</li> </ul>			<ul style="list-style-type: none"> <li>▪ Water Leak</li> <li>▪ Peel Off (Roof, Ceiling, Wall, Colum )</li> </ul>	
General Evaluation	<ul style="list-style-type: none"> <li>▪ Usual</li> <li>▪ Poor</li> <li>▪ Severe</li> </ul>		Remarks	Dismantled in 1994.			
Photograph

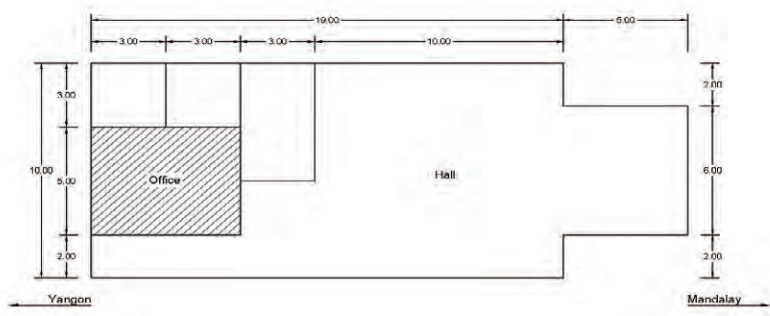
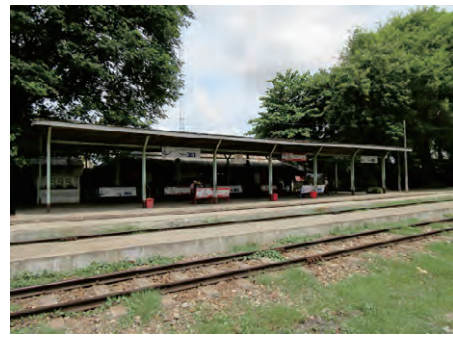
Electric system (Check <input type="radio"/> )	<input checked="" type="radio"/> Retract from outside <input type="radio"/> Solar System <input type="radio"/> Generator		Water Supply (Check <input type="radio"/> )	<input type="radio"/> Water Well (    ) <input type="radio"/> Waterwork <input checked="" type="radio"/> None		
	Condition of Main Structure	Main Damage Type & Rank*			Condition of Finish Material	Main Damage Type & Rank*	
		D	<input type="radio"/> Crack ( mm) <input type="radio"/> Settlement <input type="radio"/> Inclination <input checked="" type="radio"/> Break column			B	<input type="radio"/> Water Leak <input type="radio"/> Peel Off (Roof, Ceiling, Wall, Colum )
General Evaluation	<input type="radio"/> Usual <input checked="" type="radio"/> Poor <input type="radio"/> Severe		Remarks		No toilet room.		
Photograph

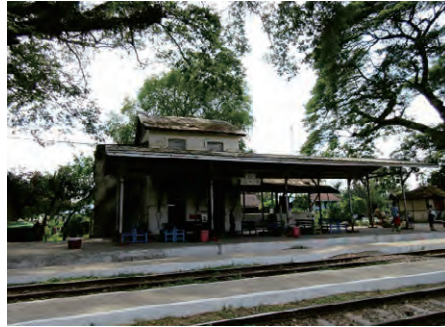
Electric system (Check <input type="radio"/> )	<input checked="" type="radio"/> Retract from outside • Solar System • Generator		Water Supply (Check <input type="radio"/> )	• Water Well (    ) • Waterwork <input checked="" type="radio"/> None		
	Condition of Main Structure	Main Damage Type & Rank*			Condition of Finish Material	Main Damage Type & Rank*	
		D	• Crack (    mm) • Settlement • Inclination			D	<input checked="" type="radio"/> Water Leak <input checked="" type="radio"/> Peel Off (Roof, Ceiling, Wall, Colum )
General Evaluation	• Usual <input checked="" type="radio"/> Poor • Severe		Remarks		No toilet room(Only staff).		
Photograph

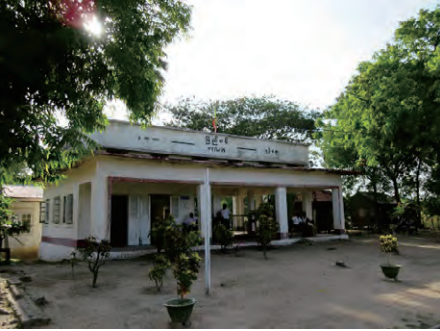
Electric system (Check <input type="radio"/> )	<input checked="" type="radio"/> Retract from outside • Solar System • Generator		Water Supply (Check <input type="radio"/> )	<input checked="" type="radio"/> Water Well (    ) • Waterwork • None		
	Condition of Main Structure	Main Damage Type & Rank*		Condition of Finish Material	Main Damage Type & Rank*		
		F	<input checked="" type="radio"/> Crack (10mm) <input checked="" type="radio"/> Settlement • Inclination		D	<input checked="" type="radio"/> Water Leak <input checked="" type="radio"/> Peel Off (Roof, Ceiling, Wall, Colum )	
General Evaluation	• Usual • Poor <input checked="" type="radio"/> Severe		Remarks	No toilet room.			
Photograph

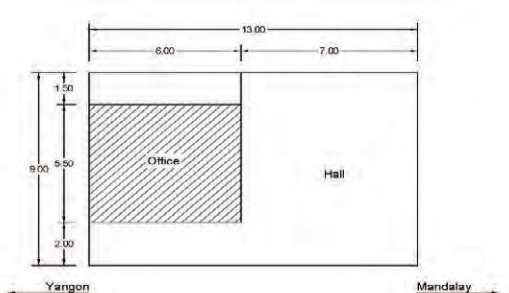
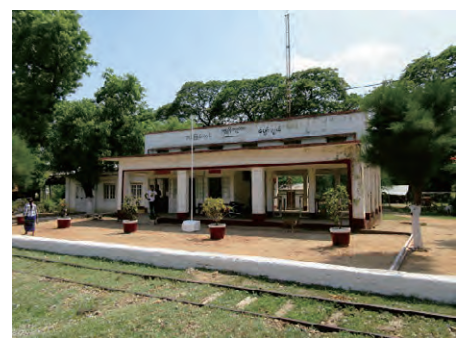
Electric system (Check <input type="radio"/> )	<input checked="" type="radio"/> Retract from outside • Solar System • Generator	Water Supply (Check <input type="radio"/> )	<input checked="" type="radio"/> Water Well ( Pump ) • Waterwork • None			
	Condition of Main Structure	Main Damage Type & Rank*		Condition of Finish Material	Main Damage Type & Rank*		
		F	<input checked="" type="radio"/> Crack ( 15mm ) <input checked="" type="radio"/> Settlement • Inclination		D	<input checked="" type="radio"/> Water Leak <input checked="" type="radio"/> Peel Off ( Roof, Ceiling, Wall, Colum )	
General Evaluation	• Usual • Poor <input checked="" type="radio"/> Severe		Remarks				
Photograph
