添付資料 9-6
工事完了証明書

1. Name of Consulting Service Assignment	The Pilot Project for Landslide and Rock fall mitigation works (Lot 1) under the Technical Cooperation for Landslide Mitigation Project
2. Performance Period	28/01/2016 – 28/07/2018
3. Contract Amount	LKR 38,268,930.00 (Final confirmed price: LKR 37,361,900.36)
4. Name of Contractor	ELS Construction (Pvt) Ltd
5. Progress of Work	As per progress report
6. Amount Payable by this Inspection	LKR 10,437,206.77
7. Note	Work progress in the report is 97.51% (Rs. 33,923,186.36) which is the progress percentage to the contract amount without contingency (10%). After this inspection on the completion of the work, defect liability period commences at the date of issuance and approval of Certificate of Completion for one year. The contractor should submit Maintenance Security to JICA for the defect liability.

CERTIFICATE OF PRACTICAL COMPLETION

Defects Liability Certificate

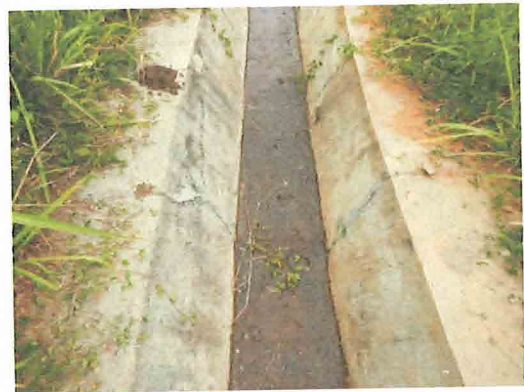
Photo 4: Cracks have been corrected (Loc.5)

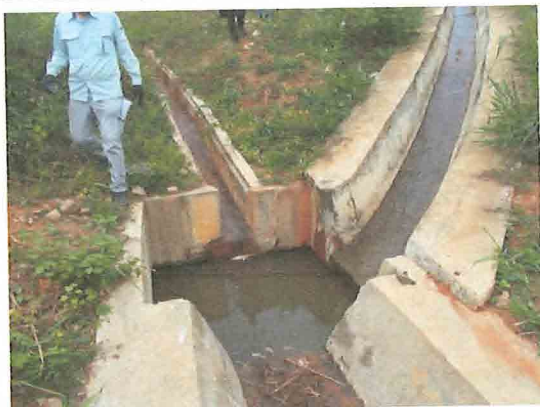
Photo 5: Soils have been removed (Loc.7)

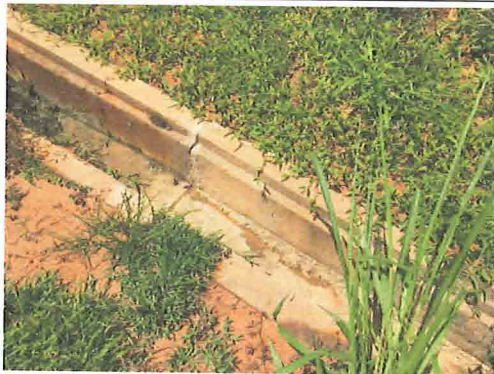
Photo 9: Crack has been corrected (Loc.11)

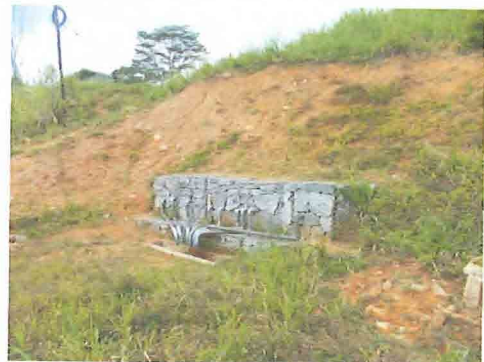
Photo 10: The small slip has been reshaped (D.P.4)

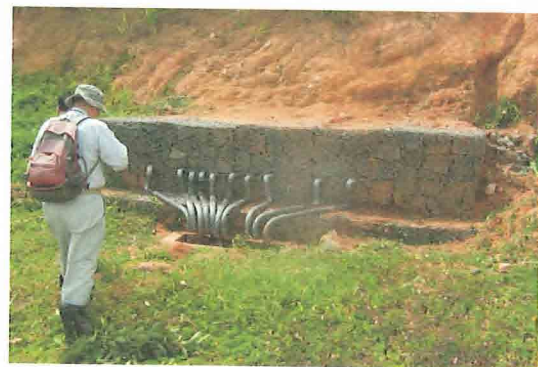
Photo 12: PVC pipe has been repaired (D.P.6)

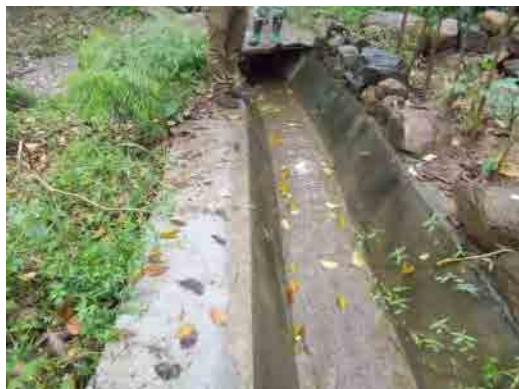
Photo 1: Crack on the ditch has been corrected.
(Loc. 1)

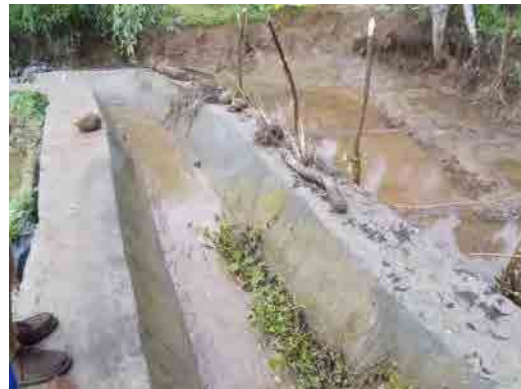
Photo 2: Leakages have been repaired.(Loc. 2)

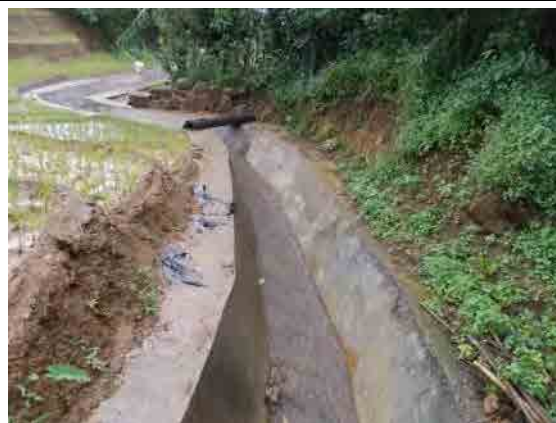
Photo 4: Leakages have been repaired.(Loc. 10)

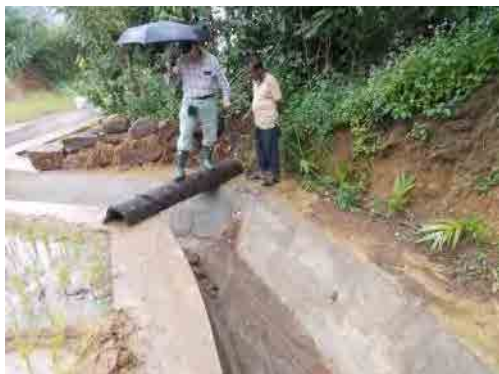
Photo 5: Crack on the ditch has been corrected. (Loc. 9)

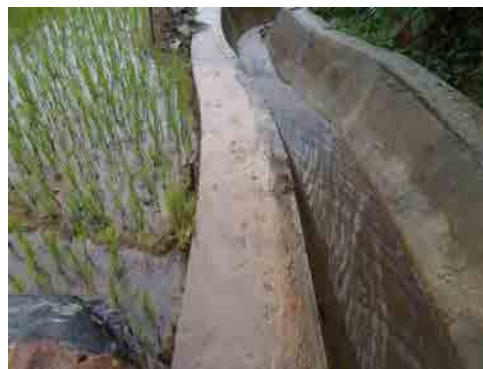
Photo 6: Crack has been corrected. (Loc. 5)

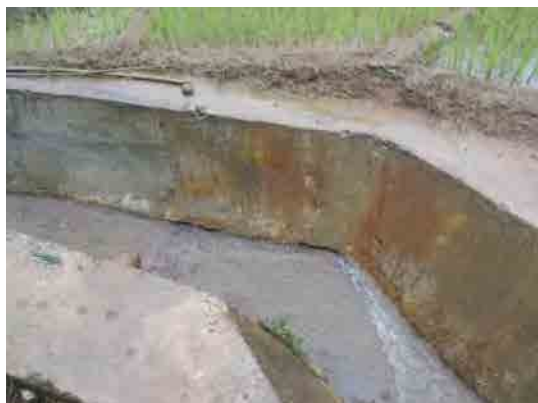
Photo 7: Erosion at the connecting point of base concrete and side wall. Repaired once, but eroded (Loc. 11)

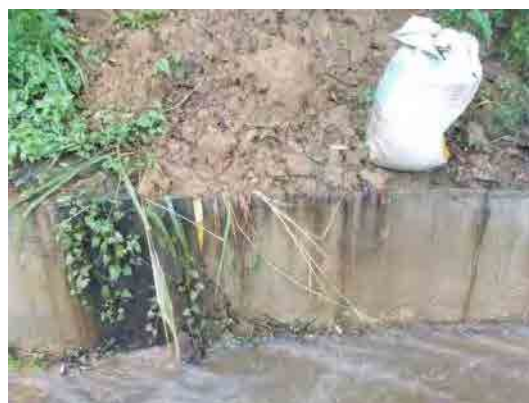
Photo 8: Eroded part was repaired once, but it is very difficult to find the exact place of erosion. (Loc. 12)

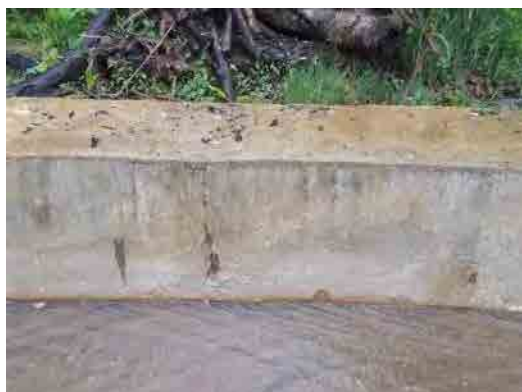
Photo 9: Leakage has been repaired. (Loc. 13)

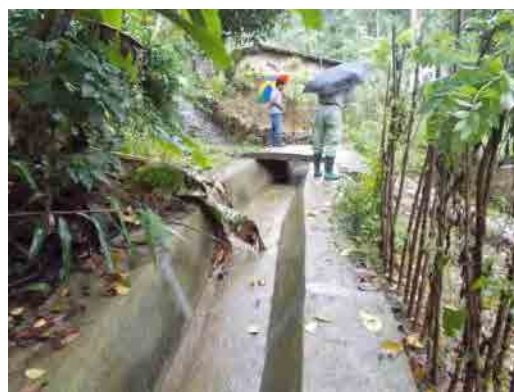
Photo 10: Crack along the expansion joint has been corrected. (Loc. 8)

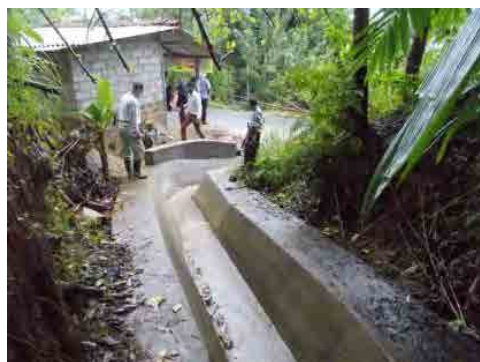
Photo 11: Additional wall for the overflowing has been constructed. (Loc. 14)

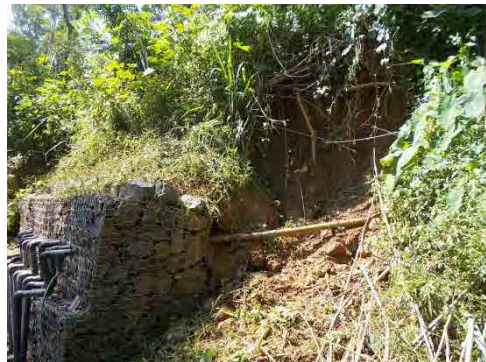
Photo 12: Collapse at the right side of gabion wall. (Horizontal drainage drilling No.10 was repaired)

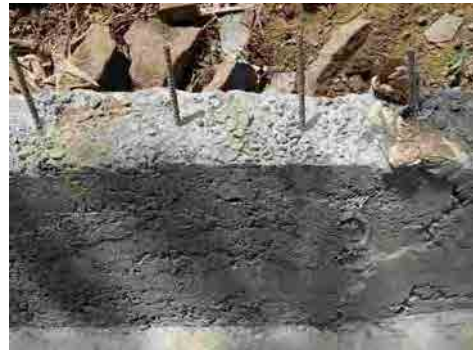
The concrete grade of the surface drainage ditch should be more than 25 grade. Otherwise, honeycombs could appear on the surface of the ditch. (see Photo 4.2) The main cause was the concrete grade and insufficient compaction with vibrator might be a cause of the honeycombs. Therefore more than a concrete grade 25 should be used for the surface drainage ditch in order to avoid such honeycombs. Also distribution of reinforce steel bars should follow the original design in order to keep the quality stipulated in the standard in Sri Lanka and the contract document (see Photo 4.3) .

Photo 4.2 Honeycombs of surface drainage ditch (already corrected)

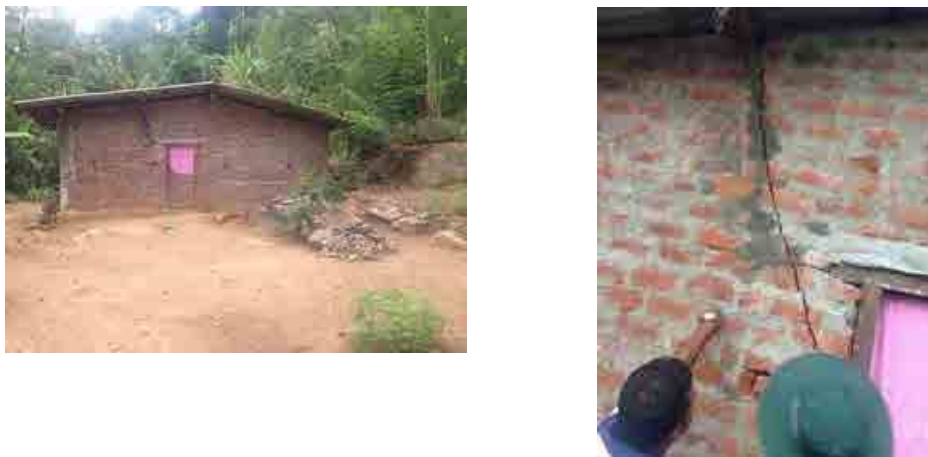
Although the cause of the appearance of the cracks was not clear, at least a rotary percussion type drilling machine could affect the appearance of the cracks. Thus if similar phenomena occur, the solution might be to change the type of drilling machine.

Photo 4.10 Cracks appeared on the wall of the house

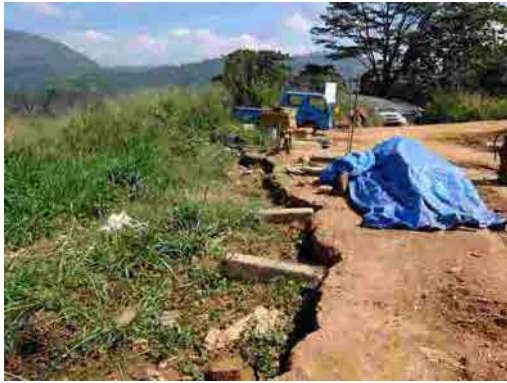
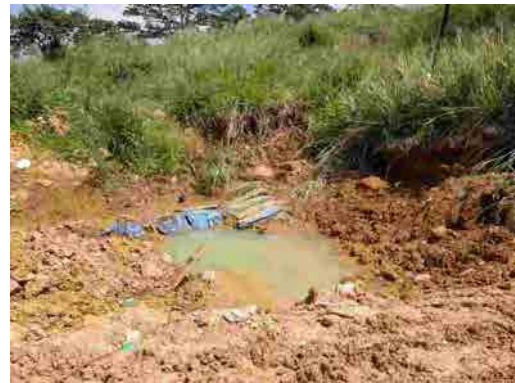
現地事務所前の盛土縁辺部に、1/26に豪雨に伴い亀裂が発生した。現地事務所周辺の平地は、斜面の切り盛りによって形成されたとのことであり、今回の亀裂は、盛土部分が滑動したものと考えられる。同時に、斜面末端部分に位置する水平ボーリング Point No.4が、土砂で埋まった状況となっている。コントラクターは、盛土部分を撤去し、斜面の安定を確保してから水平ボーリング工の施工を行う予定である。対策に関するレターがコントラクターから発出予定となっている。

盛土の滑動状況（左：現場事務所前の亀裂、右：Point 4 の埋没状況）

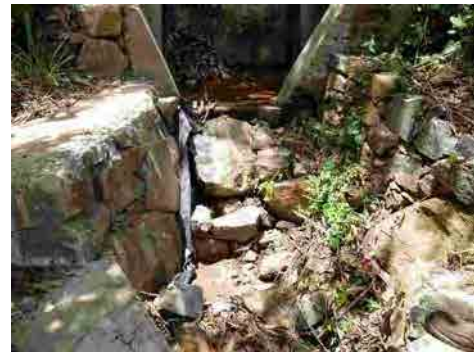
枿下部のコンクリート打設が実施されていない箇所

したがって、今後、コントラクターは漏水等の現象とあわせて、瑕疵担保期間内に施工・補修を終了させる予定である。

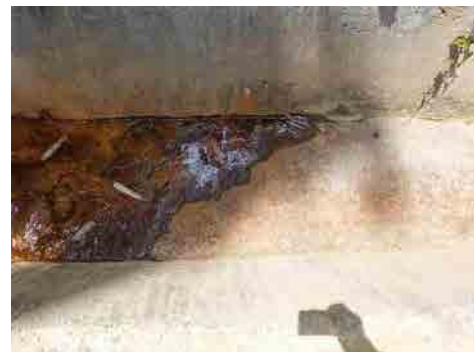
水路の漏水箇所

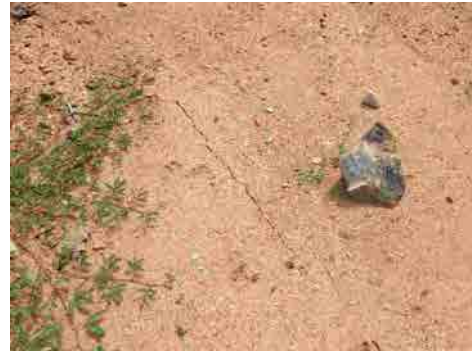
以上のことから完成検査後に特に大きな異常は生じていないと判断されるが、これらの亀裂等の状況は引き続き観察を行い、必要に応じて対策を講じる必要がある。

盛土部法肩の亀裂状況

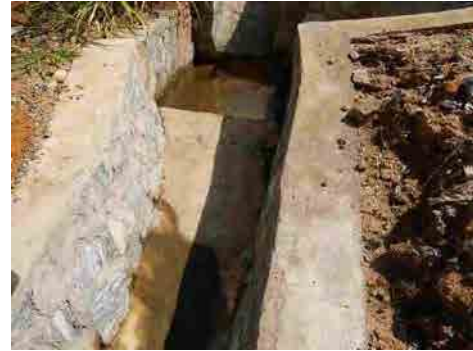
集水柵からの漏水の状況

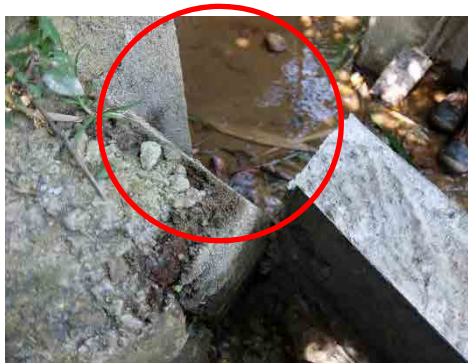
また、道路上部の水路工で豪雨時に表流水があふれる現象が確認された。水路が急角度で屈曲していることによるものと考えられる。この場所についても、コントラクターが水路工上部にコンクリート壁を建設して、対策を行っているが、実際にこの延長で問題が無いか、降雨時の確認が必要となると思われる。

柵下部の水路工の補修後の状況（検査時）

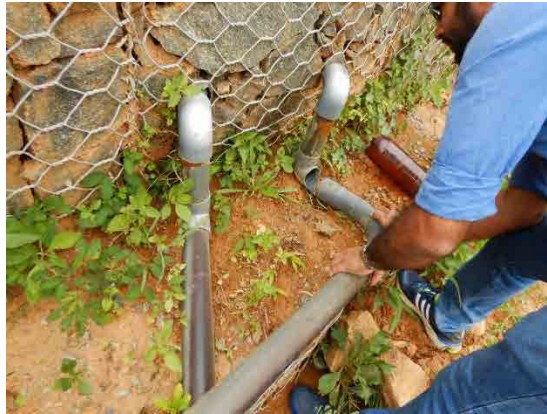
Point6の横ボーリングの一番右側のパイプが折れていた。NBROが7月の瑕疵検査までに修繕を実施する予定である。

Point6の横ボーリング孔口パイプの破損

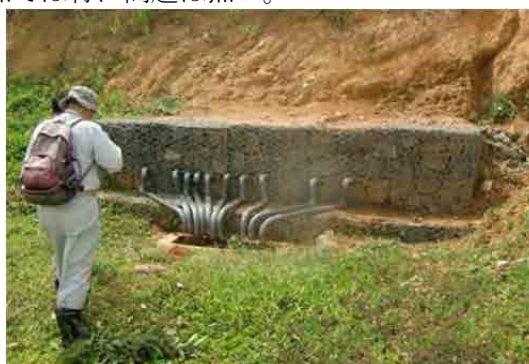
Point6の横ボーリングの一番右側のパイプが折られていたが、瑕疵検査時には補修が実施されており、瑕疵検査時点では特に問題は無い。

Point6の横ボーリング孔口パイプの破損は補修済み
