# Technical Cooperation for Landslide Mitigation Project

**Final Report**

September 2018

Japan International Cooperation Agency (JICA)

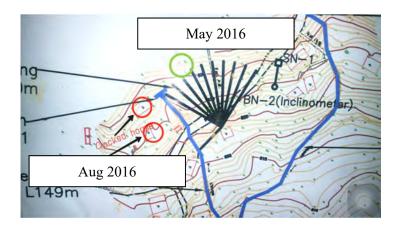
Figure 5.6 Location of the Cracks

The cracks appeared in August 2016. The distance was farther than the house cracks that occurred in May 2016. There was no possibility of the relationship between the cracks and the drilling work. The drilling method had been already changed. However, the cracks were monitored, and their expansion was not observed.

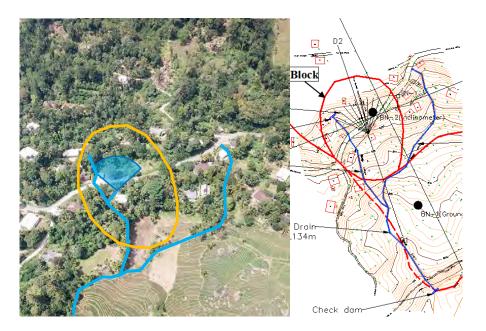
#### Figure 5.8 UAV Photograph after the Completion of Construction Work at the Udamadula Site

At the same time, the horizontal drainage holes were confirmed to be damaged at the defect reliability inspection. This defect was not determined to be due to natural disaster, and therefore, the restoration work was to be conducted by NBRO, the present management representative. After completion of the restoration work, the delegation of management authority to Walapane Division was to be carried out. The delegation will be completed with signatures on both NBRO and Divisional Secretariat letters.

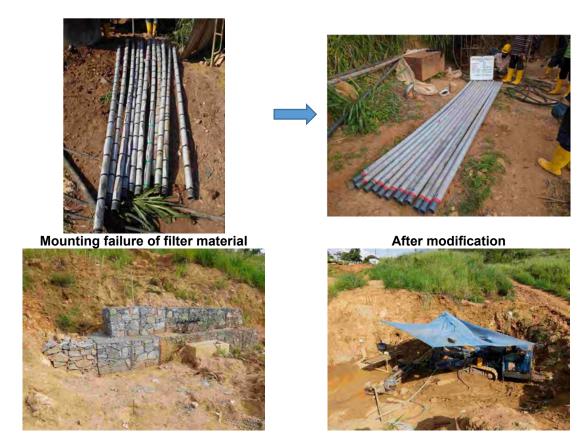
point No.1 and No.4 after rain events. Especially, the No.4 hole was completely filled by collapsed sediments. At drilling point No.1, soil flowed out of the side of the gabion caused by sediment movement. No.1 and 4 were reshaped by earthwork and these slopes were stabilized.

Cutting work at drilling point No.1

Cutting work at drilling point No.4

The Engineer advised to conduct minor earthwork to increase slope stability and to get permission from NBRO if cutting more than the fixed height was required, because the specification document had not clearly mentioned cutting earthwork at the time of horizontal boring work.
