Appendix 8-6

Certificate of completion
of the pilot site

1. Name of Consulting Service Assignment	The Pilot Project for Landslide and Rock fall mitigation works (Lot 1) under the Technical Cooperation for Landslide Mitigation Project
2. Performance Period	28/01/2016 – 28/07/2018
3. Contract Amount	LKR 38,268,930.00 (Final confirmed price: LKR 37,361,900.36)
4. Name of Contractor	ELS Construction (Pvt) Ltd
5. Progress of Work	As per progress report
6. Amount Payable by this Inspection	LKR 10,437,206.77
7. Note	Work progress in the report is 97.51% (Rs. 33,923,186.36) which is the progress percentage to the contract amount without contingency (10%). After this inspection on the completion of the work, defect liability period commences at the date of issuance and approval of Certificate of Completion for one year. The contractor should submit Maintenance Security to JICA for the defect liability.

Certificate of defect liability period
of the pilot sites

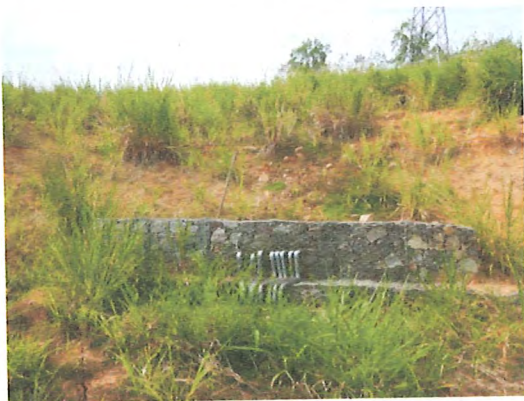
Photo 3: Small slip has been reshaped (D. P. 1)

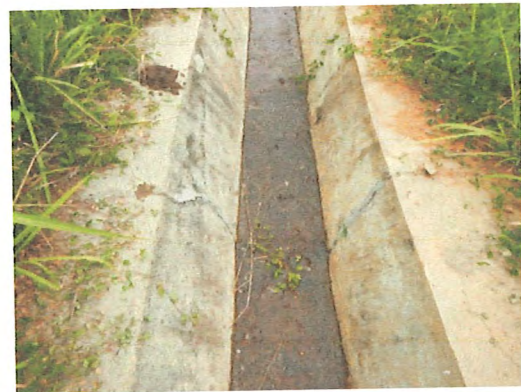
Photo 4: Cracks have been corrected (Loc.5)

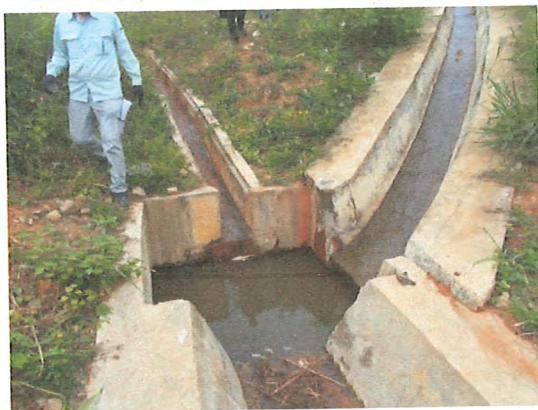
Photo 5: Soils have been removed (Loc.7)

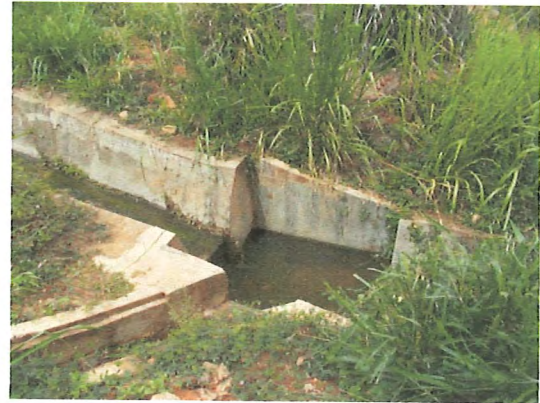
Photo 8: Soils have been removed (Loc.9)

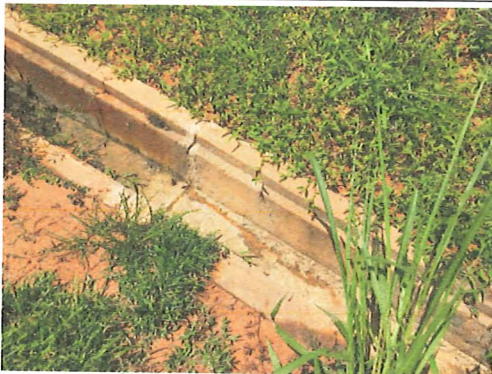
Photo 9: Crack has been corrected (Loc.11)

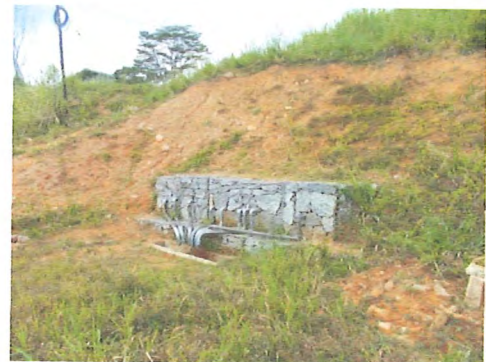
Photo 10: The small slip has been reshaped (D.P.4)

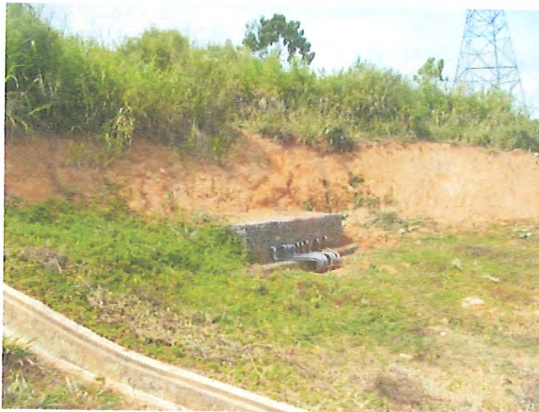
Photo 11: Soils have been removed (D.P.6)

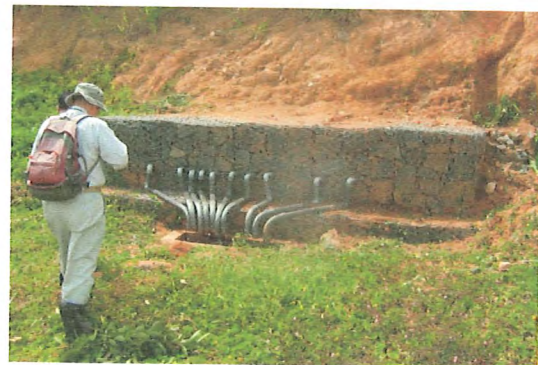
Photo 12: PVC pipe has been repaired (D.P.6)

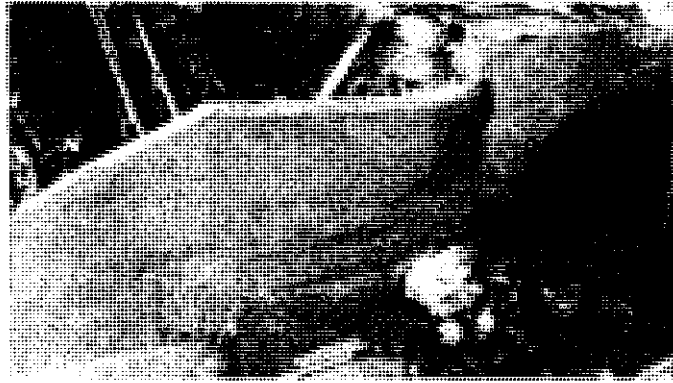
After the correction of the ditch near the catch pit

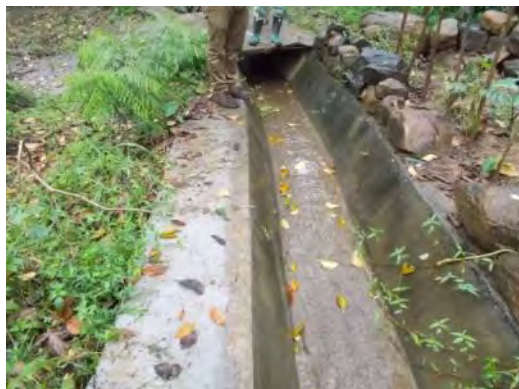
Photo 1: Crack on the ditch has been corrected.
(Loc. 1)

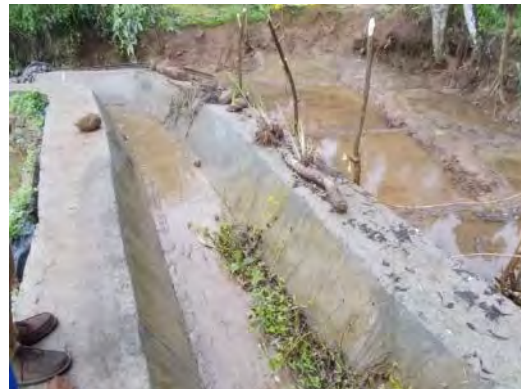
Photo 2: Leakages have been repaired.(Loc. 2)

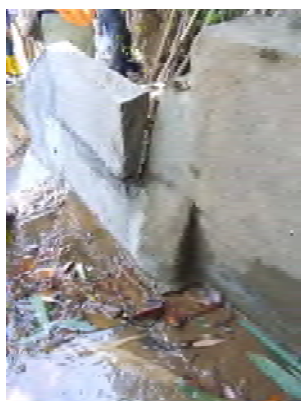
Photo 3: The ditch lower part of the pit has not been constructed properly. After the inspection, it has been corrected.(Loc. 3)

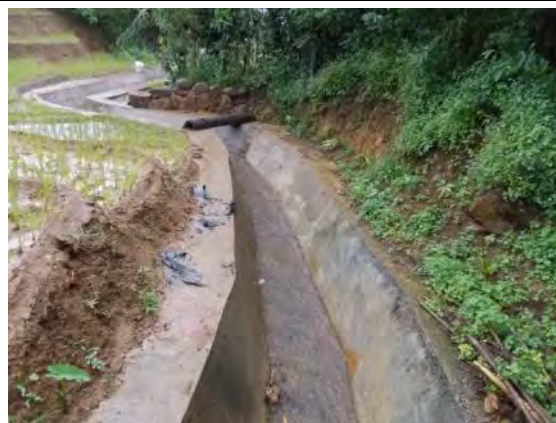
Photo 4: Leakages have been repaired.(Loc. 10)

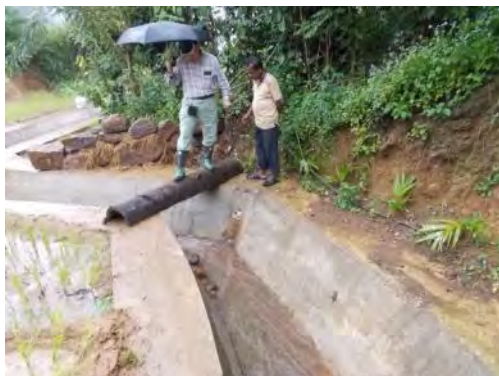
Photo 5: Crack on the ditch has been corrected. (Loc. 9)

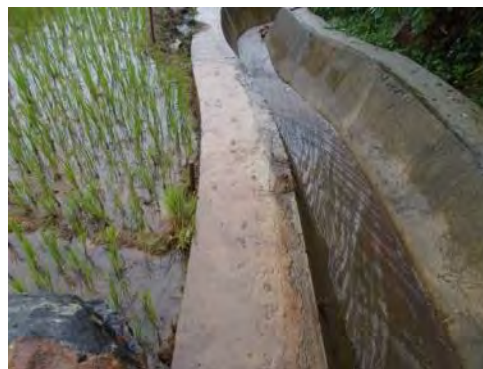
Photo 6: Crack has been corrected. (Loc. 5)

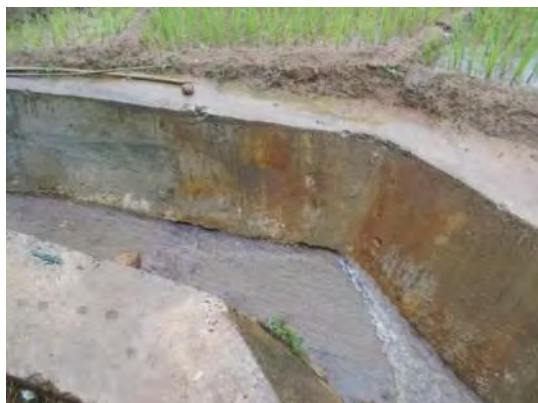
Photo 7: Erosion at the connecting point of base concrete and side wall. Repaired once, but eroded (Loc. 11)

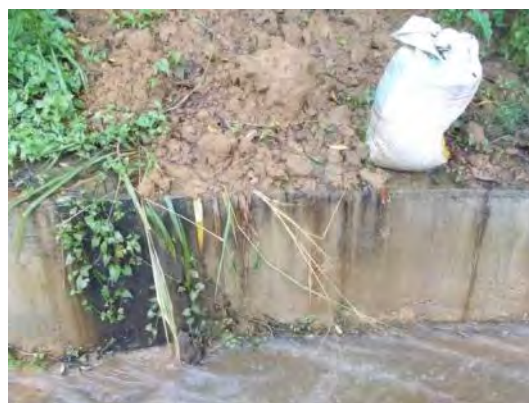
Photo 8: Eroded part was repaired once, but it is very difficult to find the exact place of erosion. (Loc. 12)

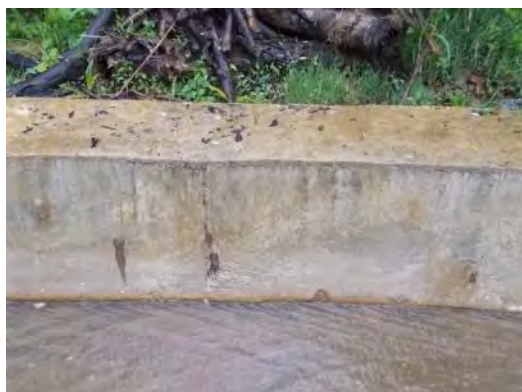
Photo 9: Leakage has been repaired. (Loc. 13)

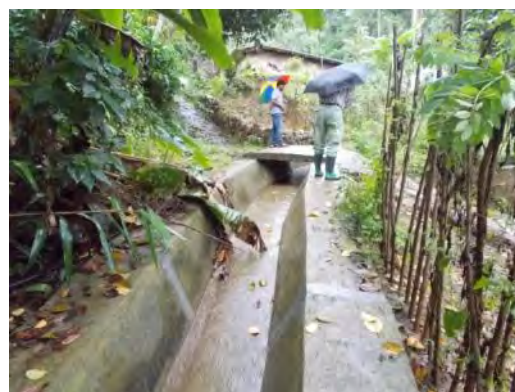
Photo 10: Crack along the expansion joint has been corrected. (Loc. 8)

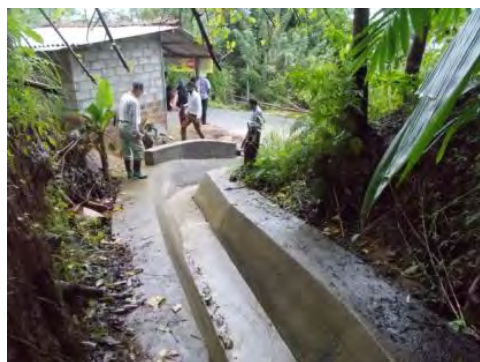
Photo 11: Additional wall for the overflowing has been constructed. (Loc. 14)

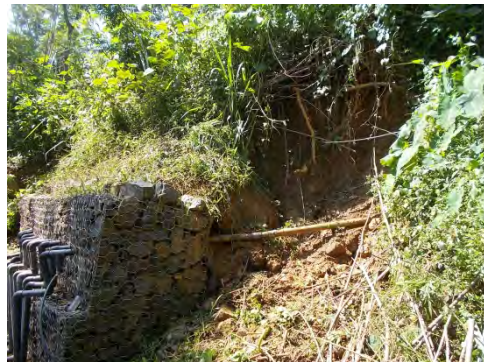
Photo 12: Collapse at the right side of gabion wall. (Horizontal drainage drilling No.10 was repaired)

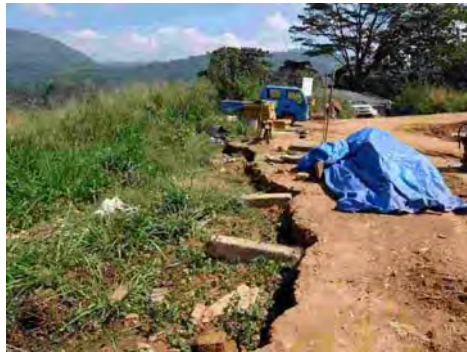
During the construction period of the pilot project, small landslides occurred at drilling points No.1 and 4 due to cutting/ excavation for installation of horizontal drilling platforms in Badulusirigama, Badulla. Finally, reshaping and additional gabion works were conducted for stabilization of the slopes and regarding No.4, even the location of the drilling point was changed.

Cracks at the shoulder of the slope caused by cutting work (Point No.4)

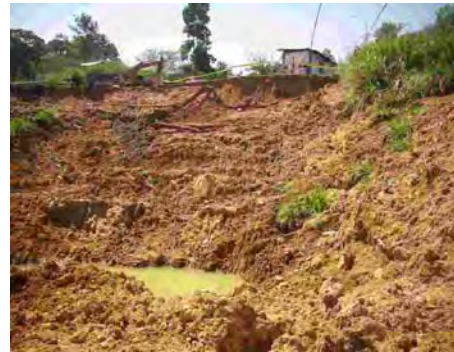
Whole picture of the small landslide (Point No.4)

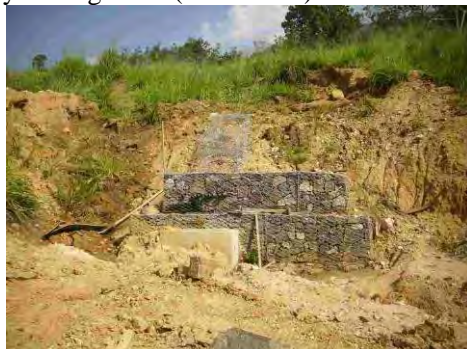
Small landslide behind the gabion wall caused by cutting work (Point No.1)

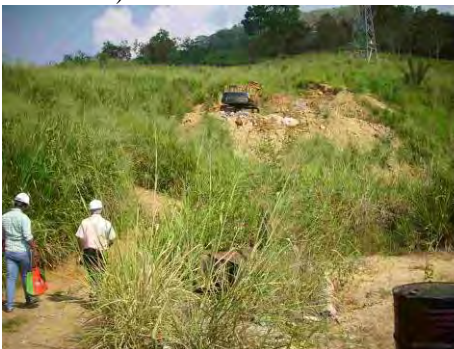
Embankment at the middle of the slope (Point No.1)

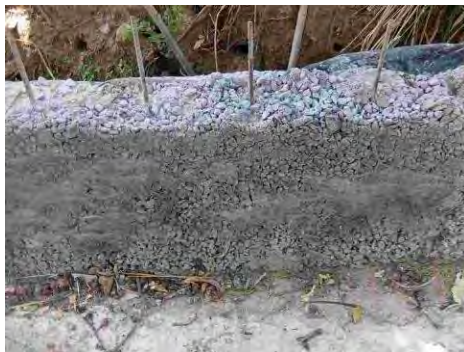
The concrete grade of the surface drainage ditch should be more than 25 grade. Otherwise, honeycombs could appear on the surface of the ditch. (see Photo 4.2) The main cause was the concrete grade and insufficient compaction with vibrator might be a cause of the honeycombs. Therefore more than a concrete grade 25 should be used for the surface drainage ditch in order to avoid such honeycombs. Also distribution of reinforce steel bars should follow the original design in order to keep the quality stipulated in the standard in Sri Lanka and the contract document (see Photo 4.3) .

Photo 4.2 Honeycombs of surface drainage ditch (already corrected)

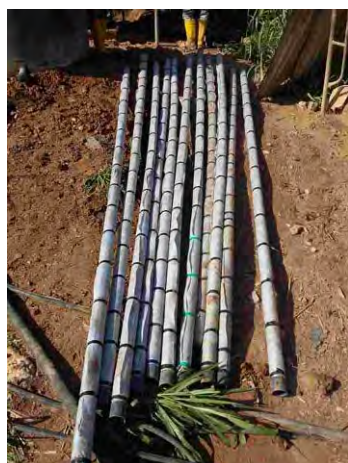
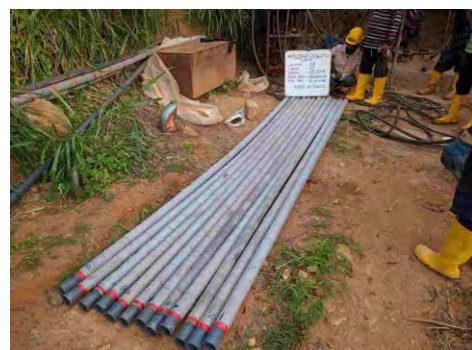
Wrapping of the geotextile in the PVC pipe is important. Sometimes the geotextile becomes unstuck because of improper wrapping. After that soil flows into the PVC pipes, and the PVC pipes might be blocked. Actually, after the change of wrapping from left to right (see Photo 4.7), PVC pipes were not blocked in the pilot project.

**Photo 4.7 Wrapping of geotextile to PVC pipes
(left: improper wrapping, right: proper wrapping)**

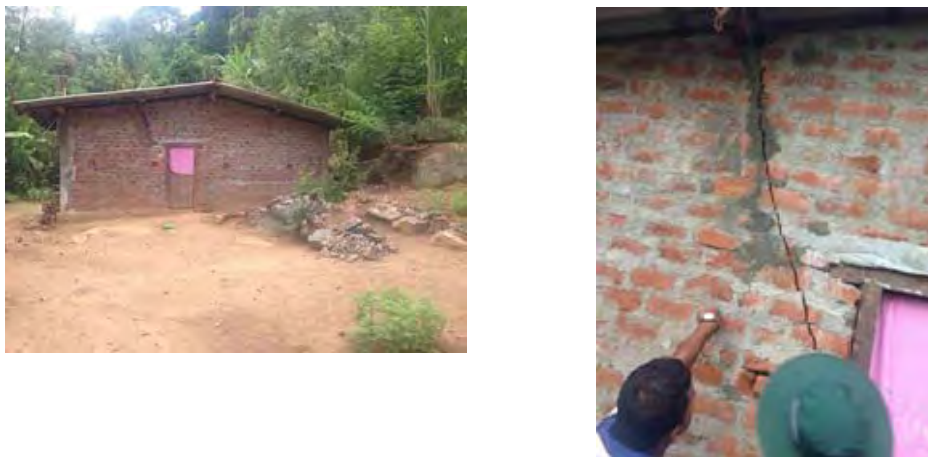
Although the cause of the appearance of the cracks was not clear, at least a rotary percussion type drilling machine could affect the appearance of the cracks. Thus if similar phenomena occur, the solution might be to change the type of drilling machine.

Photo 4.10 Cracks appeared on the wall of the house
