APPENDIX-3

SITE SURVEY FOR OVER HEAD TRANSMISSION LINE

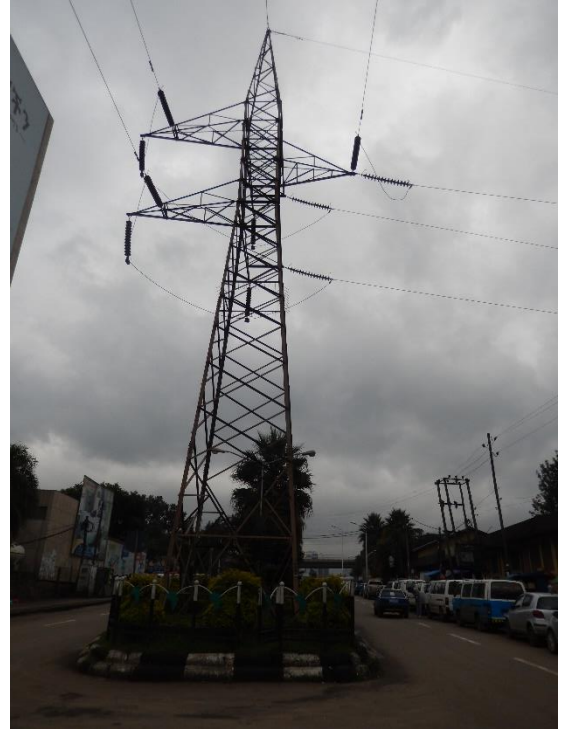
T-02 is kept in good condition.
Tower is located in median strip of two (2) lane road.

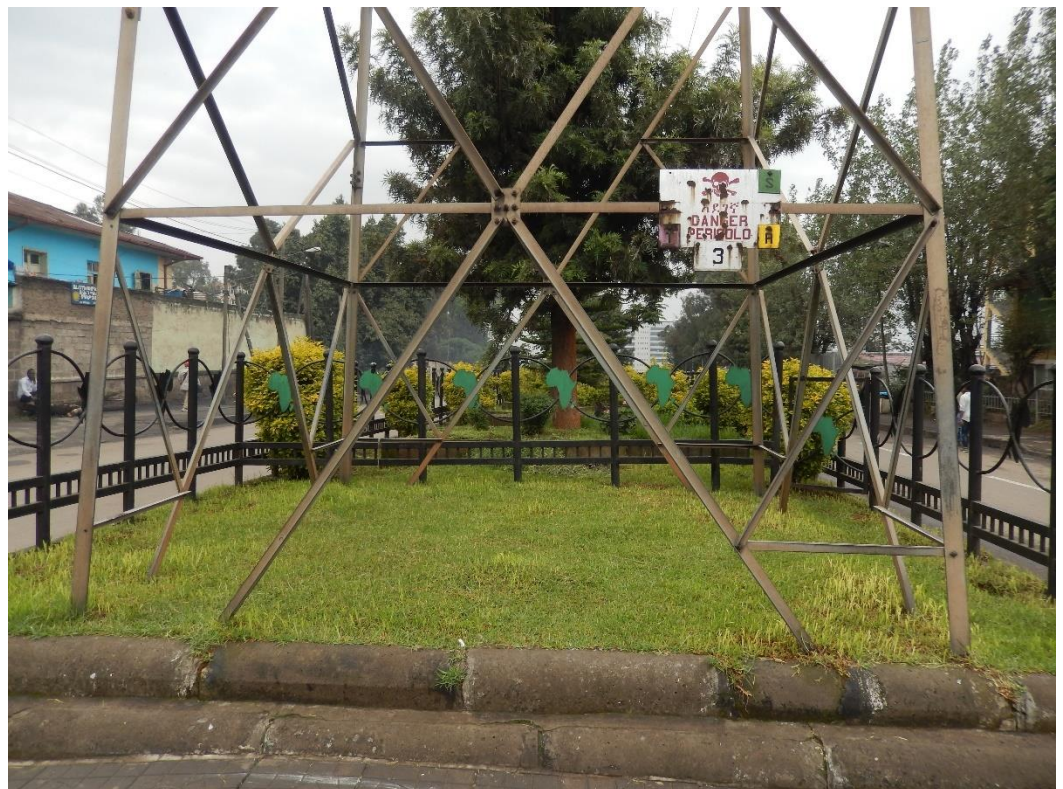
T-03 is kept in good condition.
Foundation was covered by embanked soil
due to ground level become higher
than original level.

Tower T-03 views from main road.
No traffic on road due to Ramadan Holiday.

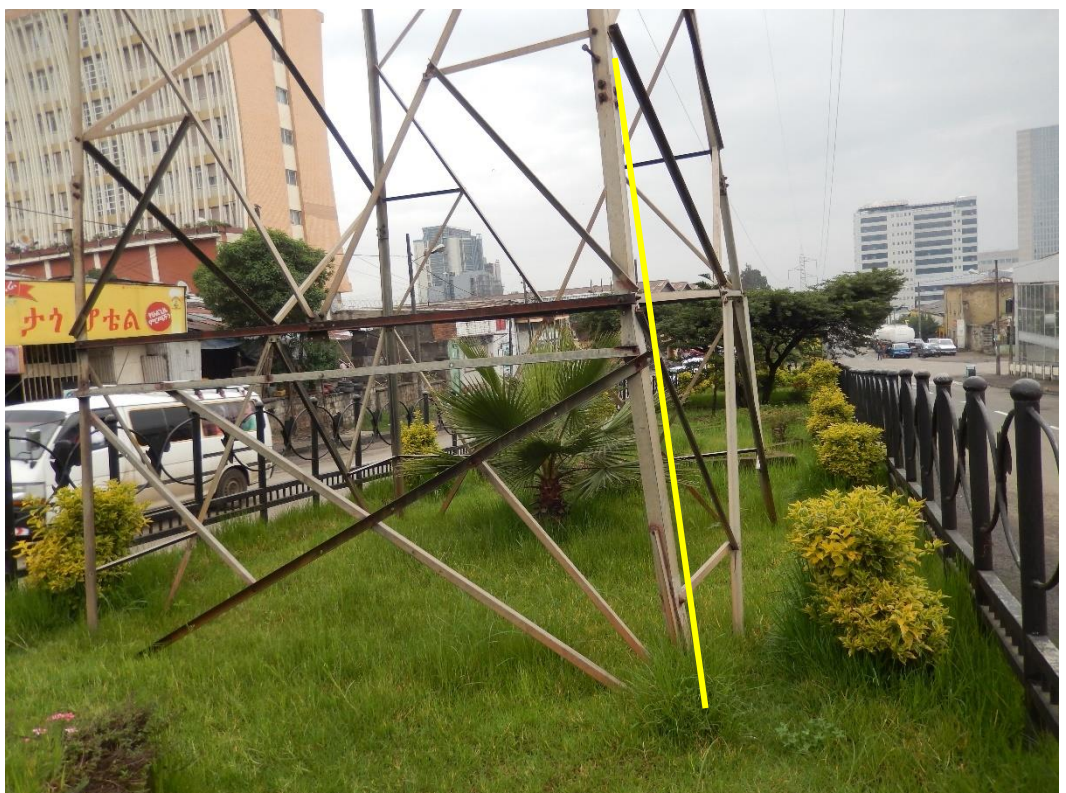
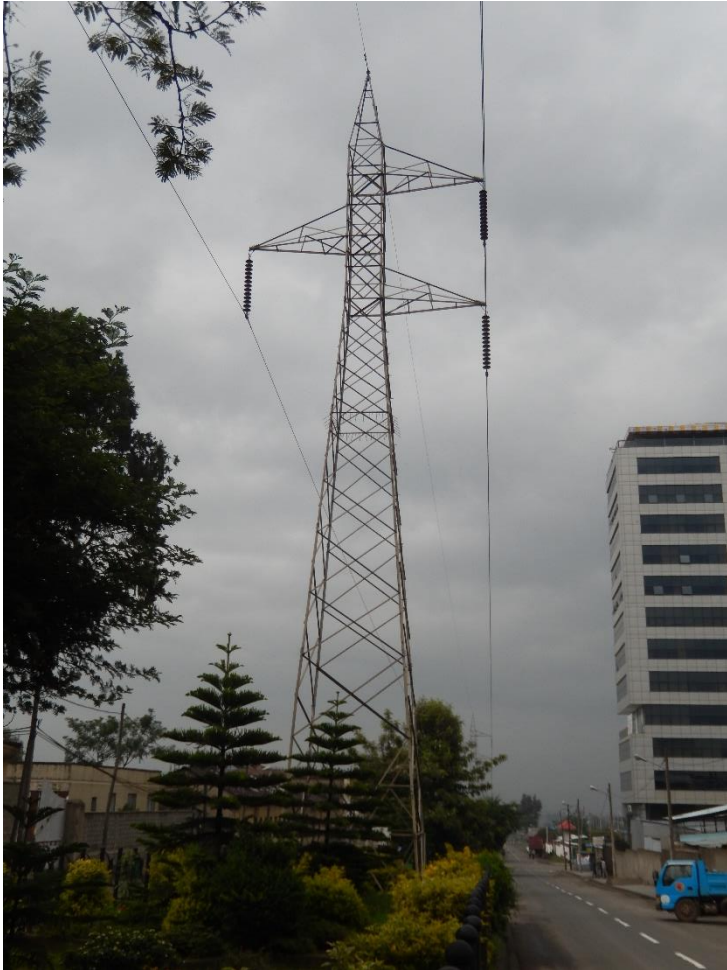
T-04 has been damaged heavy.
Damages were repaired temporary
however, tower is in critical condition,
as one of main leg has been twisted completely.

Damages seems to be occurred in long time ago.

Tower T-04 views from main road.
No traffic on road due to Ramadan Holiday.

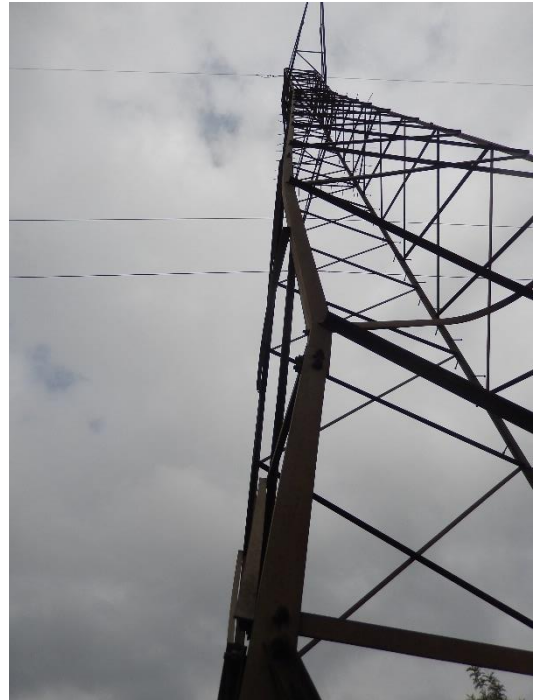
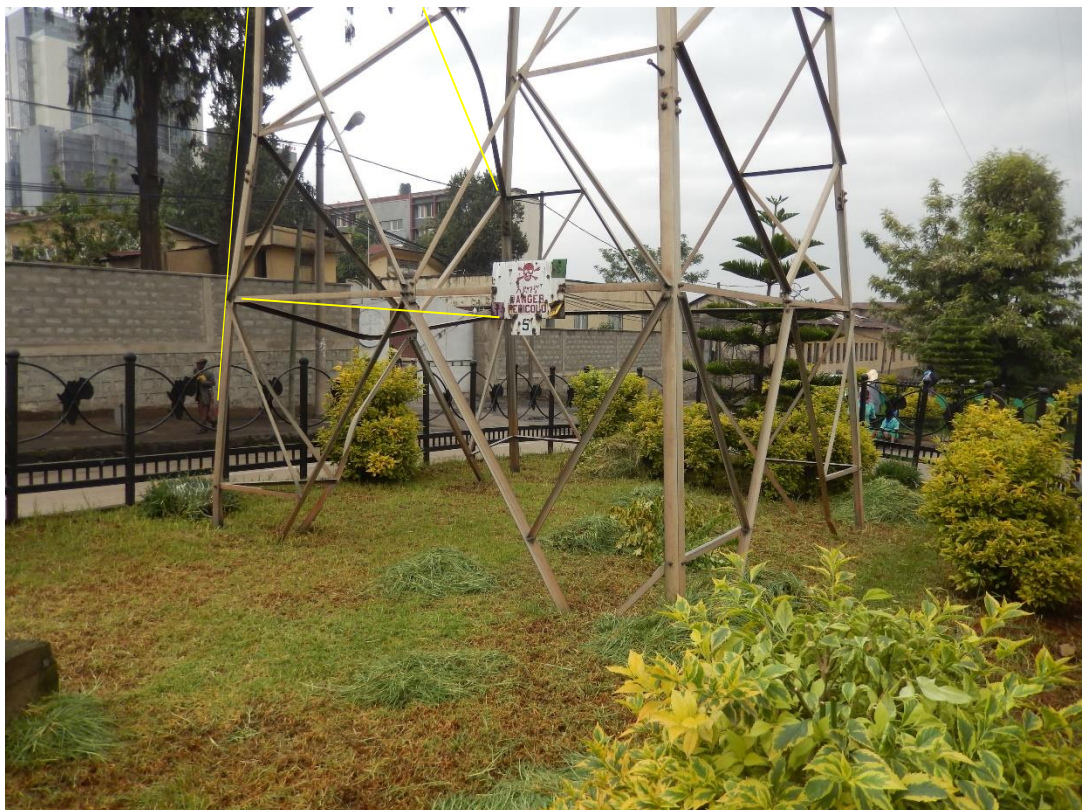
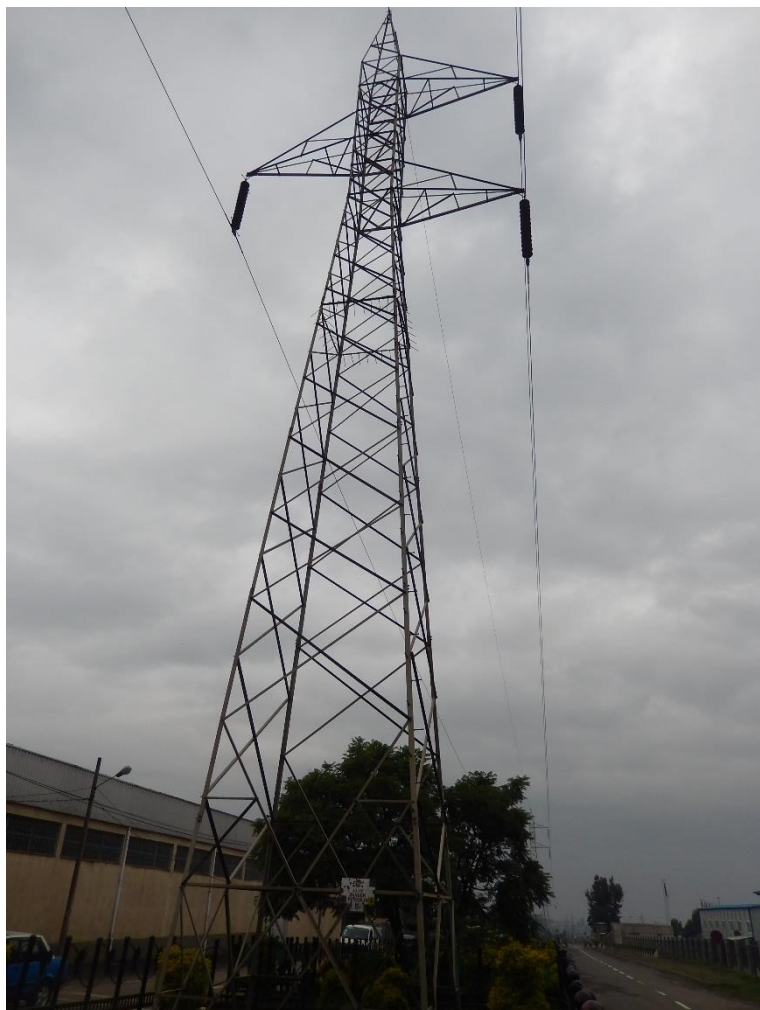
T-05 has been damaged heavy.
Damages are in critical condition,
as main legs have been twisted completely and
Secondary members of legs were out of function
due to deformation .

Damages seems to be occurred in long time ago.

Tower T-05 views from main road.
No traffic on road due to Ramadan Holiday.

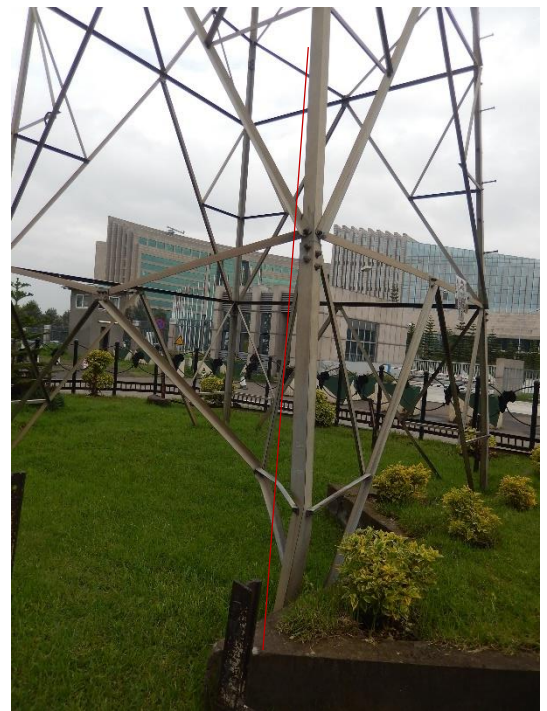
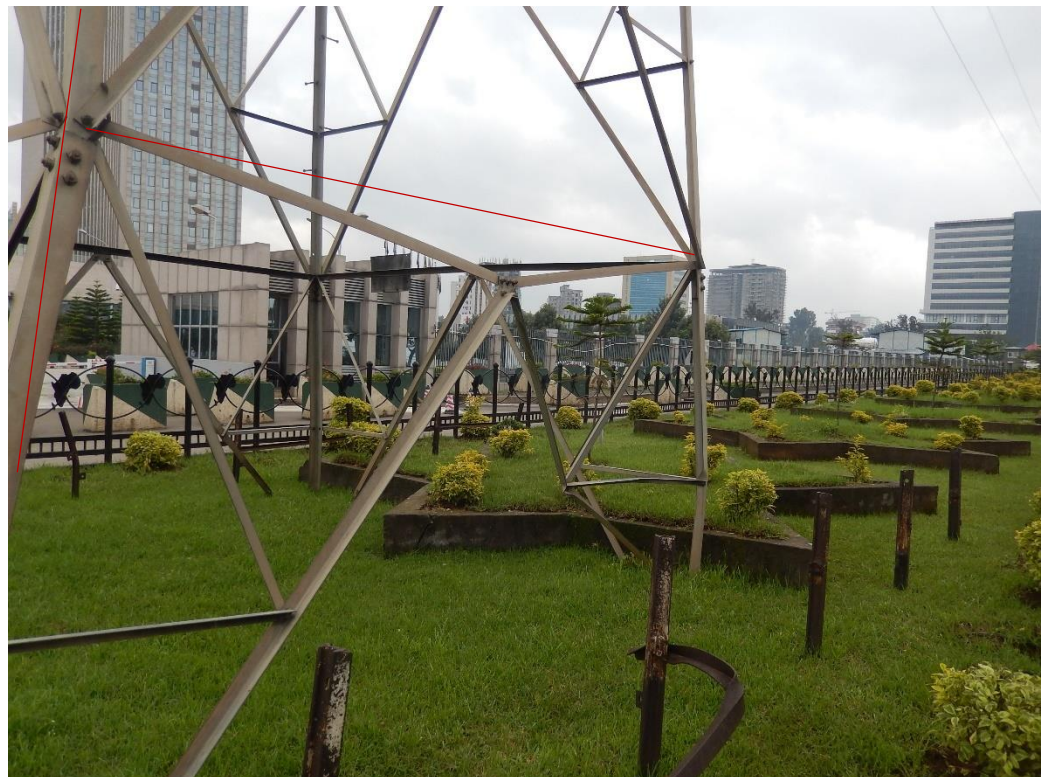
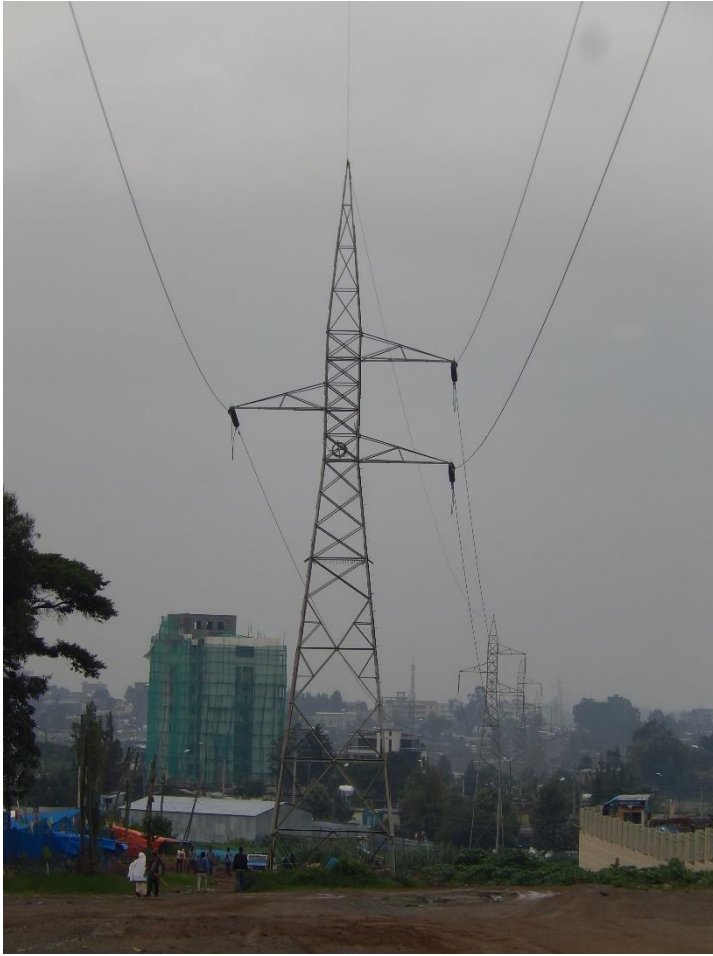
T-07 has been damaged heavy. Damages are in critical condition, as main legs have been twisted completely and Secondary members of legs were out of function due to deformation .

Damages seems to be occurred in long time ago.

Tower T-07 views from main road toward T08.
No traffic on road due to Ramadan Holiday.

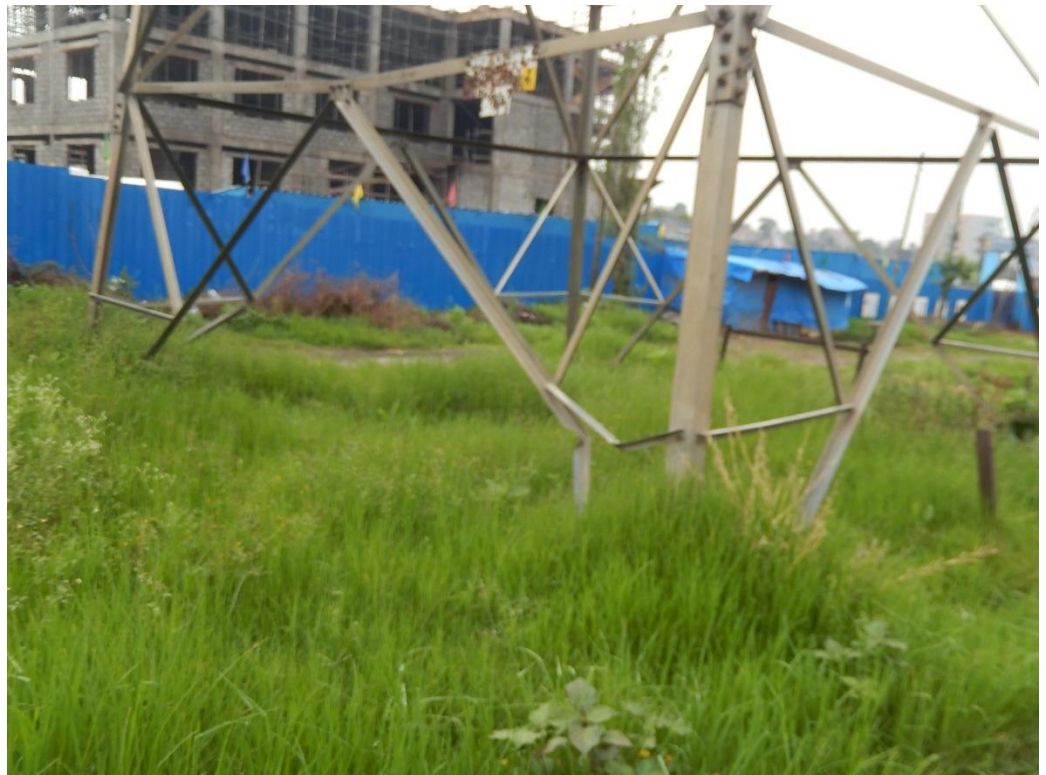
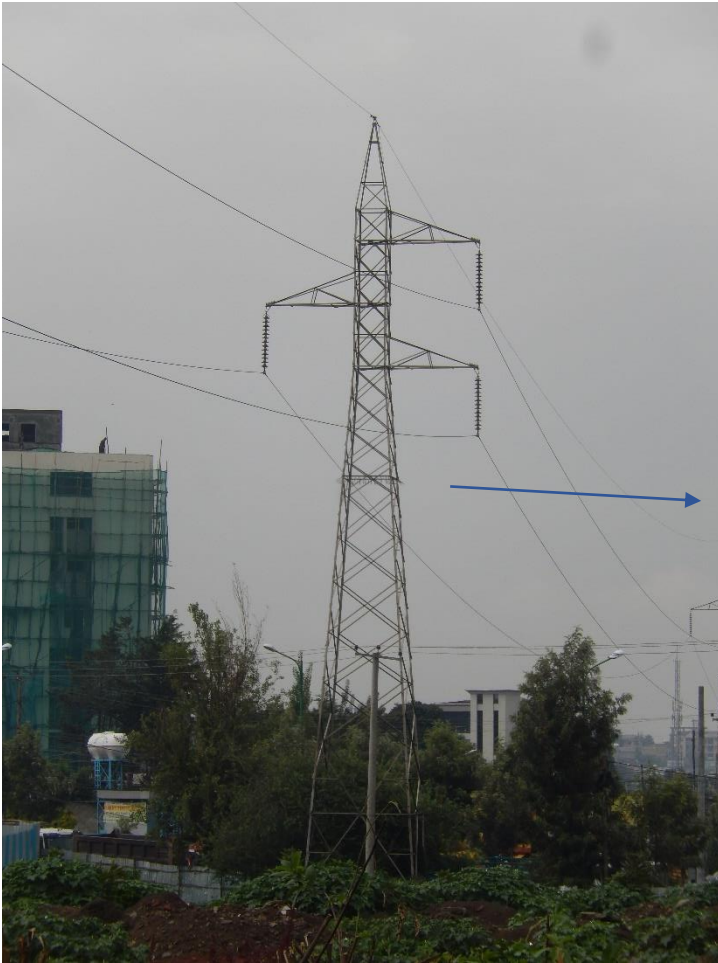
T-08 has been damaged heavy.
Damages are in critical condition,
as main legs have been twisted completely and
Secondary members of legs were out of function
due to deformation .

Insulator disc has been damaged.
It seems to be broken by shutting
as two (2) continuous discs were damaged.

Tower T-08 views from main road toward T09.
A section tower with deviation angle.
OPGW joint box is located,

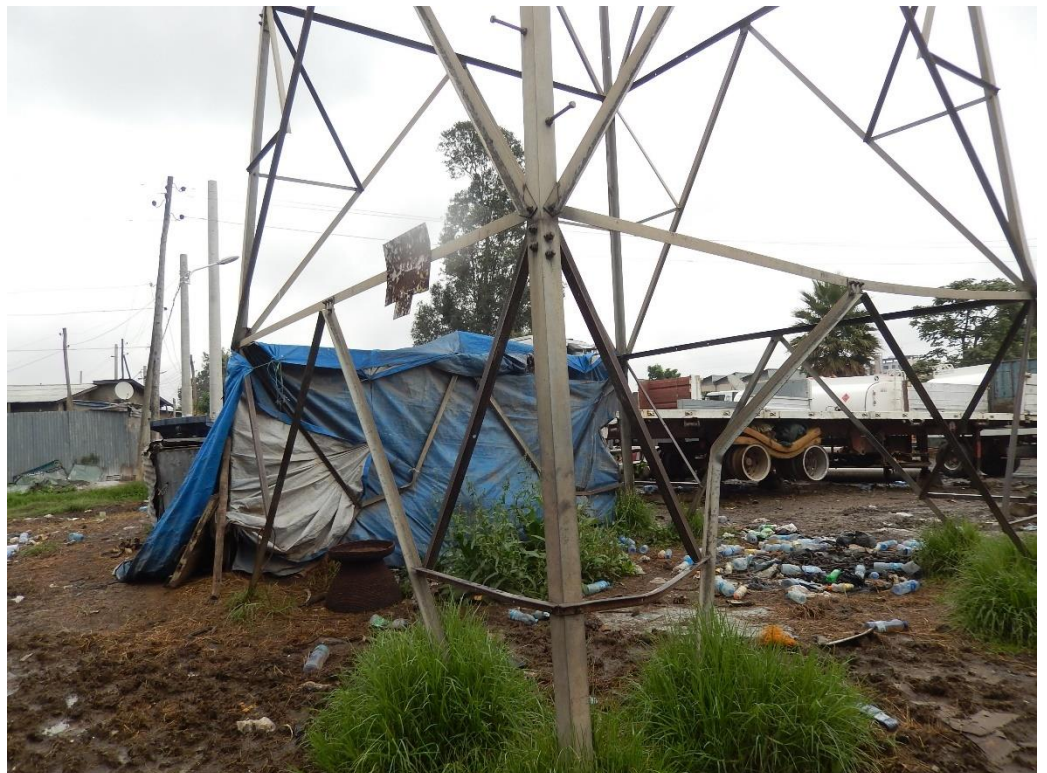
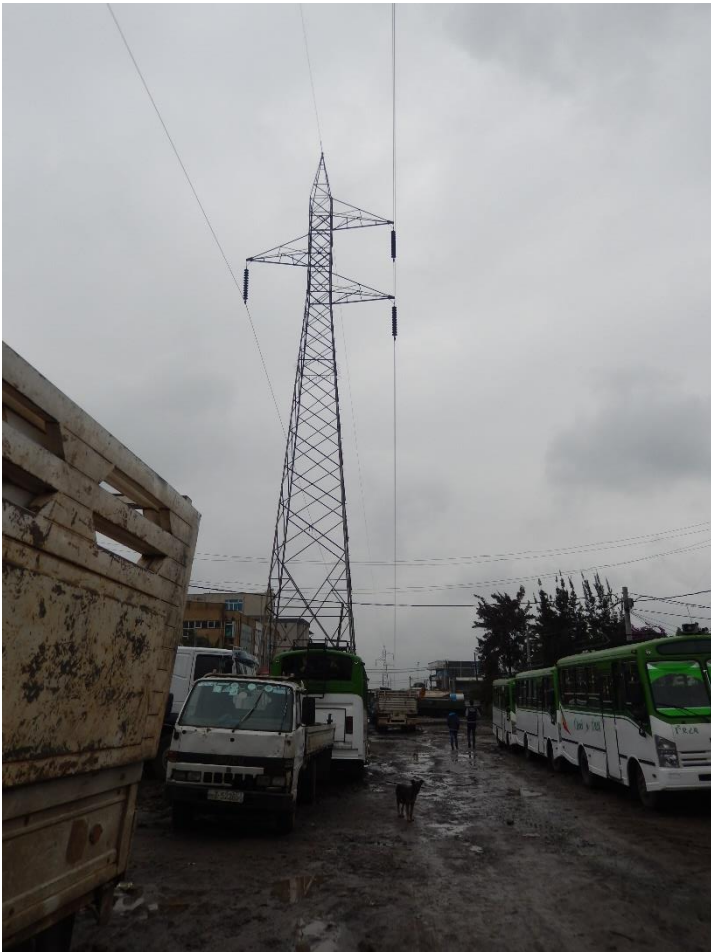
T-15 has been damaged heavy.
Damages are in critical condition,
as main legs have been twisted completely and
Secondary members of legs were out of function
due to deformation .

Damages seems to be occurred in long time ago.

Tower T-15 views from ROW corridor.

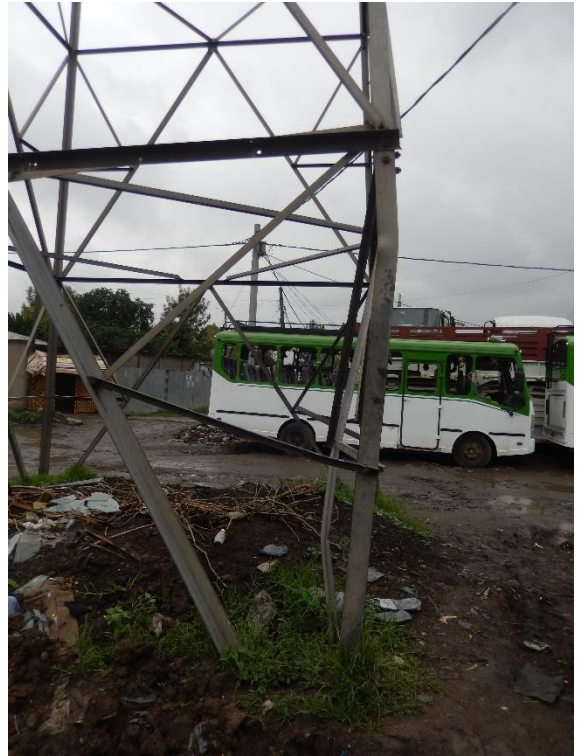
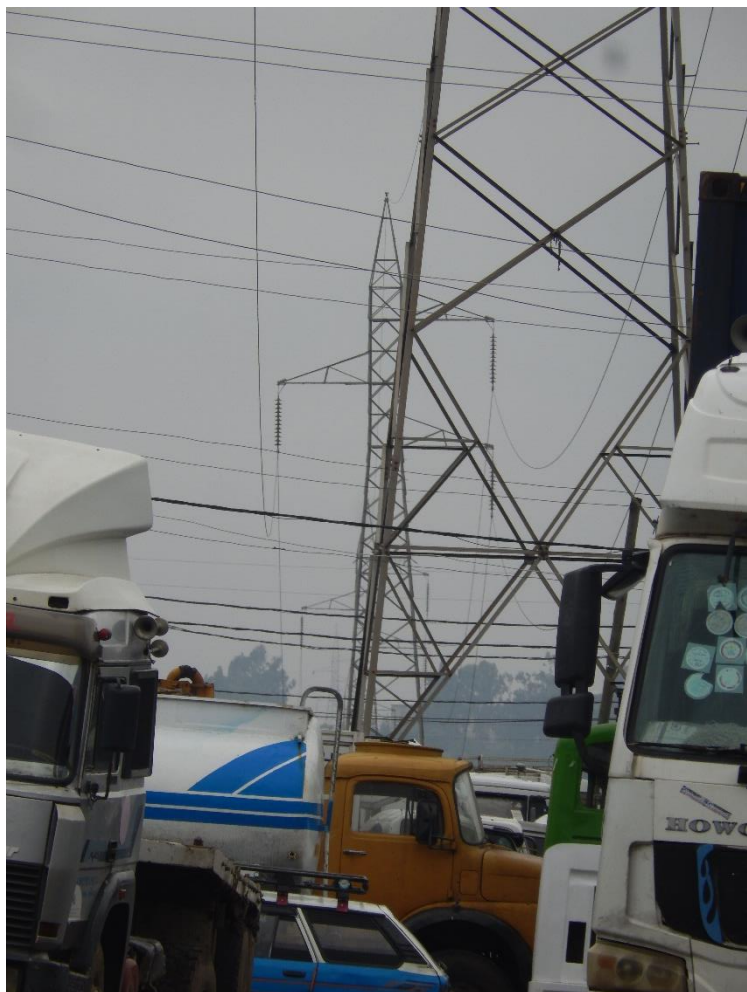
T-16 has been damaged heavy.
Damages are in critical condition,
as main legs have been twisted completely and
Secondary members of legs were out of function
due to deformation .

Damages seems to be occurred in long time ago.

Tower T-16 views from ROW corridor.

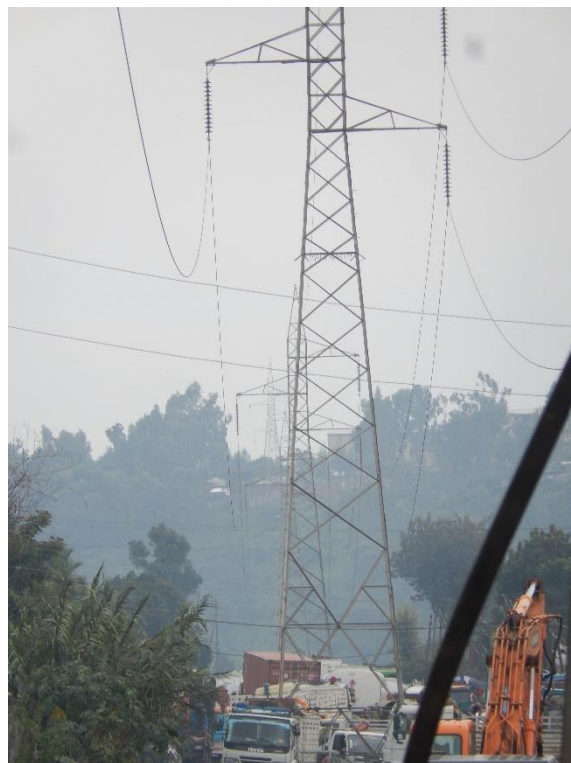
T-17 & T-18 have been damaged and inclined.
As seen from tower body was inclined.

Insulator assemblies were twisted due to tower inclined.

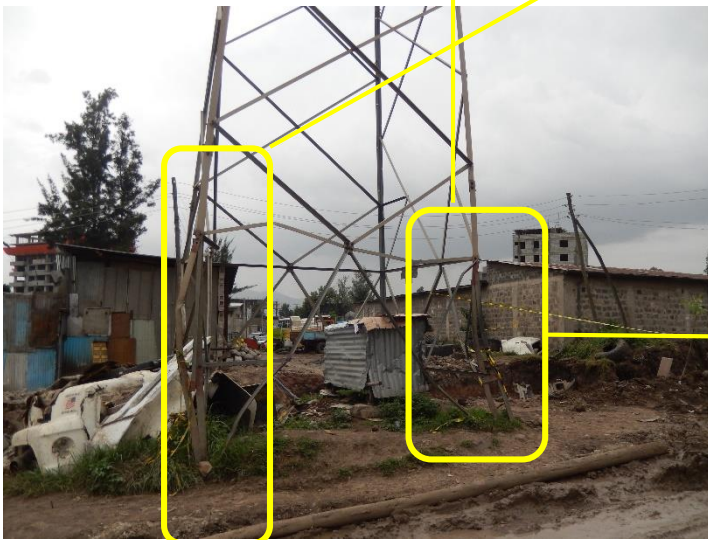
Two (2) legs were bend and does not hold the tower weight anymore.

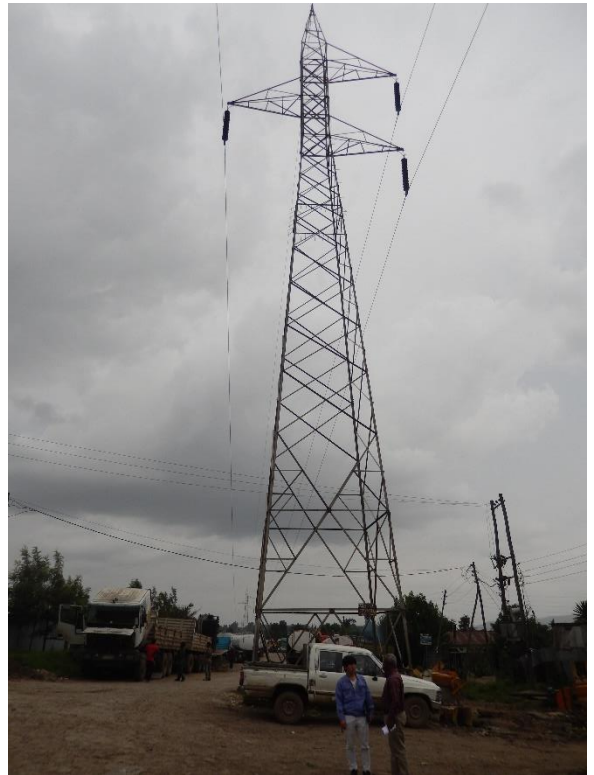
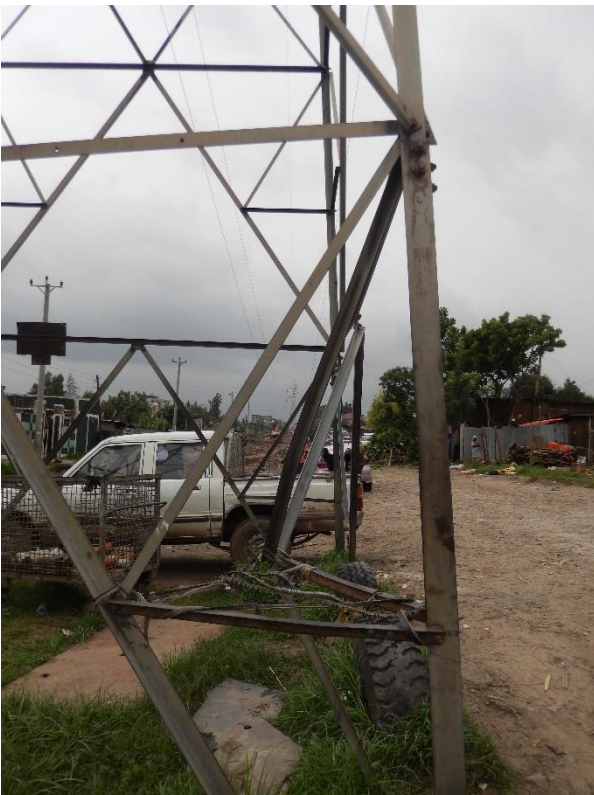
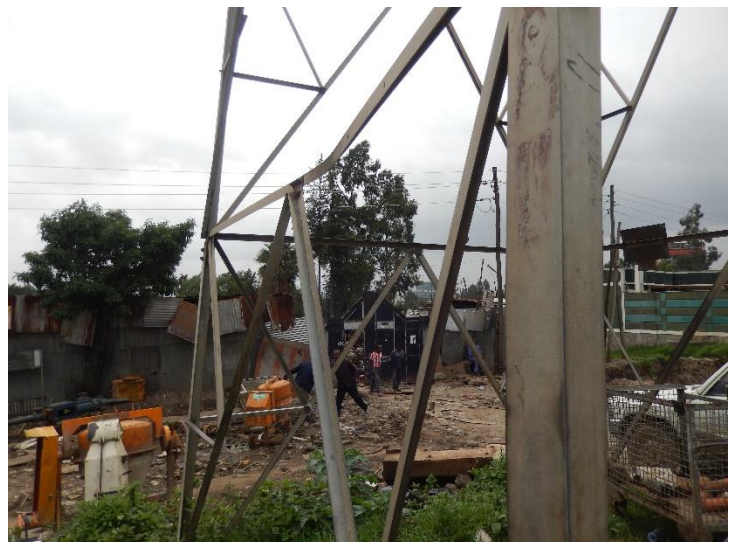
T18 Damaged Leg steels

Tower legs had been damaged heavily.
Tower inclined slightly.

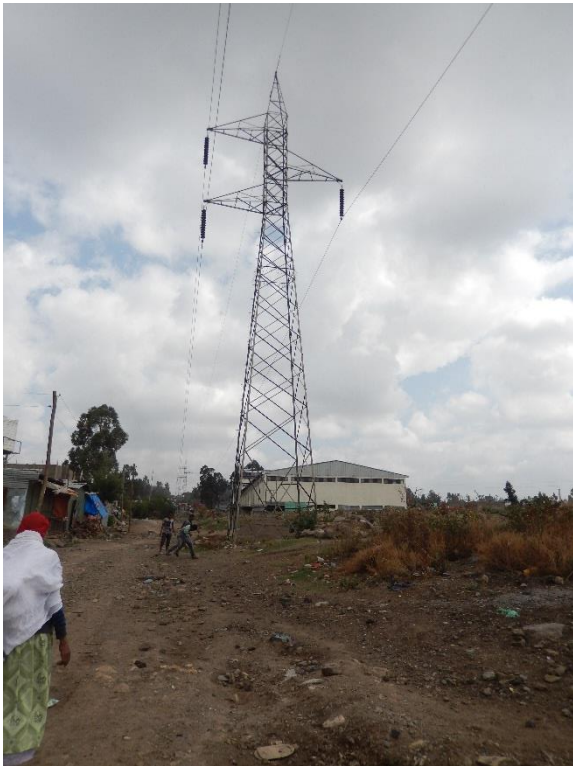
T34
DSCN0494 T34 Elevation level of road is 5 meter higher than elevation of T34. Electrical clearance to road is not enough.

Elevation of road become much higher than tower foundation level, during embankment work for construction of road.

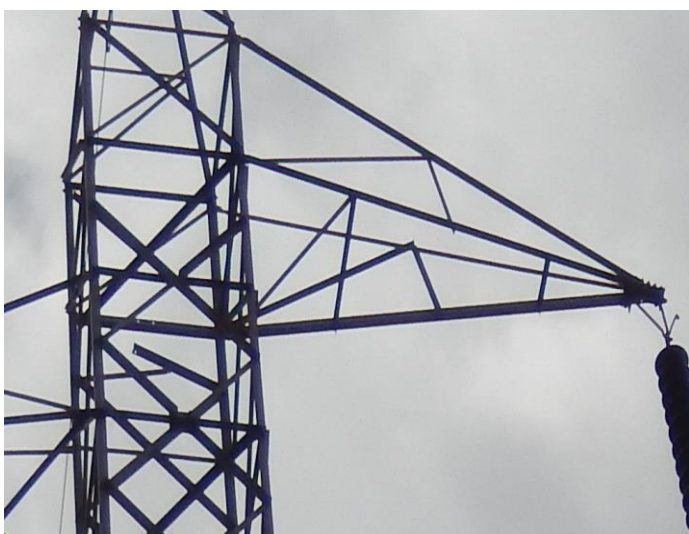
T 45
DSCN0802 T45 top plate are missing or not installed.

Plates for cross arms are disappeared at compressed steel members.

The remedial works shall be arranged.

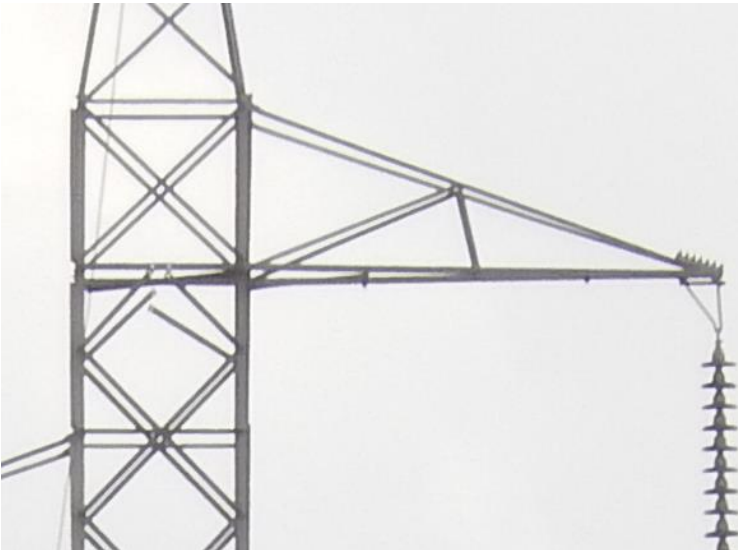
DSCN0824 T49 from T48
Plate missing, Steel members are not fixed by bolts.

Plates for cross arms are disappeared at compressed steel members.

The remedial works shall be arranged.

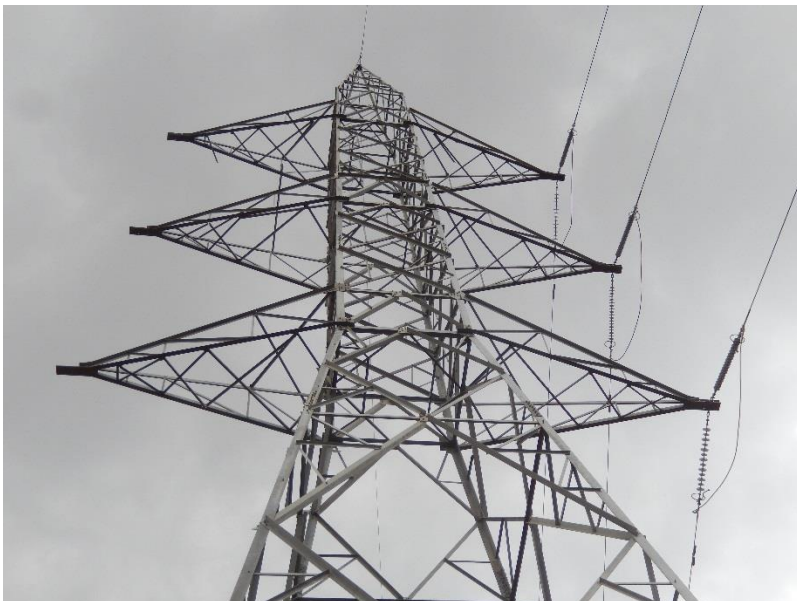
DSCN0865 T54 has many missing steel members.

The tower erection is not completed yes as many steels are missing condition.

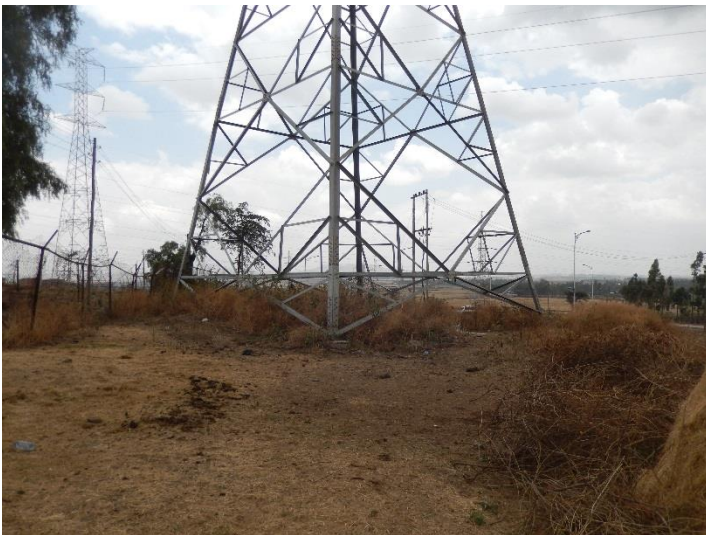
DSCN0867 T55 bottom
T55 has many missing steel members.

The tower erection is not completed yes as many steels are missing condition.

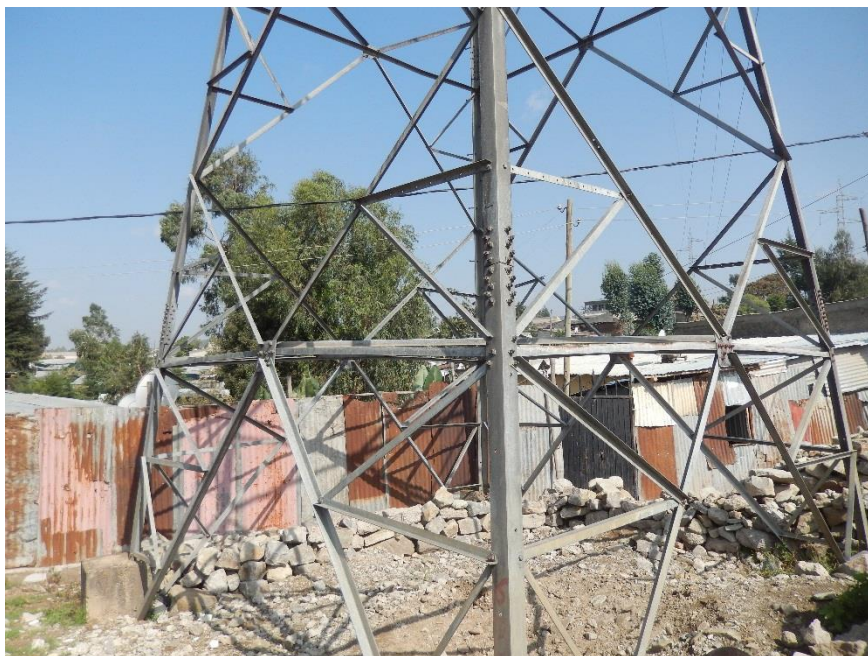
DSCN0452 First horizontal members are all bent

Remarks
Foundation for all four legs are
damaged due to soil pressure from
surface.

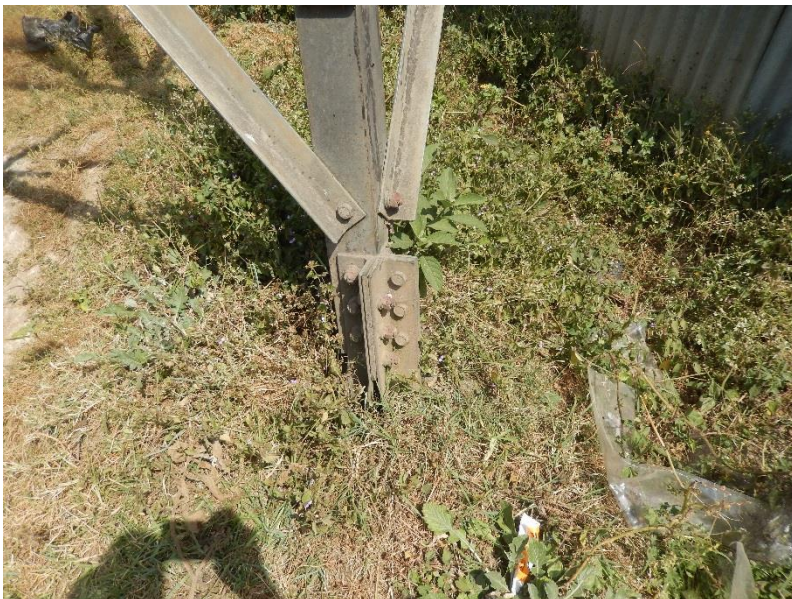
T52 Kaliti – Sebeta
Existing Foundation
Two steel angles were used for each leg to support tower
