APPENDIX-3

SITE SURVEY FOR OVER HEAD TRANSMISSION LINE

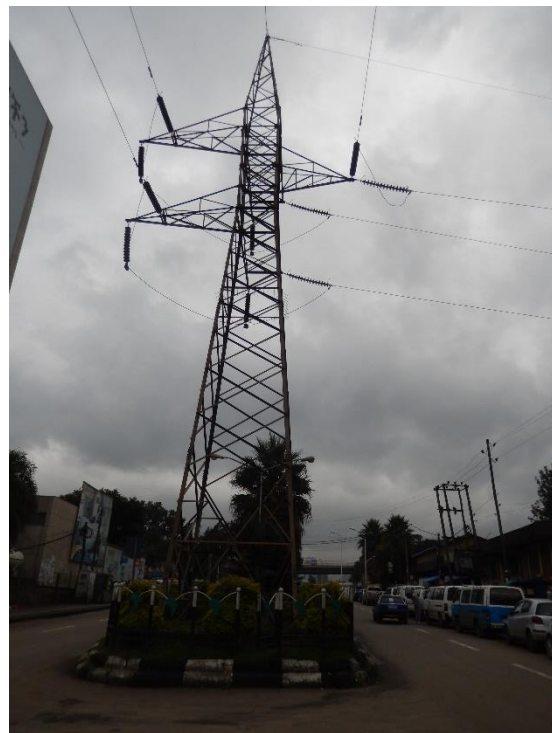
T-02 is kept in good condition.
Tower is located in median strip of two (2) lane road.

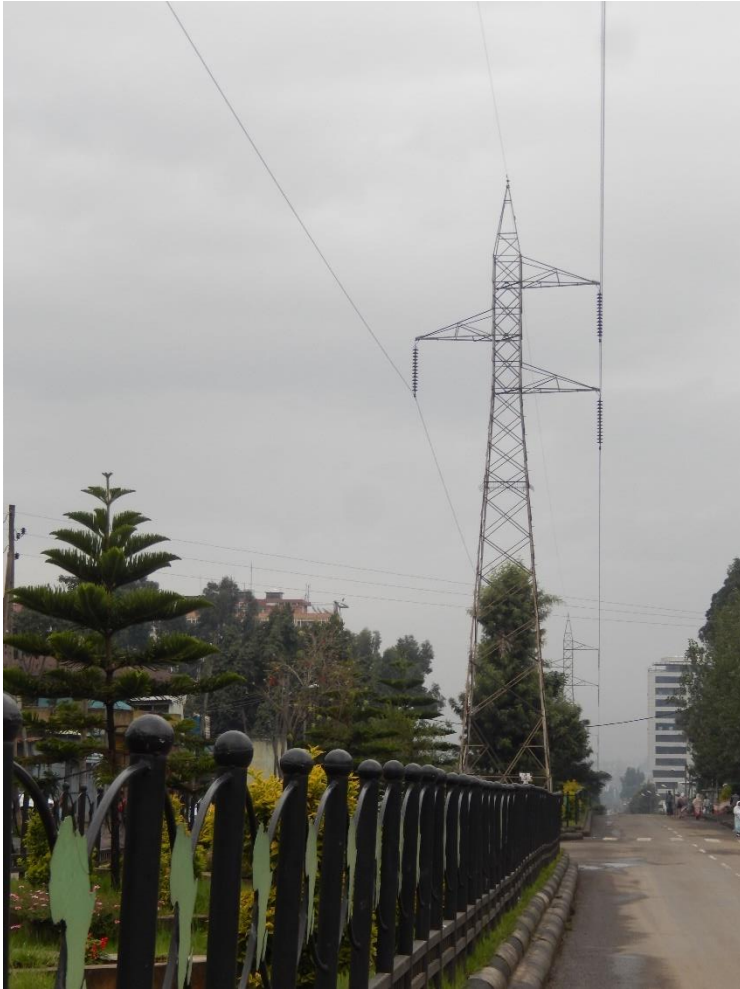
T-03 is kept in good condition.
Foundation was covered by embanked soil
due to ground level become higher
than original level.

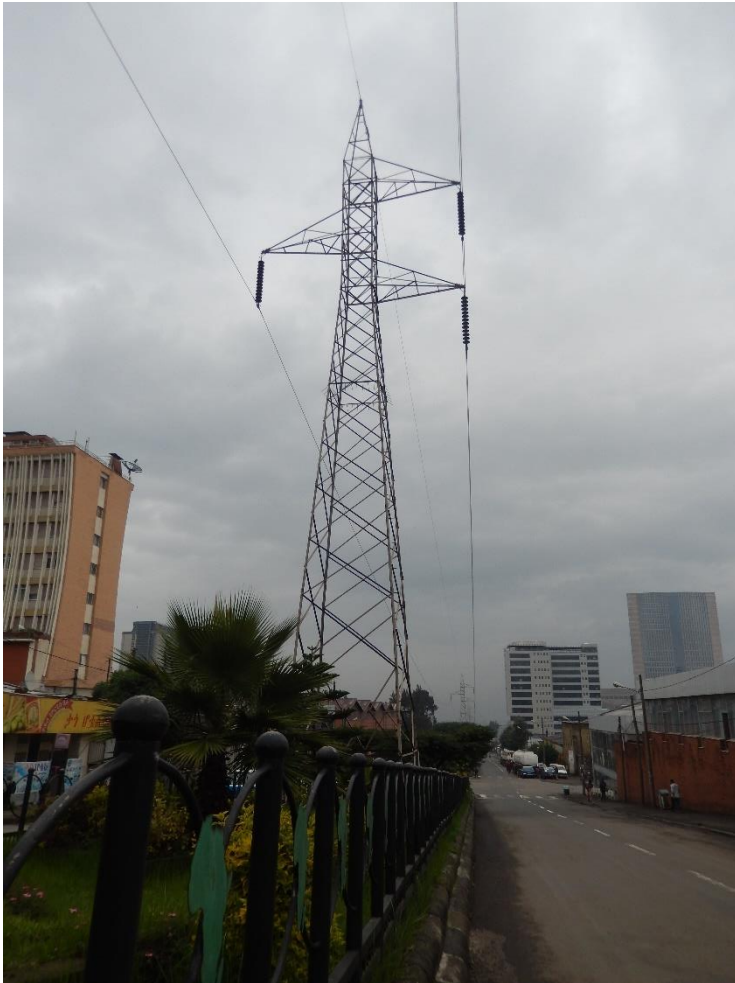
T-04 has been damaged heavy.
Damages were repaired temporary
however, tower is in critical condition,
as one of main leg has been twisted completely.

Damages seems to be occurred in long time ago.

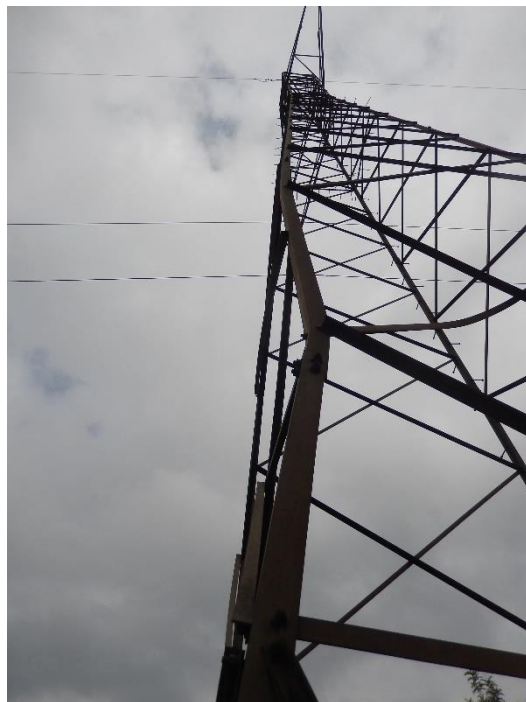
T-05 has been damaged heavy.
Damages are in critical condition,
as main legs have been twisted completely and
Secondary members of legs were out of function
due to deformation .

Damages seems to be occurred in long time ago.

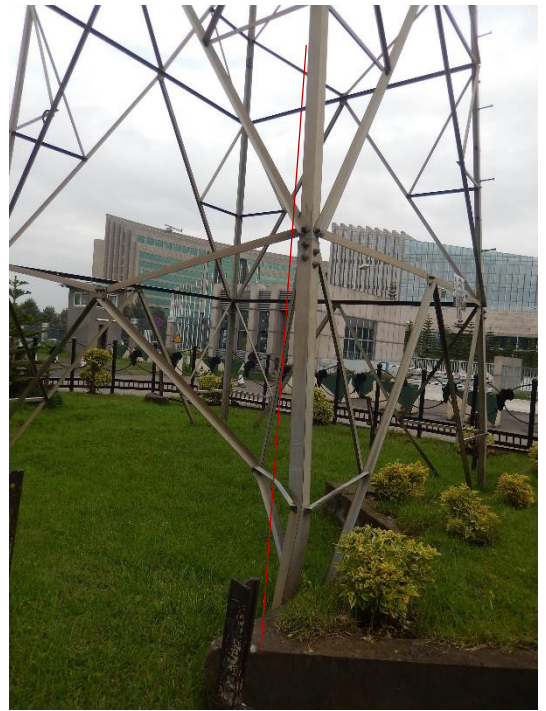
T-07 has been damaged heavy. Damages are in critical condition, as main legs have been twisted completely and Secondary members of legs were out of function due to deformation .

Damages seems to be occurred in long time ago.

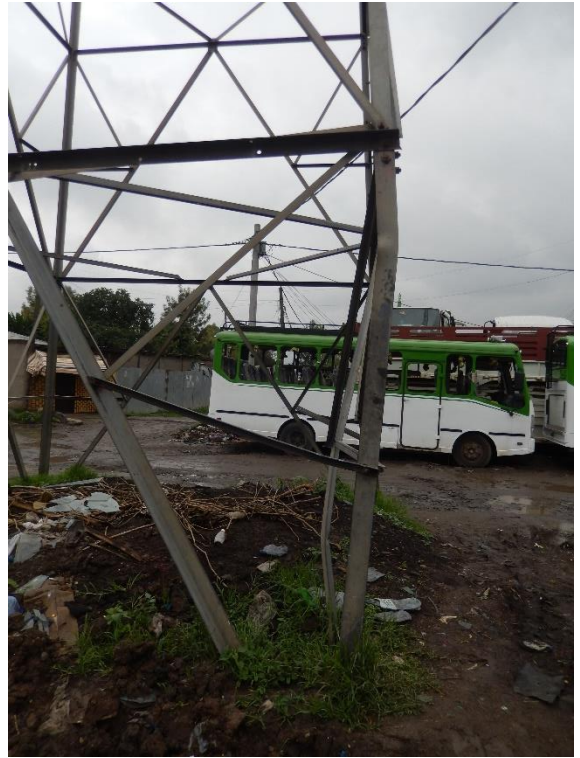
T-16 has been damaged heavy.
Damages are in critical condition,
as main legs have been twisted completely and
Secondary members of legs were out of function
due to deformation .

Damages seems to be occurred in long time ago.

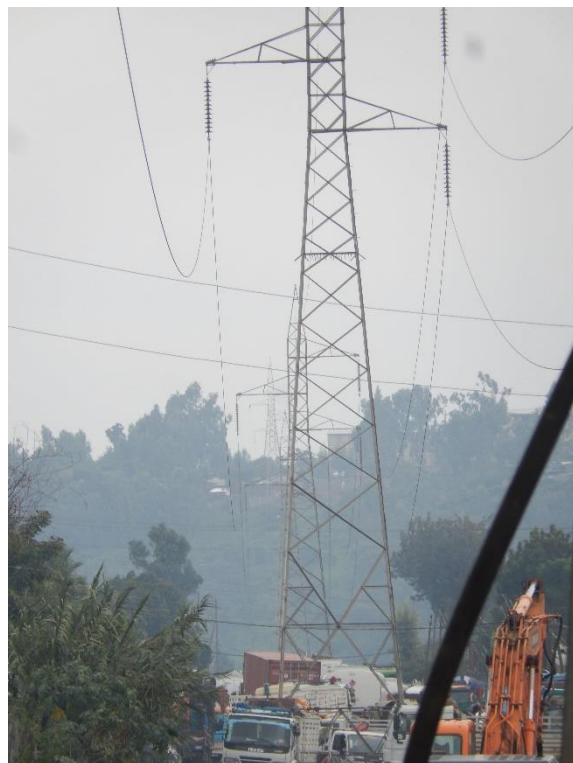
T-17 & T-18 have been damaged and inclined.
As seen from tower body was inclined.

Insulator assemblies were twisted due to tower inclined.

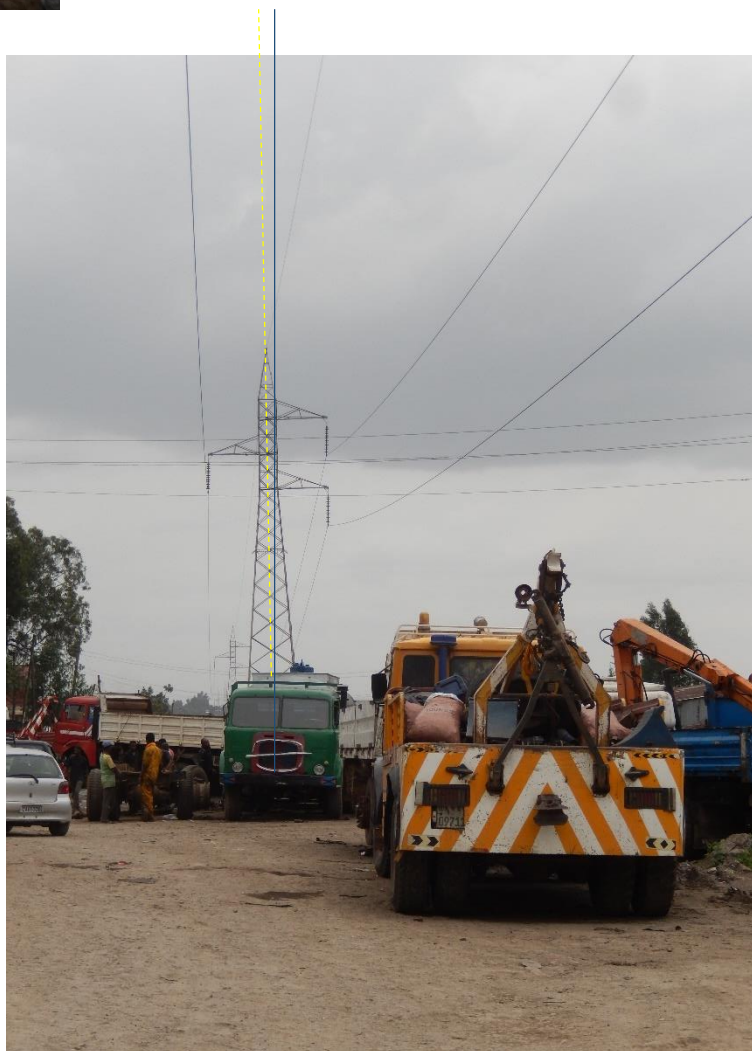
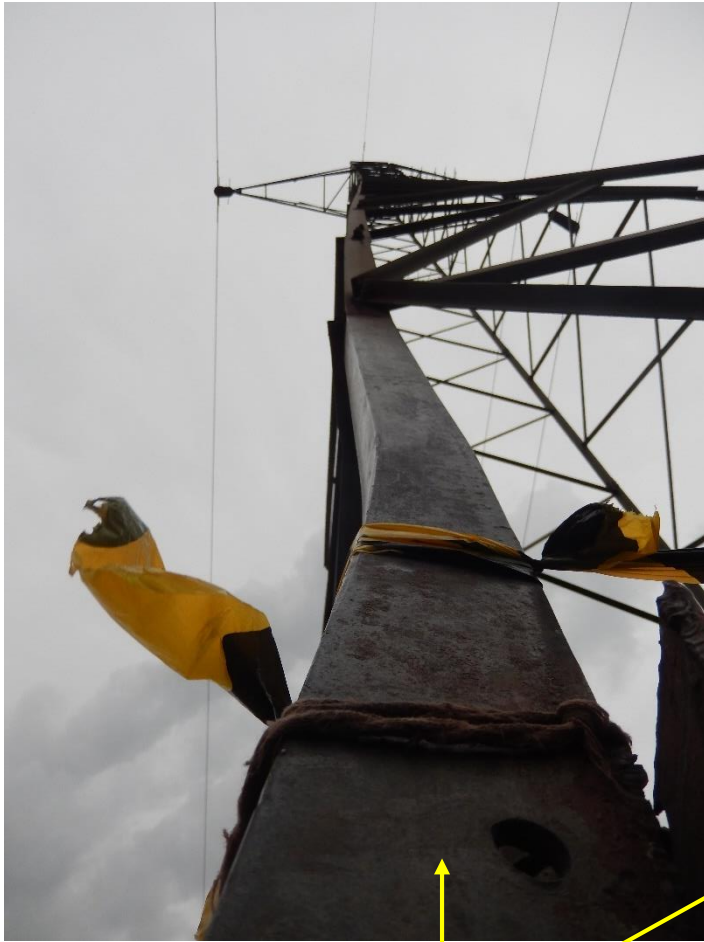
This T17 has been damaged by activities of road construction and almost collapsed.

Insulator assemblies are inclined due to tower inclination.

Now conductor supports the tower.

Tower is in dangerous condition to collapse.

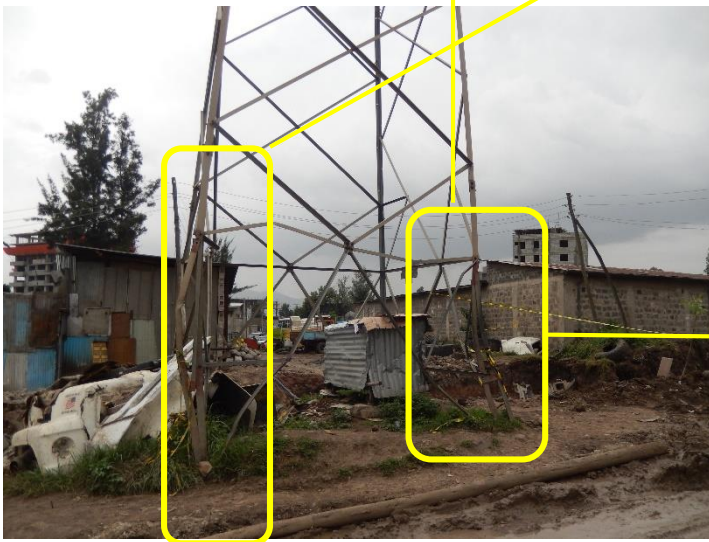
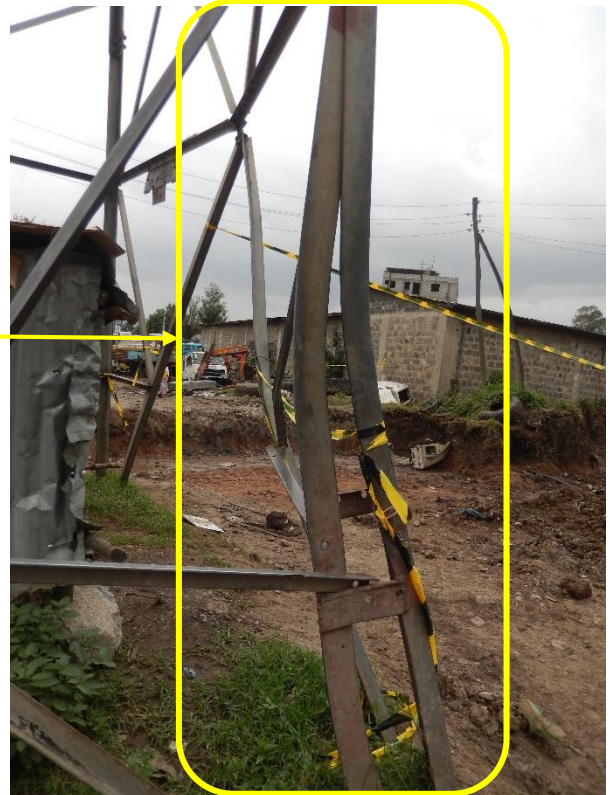
Two (2) legs were bend and does not hold the tower weight anymore.

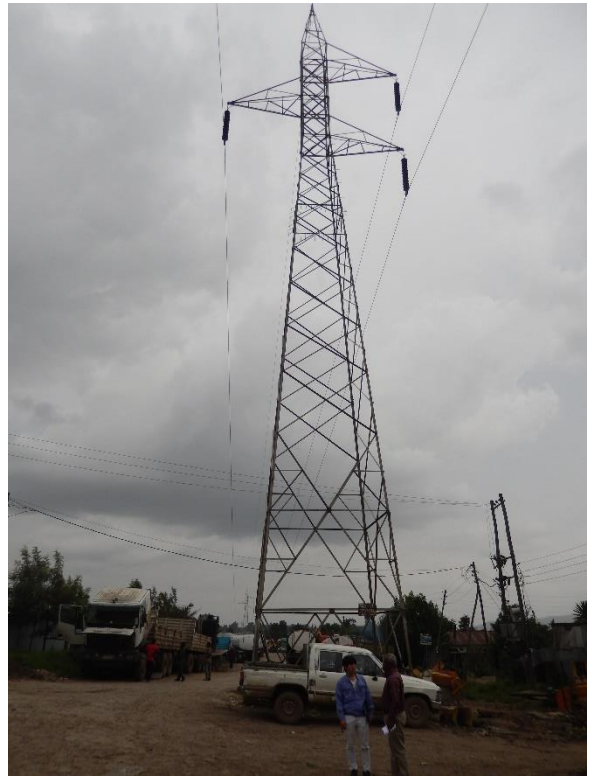
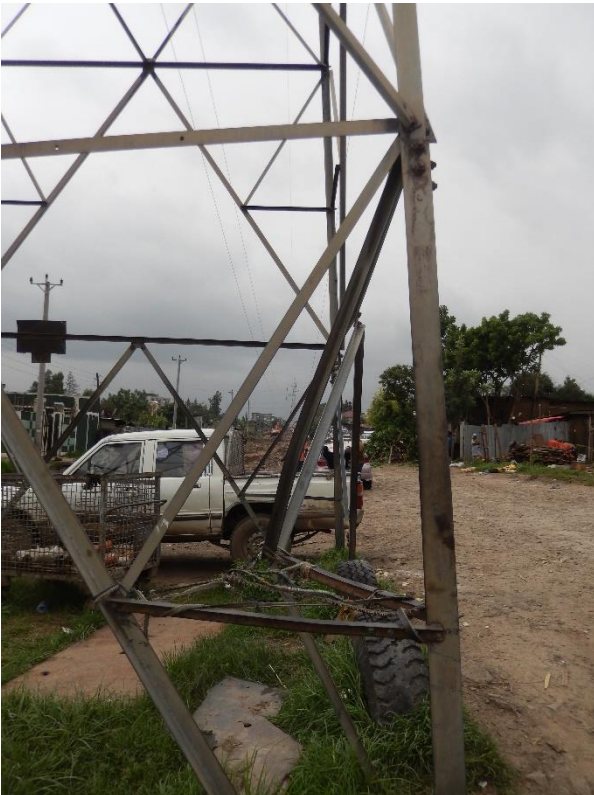
T18 Damaged Leg steels

Tower legs had been damaged heavily.
Tower inclined slightly.

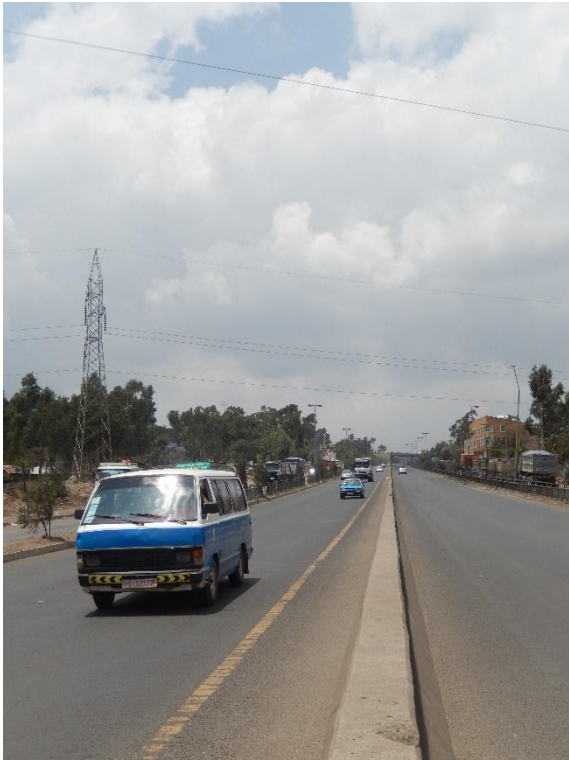
This tower has been damaged by traffic vehicle on the main leg. The Tower condition is very critical .

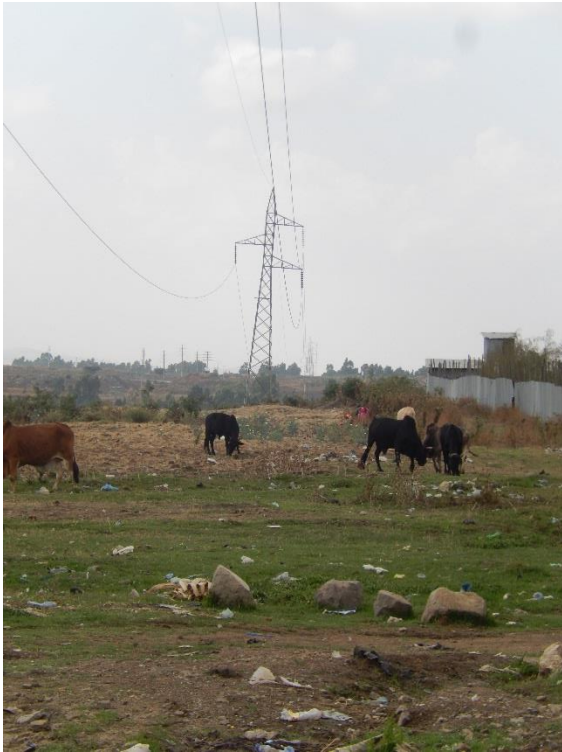
T 36 viewed from T35.
DSCN0707 T36. Tower is in inclineing.

T36 is almost collapsed due to heavy damages on the leg. The suspension clamps hold conductor with unbalanced tensions. The condition of this tower is in very critical conditions.

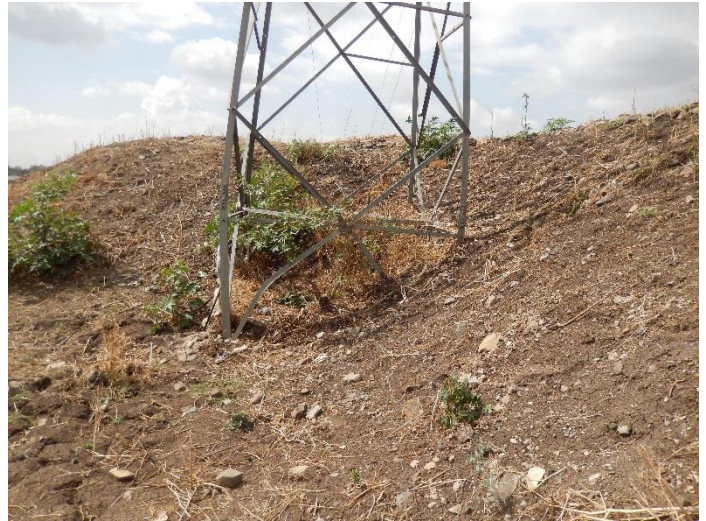
T36
DSCN0717 T36 Bottom
Main leg was damaged and bent by soil pressures or hit by heavy equipment.

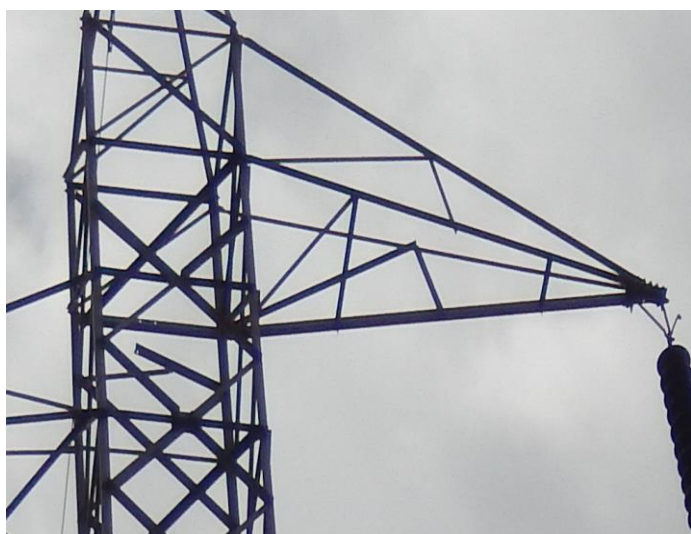
T 45
DSCN0802 T45 top plate are missing or not installed.

Plates for cross arms are disappeared at compressed steel members.

The remedial works shall be arranged.

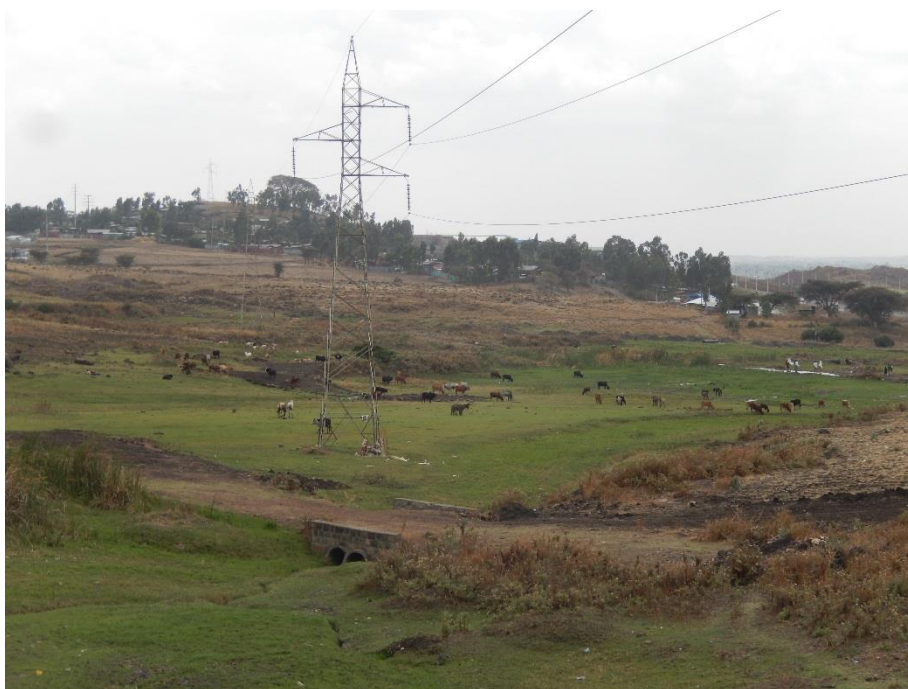
T48
DSCN0826 T48 from 49
Plates for tower cross arm are missing

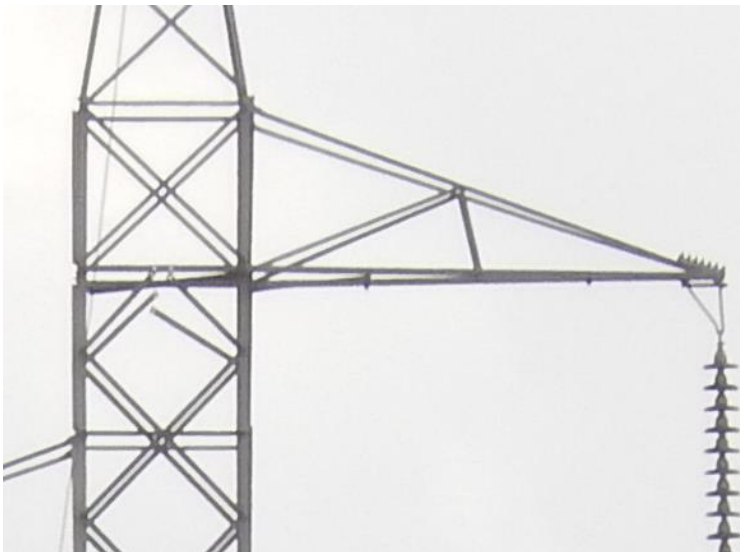
DSCN0824 T49 from T48
Plate missing, Steel members are not fixed by bolts.

Plates for cross arms are disappeared at compressed steel members.

The remedial works shall be arranged.

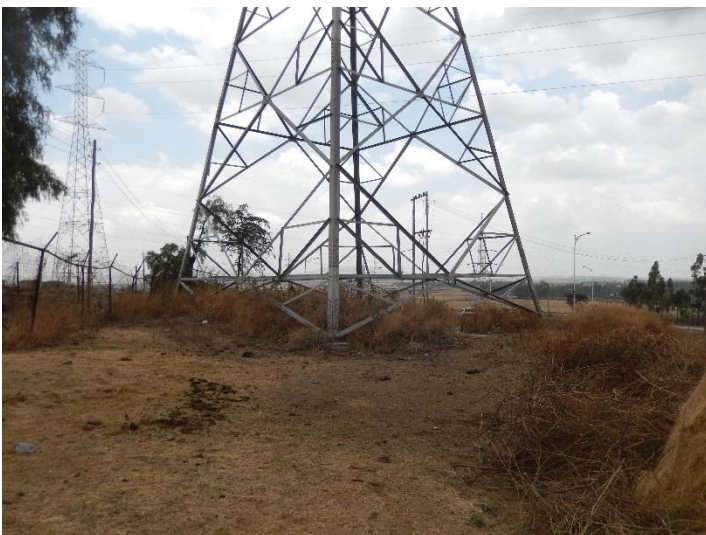
DSCN0867 T55 bottom
T55 has many missing steel members.

The tower erection is not completed yes as many steels are missing condition.

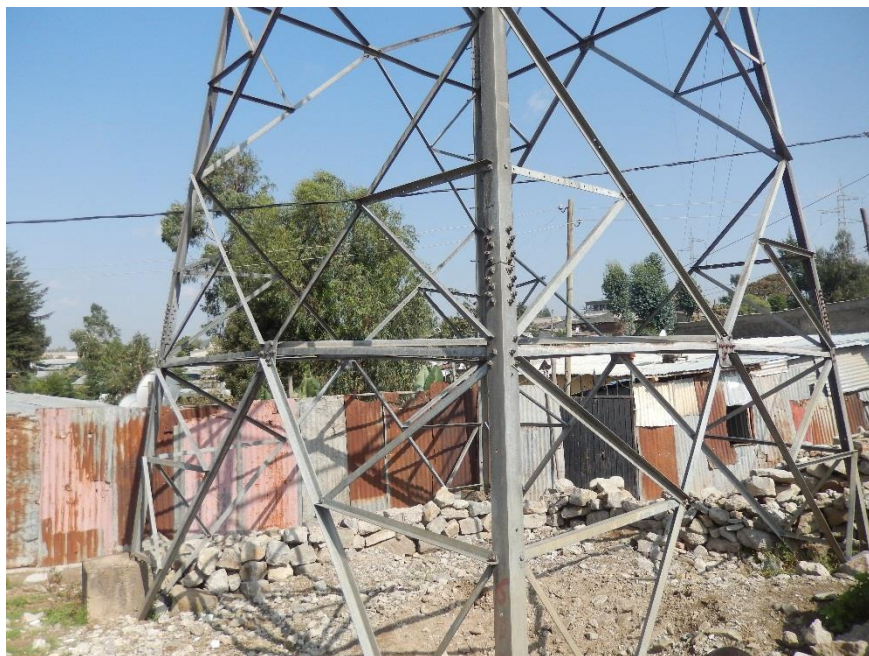
DSCN0452 First horizontal members are all bent

Remarks
Foundation for all four legs are
damaged due to soil pressure from
surface.

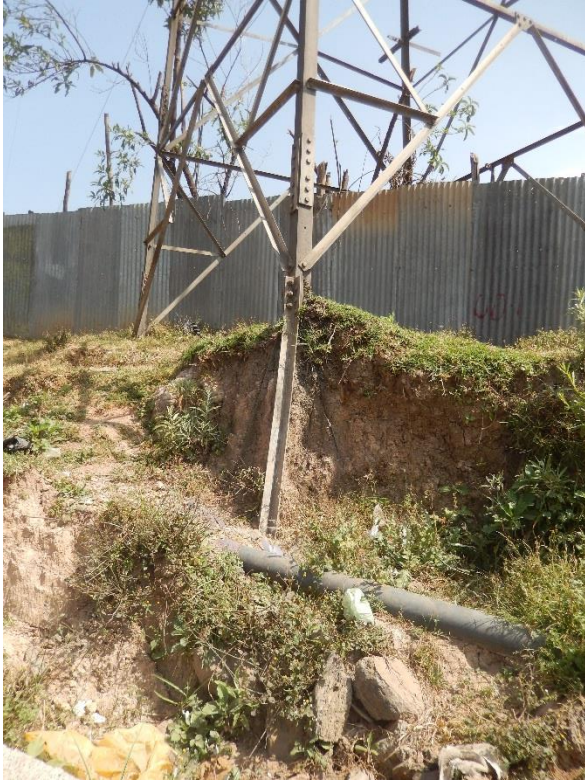
T52 Kaliti – Sebeta
Existing Foundation
No concrete Chimney for stub
DSCN2408
