Final Report on Building Inventory, Damage and Seismic Intensity Survey for the JICA Aided the Project for Assessment of Earthquake Disaster Risk for the Kathmandu Valley in Nepal

Ref. No. R7011/JICA/015

National Society for Earthquake Technology-Nepal (NSET)

February 2016

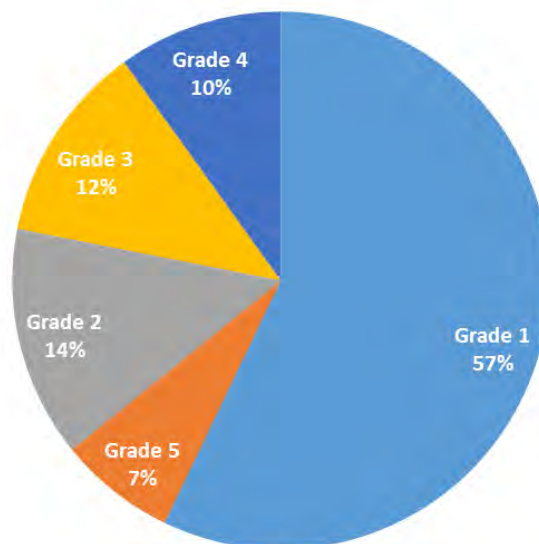
Fig. 4-9: Percentage distribution of damage degree of buildings in Bhaktapur Municipality.

Regarding the damage degree, most important part of this survey, the following chart (Fig. 4-9) shows that there are about 57 % of building lies under category of Damage Grade 1. About 14% are in damage grade 2, 12% in damage grade 3, 10% in damage grade 4, and 7% in Damage grade 5 were recorded. The details can be seen in Table 4-5, in section 4.2 below, for ward-wise distribution of damage.

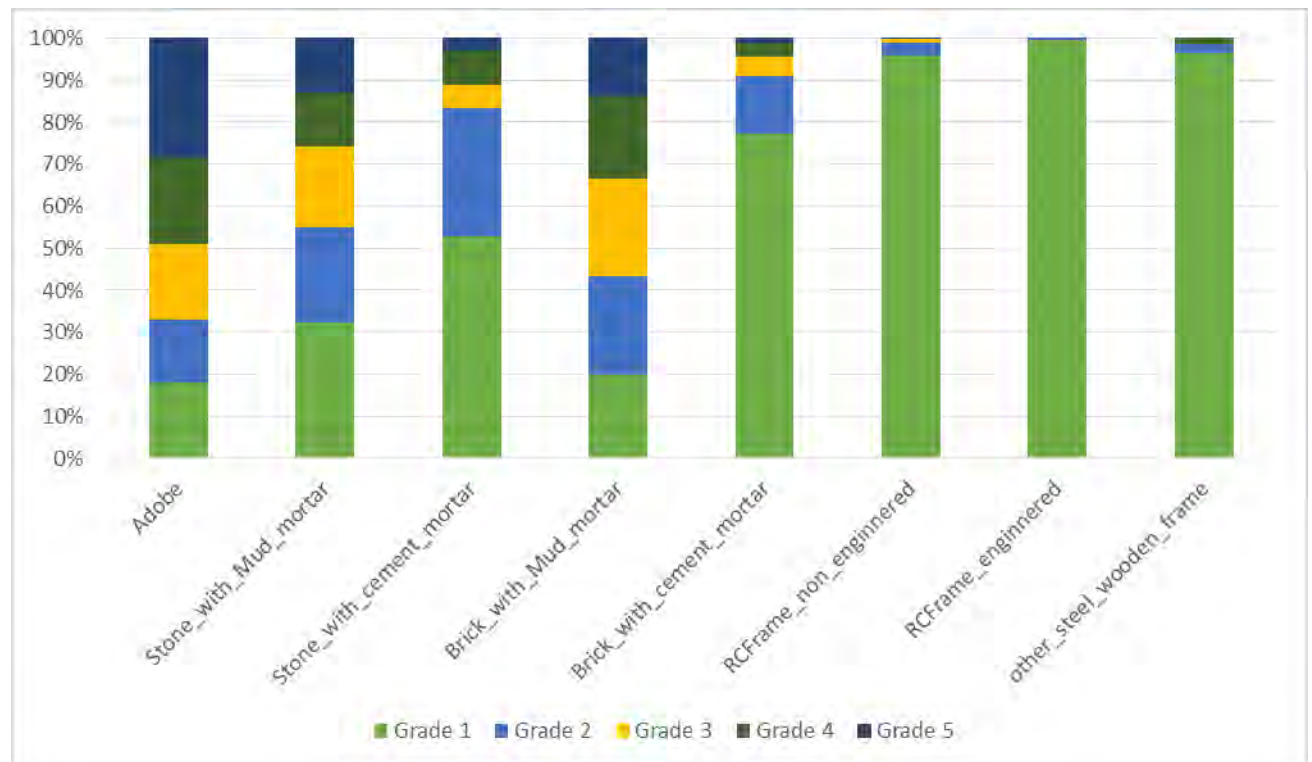
Fig. 4-10: Damage Grade by Building Typologies in Bhaktapur Municipality.

From the above Fig. 4-10, it is clearly visible that the majority of higher degree of damage is seen in BMM and BCM type of buildings whereas RC Frame (engineered and non-engineered) has less damage).

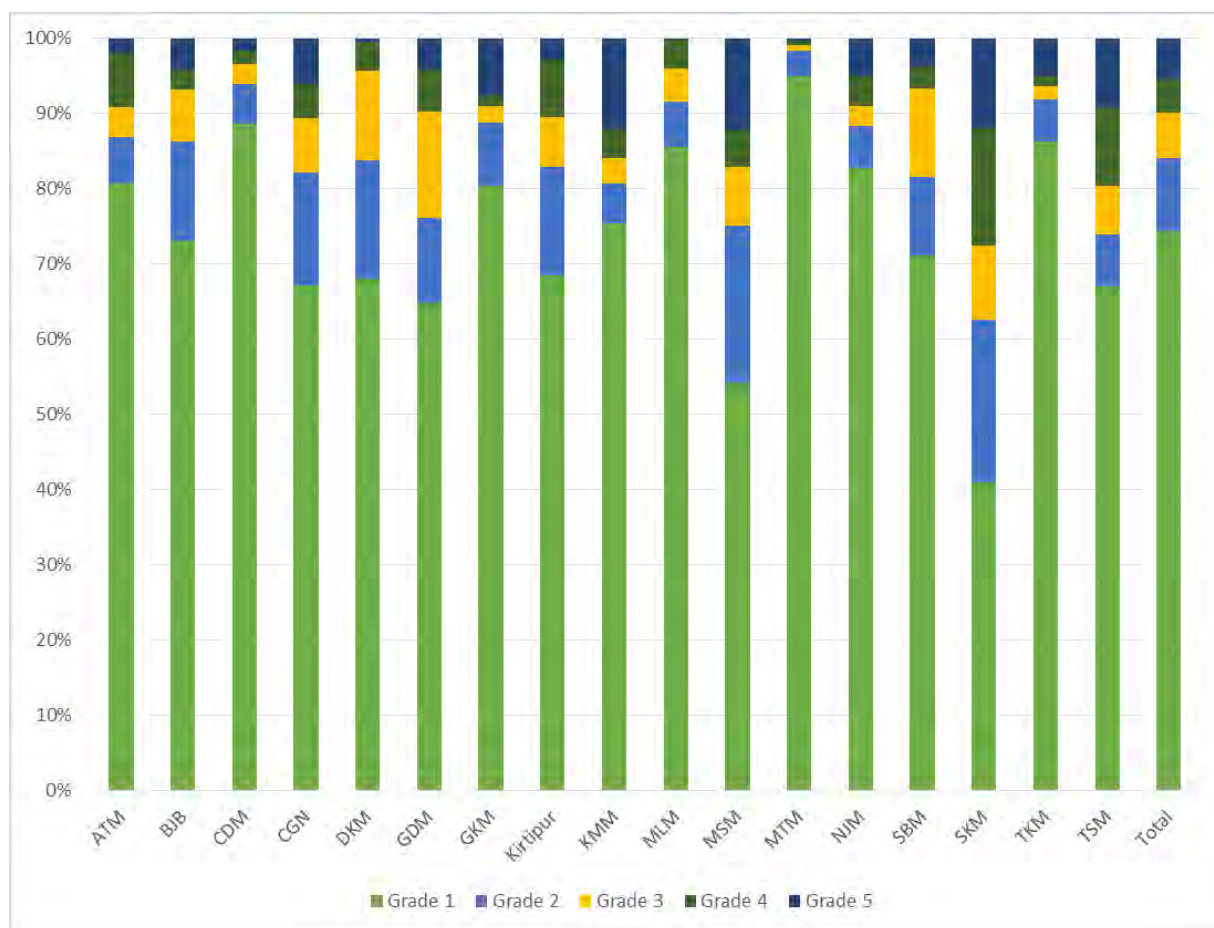
Fig. 4-16: Damage Grade by Municipalities in KV.

Damage Grade (DG)					
Municipalities		Grade 1	Grade 2	Grade 3	Grade 4	Grade 5	Total
Anantalingeshwore	ATM	450	35	22	40	11	558
Bajrabarahi	BJB	452	82	43	16	26	619
Chandragiri	CDM	945	57	29	18	18	1067
Changunarayan	CGN	482	108	52	32	44	718
Daxinkali	DKM	155	36	27	9	1	228
Godawari	GDM	492	87	107	42	32	760
Gokarneshwor	GKM	656	68	18	11	63	816
Kirtipur	Kirtipur	473	99	46	52	20	690
Kageswari-Manahara	KMM	778	54	34	40	125	1031
Mahalaxmi	MLM	529	37	27	24	1	618
Mahamanjushree	MSM	298	114	43	27	67	549
Madhyapur Thimi	MTM	520	19	4	3	2	548
Nagarjun	NJM	413	28	13	20	25	499
Suryabinayak	SBM	566	83	93	23	30	795
Shankharapur	SKM	198	104	48	75	58	483
Tokha	TKM	395	26	8	6	23	458
Tarkeshwor	TSM	394	41	38	61	54	588
Total		8196	1078	652	499	600	11025
%		74.34	9.78	5.91	4.53	5.44

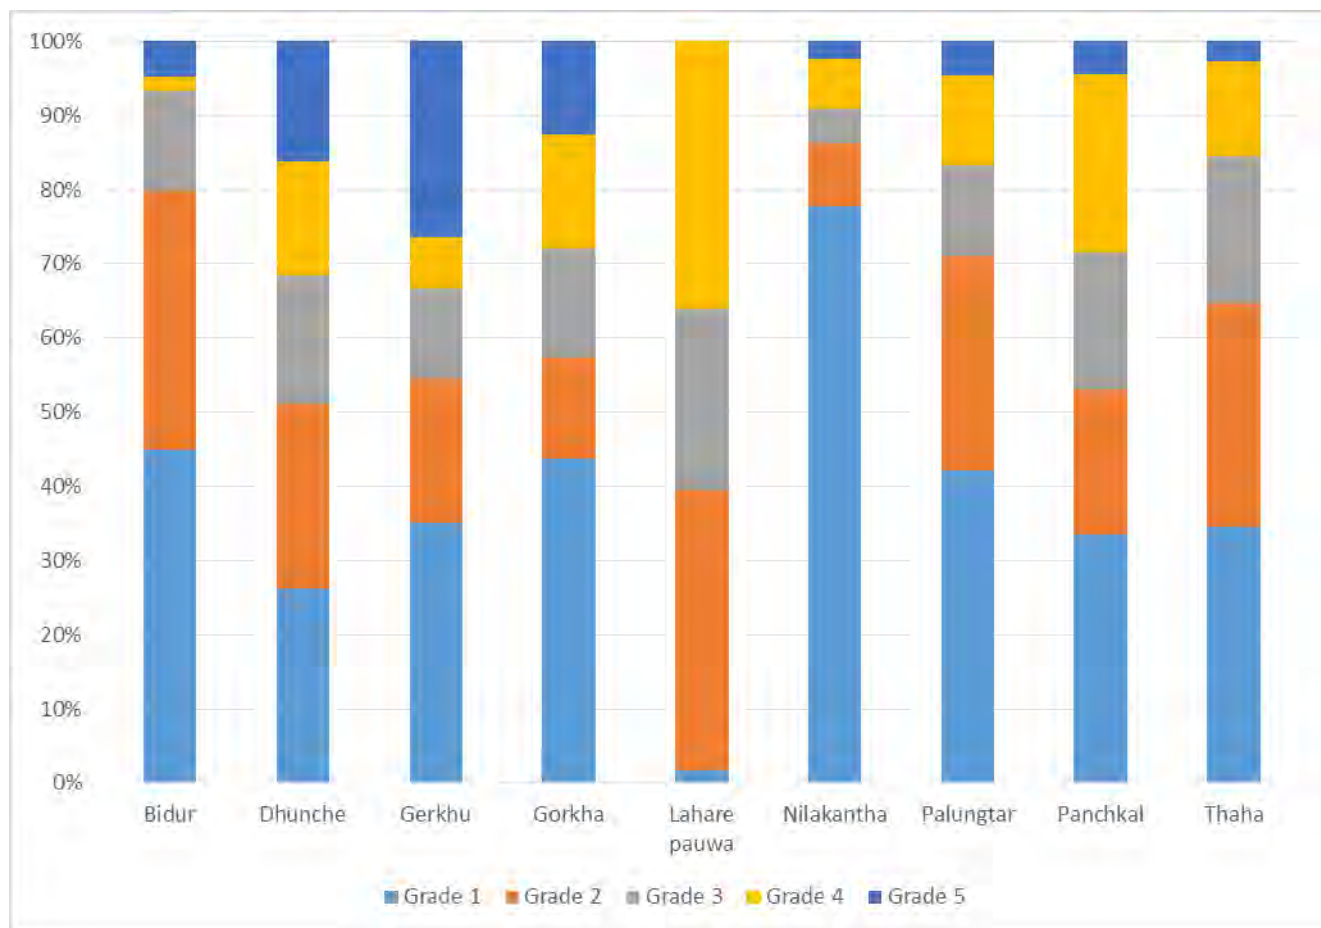
Fig. 4-22: Damage grade outside KV Municipalities

Municipality	Damage Grade					Total
	Grade 1	Grade 2	Grade 3	Grade 4	Grade 5	
Bidur	67	52	20	3	7	149
Dhunchhe	55	52	36	32	34	209
Gerkhu	20	11	7	4	15	57
Gorkha	80	25	27	28	23	183
Lahare pauwa	1	23	15	22		61
Nilakantha	136	15	8	12	4	175
Palungtar	73	50	21	21	8	173
Panchkal	106	62	59	76	14	317
Thaha	38	33	22	14	3	110
Total	576	323	215	212	108	1434

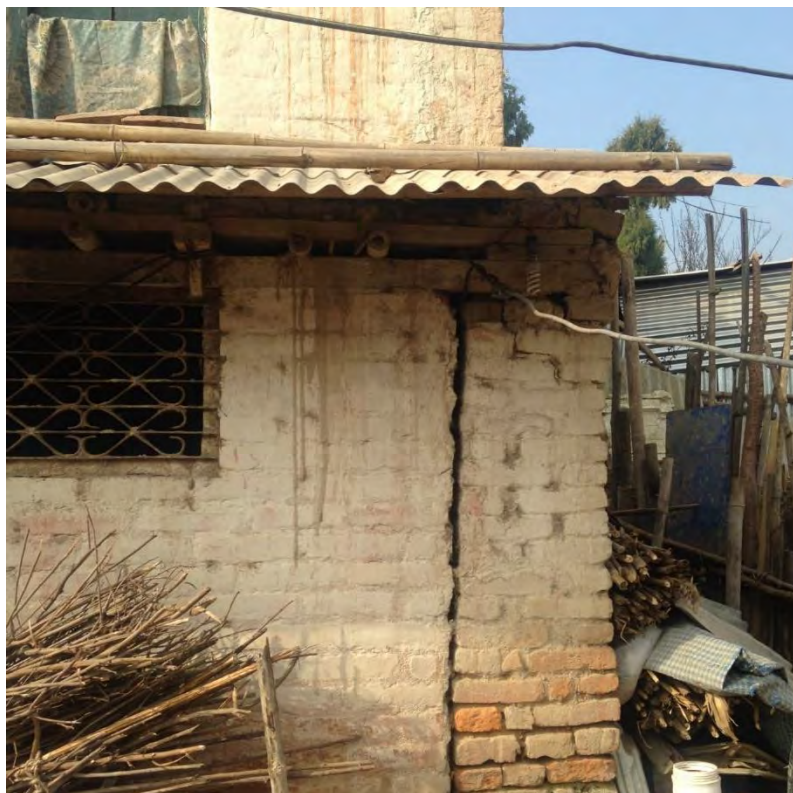
- Third story was damaged heavily due to Gorkha earthquake.
- Third story was removed and only two was present
- The observed damage grade is DG3 according to damage classification by EMS 98. (refer Annex 1 for damage grade information)

Figure 2. Crack formed in the corner due to Gorkha earthquake

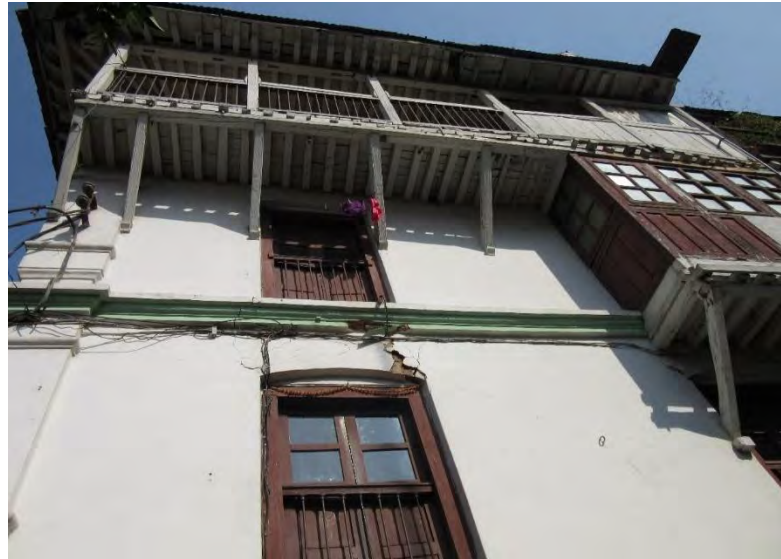
- The observed damage grade is DG3 according to damage classification by EMS 98. (Refer Annex 1 for damage grade information).

Figure 4. Crack above the window due to Gorkha earthquake

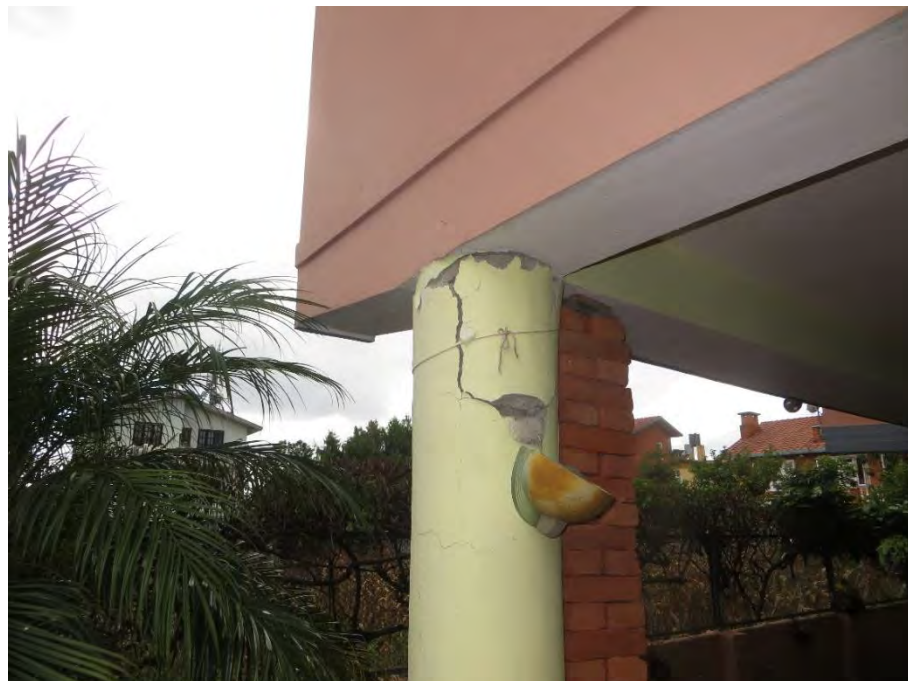
- More than 5mm cracks in the ground floor column. All the damages was concentrated in ground floor only.
- Shear crack in infill walls.
- Cracks in beam column joints.
- The observed damage grade is DG3 according to damage classification by EMS 98. (refer Annex 2 for damage grade information)

Figure 7. Crack in columns of ground floor due to Gorkha earthquake
