**INDONESIA LIGHTNING PROTECTION  
DESIGN SURVEY  
FOR  
VESSEL TRAFFIC SERVICE EQUIPMENT  
REGARDING  
TECHNICAL COOPERATION PROJECT ON  
ENHANCING OF VESSEL TRAFFIC SERVICE  
SYSTEM MANAGEMENT CAPACITY  
IN  
INDONESIA

FINAL REPORT**

**MARCH 2013**

**ORIENTAL CONSULTANTS CO., LTD. (OC)  
JAPAN AIDS TO NAVIGATION ASSOCIATION (JANA)**

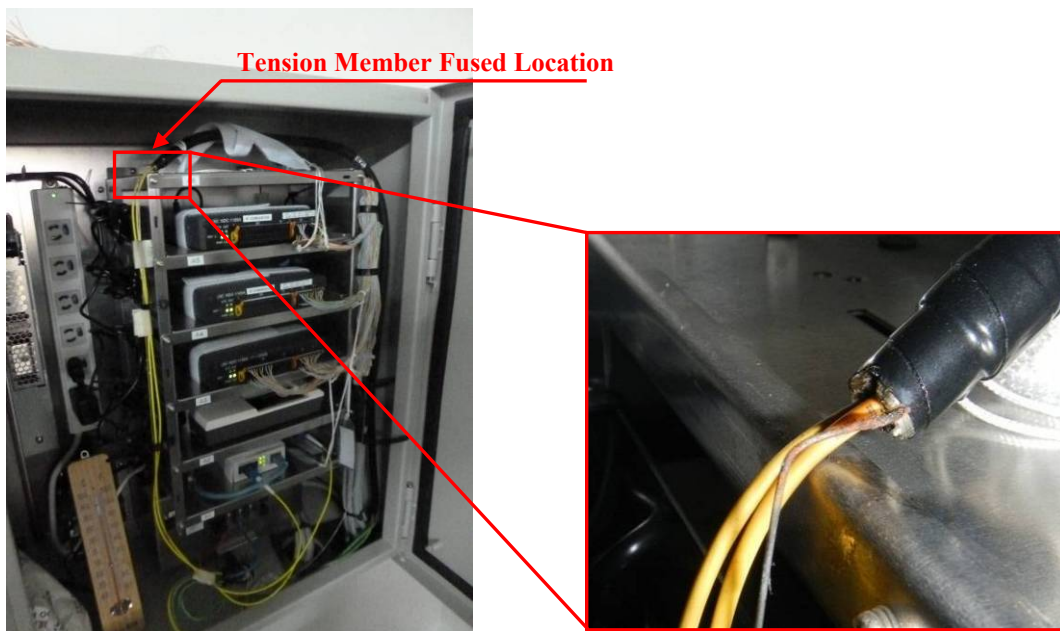
In Hiyu Kecil, the tension members of optical cables connected between the rack in the equipment building and the generator house are fused. Evidence of sparks was found at the cable fixing plate and the LAN cable beside the optical cables. The sparks may have occurred due to lightning surge invasion through tension members of the optical cable when the lightning strikes hit the steel tower. The fused conditions are as shown in Photo 2-1.

(1) Equipment Rack in Hiyu Kecil                      (2) Fused Optical Fiber Cable  
**Photo 2-1 Fused Condition of Optical Fiber Cable in Equipment Rack in Hiyu Kecil**

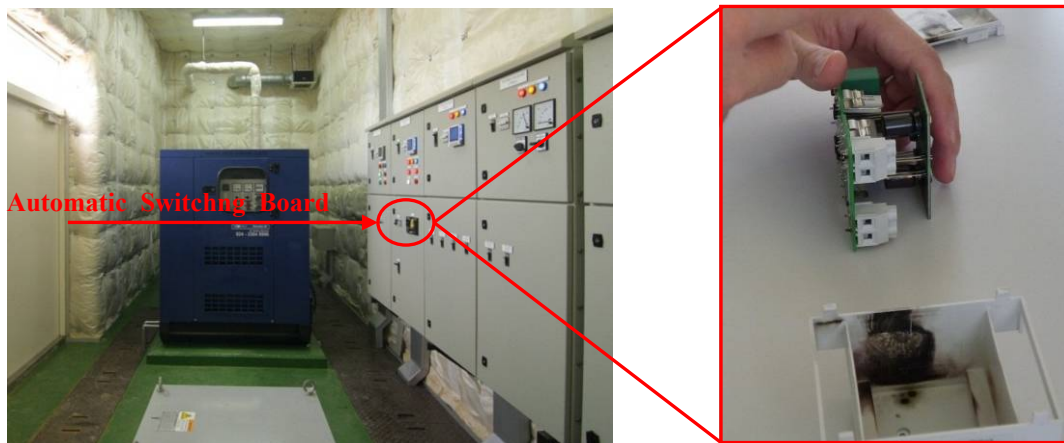
Damage by the lightning that occurred in November 2012 is concentrated in the power supply system. Photo 2-2 (2) shows damage of a control device for an automatic switcher between

commercial power supply and emergency power supply that was installed on the control panel as shown in Photo 2-2 (1). On the other hand, there is no damage on the radar system and other communication systems.

(1) Switching Panel in VTS Center                      (2) Fused Switching Board  
**Photo 2-2 Fused Condition of Switching Board in Batu Ampar VTS Center**

Damage at Batu Ampar VTS Center was found only in the power distribution devices while no damage was found in VTS equipment. According to the field survey, direct lightning might have struck the air terminal since there was deformation and burned traces were found its top. However, because of the equipment's condition, the cause of damage may not be due to direct lightning that might have hit the tower and/or the VTS Center building. Lightning surges induced by lightning near the site may invade through public power transmission cables to the building.

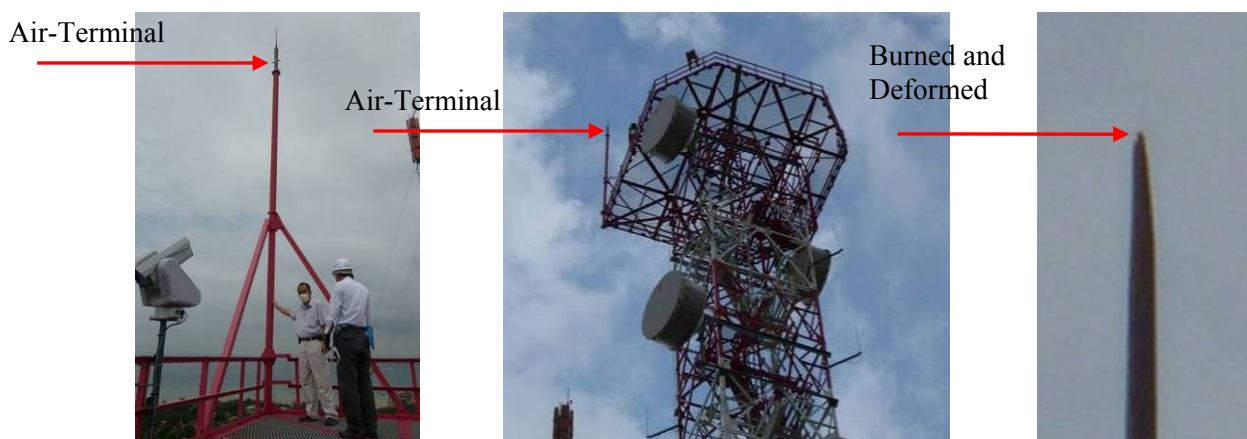
An air-termination system at VTS Center and each sensor station is installed at the top of the steel tower with a protection angle of 60 degrees based on JIS A4201 (1992). The air-terminal installed conditions at Batu Ampar VTS Center are as shown in Photo 2-3. Other stations have the same conditions. It was surmised that direct lightning to the air terminal might have occurred because deformation and burned trace were found at the top of the air terminal as shown in Photo 2-3 (3).

(1) Overall View                      (2) Air Terminal                      (3) Toe Condition

**Photo 2-3 Present Conditions of Air-Termination System**

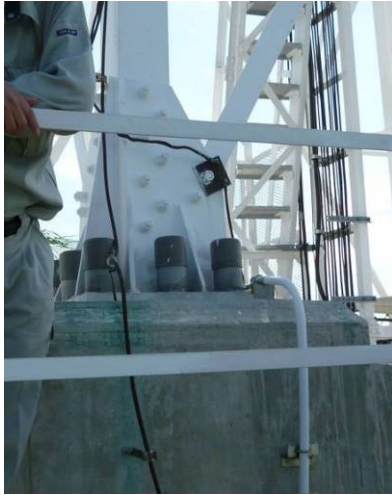
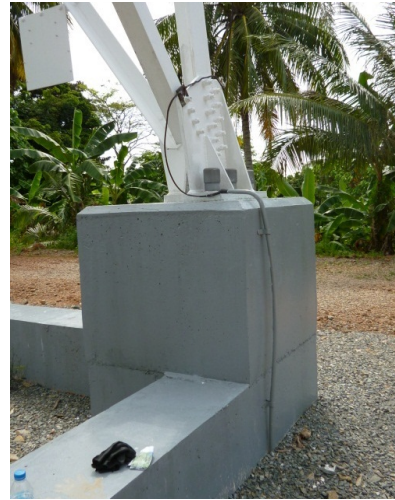
One (1) down-conductor is installed. It is connected to the air-termination system by copper wire and bonded at the leg of the steel tower near the concrete foundation. Earth terminals are provided at two (2) legs near the foundation and one of them is bonded with a down-conductor. Conditions of earth termination are as shown in Photo 2-4.

**Photo 2-4 Present Conditions of Down-Conductor**

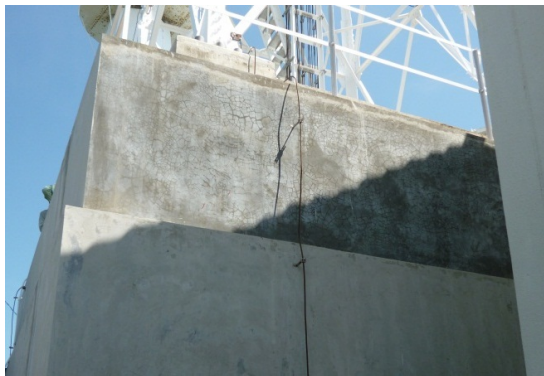
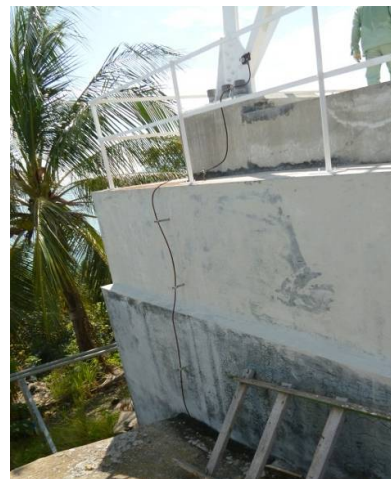
In Hiyu Kecil, measures were conducted on trial by DGST after the damage in May 2011. Earth terminations were installed at four (4) legs as shown in Photo 2-5 by adding two (2) legs.

**Photo 2-5 Present Conditions of Earth Terminals in Hiyu Kecil**

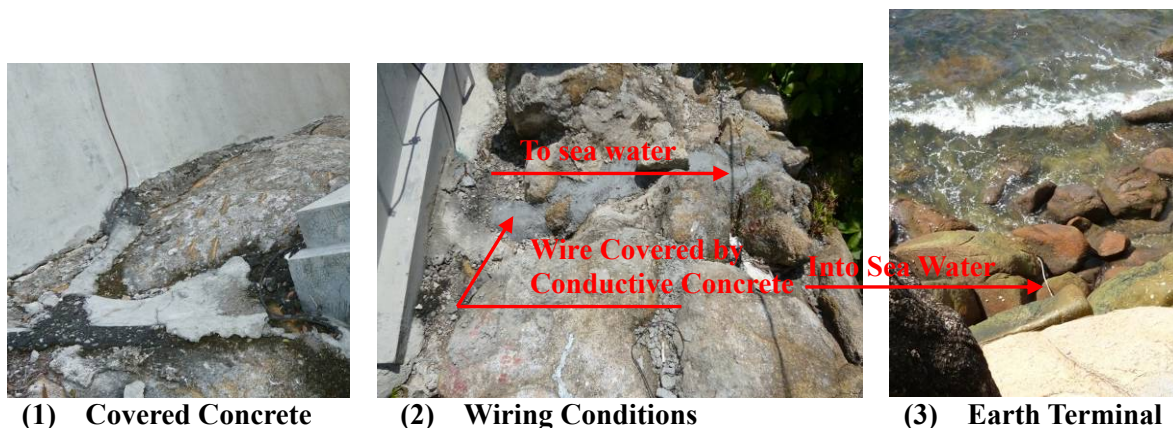
In Hiyu Kecil, ring earth electrodes were adapted for the generator house, equipment building and the steel tower considering the rocky ground conditions. Since these electrodes (wires) cannot be installed underground due to the rocky ground surface, they are to be covered by conductive concrete as shown as Photo 2-6.

**Photo 2-6 Present Conditions of Underwater Earth Electrode in Hiyu Kecil**

After lightning damage in May 2011, terminal wire extension into seawater and two (2) additional extended earth terminals installations were conducted on trial by DGST. The present conditions of the underwater earth electrodes are shown in Photo 2-6.

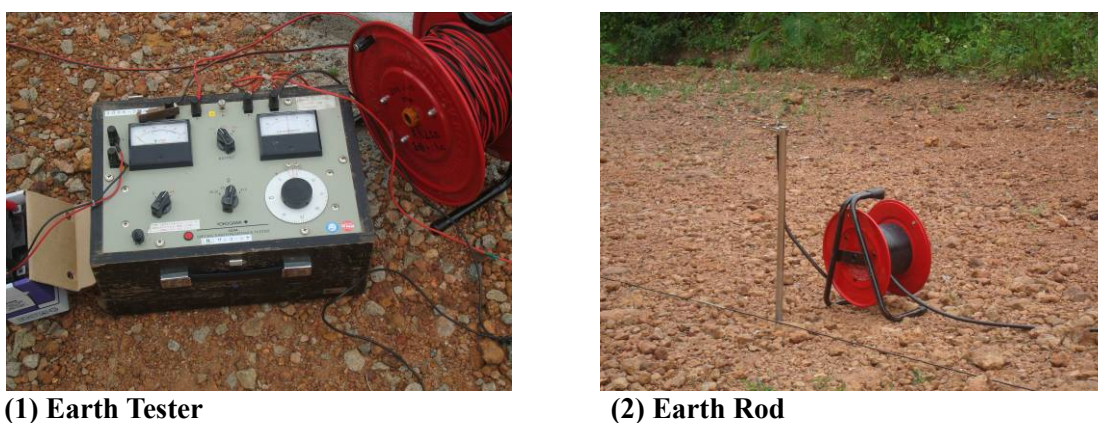
Earth resistances were measured at all sites as shown in Photo 2-7. The results are as shown in Table 2-2 below.

**Photo 2-7 Measurement of Earth Resistance**

Earth resistances are lower than 5 ohms and the above requirements are satisfied at all sites. In conclusion, earth-termination system and earth resistance are in good condition at all sites.
