**THE FOLLOW-UP COOPERATION STUDY
ON THE PROJECT FOR WATER SUPPLY
IN AFAR REGION IN THE FEDERAL
DEMOCRATIC REPUBLIC OF ETHIOPIA**

FINAL REPORT

February 2016

**JAPAN INTERNATIONAL COOPERATION AGENCY
KOKUSAI KOGYO CO., LTD.**

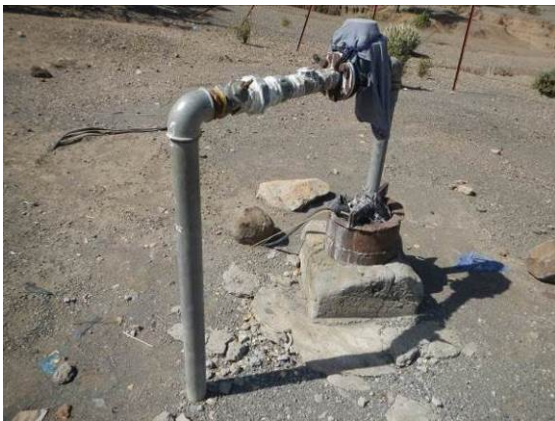
Figure 1-1 Existing well

An existing submersible pump and a flow meter of a pump unit were working. An existing generator was not working due to a malfunction in the fuel feed pump, and therefore was not in use at the time of inspection. The facility has been operating with commercial power since 2013.

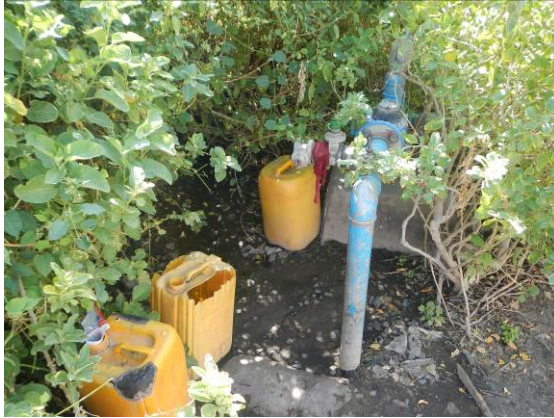
Figure 1-3 Production well

The AWRB reported that the pumping discharge of a production well, which was constructed by the previous grant aid, was reduced, and therefore a well development and pumping test were carried out in the Study. A submersible pump installed by the previous grant aid was replaced by the AWRB because it was out of order in 2010. Thereafter, the broken submersible pump was replaced with another pump (18.5 kW). However, the pump was not fulfilling its function due to a failure with the impeller. The flow meter and compound gauge of the pump unit were working. The generator had not been used since the facility was electrified with commercial power in 2013.

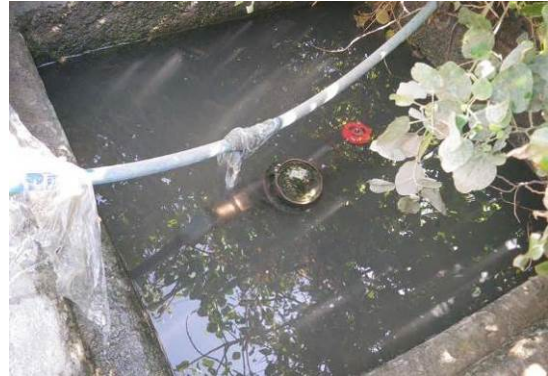
Figure 1-7 Existing public fountain No.1

Existing public fountain No.1 was working, but the flow meter and a gate valve were not.

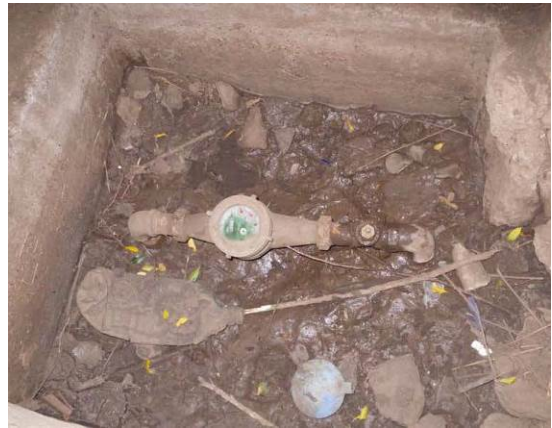
Figure 1-10 Existing public fountain No.4

Existing public fountain No.4 was working, but the flow meter and a gate valve were not.

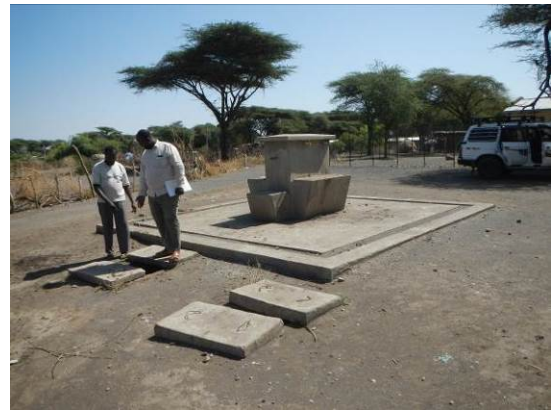
Figure 1-11 Public fountain No.1

Public fountain No.1, which was constructed by the previous grant aid, had not been used because the water was not running. That was not considered due to distribution pipelines' problem because water could be supplied by private connections through the distribution pipelines. Therefore, the cause seemed to be a malfunction of a gate valve in the chamber. In addition, the flow meter was removed.

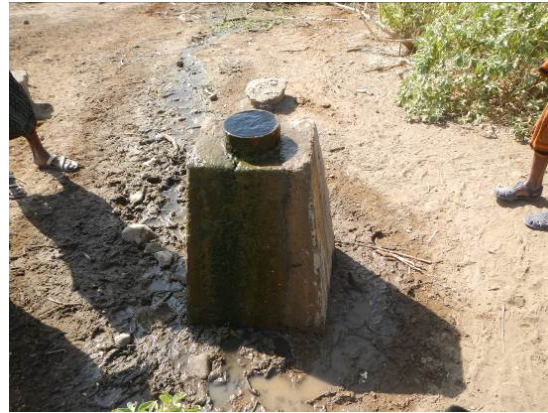
Figure 1-13 Existing well

The existing well had not been used since a submersible pump fell in the well in 2015. However, the well was not required to be rehabilitated because the salt concentration of the groundwater was too high to drink.

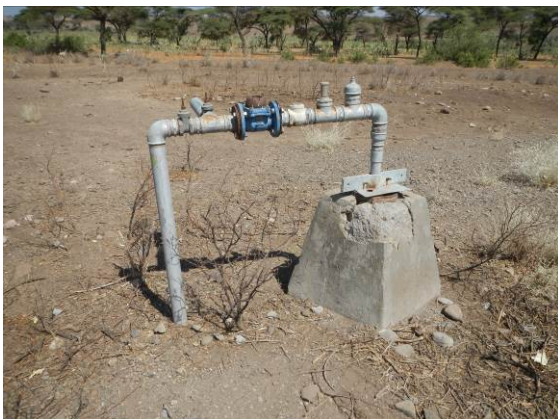
Figure 1-14 Test well

A submersible pump installed by the previous grant aid had also not been used and was left in the well since its last use in 2012. The pump was confirmed to not work in the Study. In addition, thread connections of riser pipes were damaged by corrosion. The flow meter and compound gauge of the pump unit were not working. A generator installed by the previous grant aid was not working due to a malfunction in the alternator, and therefore was no longer in use at the time of inspection.

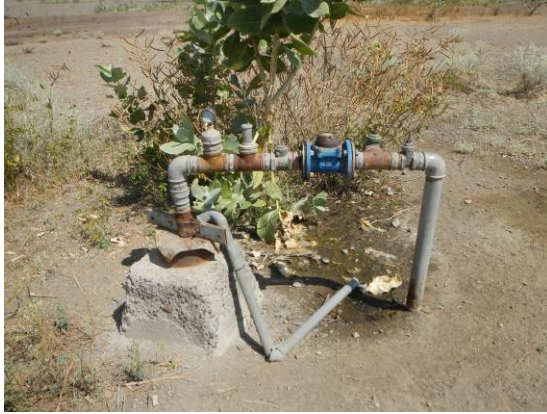
Figure 1-16 Production well

The submersible pump installed by the previous grant aid was working. A flow meter and a compound gauge of the pump unit were not working. The generator installed by the previous grant aid malfunctioned and was replaced by the AWRB in 2014. The replaced generator was working properly.

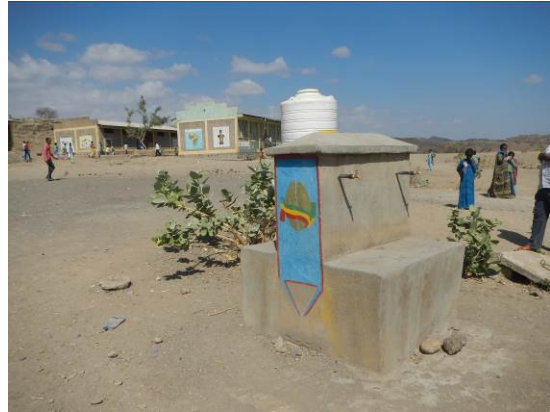
Figure 1-20 Existing public fountain No.1

Existing public fountain No.1, located in a school, was working but the flow meter and a gate valve were not.

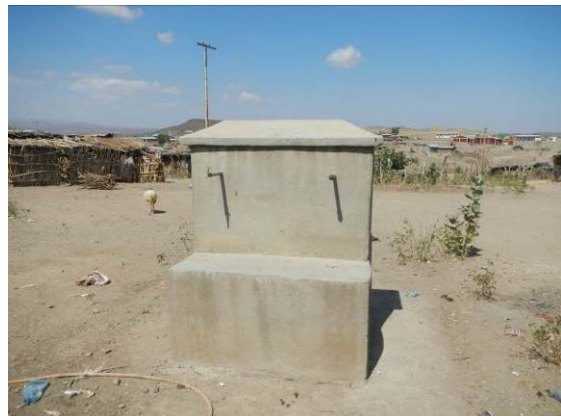
Figure 1-22 Existing public fountain No.3

Existing public fountain No.3 was working but the flow meter and a gate valve were not.

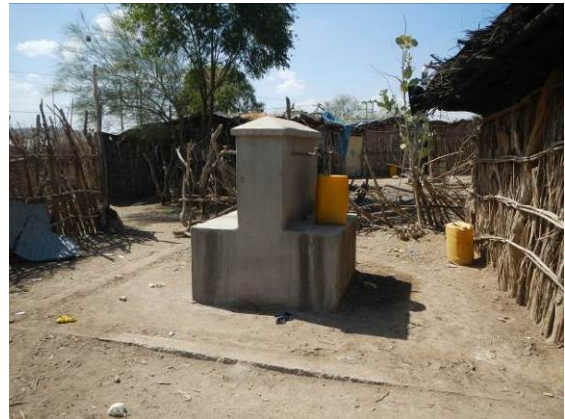
Figure 1-23 Existing public fountain No.4

Existing public fountain No.4 was working. The flow meter was also working but a gate valve was not.

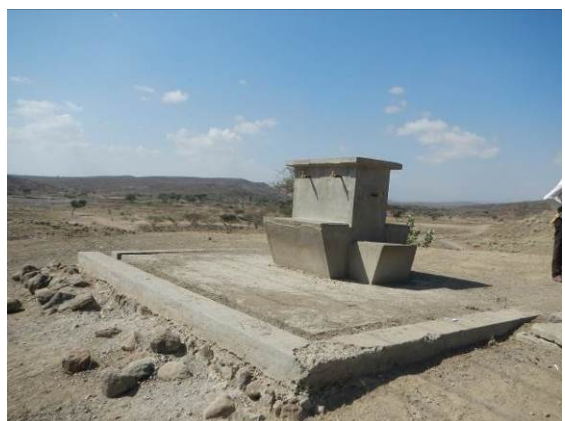
Figure 1-25 Public fountain No.2

Public fountain No.2, which was constructed by the previous grant aid, was working, and the flow meter was also working, but a gate valve was not.

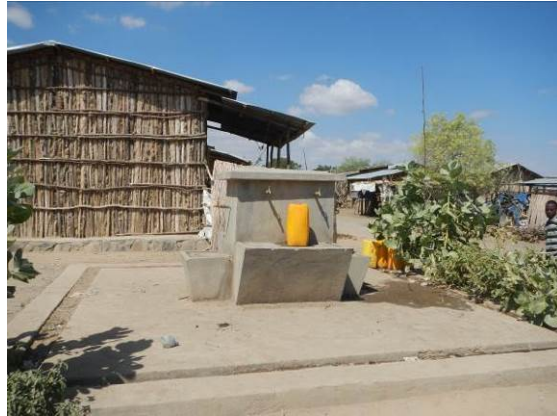
Figure 1-26 Public fountain No.3

Public fountain No.3, which was constructed by the previous grant aid, was working but the flow meter and a gate valve were not.

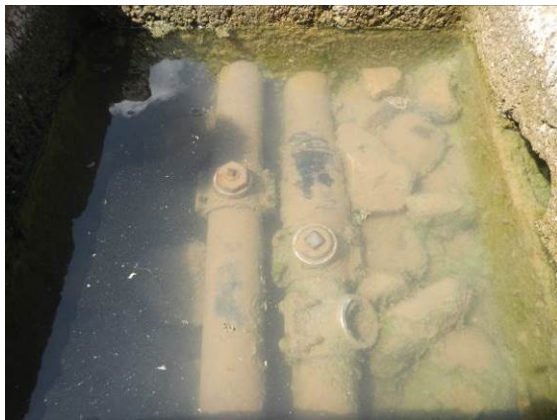
Figure 1-27 Transmission pipeline

High-density polyethylene (HDPE) transmission pipelines constructed by the previous grant aid were leaking. Two air release valves in a chamber were removed.

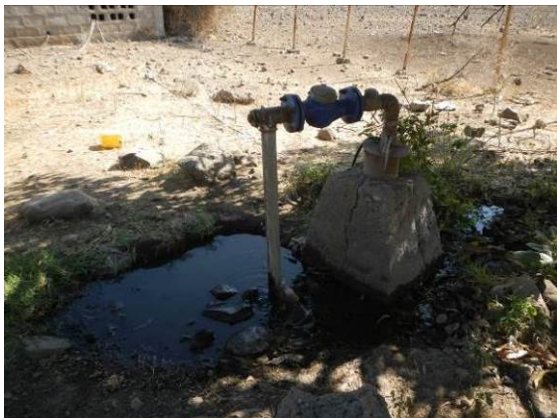
Figure 1-28 Existing well

The submersible pump installed by the previous grant aid malfunctioned and was replaced by the AWRB. The flow meter of the pump unit had broken down. The facility was electrified with a photovoltaic power plant provided by the Afar community initiative sustainable development association (ACISDA) in 2014, and therefore the existing generator was used as a standby power source.

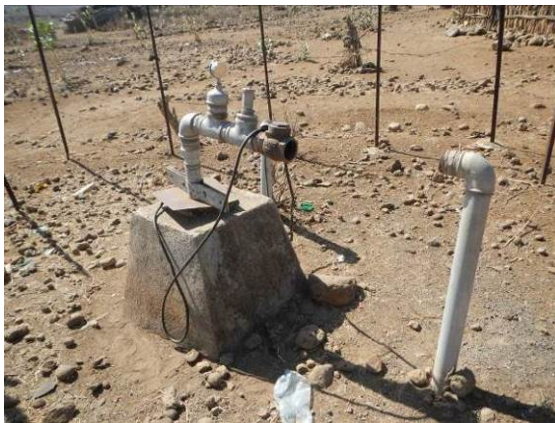
Figure 1-32 Production well

The production well operating with a diesel generator had not been used since 2014 due to high operating costs compared to other facilities which were electrified with photovoltaic power in 2014. However, operating the production well was required to resolve water shortages in the town, and therefore the AWRB intended to electrify the facility to reduce the operating costs. In this situation, with the electrification as a condition, a well development and a pumping test were carried out to rehabilitate the well in the Study.

A submersible pump installed by the previous grant aid had not been used and was left in the well since 2014 due to the above-described reason. The pump was confirmed to not work in the Study. In addition, thread connections of riser pipes were damaged by corrosion. A flow meter was removed and a compound gauge, a check valve, an air release valve and gate valves of the pump unit failed. A generator installed by the previous grant aid was also out of operation, and had been left unused since 2014.

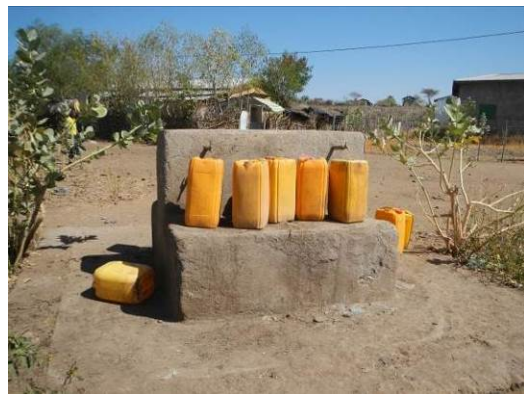
Figure 1-36 Existing public fountain No.2

Existing public fountain No.2 was working. The flow meter was working but a gate valve was not.

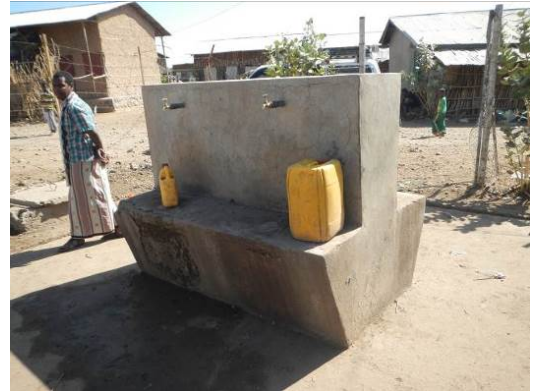
Figure 1-37 Existing public fountain No.3

Existing public fountain No.3 was working. The flow meter was also working but the gate valve was not.

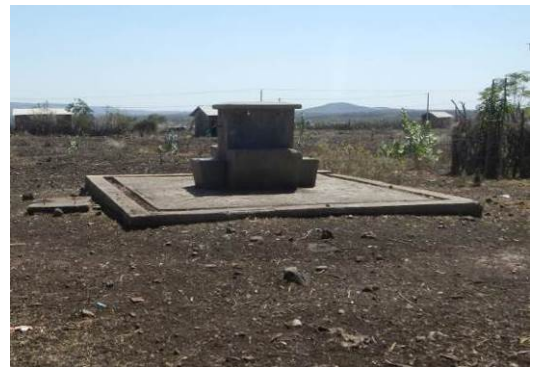
Figure 1-38 Public fountain No.1

Public fountain No.1, which was constructed by the previous grant aid, was working. The flow meter was also working but the gate valve was not.

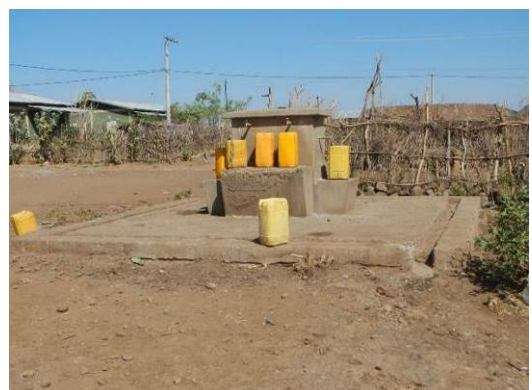
Figure 1-39 Public fountain No.2

Public fountain No.2, which was constructed by the previous grant aid, was working. The flow meter was also working but the gate valve was not.

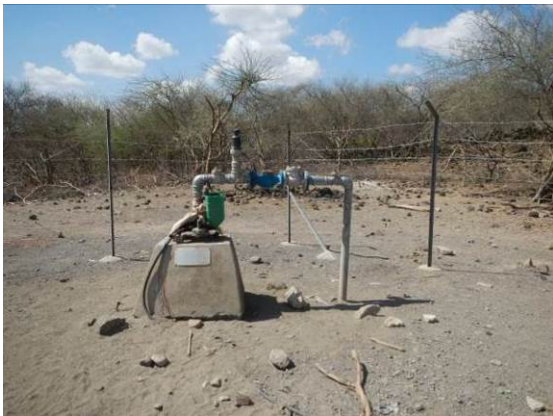
Figure 1-40 Production well

A submersible pump installed by the previous grant aid malfunctioned and was replaced by the AWRB in 2011. Thereafter, two submersible pumps continuously malfunctioned and were replaced, and thereby the forth pump was operating. However, according to AWRB, the performance of the pump was not sufficient and the specifications were unknown. The flow meter and the compound gauge of the pump unit failed. The facility was electrified with commercial power by CARE Ethiopia and USAID in 2013, and therefore a generator installed by the previous grant aid was used as a standby power source.

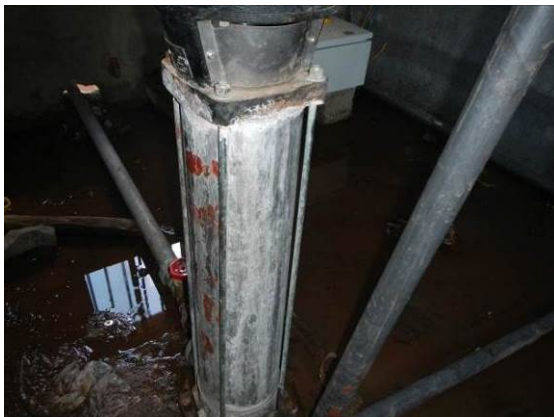
Figure 1-42 Booster pump

A booster pump installed by the previous grant aid was operating but was leaking a lot of water from the body. It was also confirmed that a pipeline around the pump was leaking.

- A backup booster pump, which was procured by the past grant aid, had been used to replace a malfunctioning pump. Therefore, additional booster pumps for station No.1 and No.2 shall be procured as a backup.

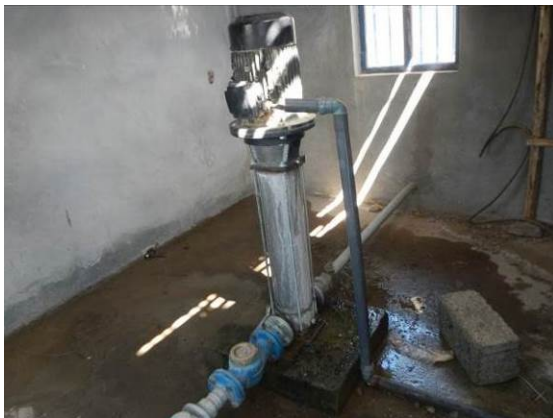
Figure 1-45 Booster pump

A booster pump installed by the previous grant aid malfunctioned and was replaced with a backup pump in 2015. The replaced booster pump was operating and leaking some water from the body. A generator installed by the previous grant aid has not been used since the facility was electrified with commercial power in 2013.

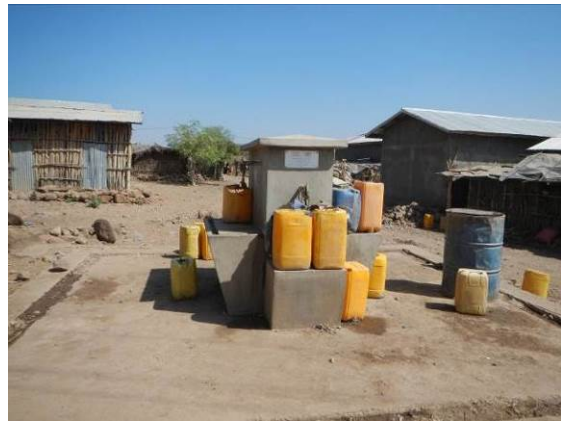
Figure 1-49 Public fountain No.1

Public fountain No.1, which was constructed by the previous grant aid, was working. The flow meter was also working but a gate valve was not.

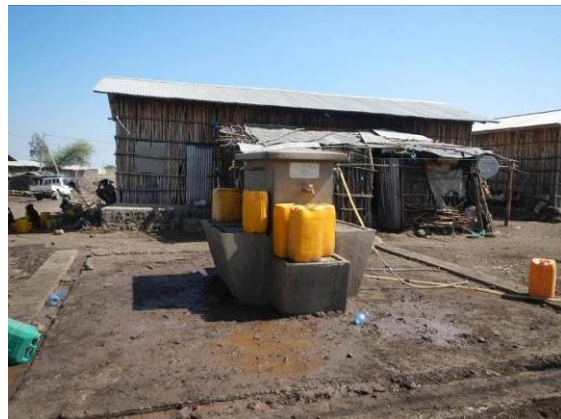
Figure 1-50 Public fountain No.2

Public fountain No.2 was working. The flow meter was also working but a gate valve was not.

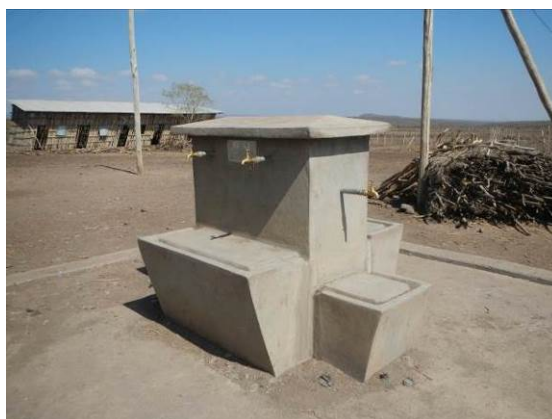
Figure 1-51 Public fountain No.3

Public fountain No.3 was working. The flow meter was also working but a gate valve was not.

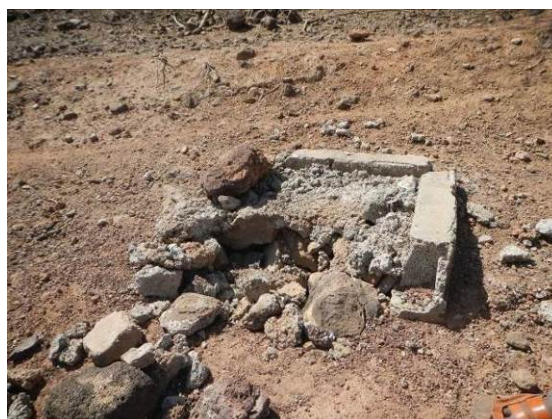
Figure 1-53 Chamber of air release valve

According to the AWRB, all air release valves installed by the previous grant aid along transmission pipelines were removed by residents living around the site. Therefore, all chambers of the valves were covered with concrete or cobble to prevent additional damages.

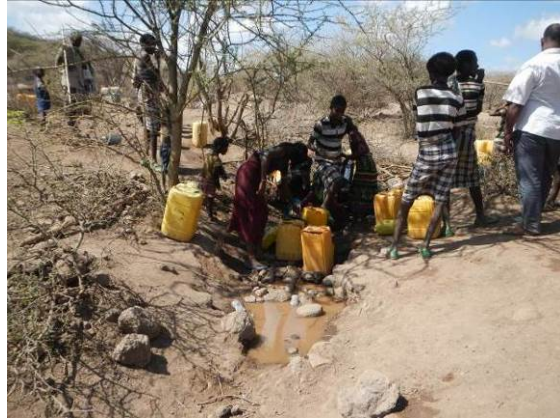
Figure 1-54 Leaking water of pipeline

Residents living around the site used leaking water from the transmission pipeline. The leakage shall be repaired for proper management, even though the residents need water. The AWRB intended to take measures against the leakage because it was a regional issue.

- Residents used leaking water from a transmission pipeline in Kumami. The leakage shall be repaired for proper management, even though the residents needed the water. The AWRB intended to take a measure against the leakage, and thereby the repair is not included in the Follow-Up Cooperation.
