CHAPTER 9 Technology Transfer

9-1 Maintenance of Transmission and Distribution Equipment

9-1-1 State of Power Transmission/Distribution Facilities

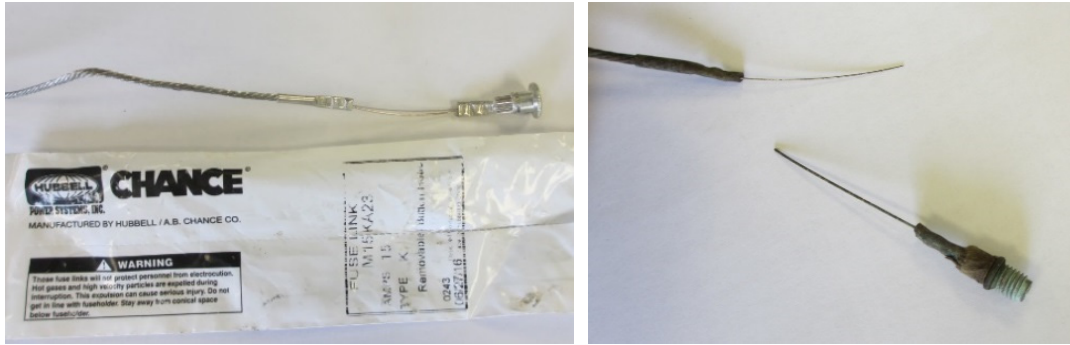
Figure 9-1-2.6 Example of an enclosed fuse installed on a PPUC power line (left, new product; right, after fusing)

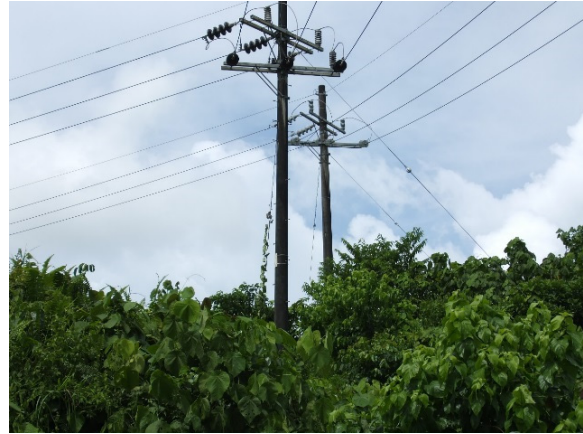
(b) Example of a vine climbing up a guy wire

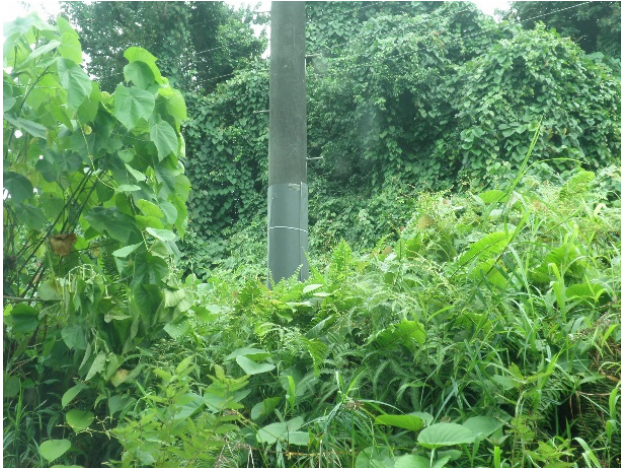
Sample surveys were also done approximately 6 months and 12 months after installation. Almost no wrapping of vine was seen in the places where the guards were attached, (Figure 9-1-4-1.2). Vine wrapped slightly around one guy wire, but the tip of the vine had already died and no further growth was expected (Figure 9-1-4-1.3).

Figure 9-1-4-1.2 Status of vine near a utility pole

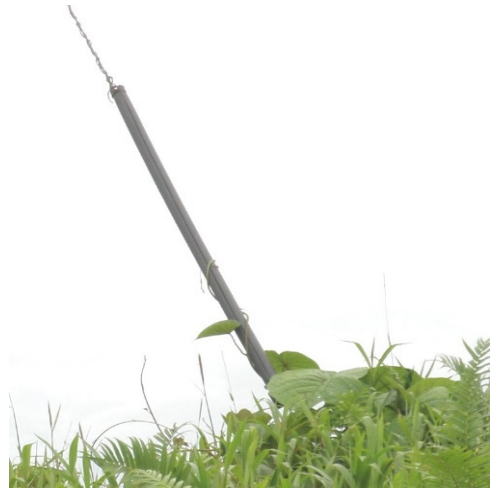
Figure 9-1-4-1.3 Vine winding around a guy wire

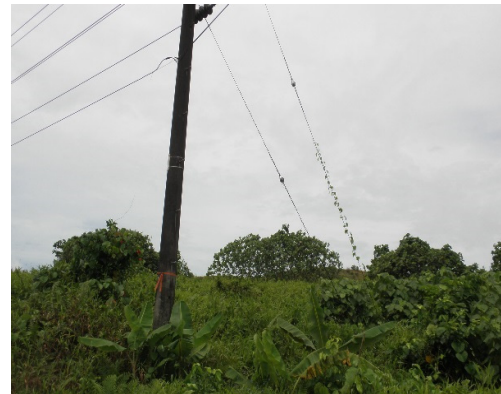
Fig. 9-1-4-1.8 shows a vine wrapping itself around a guy wire without a vine guard. This vine grew about 3 to 4 meters over the period between Nov. 2017 and Apr. 2018. The vine guards seem to be effective in preventing the rapidly growing vines from wrapping themselves around the equipment.

Figure 9-1-4-1.8 Growth on guy wires without a vine guard

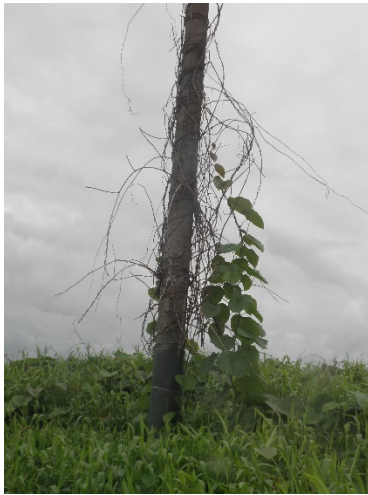
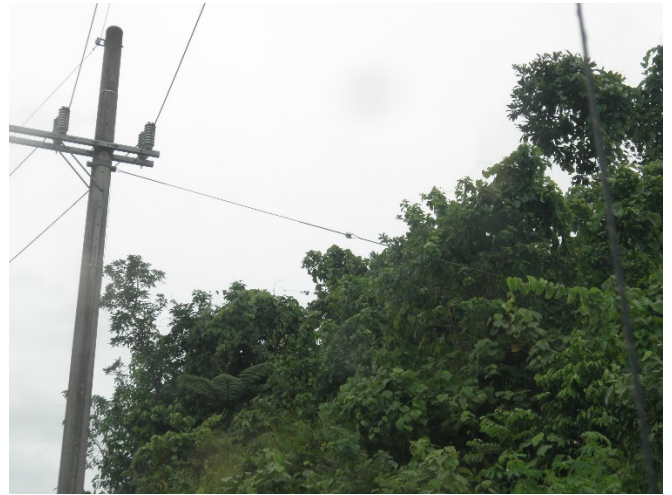
Figure 9-1-4-1.9 Status of vine growth (no vine guard attached)

(A) Growth through the detour route of a pole

(b) Winding around a guy wire

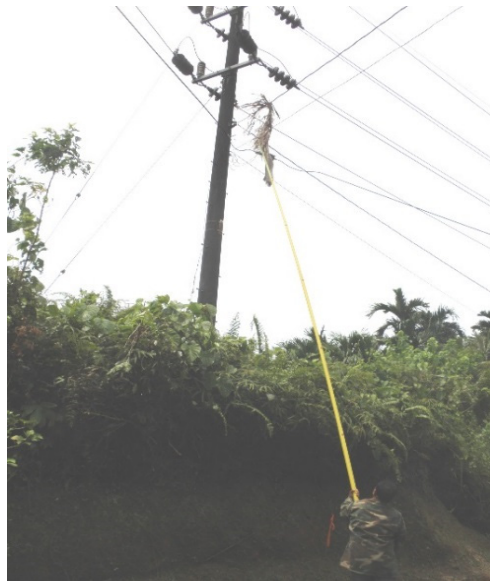
In the period between Nov. 2017 and Apr. 2018, only two faults occurred in the Nekken transmission line. In one case, a patrol was sent out to check the indicator according to the prescribed procedure (the cause was contact with a windblown branch, Fig. 9 -1-4-1.12). In the other case, no trip information was transmitted from the substation operator to the lineman, so no patrol was dispatched.

Figure 9-1-4-1.12 Windblown branch (cause of a fault)

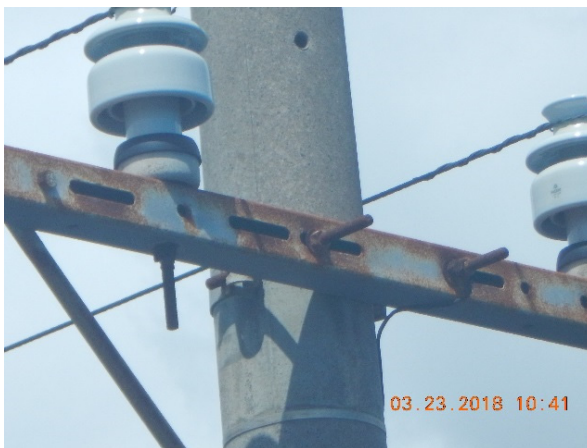
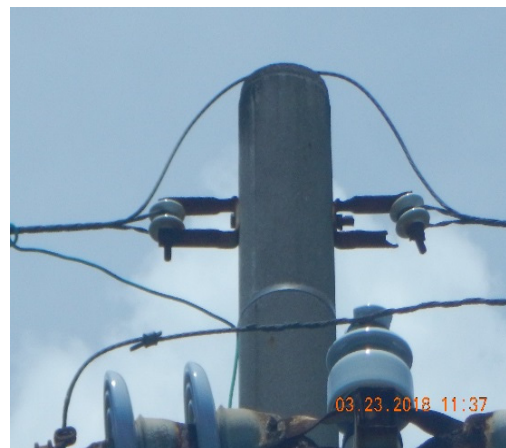
Figure 9-1-5-1.1 Rust of iron materials

- ✓ Rusting of the iron materials (Figure 9-1-5-1.1)
- ✓ Loose bolts and nuts (Figure 9-1-5-1.2)
- ✓ Inclination of the arms (Figure 9-1-5-1.3)
- ✓ Damage of the arrester / cut-out (Figure 9-1-5-1.4)
- ✓ Chipping of the insulators (Figure 9-1-5-1.5)
- ✓ Disconnection of the grounding wire of the overhead ground wire / neutral wire (Figure 9-1-5-1.6)
- ✓ Broken wire grip (Figure 9-1-5-1.7)
- ✓ Temperature rise of the transformer · Overheating of a wire connection (Figure 9-1-5-1.8)
- ✓ Approaching tree growth (Figure 9-1-5-1.9)
- ✓ Disappearance of the utility pole number · Loss of the utility pole number tag

(a) Rusting arm brace

(b) Broken support hardware for the insulator by rust

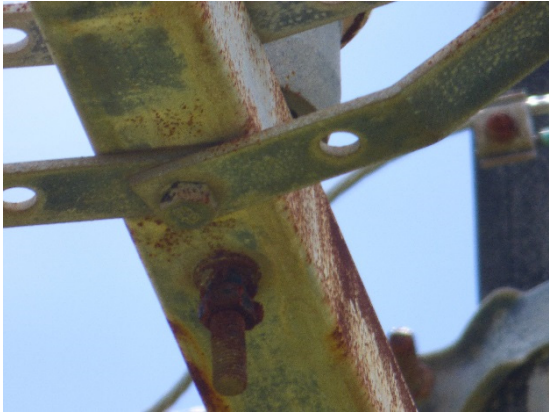
Figure 9-1-5-1.2 Loosening of the nut for the insulator

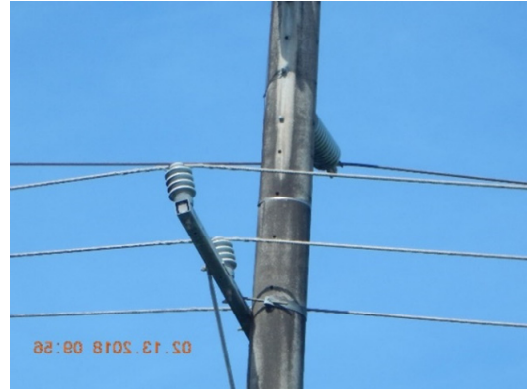
Figure 9-1-5-1.3 Inclination of the arm

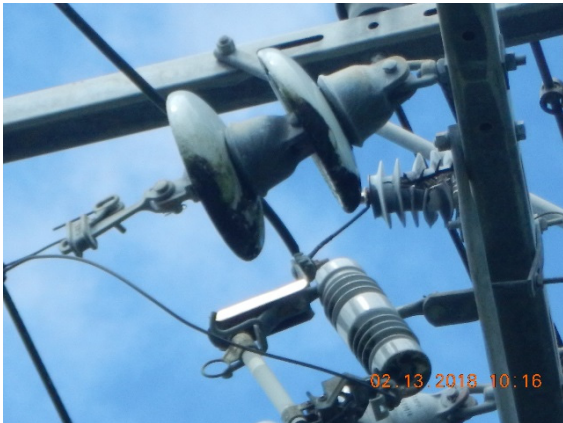
Figure 9-1-5-1.4 Equipment damage (arrester)

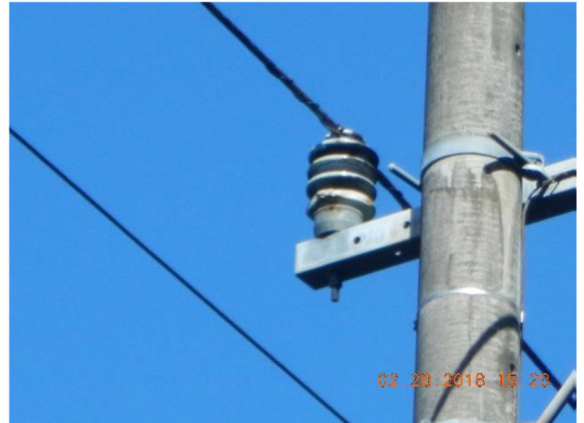
Figure 9-1-5-1.5 Chipped insulation

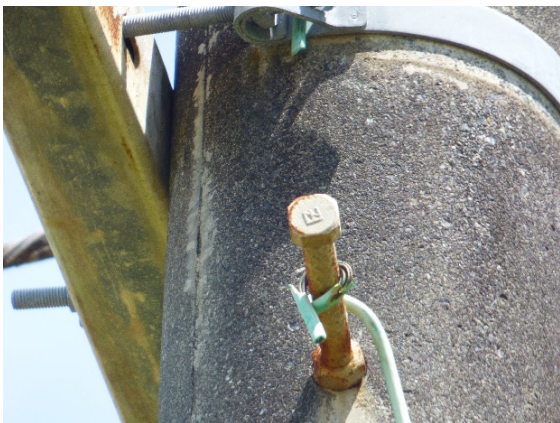
Figure 9-1-5-1.6 Disconnected grounding wire

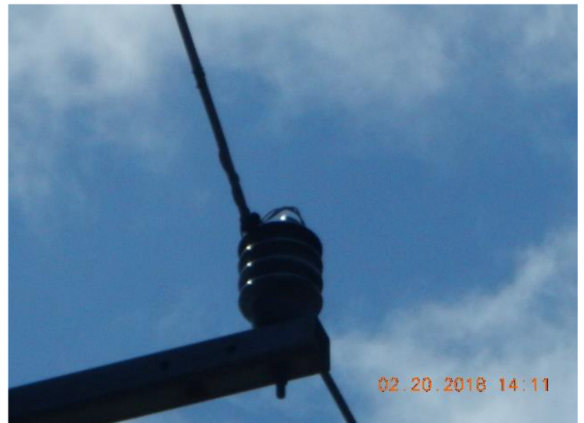
Figure 9-1-5-1.7 Escape from the wire fixing grip

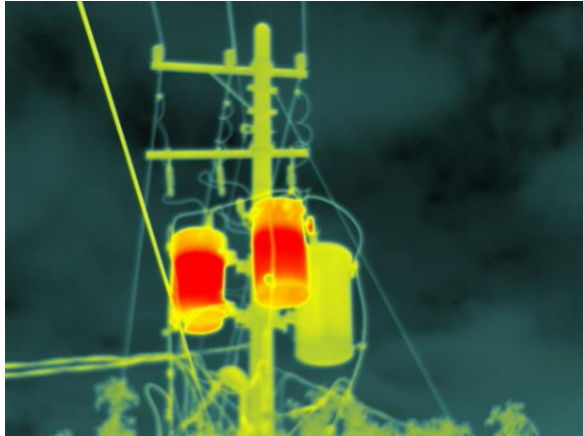
Figure 9-1-5-1.8 Temperature rise of the transformer

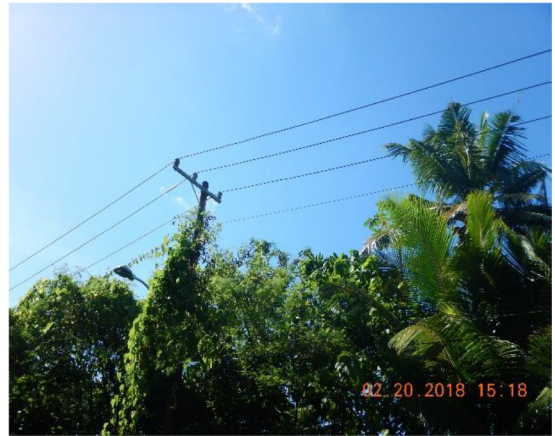
Figure 9-1-5-1.9 Approaching tree growth
