PROPOSED DESIGN MAIN CANAL - Sibalaya

Gumbasa Irrigation Project

Project Preparation Consultant (PPC) Firm for
Development of the Gumbasa Irrigation System
and its Facilities, Palu and Sigi Districts, Central
Sulawesi Province.

January 2021

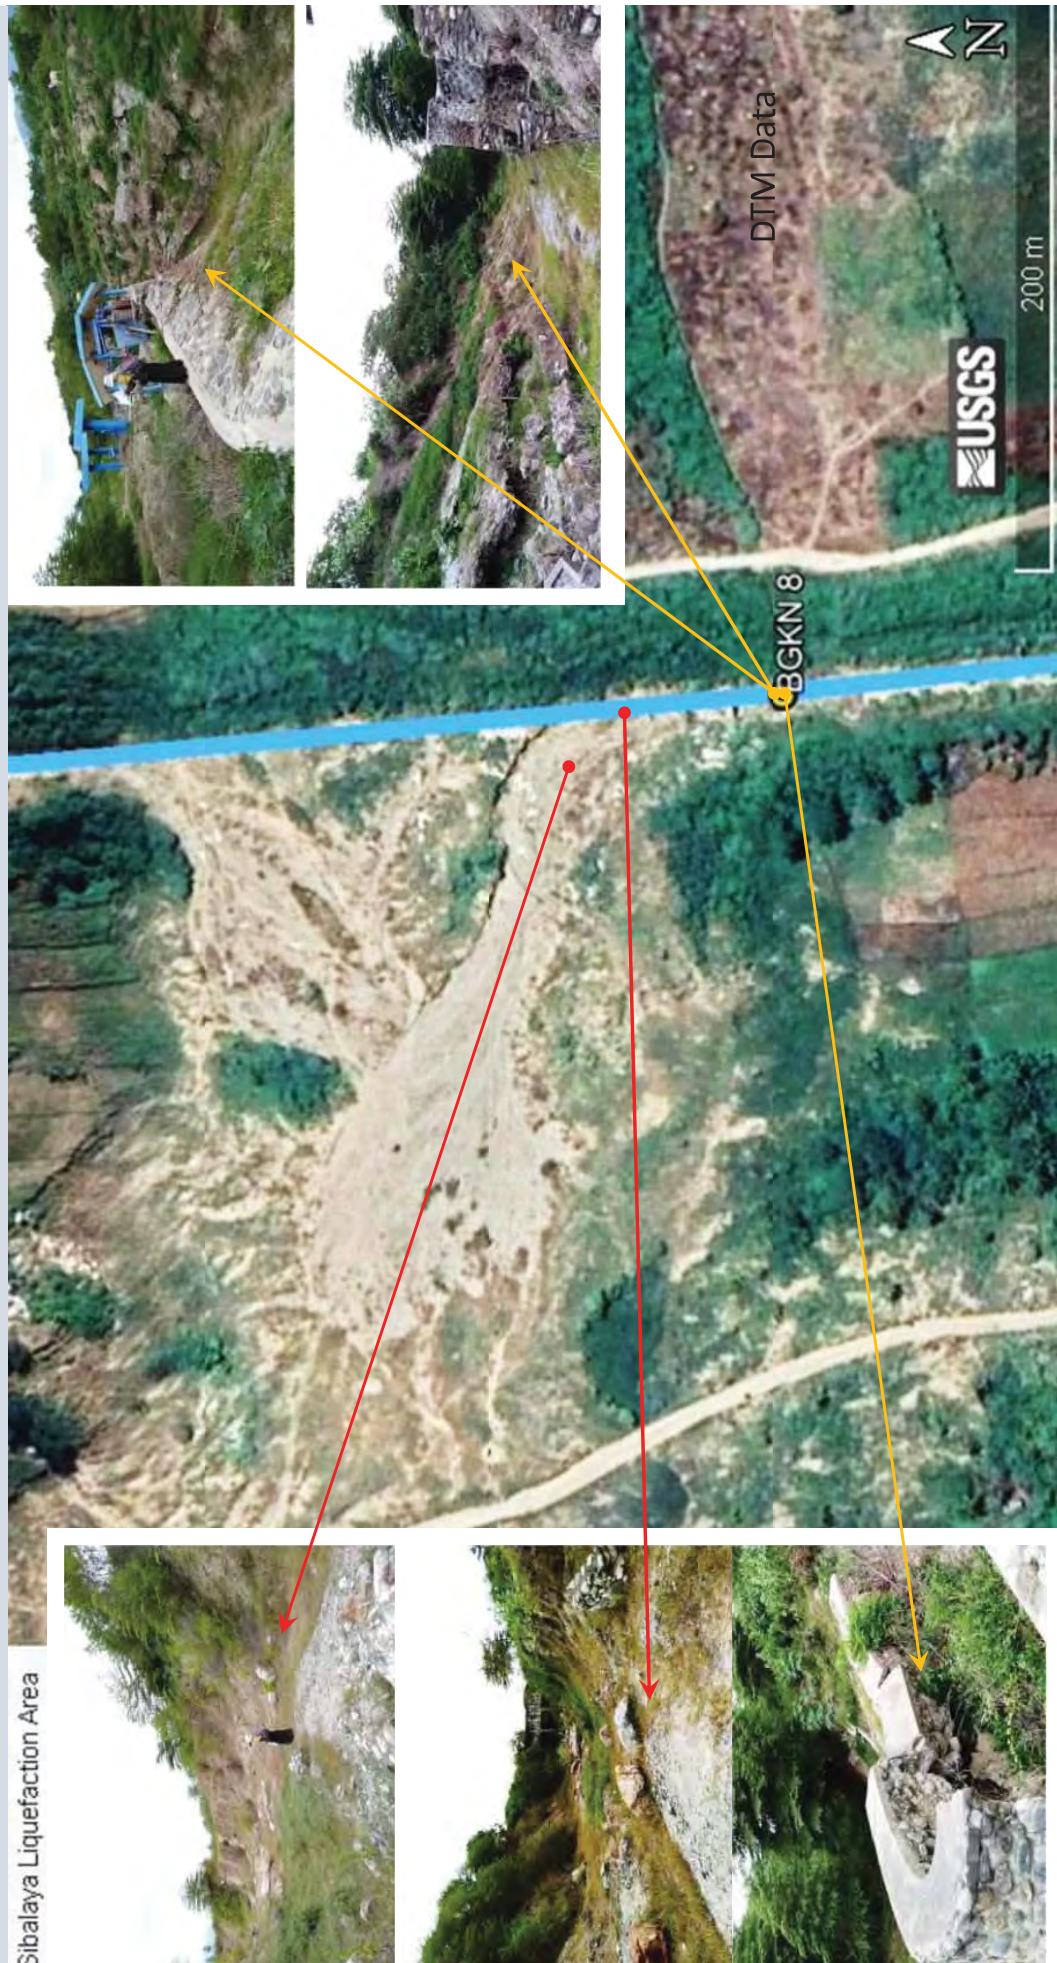
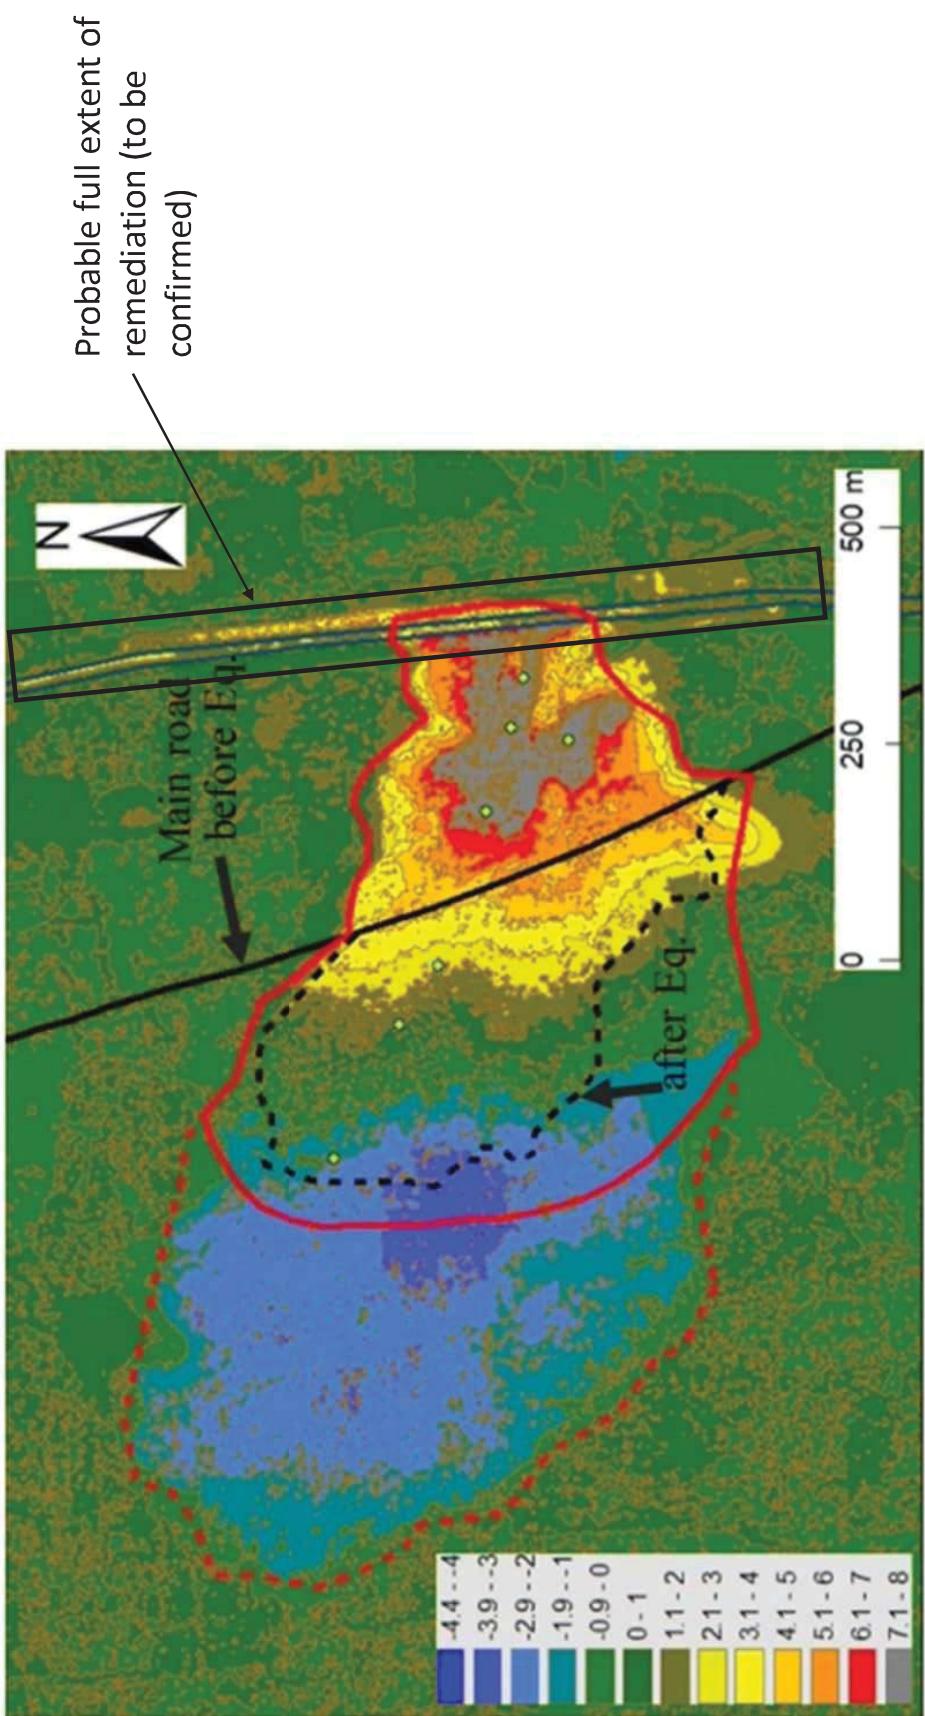
Figure 4: Contours of change in elevation (in metres) at Sibalaya (c)

- The Sibalaya slip is very complex, and appears to have resulted from a catastrophic loss of strength on a 10 m deep or so shear plane, with sudden drop in ground just after shaking finished, and so not straightforward liquefaction alone.
- Canal leakage was likely a factor as was trapped groundwater pressure generated during the event.
- These flows were most likely **only** happening because of long term canal leakage (the one flow site without canal is sat directly at the main strike slip fault and was closest to the epicentre, and so acceleration levels were likely much more intense and it is reported that slope angle was the greatest of all sites, and so if a naturally high water table and right soil condition then flow can be explained for that situation).
- Future earthquakes may well dislodge Blocks A and B, further undermining the canal.

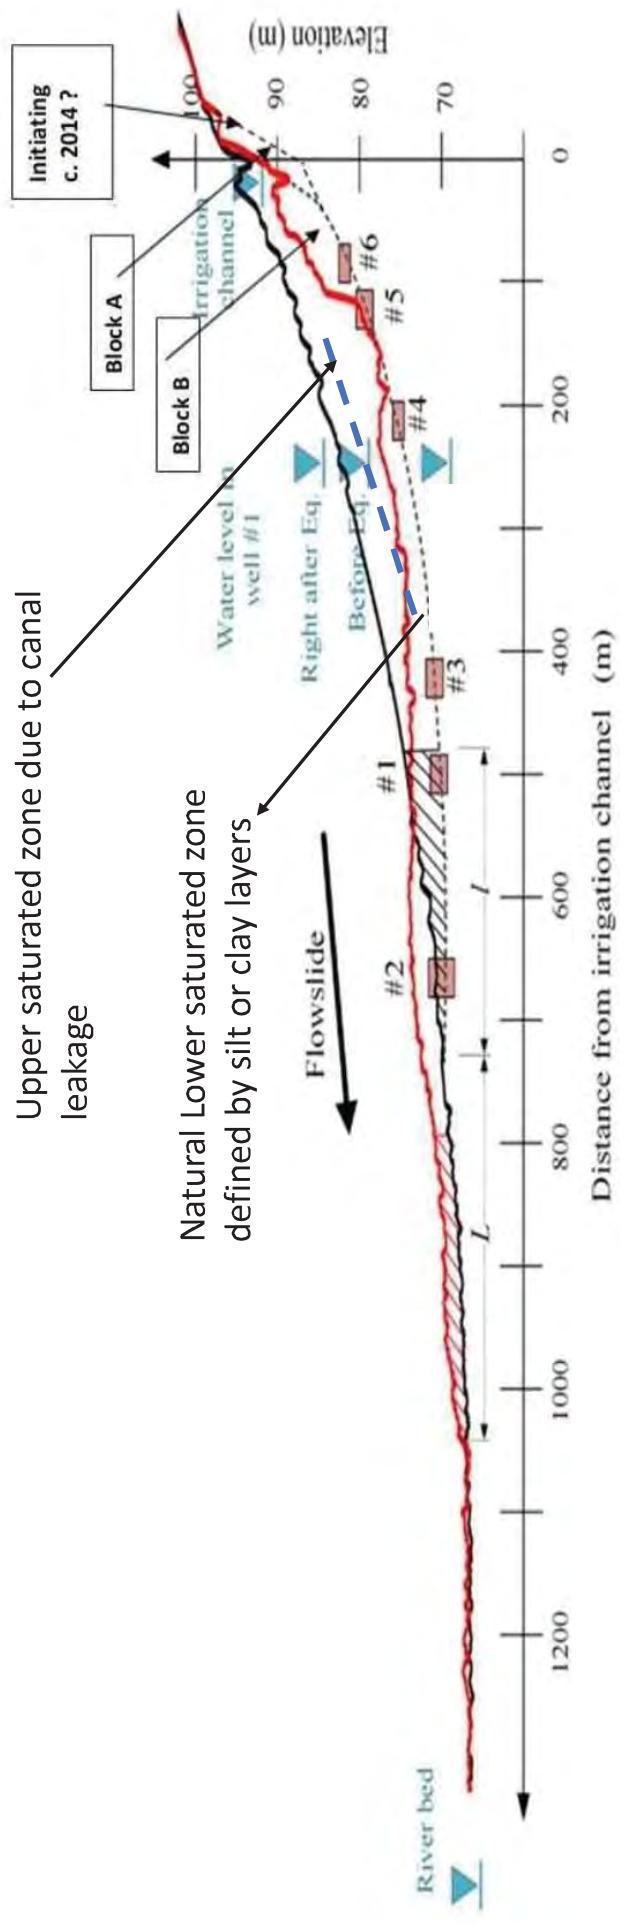
Figure before and after the earthquake together with highly sheared depths detected in trenches (Okamura et al. 2020).

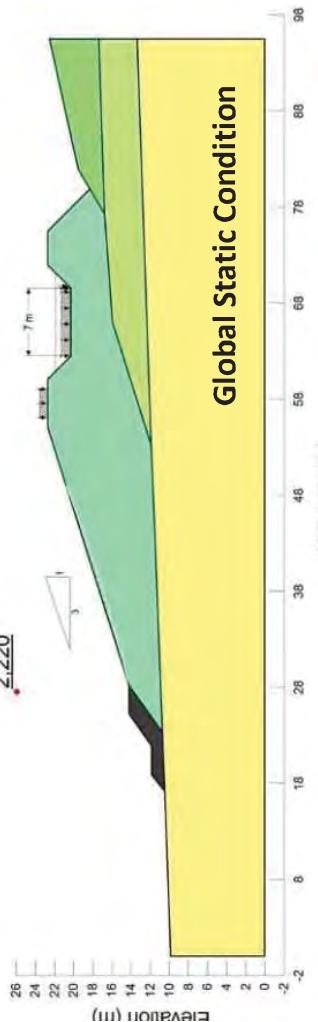
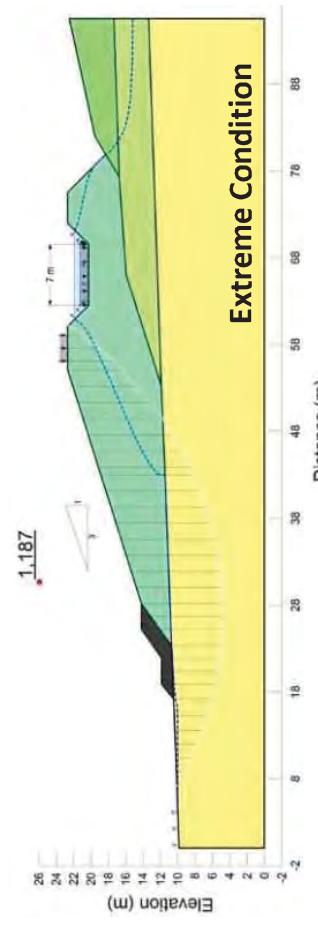
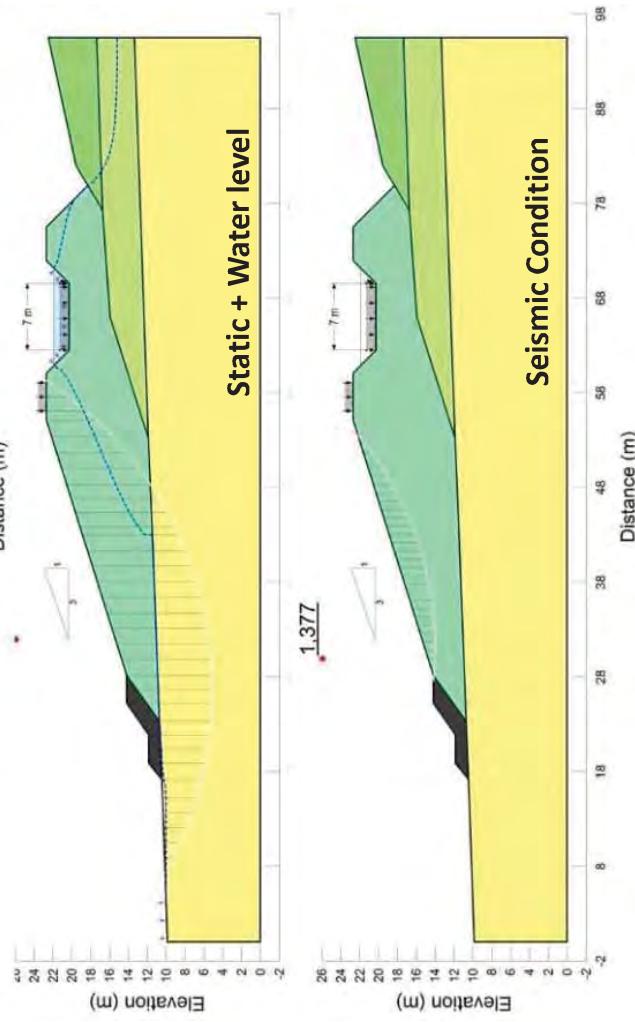
Option One Riprap Reinforced Slope

No.	Slope Angle Variation	Global FS	Note
1.	Static condition	2,220	> 1,5
2.	Static + water level	2,074	> 1,5
3.	Seismic condition	1,377	> 1,1
4.	Extreme seismic + water level	1,187	> 1,1
	FS minimum for seismic		1,1

Note: 1. All FS not satisfied

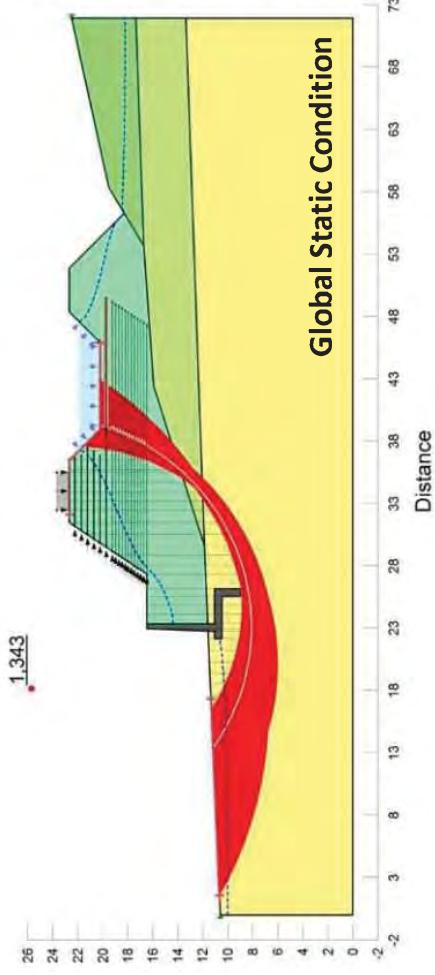
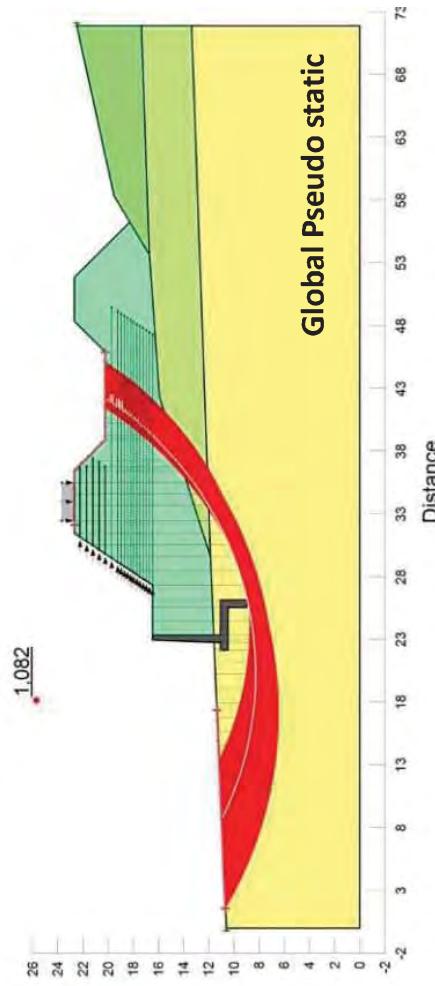
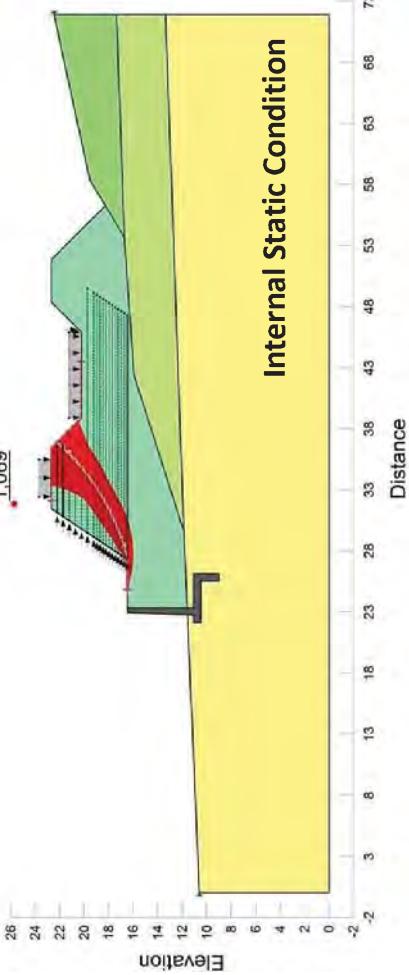
M M OPTION 3 GEOSYNTHETIC with CANTILEVER Reinforced Slope

No.	Slope Angle Variation	Global FS	Note
1.	Static + water level	1,343	< 1,5
2.	Global Seismic condition	1,082	< 1,1
3.	Internal Seismic condition	1,069	< 1,1
	FS minimum for seismic	1,1

Note:
1. All FS not satisfied

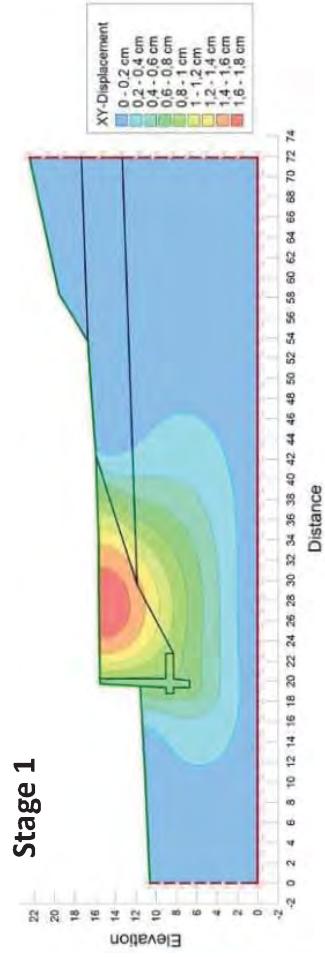
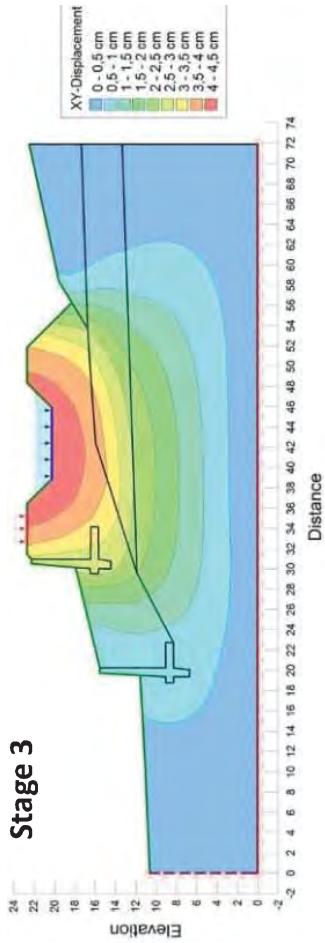
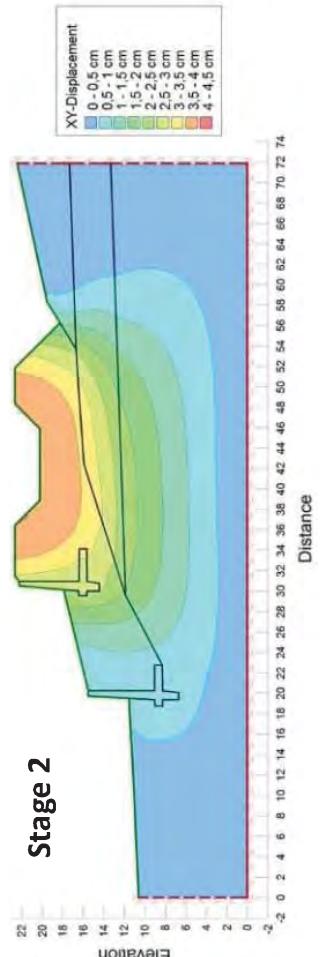
**MOTT
MACDONALD M M GLOBAL STABILITY ANALYSIS—CANTILEVER WALL**

1. Deformation maximum ± 4.5 cm at stage 3 service condition.

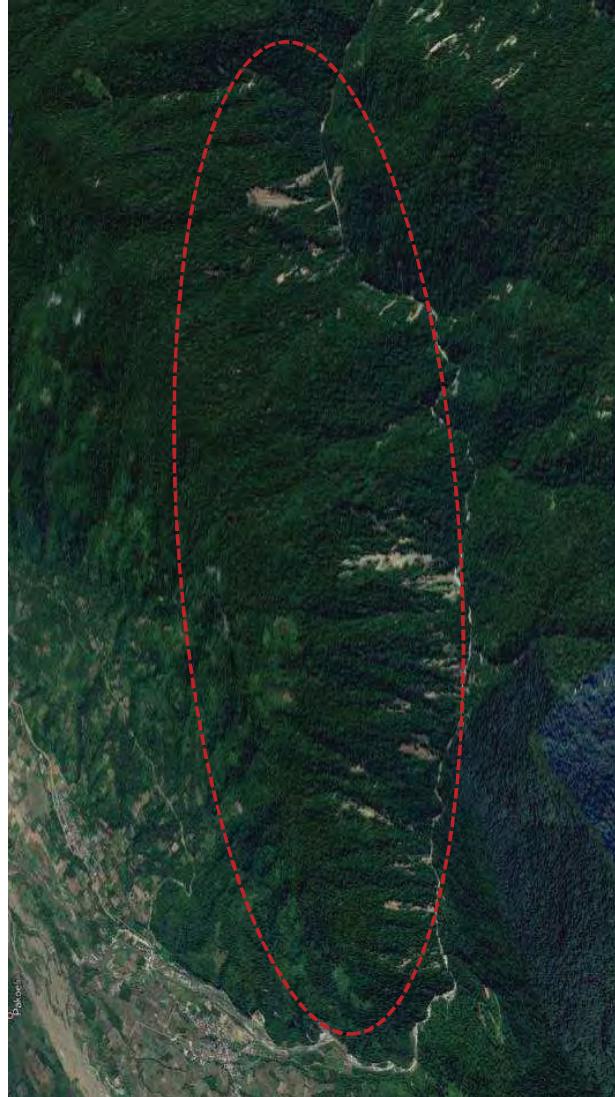
Causes of sediment generation in mountainous areas

The slope collapse on the south slope (right bank side) of the Gumbasa River is remarkable. It is presumed that this collapsed sediment accumulates on the riverbed, and the sediment flows down as a debris flow during a flood.

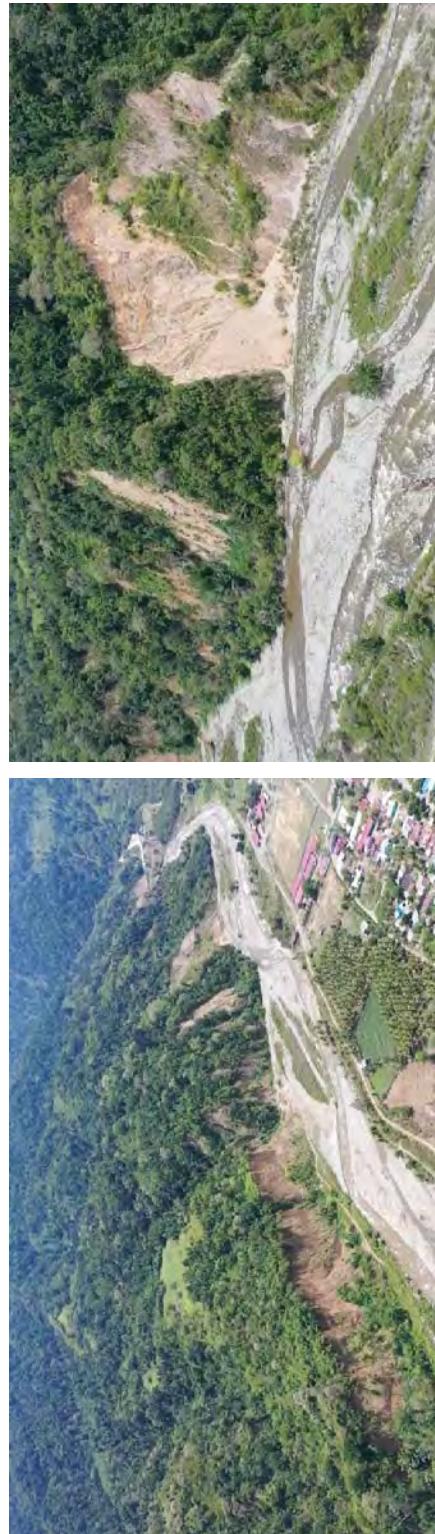
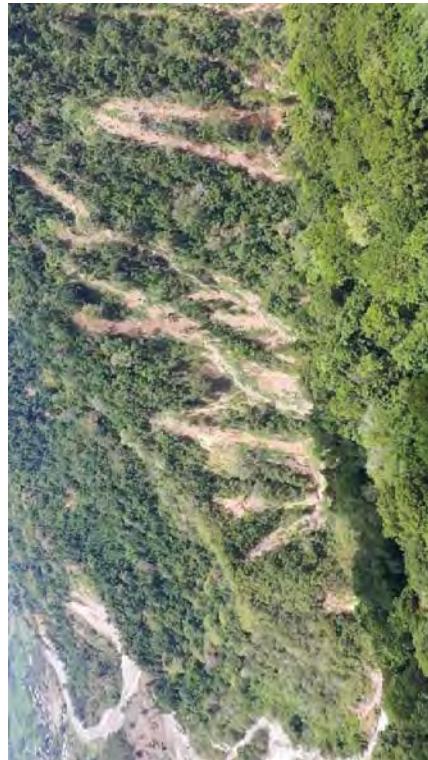
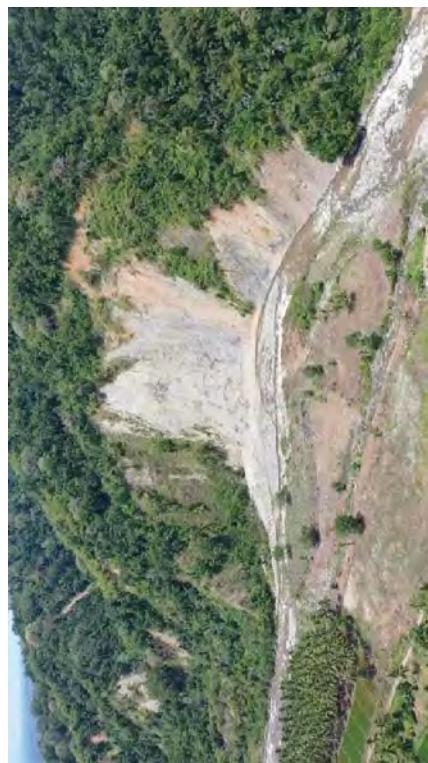
Causes of sediment generation in mountainous areas

The mountainous area upstream of the Gumbasa River is subject to many slope failures. The sediment generated here increases the flow rate of the river and causes the river to meander in the downstream fan areas. This causes scouring of the right bank side and new slope failures. The potential for sediment runoff is very high.

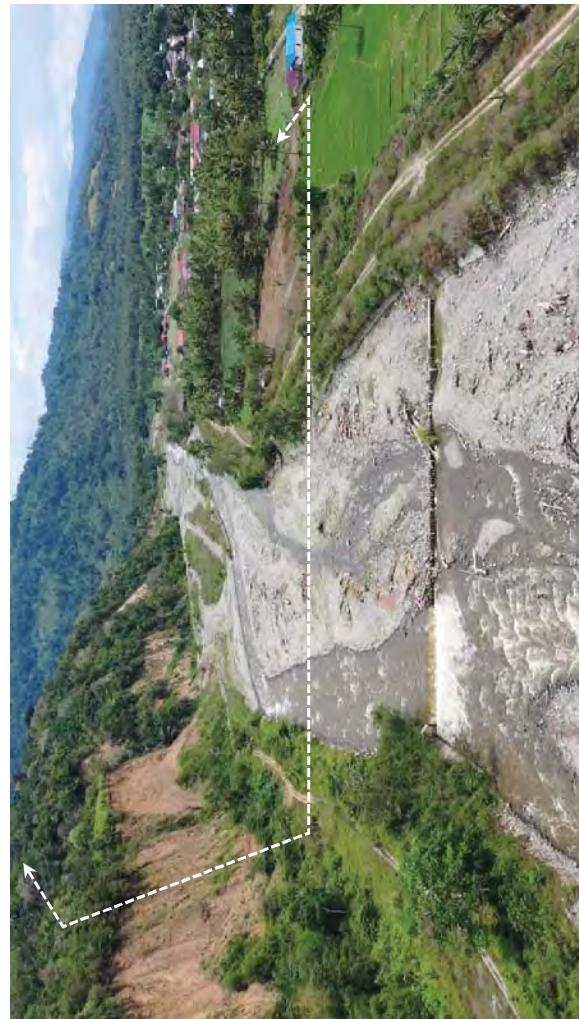
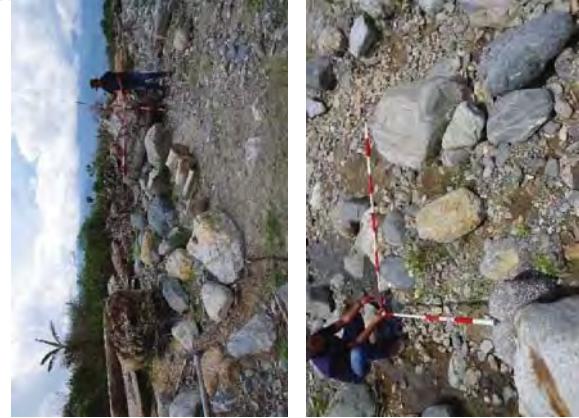
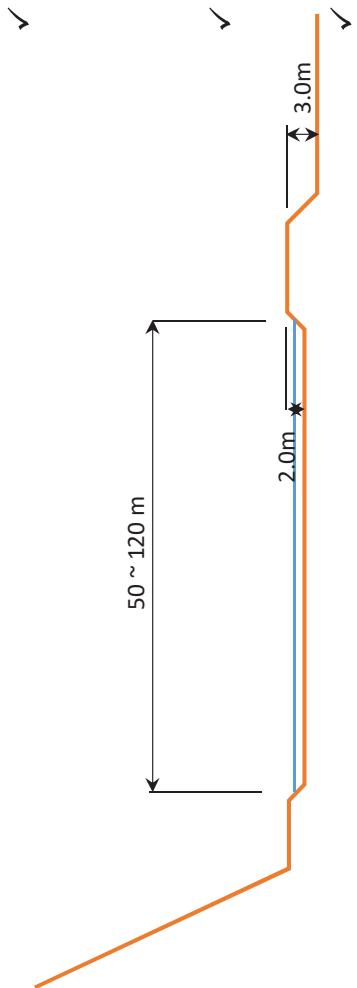
Causes of sediment generation in mountainous areas

- ✓ The riverbed has been rising since the earthquake. The height of the river bed is already the same as the height of the land inside the bank, or the river bed is higher.
- ✓ The material of the riverbed has an average grain size of about 50 cm. The maximum grain size is 1.0m. There is also a lot of driftwood, with a maximum diameter of 1.0 m and a maximum length of 10 m.

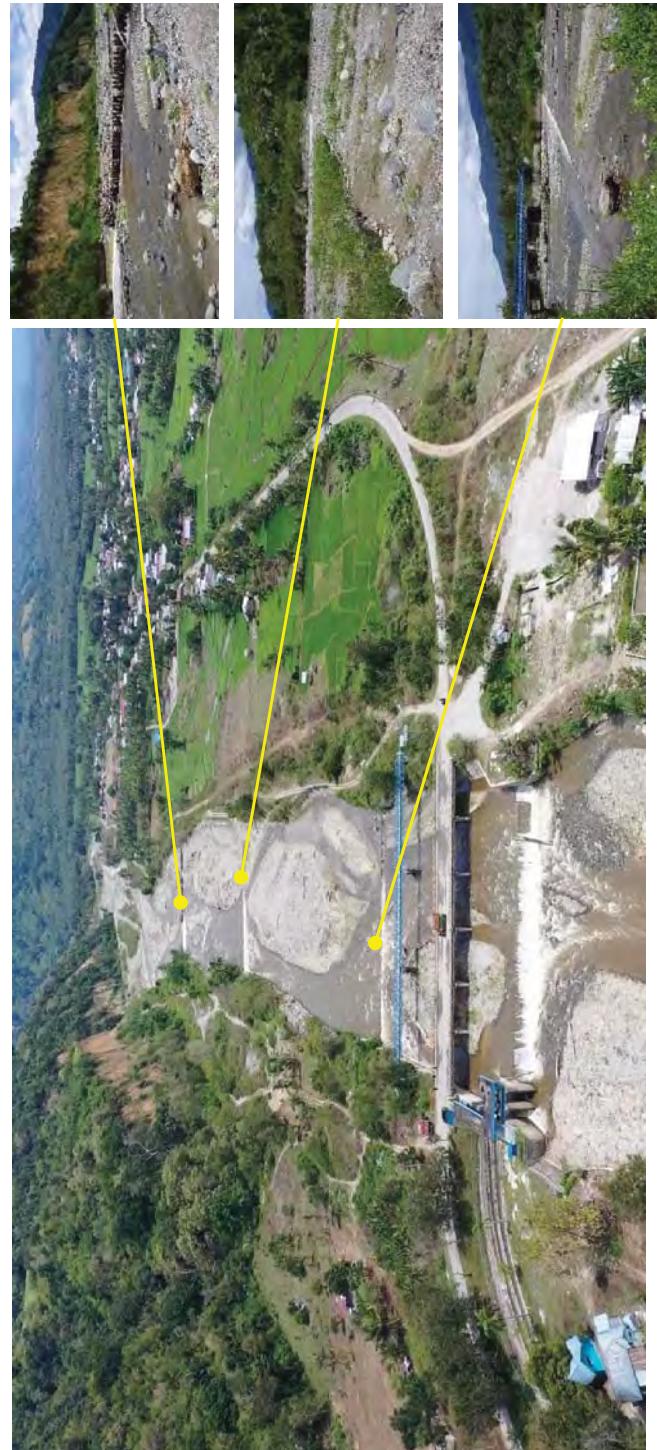
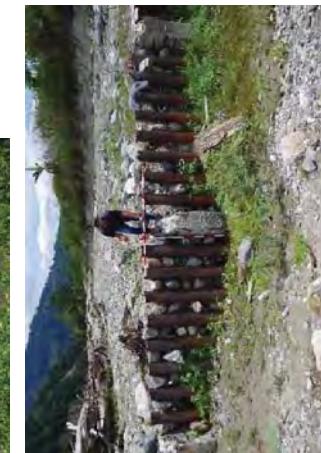
Causes of sediment generation in mountainous areas

Three bed consolidation works have been installed upstream of the Gumbasa irrigation facility to control the rapid runoff of sediment. The structure is in the form of piles of 20cm steel tube omission, and only the sediment is supplemented and the flowing water is allowed to pass through. The structure is aging and is severely damaged.
