3.3.8 Madiwela South Diversion

3.3.9 Bolgoda Canal

Appendix-3

Baseline Environmental and Social Conditions of Project Area
(Mudun Ela Drainage Improvement Project)

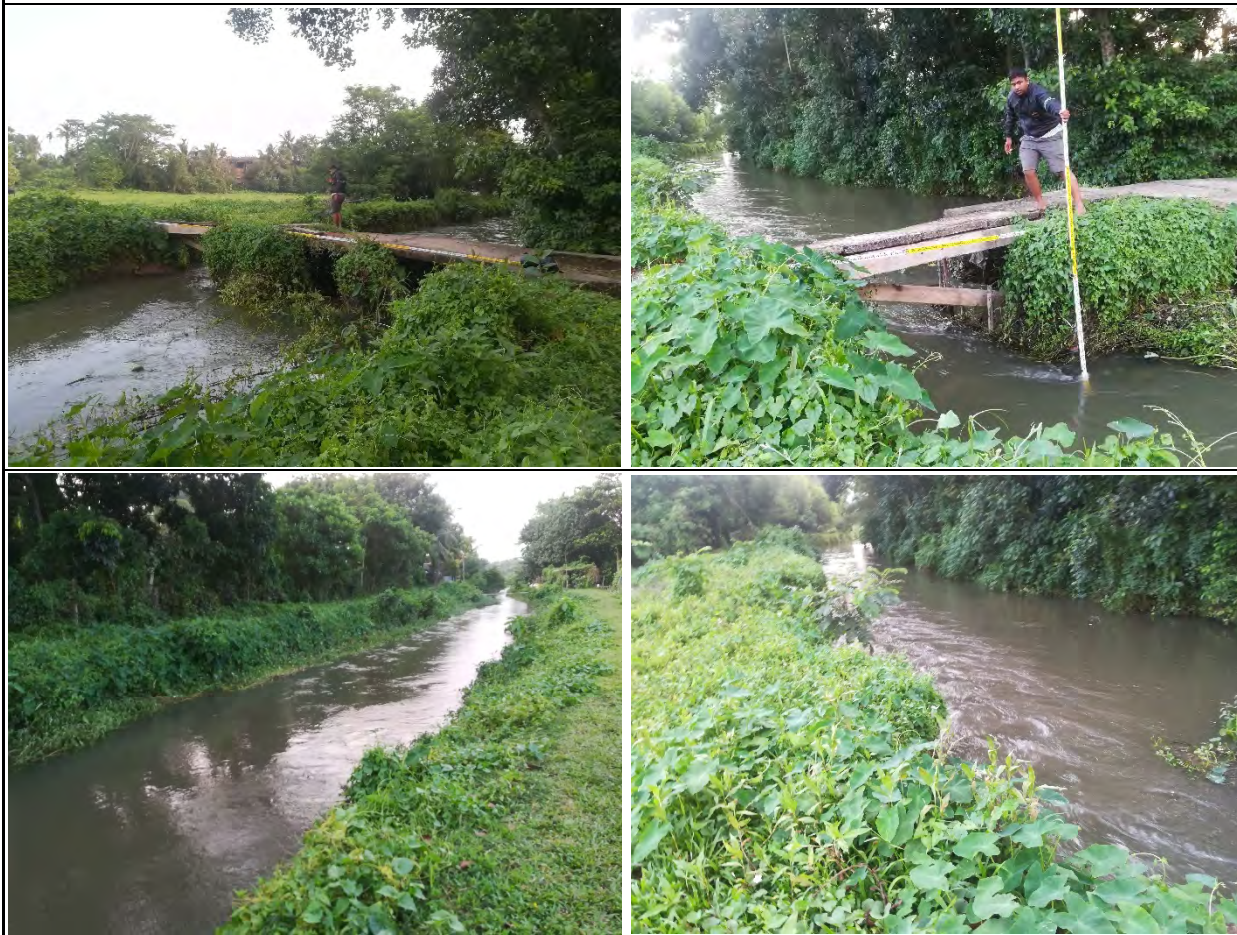
SITE CONDITION

ID: MSD-2	JICA 2003 M/P	SLDLC 2017	2018 F/S
	Anicut at 5+151		
COORDINATE	E		N
	79.918777		6.823825
PURPOSE	Anicut		
OPERATION	broken

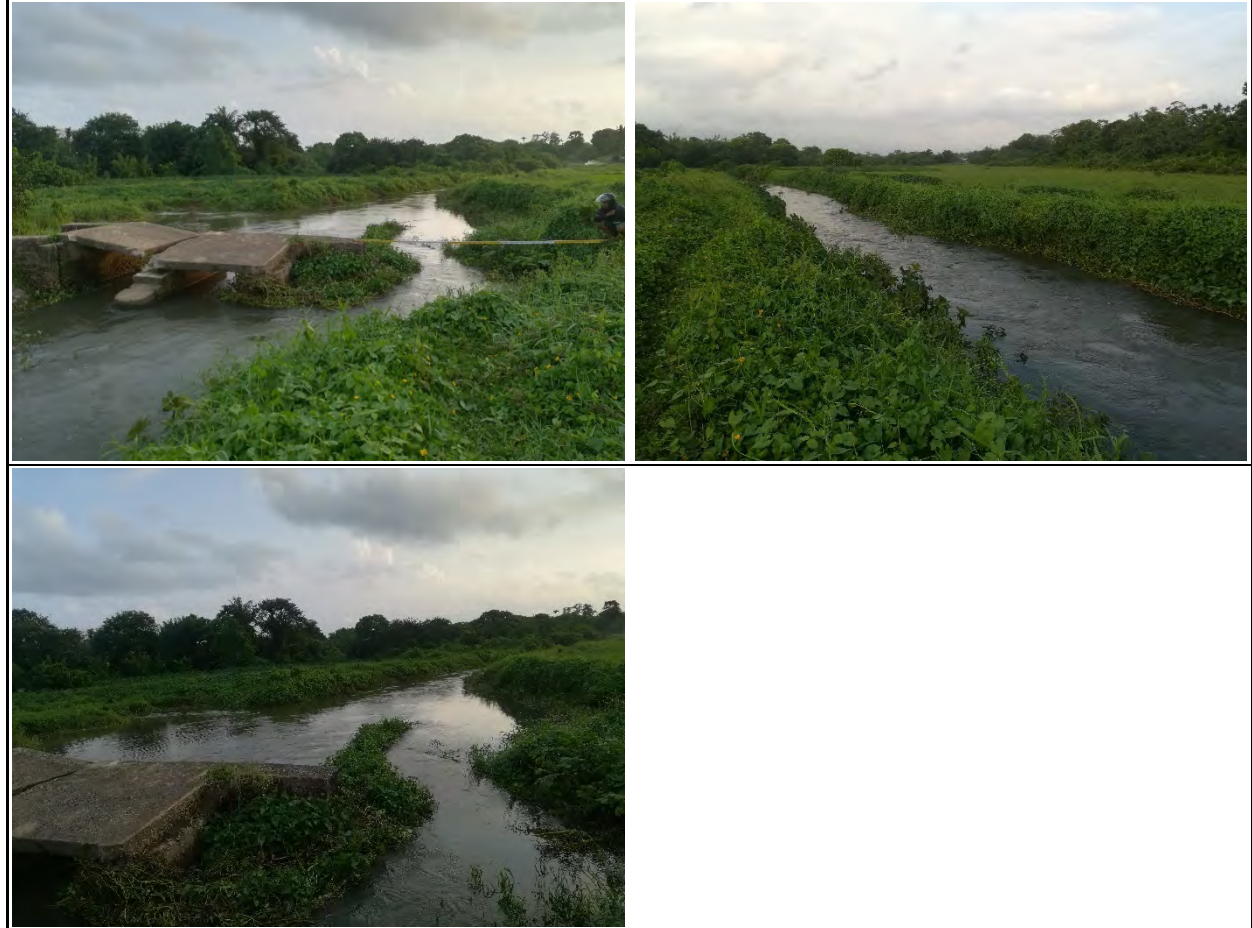
SITE CONDITION

ID: MSD-3	JICA 2003 M/P	SLDC 2017	2018 F/S
	Anicut at 4+739		
COORDINATE	E		N
	79.921356		6.826121
PURPOSE	Anicut		
OPERATION	broken		
DRAWING			
<p style="text-align: center;">(Source: JICA 2003 M/P Report)</p>

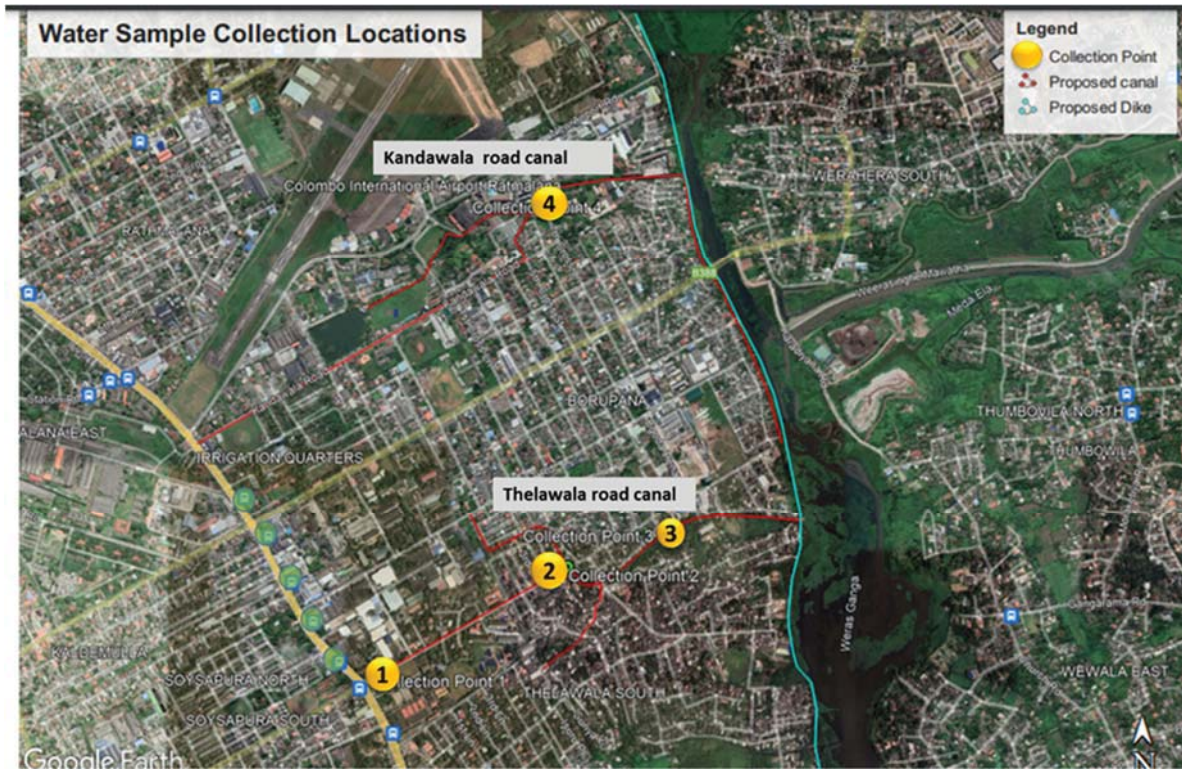
Figure 1-7: Densely populated urban watershed of Telawala and Kandawala drainage area. Indicated are water sampling locations for visual observations used for water quality impairment assessment.

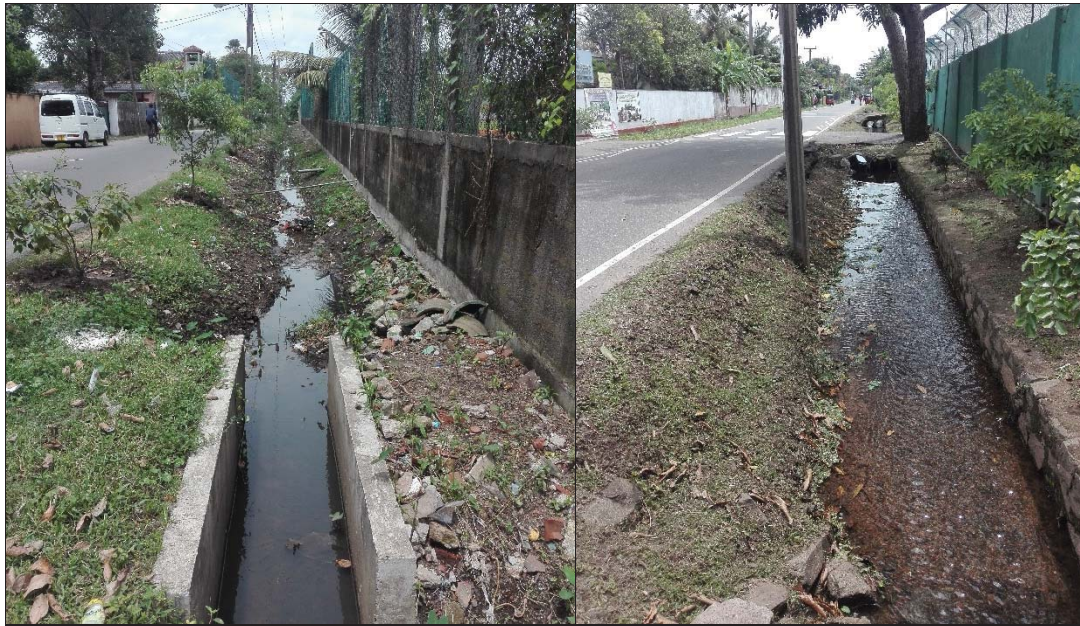
Figure 1-11: Kandawala road canal near Galle Road (L): -Fish were observed in the water (R) Kandawala road canal near Kothawala Defense University. Clear water, no bottom sediments, fish were observed suggesting relatively low pollution load in this canal section

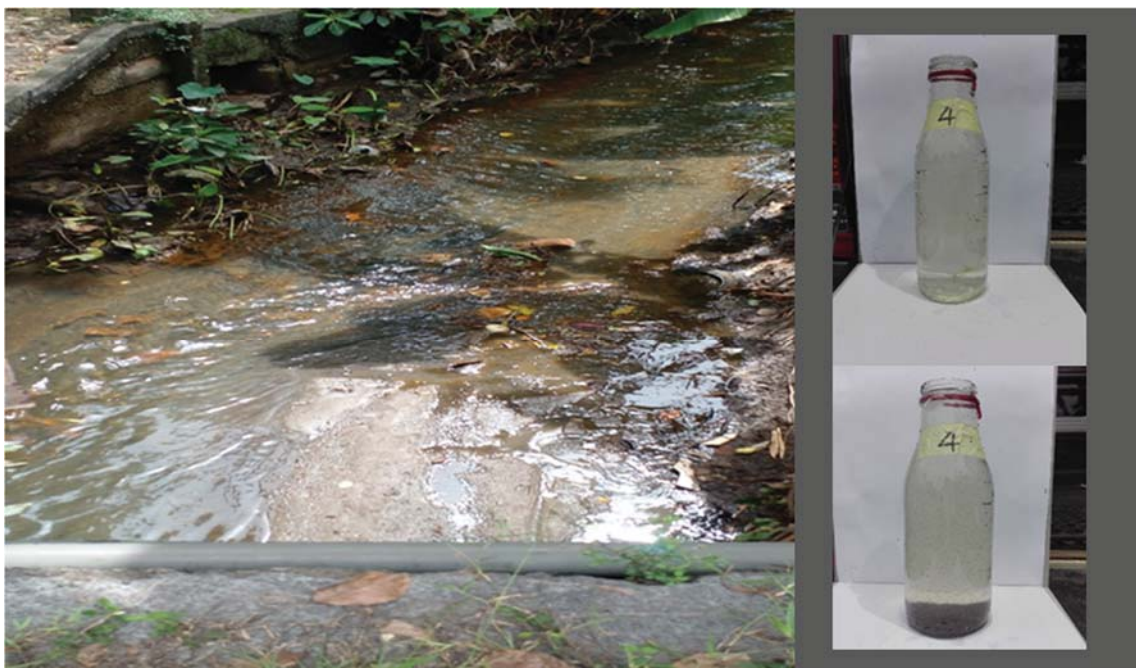
Figure 1-12: Location 4: Kandawala Road Canal

Further downstream: murky waters, slicks of oil, dark bottom sediments, growth of microbial slimes indicating water quality impairment; Sample of water collected from the canal with soft black surface sediment suggesting water quality impairment
