斜面カルテによる調査結果

Code no.	N	1	5	-	1						
Region Office	Abbottabad										
Maintenance Unit	Balakot

Evaluation sheet (Slope failure/Rockfall)

Coordinates	Latitude				N 34°27' 49.7"						
	Longitude				E 73°19' 58.3"						
Road name	N	1	5		Km	2	8	+	4	0	0

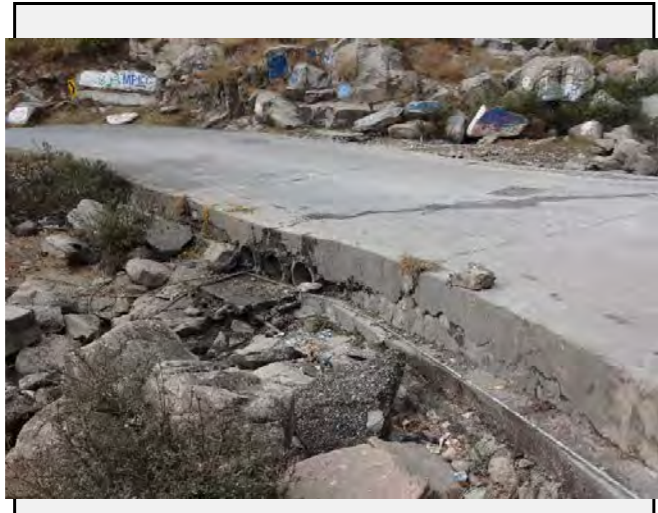
Road condition: The causeway is installed crossing the stream.

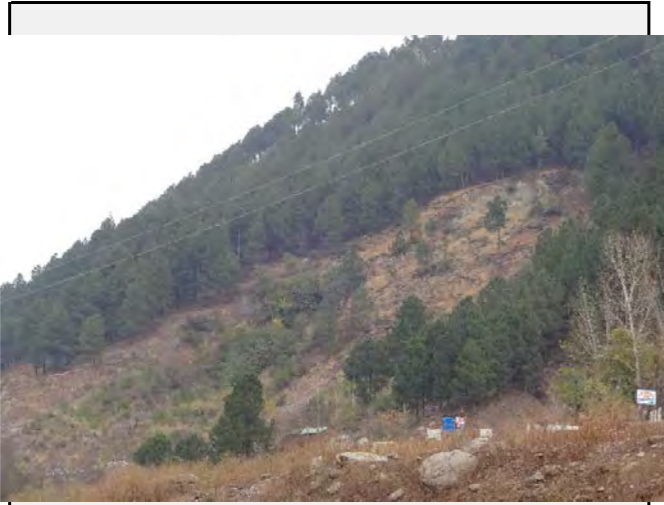
Mountain side: Scarp can be observed on the upper part of the slope. The slope is covered by tree and bushes.

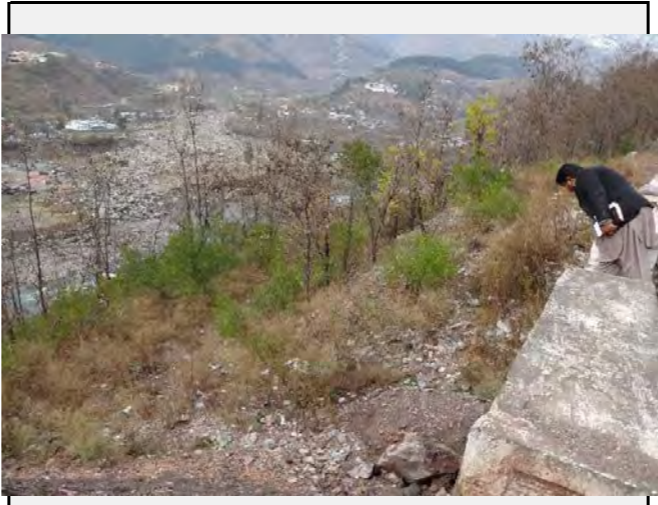
Valley side: The valley is covered by tree and bushes.

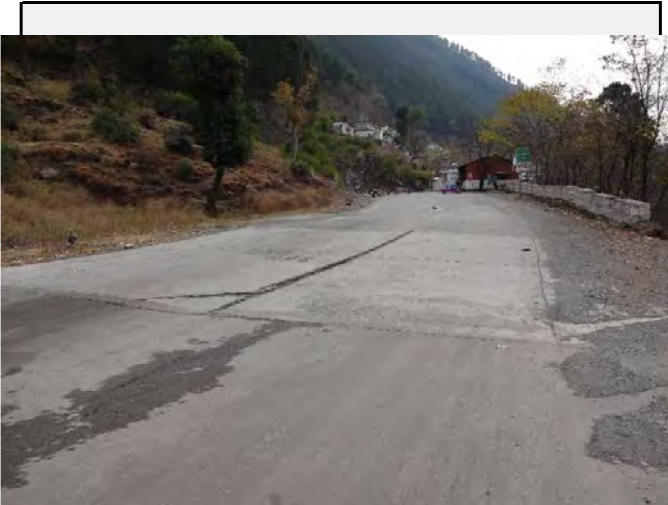
Road condition: Partial of the road were replaced due to subsidence.

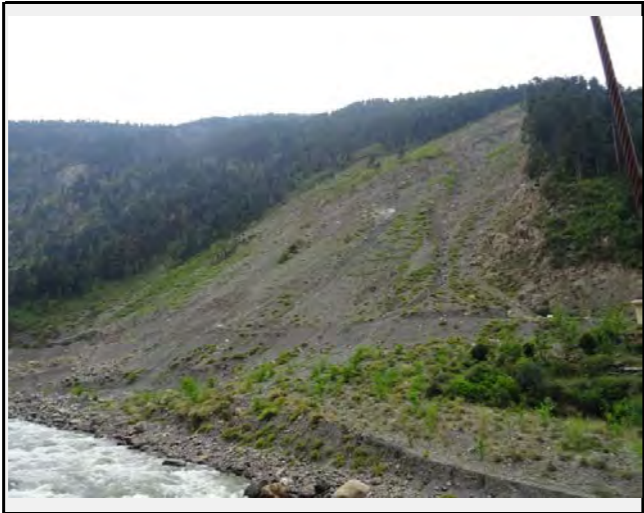
Overall view of the slope from the opposite site of the river. Talus deposited on whole surface of the slope failure area.

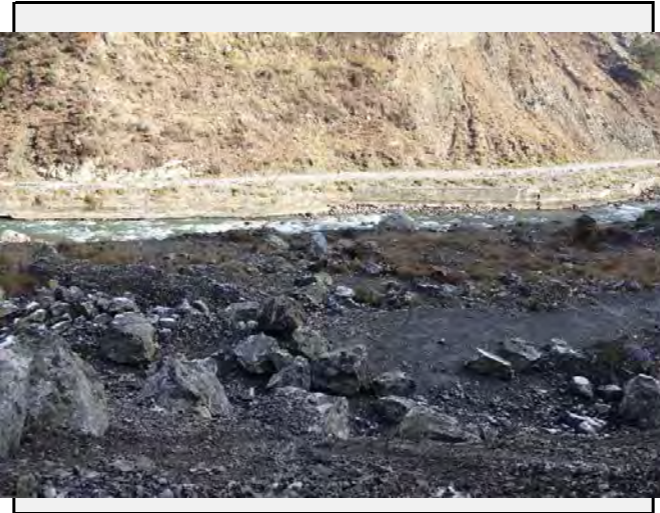
Valley side: Talus deposits can be observed on the valley side of the slope.

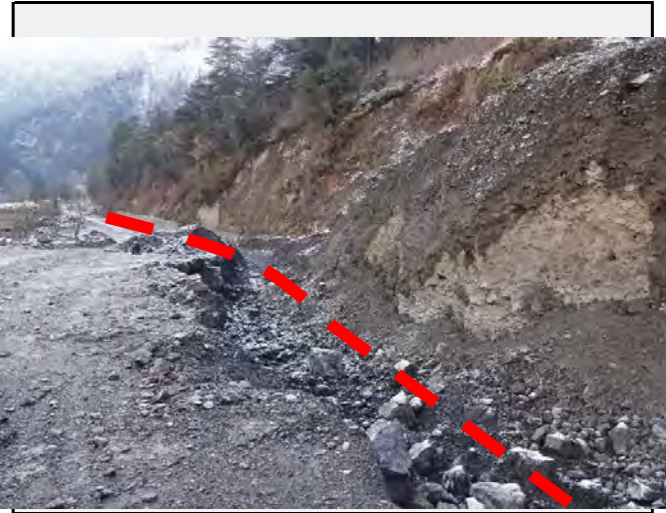
Road condition: Existing road is still buried 5m under the talus deposits.

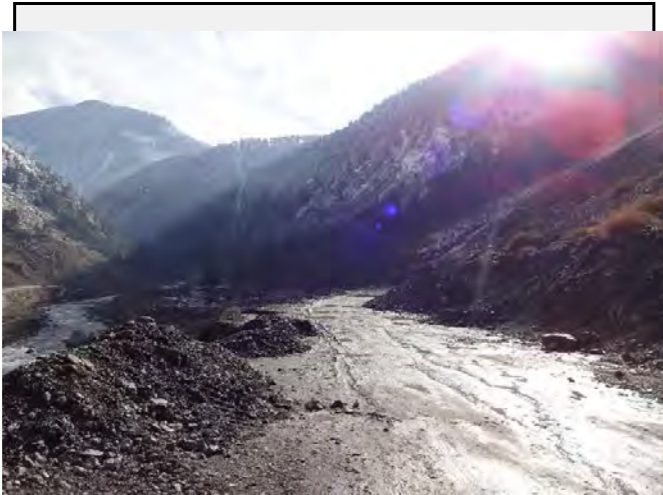
Existing countermeasures: Temporary access road used for the long-sized truck which cannot pass the road alignment on the bypass road.

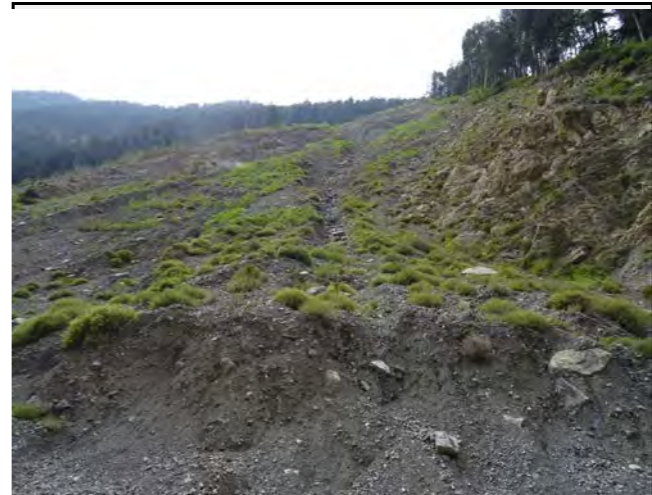
Mountain side: Talus deposits can be observed throughout the slope.

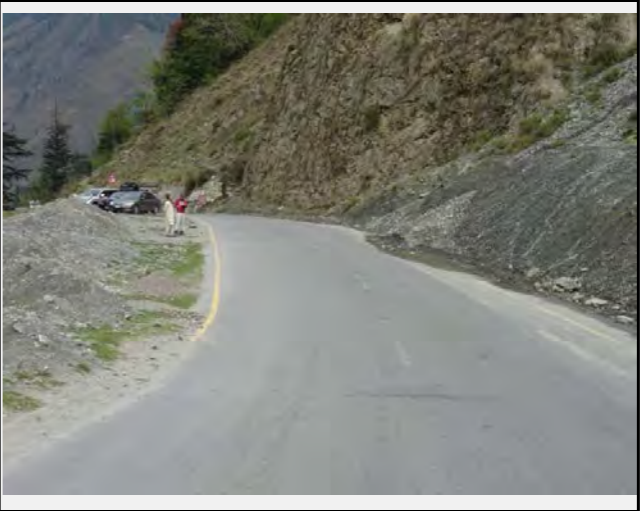
Road condition: road ditch is covered by debris

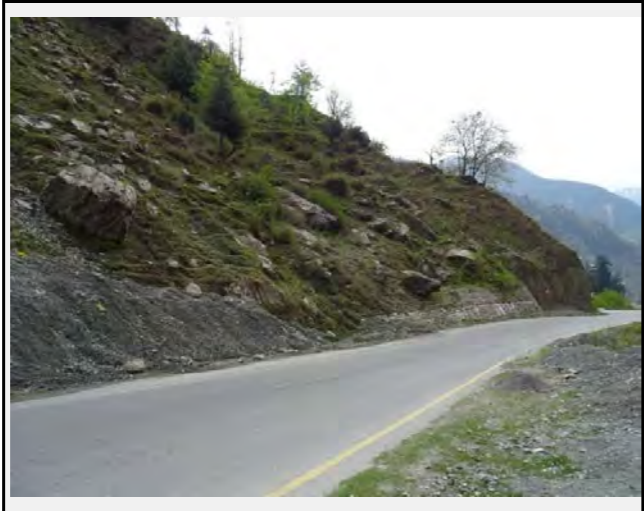
Existing countermeasures: Retaining walls are constructed partially on the mountain side. They are partially damaged by the slide

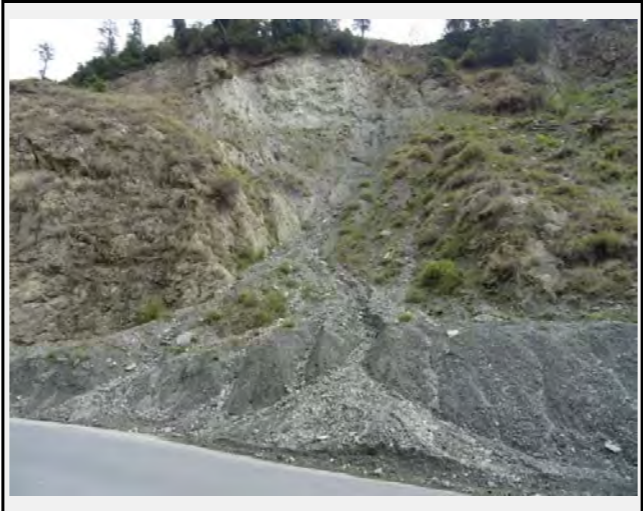
Part of the slope is highly eroded and shows multiple gullies

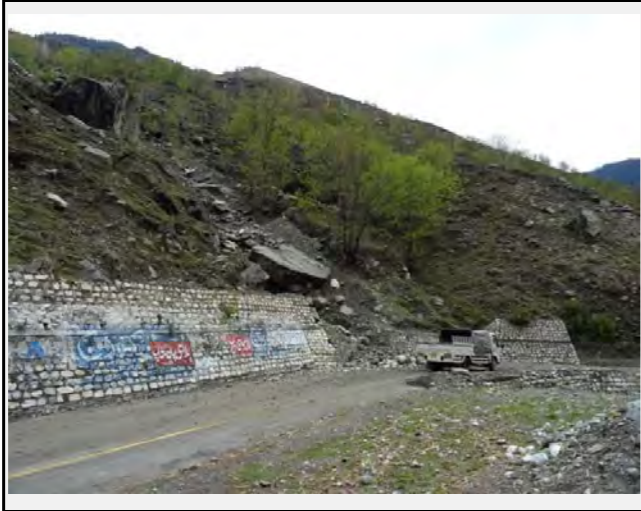
Mountain side: Big boulders (2~5m) can be observed at the exit of the stream on the mountain side.

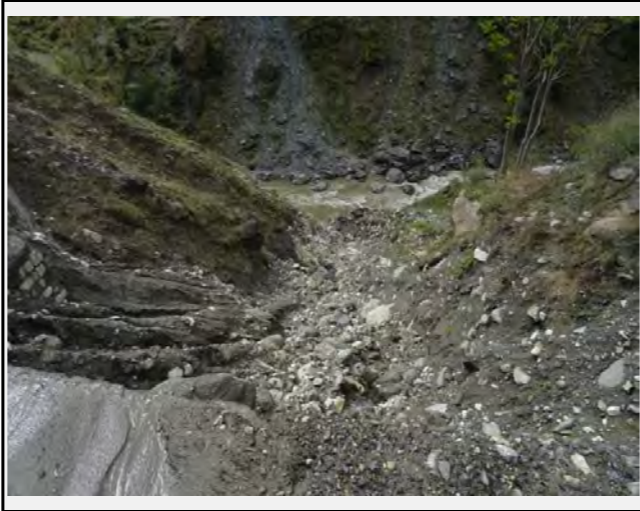
Valley side: The starting point of the stream on the valley side are narrow. Boulders can be observed on the valley side.

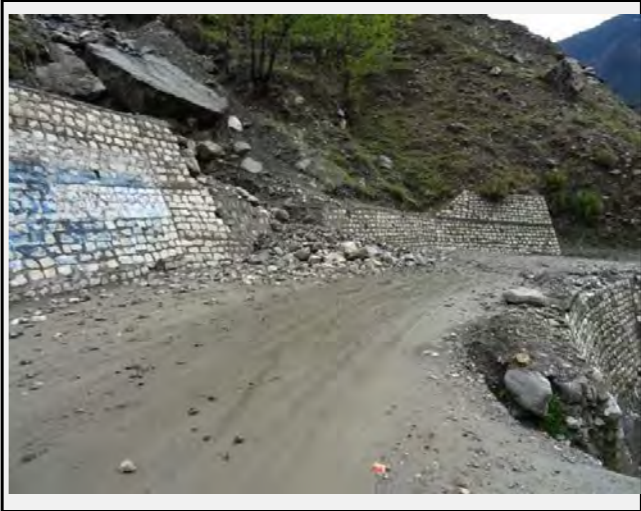
Road condition: there is mud and debris on the road and the road surface is damaged considerably

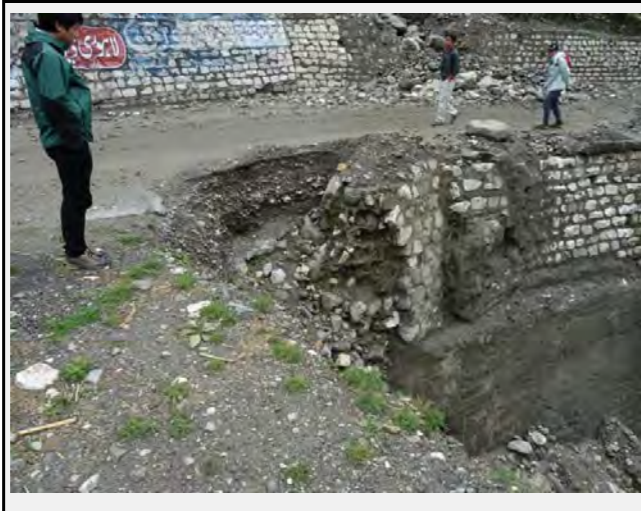
Existing countermeasures / anomalies: small damage (2m) of the retaining wall on the shoulder of the road (valley side) due to the debris flow.

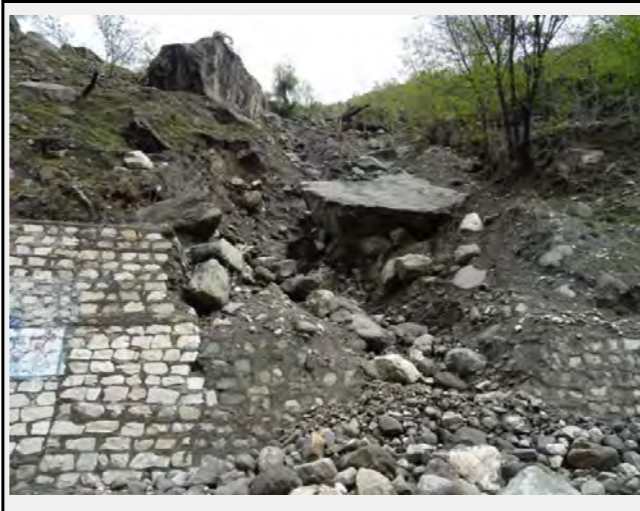
Existing countermeasures / anomalies: The exit of the retaining wall on the mountain side was re-shaped to allow the debris flow. However, this is resulting a steeper angle of the stream. The thickness of the sediment in the stream bed is around 2m

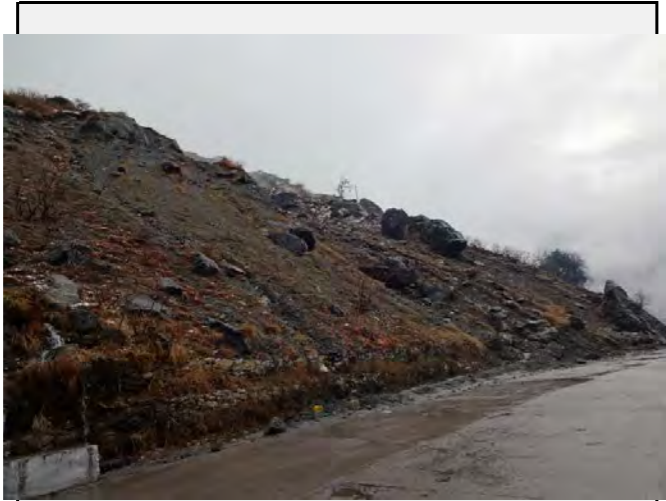
Mountain side: Talus deposit, boulders and outcrop can be observed on mountain side.

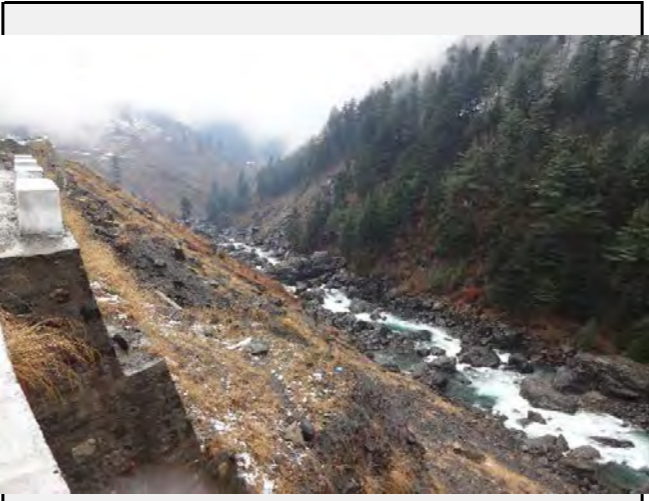
Valley side: Mostly talus deposit can be observed in the valley side.

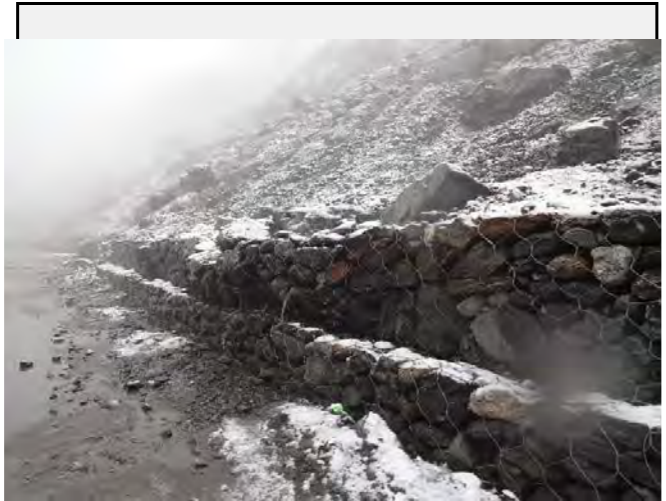
Existing countermeasures / anomalies: Several damages on the gabions was confirmed due to overload of the deposit.

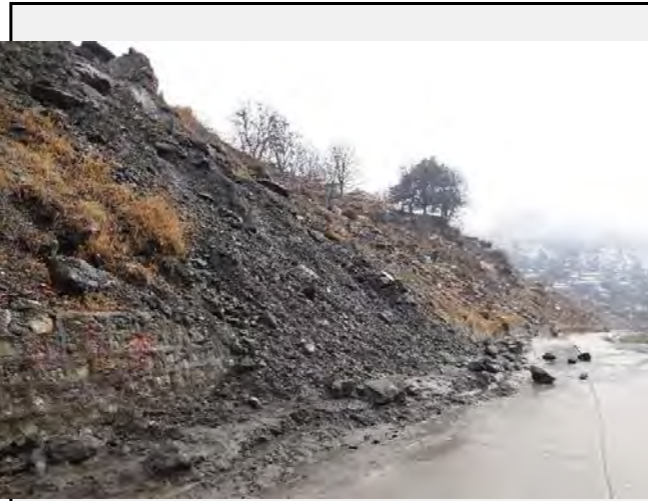
Existing countermeasures / anomalies: The slope failure is causing rocks on the road.

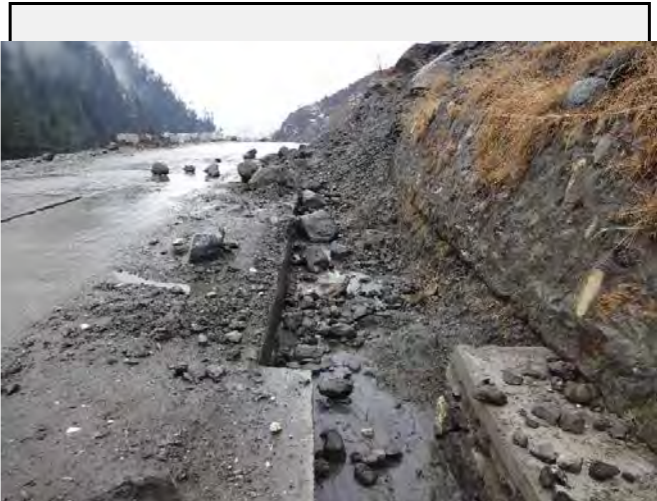
Existing countermeasures / anomalies: Some part of the water canal are filled with the debris.

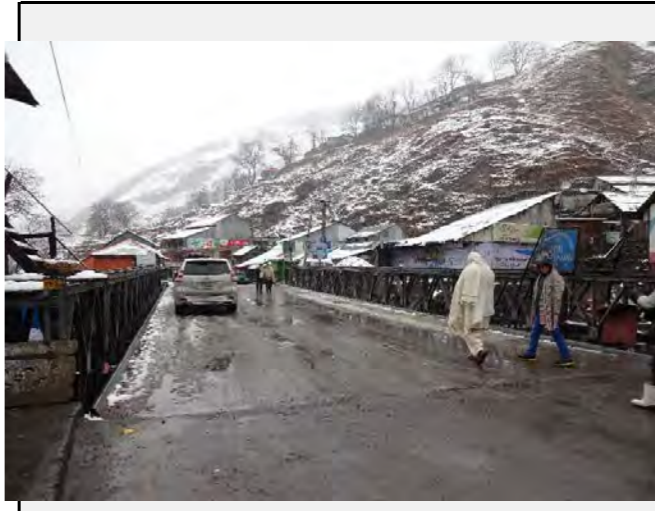
Road condition: No anomalies was confirmed on the road (bailey bridge)

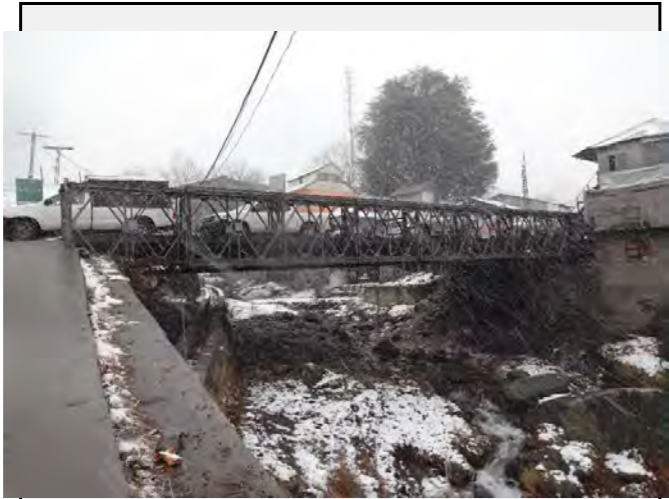
Existing countermeasures: The height of the bridge from the stream bed seems have enough capacity for debris flows at present.

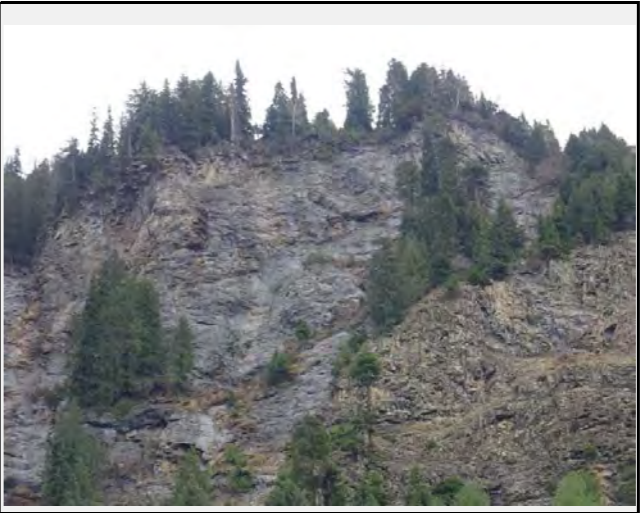
The vertical rock wall that produces the falls seems to have significant fractures

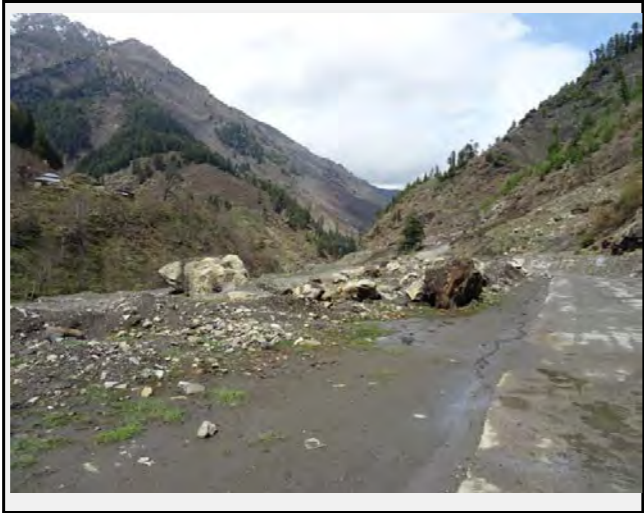
There is evidence of rock falls in the past that have been pushed to the valley side to clear the road

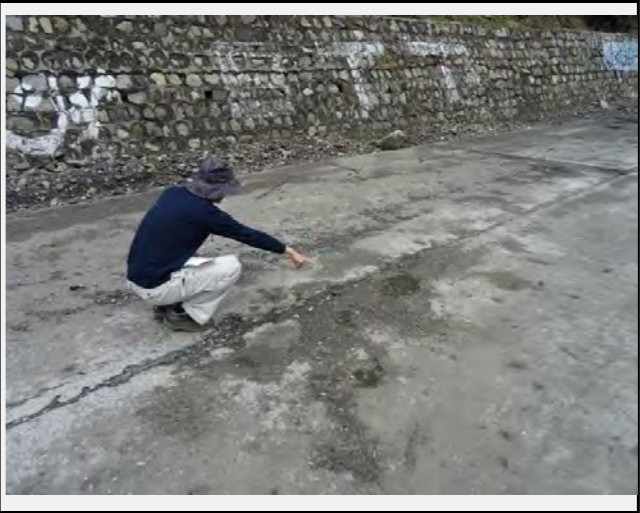
The rock falls cause damage on the road bed forming pot holes

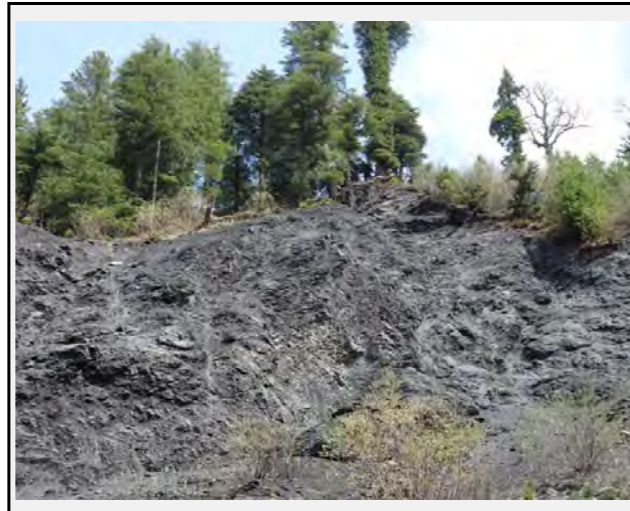
Outcrops of the base rock can be identified throughout the slope. The outcrops are highly weathered and fractured.

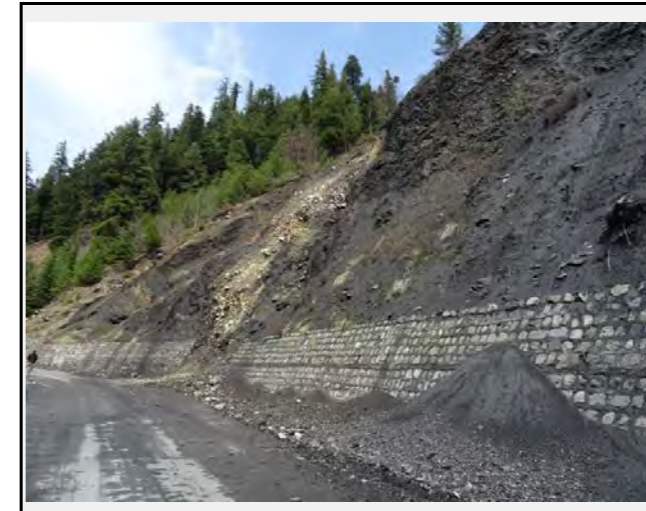
In some sections the retaining wall is damaged and the debris reach the road directly.

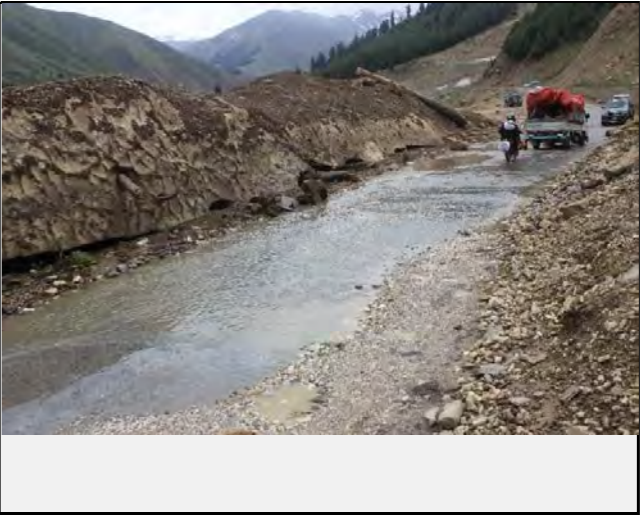
View of Glacier on the left flank of the Landslide

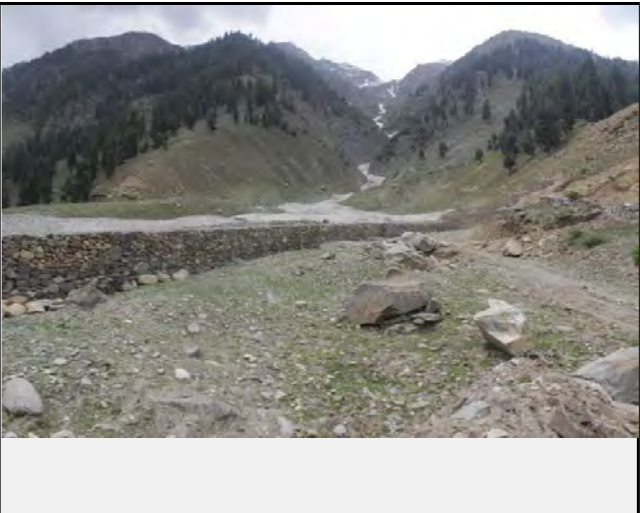
Existing countermeasures / anomalies: Gabion wall has been constructed along the Debris Flow

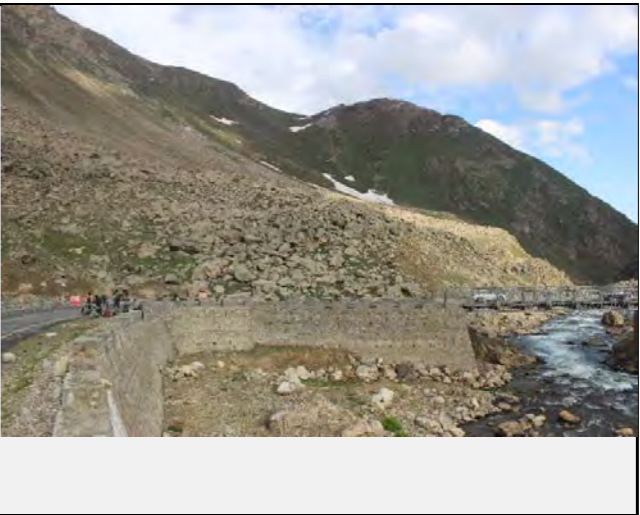
View of the toe of Landslide cut by the stream

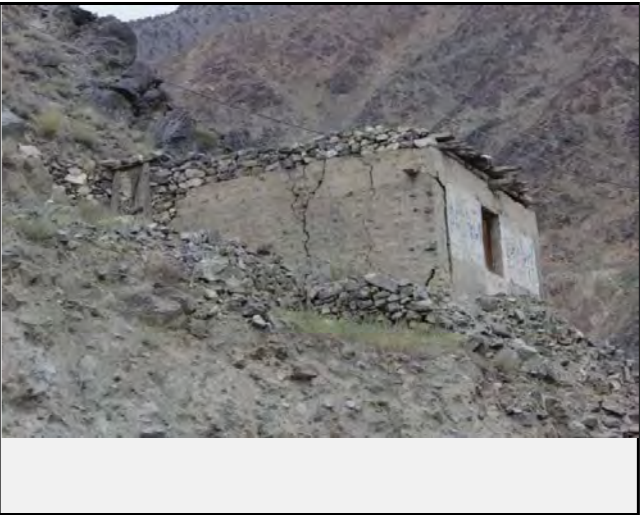
Existing countermeasures / anomalies: No Counter Measure. House has been damaged along the Debris Flow

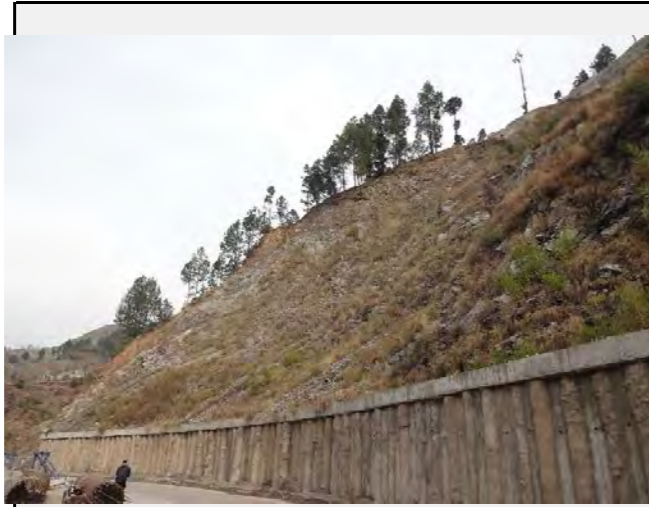
Mountain side: Outcrop and bushes can be observed on the body of the slope.

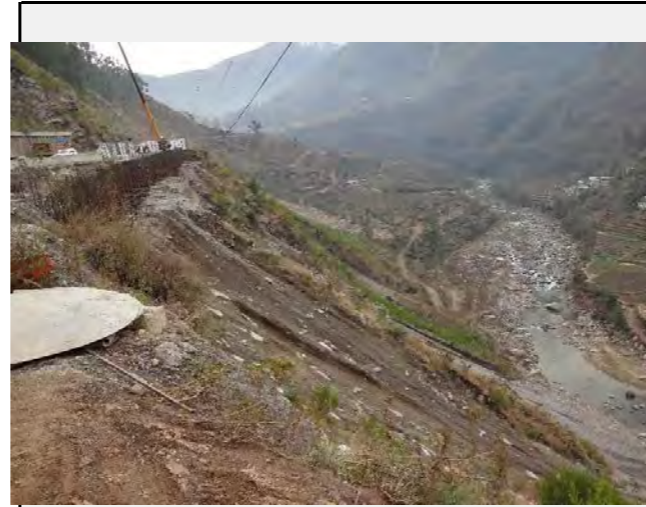
Valley side: Talus deposit can be observed on the valley side of the slope

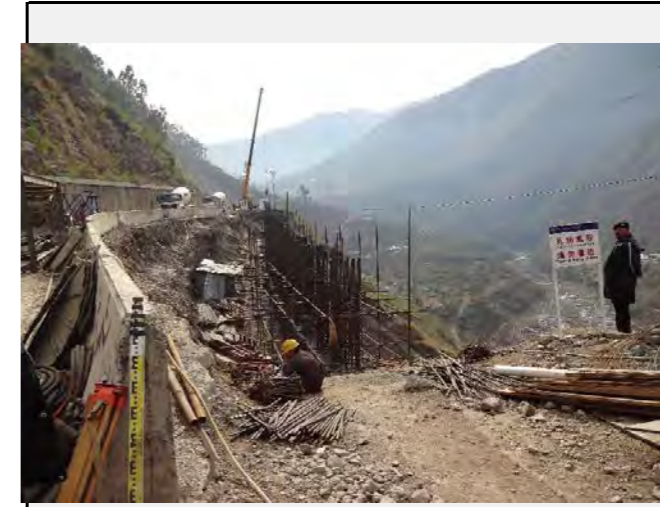
Road condition: Construction on shifting the road alignment to the valley side is being carried out by CPEC.

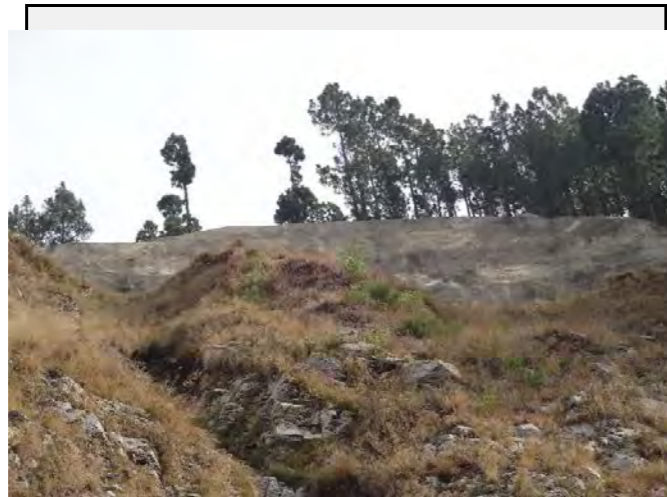
Existing countermeasures : Shotcrete was undertaken by FWO on the head of the slope to minimize the surface erosion.

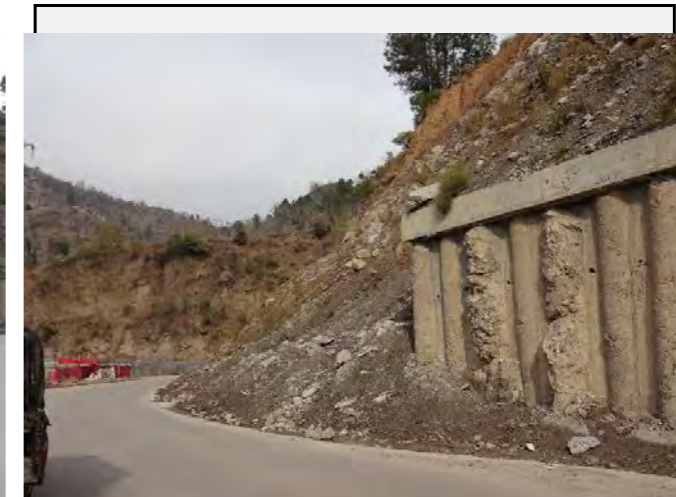
Existing anomalies: New slope failure was confirmed at the side of the previous slope where the talus deposit covered a part of the road. Some treatment maybe necessary.

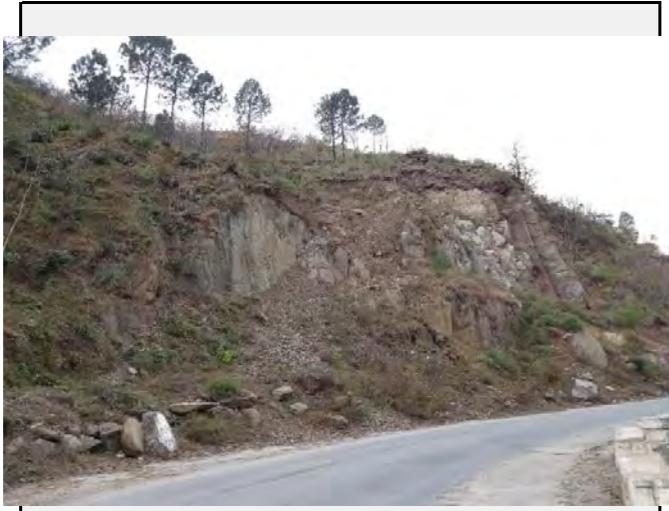
Mountain side: Both slope failure and rock fall was observed at this site.

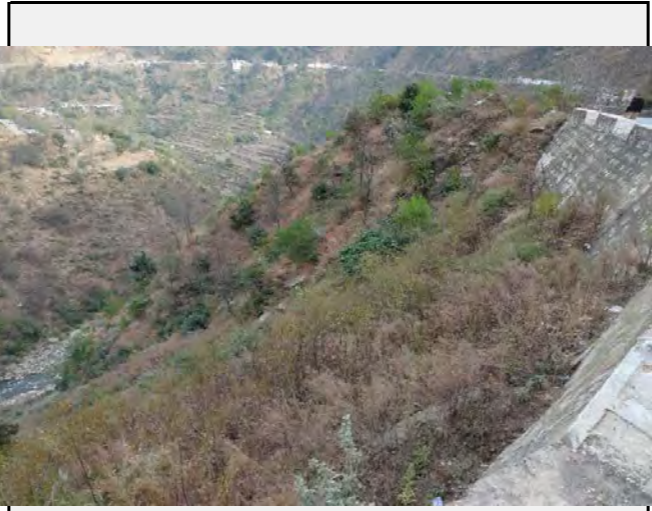
Valley side: The valley side is abundant with vegetation and no trace of slope failure was confirmed.

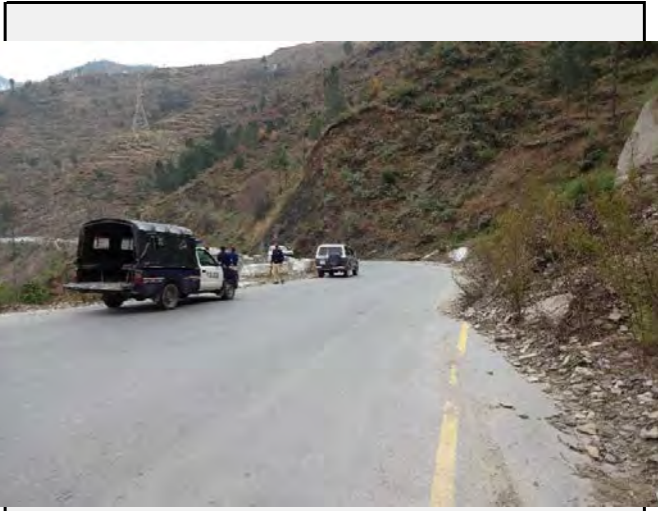
Road condition: No anomalies or damages was confirmed on the road though there was a small portion of talus deposit observed at the shoulder of the road.

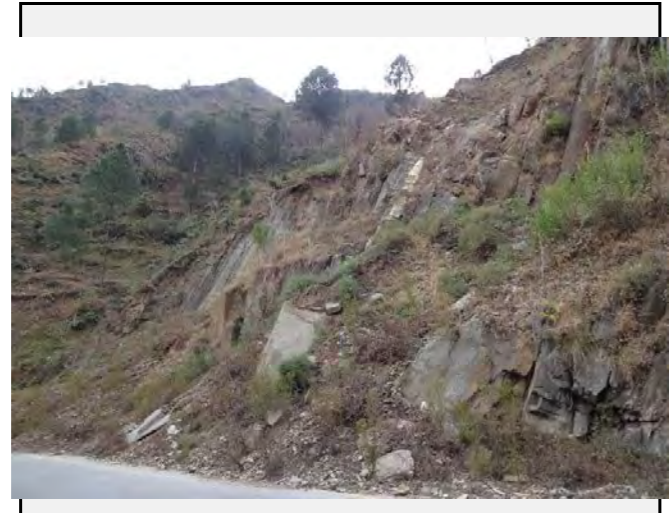
Existing anomalies: Dip slope of bedding towards the road can be observed on the slope.

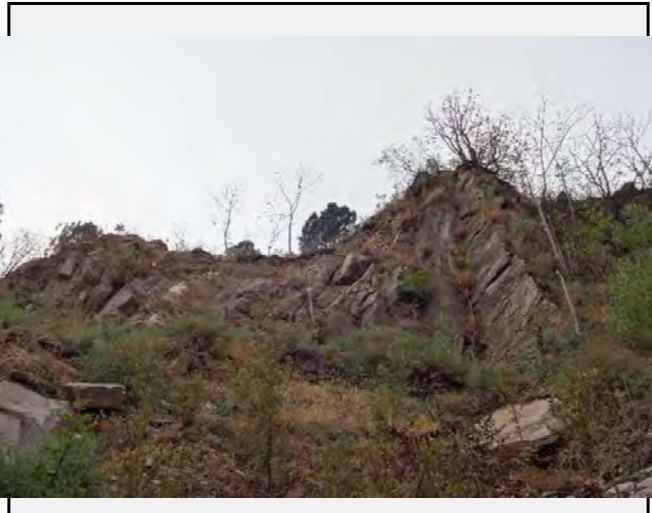
Existing anomalies: Unstable rocks can be observed at the top part of the slope. The cacks are also mostly vertical.

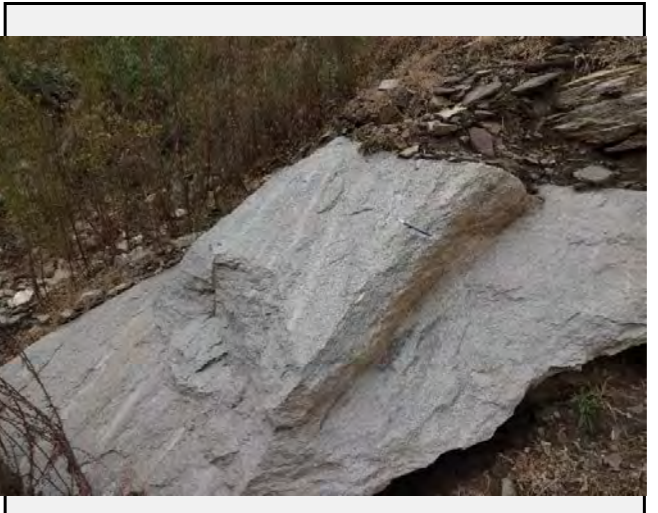
Existing anomalies: The size of the fallen rock is large enough to damage the road or cars.
