Code no.	Sat_	N	4	5	_	1			
Region Office									
Maintenance Unit

## Evaluation sheet (Slope failure/Rockfall)

Coordinates	Latitude	35° 39' 37.3"							
	Longitude	71° 45' 58.9"							
Road name					Km

Date	2018/12/4								
Inspector	Yasir, Sajid, Shafique, Basharat

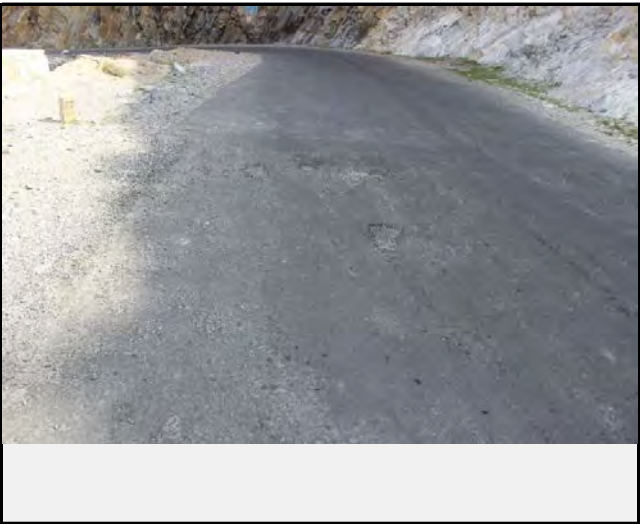
Road condition: Cut slope at the start point

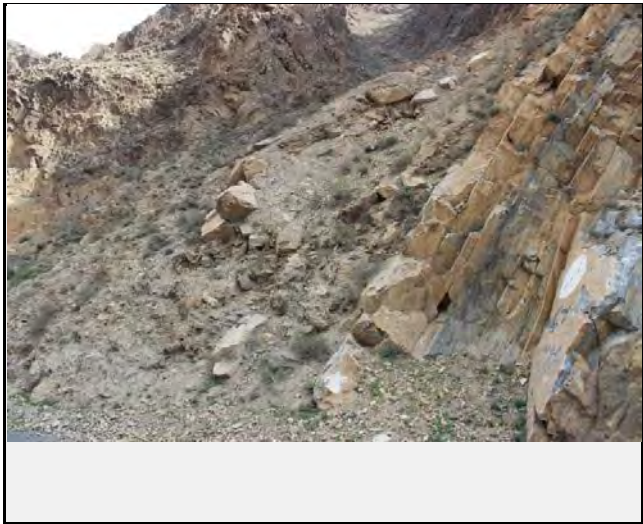
View of the slope failure at the middle point

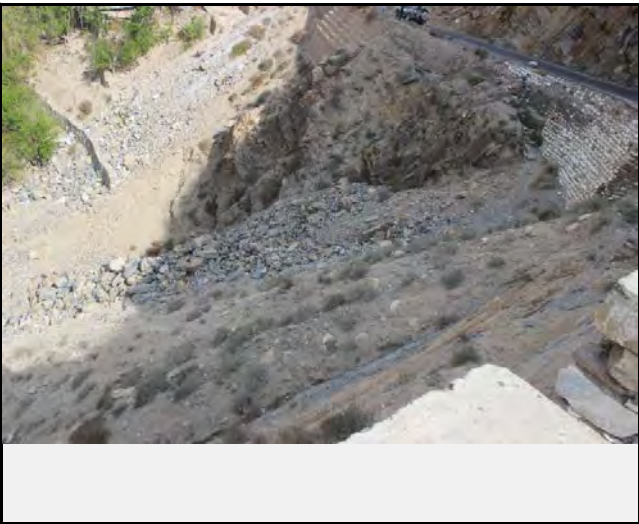
Existing countermeasures / anomalies: View of retaining wall as counter measure for N-45

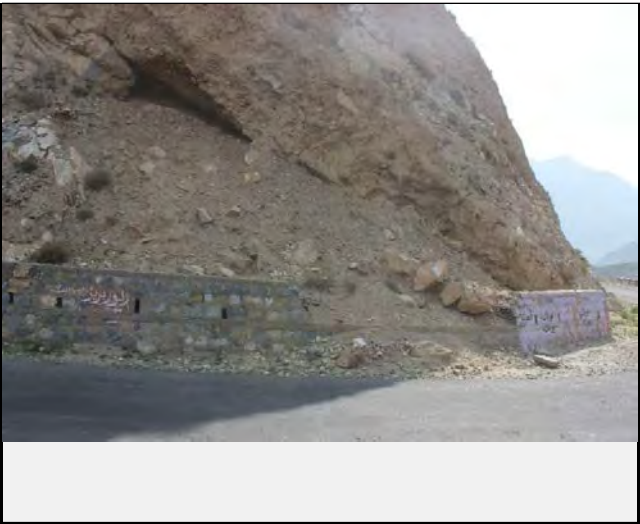
View of unconsolidated material with damaged retaining wall.

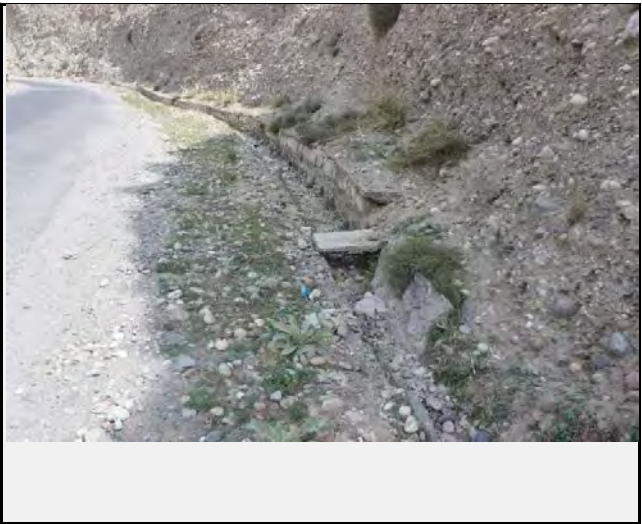
Existing countermeasures / anomalies: View of channel at the toe of Slope Failure

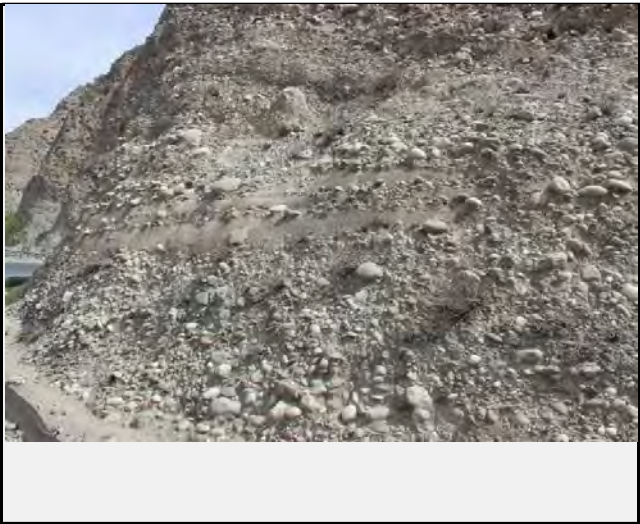
View of sandy layer in the alluvial deposits.

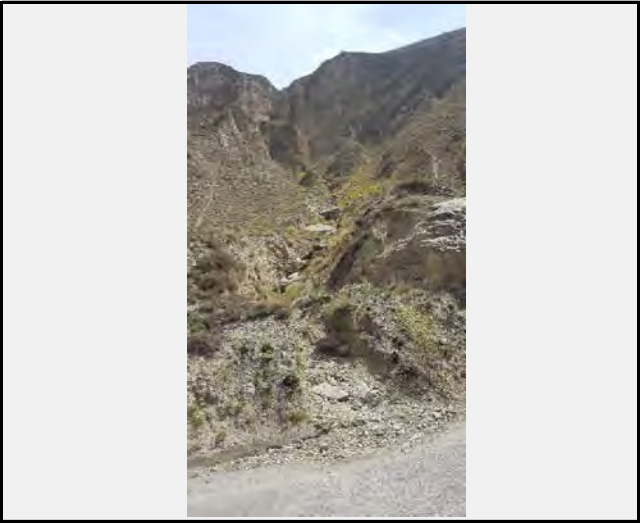
View of gully erosion in the middle of slope failure

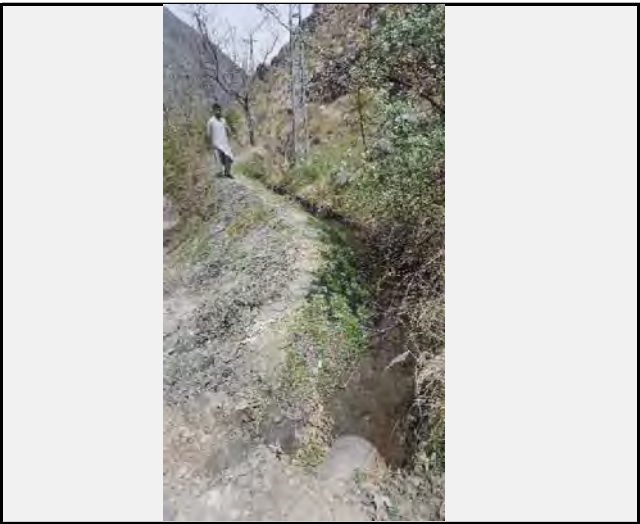
View of water Supply Scheme passing in the middle of the slope failure

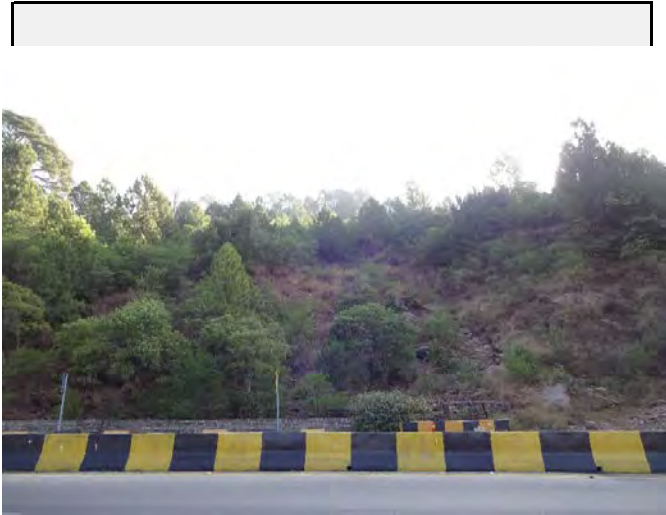
Mountain side: Trace of slope failure was observed at the mountain side

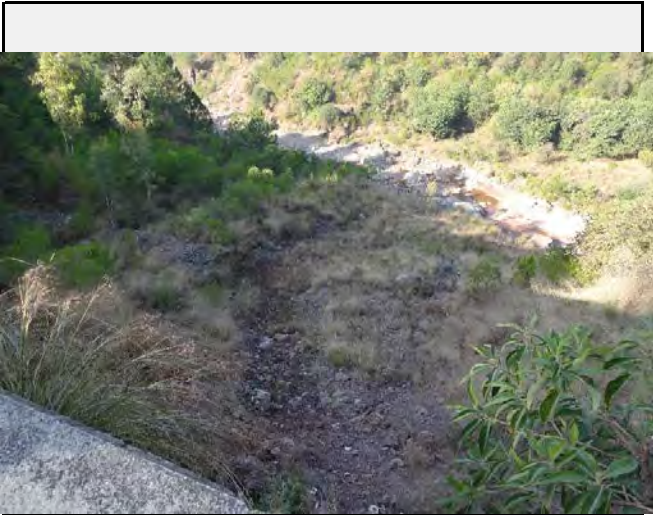
Valley side: Trace of debris flow was observed at the valley side.

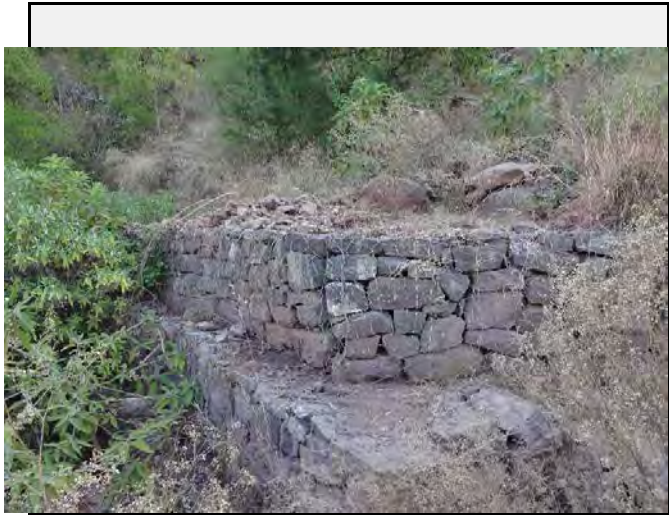
Existing countermeasures: Gabion works are undertaken at the toe of the mountain side. However, the debris is deposited on the top of the gabion and may outflow the gabion works in the future.

Trace of debris flow was observed at the valley side of the road. Gabion which are installed on the waterway was washed away probably during heavy rain. Reinforcement of the gabion is necessary to stabilize the gradient of river bed.

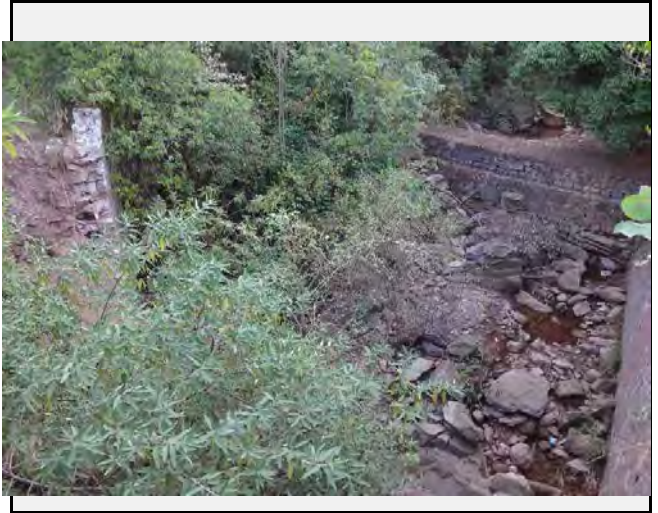
The collapse of the retaining wall was observed at the north side (undercut slope) of the bank near the box culvert. It maybe caused by the poor water drainage which of the back of the retaining wall. However, the box culvert under the road were clear from deposits and has a enough capacity to to drain the debris to the valley side. River training works have been carried out and the catchment area is full of vegetation

Existing countermeasures / anomalies: Damage on the retaining wall on the north side (undercut slope) on the mountain side.

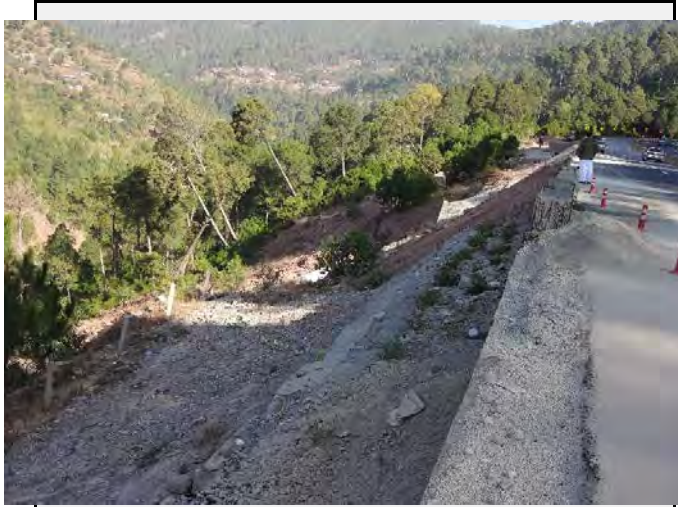
Existing countermeasures / anomalies: Surface erosion protection net are installed to minimize the surface erosion.

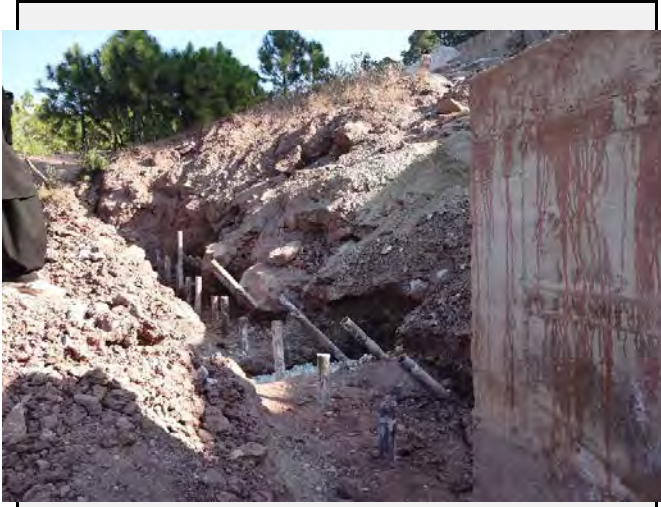
Existing countermeasures / anomalies: Micro piles are installed at the foundation of the lowest retaining wall (ongoing construction).

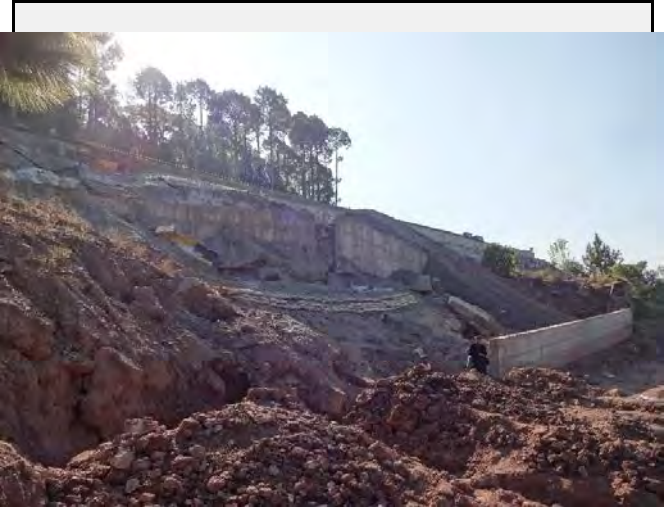
Existing countermeasures / anomalies: Retaining walls are constructed at the valley side of the road (ongoing construction).

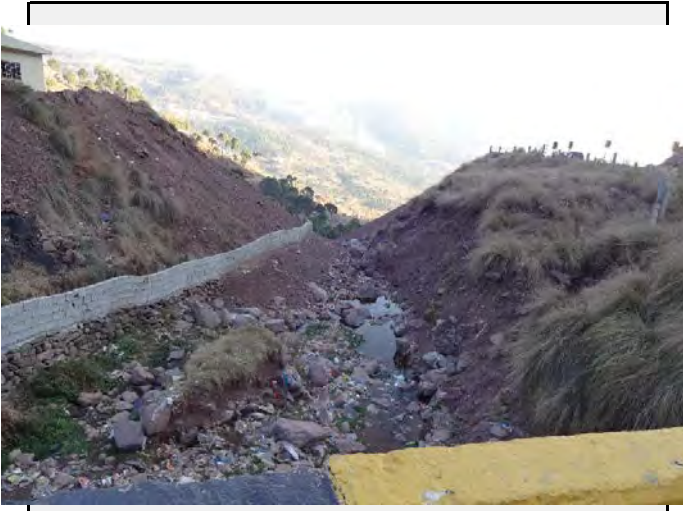
Valley side: Deposits in the valley side. Erosion on the bank may occurs in future.

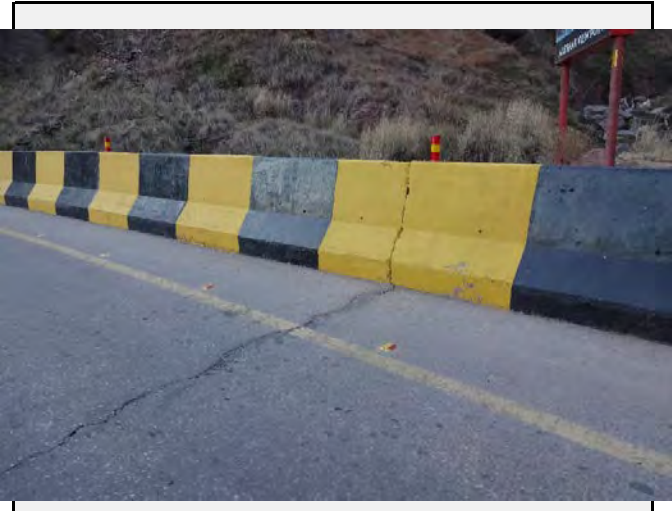
Road condition: Some cracks was observed at the joints of the bridge.

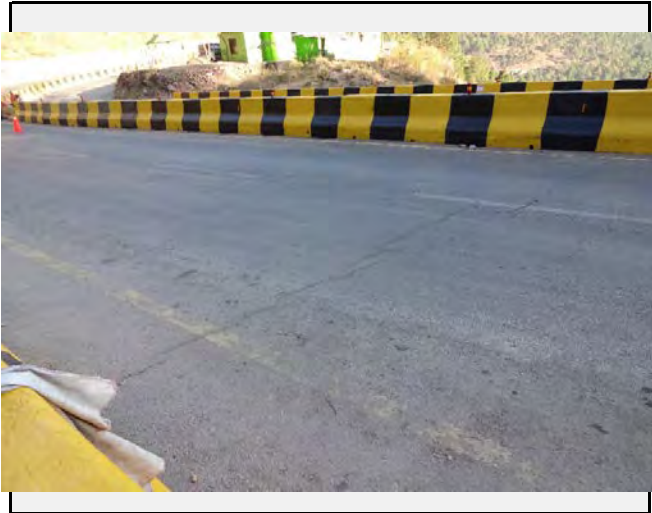
Road condition: Small cracks was confirmed at the joint section of the road and bridge.

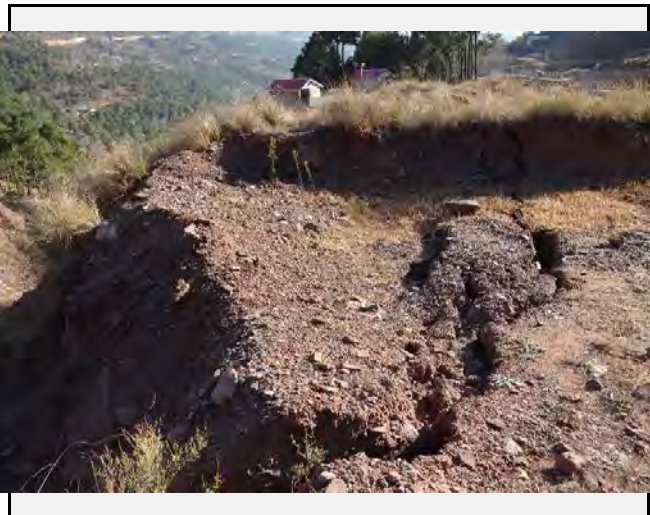
Existing anomalies: Cracks was confirmed on the bank of the valley side. It may collapse in near future due to the erosion.

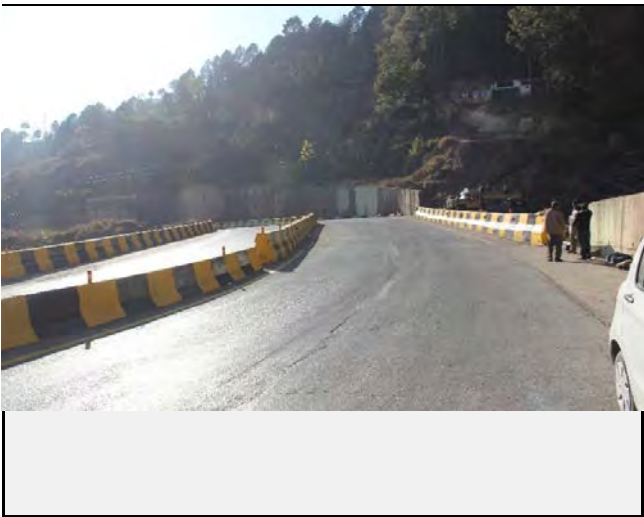
The crack on road has been observed

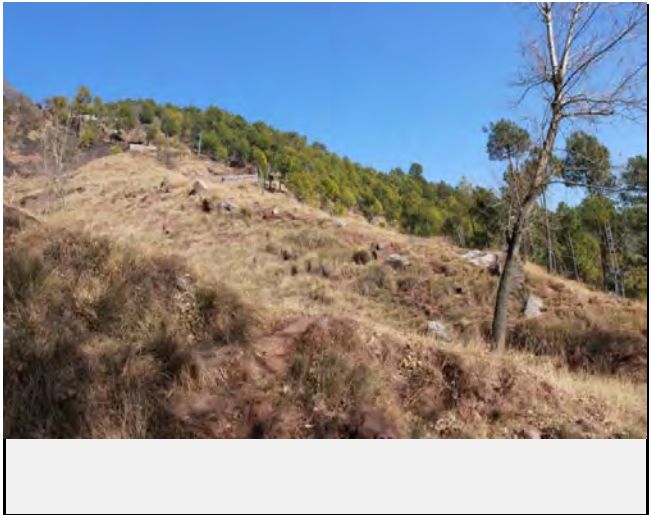
Future potential landslide. Vegetation and trees on the main body of landslide

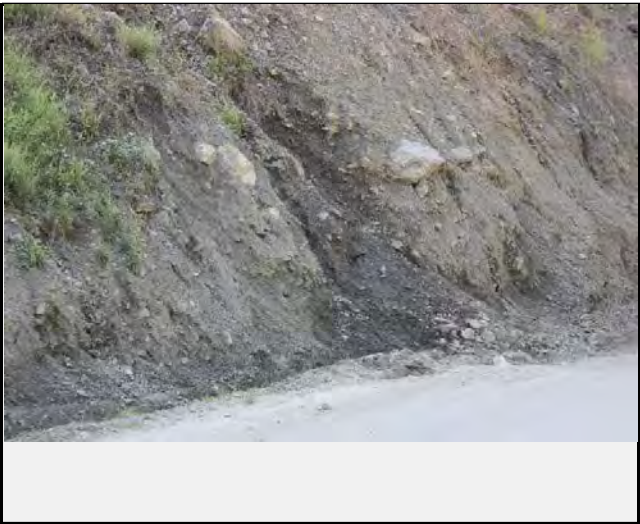
View of seepages in the slope failure

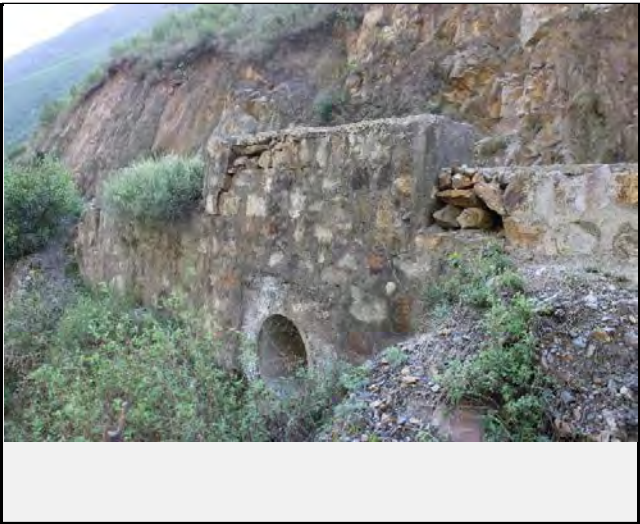
View of Drainage pipe and damaged retaining wall

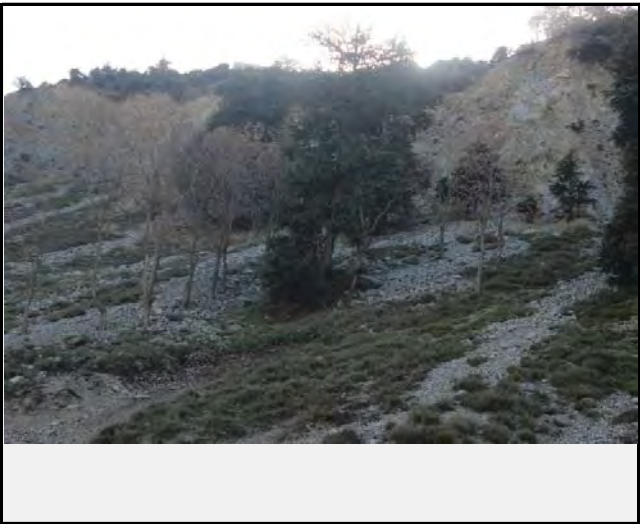
View of scarp of the slope failure

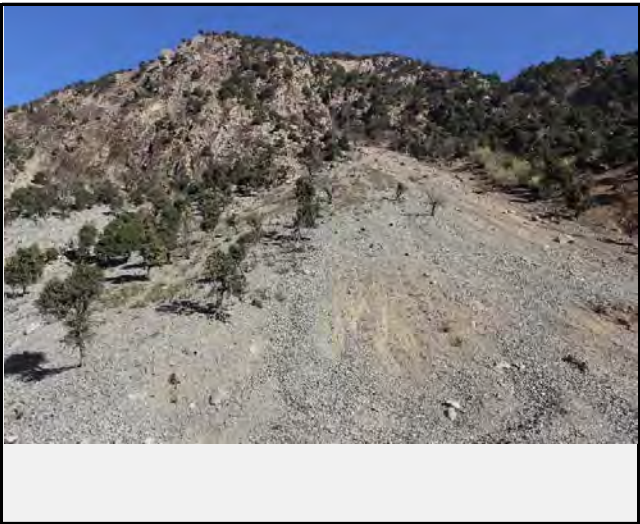
View of gully developed in the slope failure
