### 日本人制限域における調査報告書

# **SLOPE FAILURE ANALYSIS ALONG THE MAJOR ROADS NETWORK IN NORTHERN PAKISTAN**

Kokusai Kogyo Co., Ltd, Tokyo, Japan

Dr. Muhammad Basharat  
Dr. Muhammad Shafique  
Mr. Yasir Sarfraz  
Mr. Sajid Ali

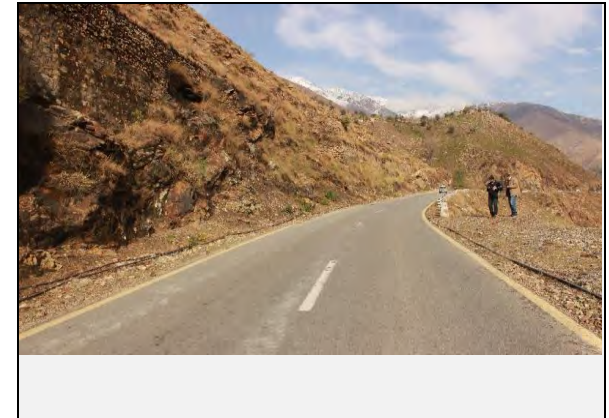
Road condition: Cut slope at the start point

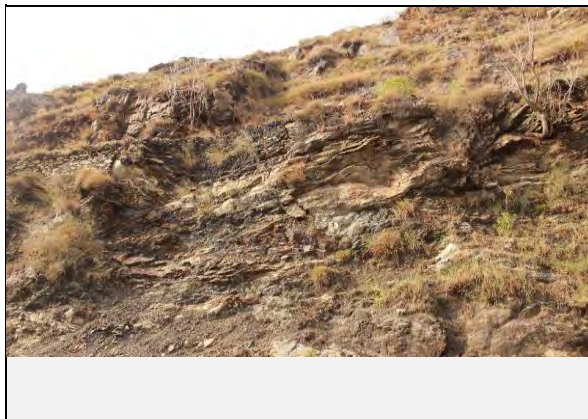
View of the slope failure at the middle point

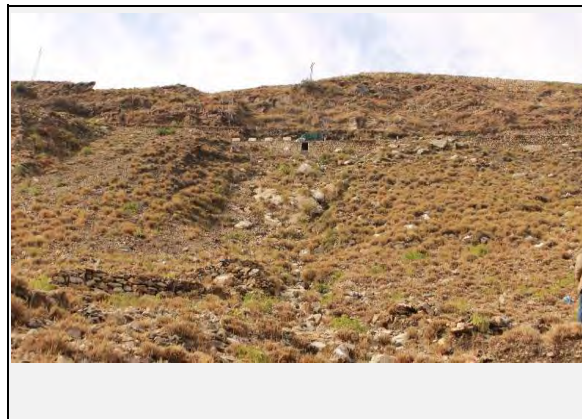
Existing countermeasures / anomalies: View of Culvert outlet as counter measure and retaining wall for N-35

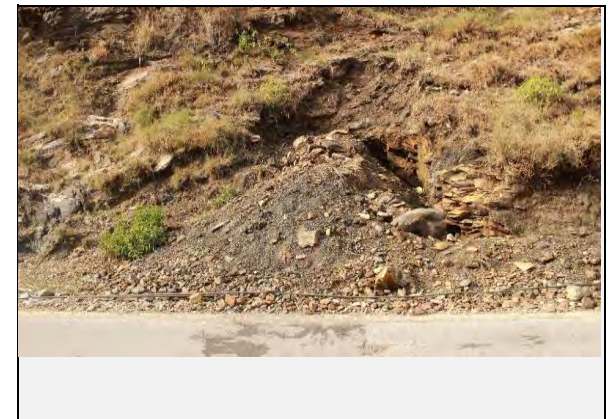
View of new slope failures within the N-35-1

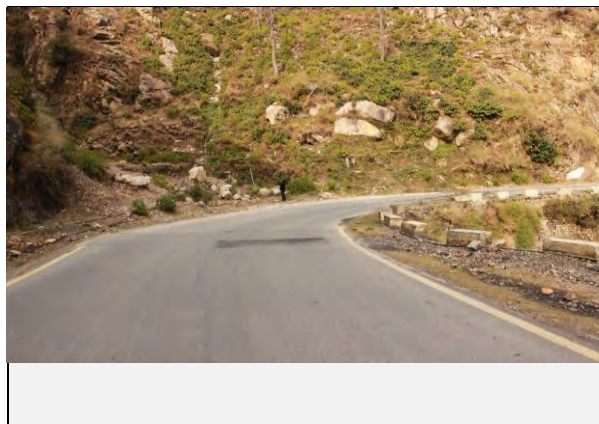
The patch work on the road has been observed

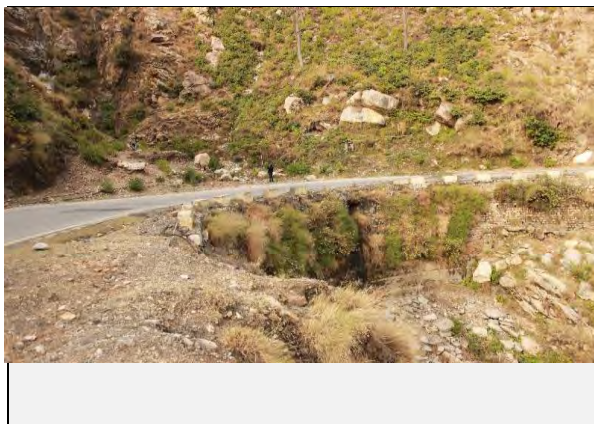
Existing countermeasures / anomalies: Inlet of the culvert is choked by the debris.

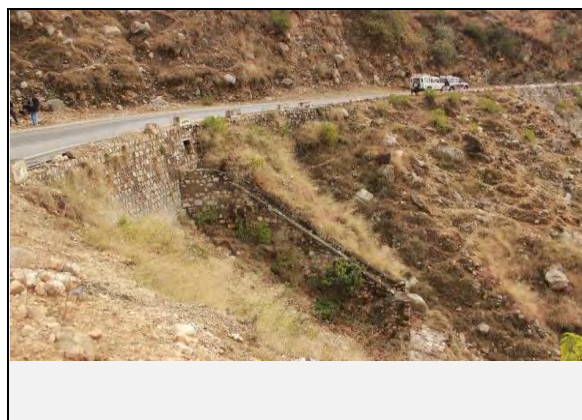
Existing countermeasures / anomalies: View of Culvert as counter measure and retainin wall

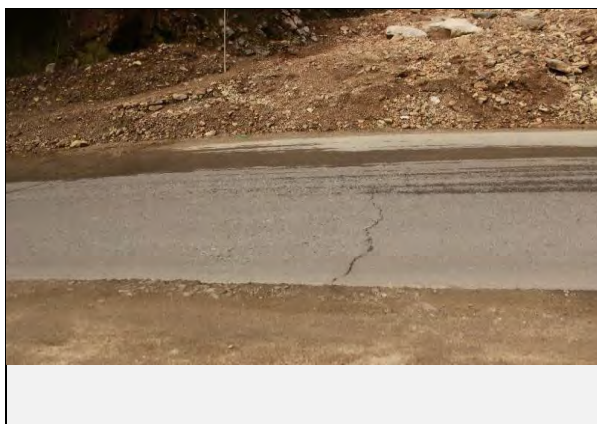
The crack on road has been observed

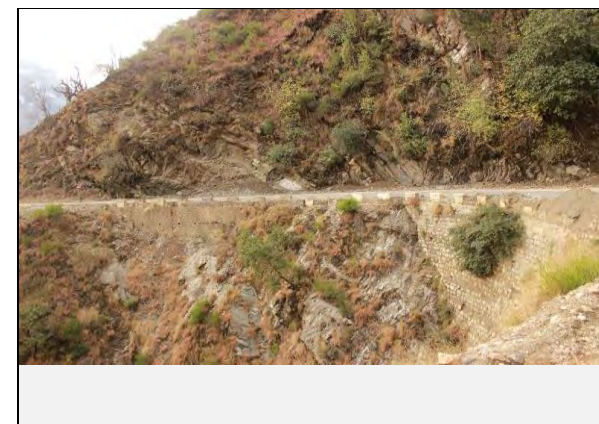
Existing countermeasures / anomalies: Retaining wall has been constructed at the toe of the slope failure

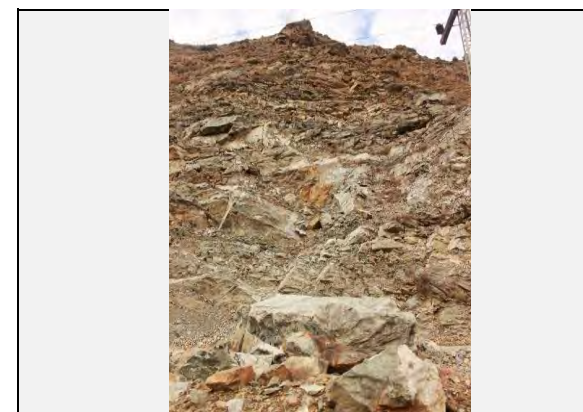
View of fallen blocks along the slope failure which threaten the household at the toe of the slide

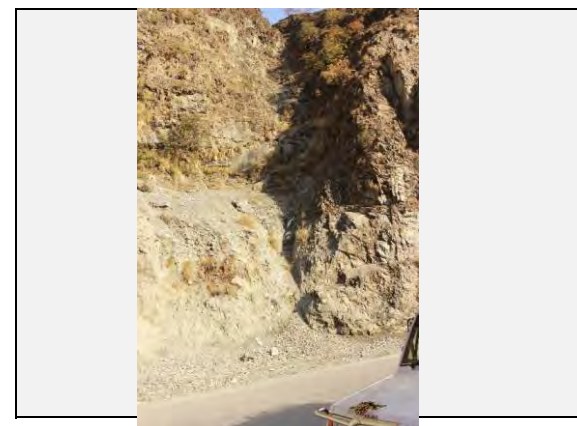
View of Gully erosion along the slope failure

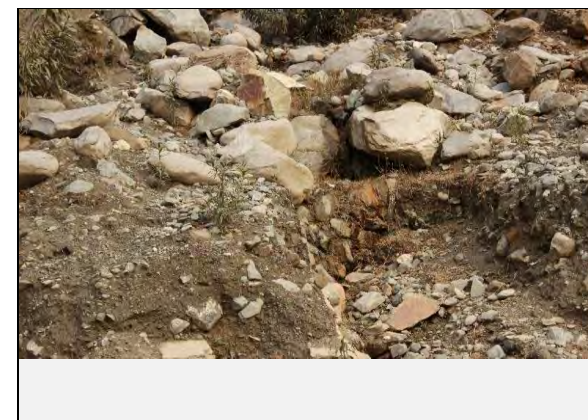
View of fallen blocks along slope failure

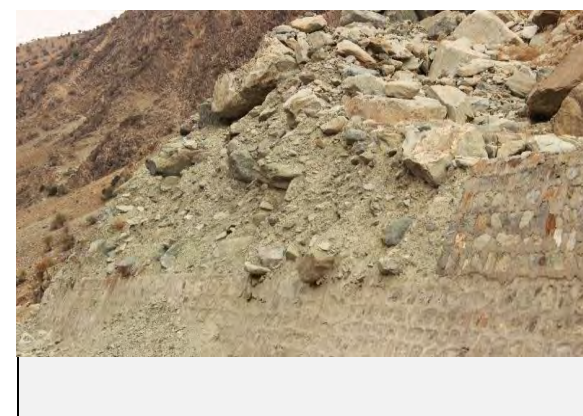
View of fallen blocks

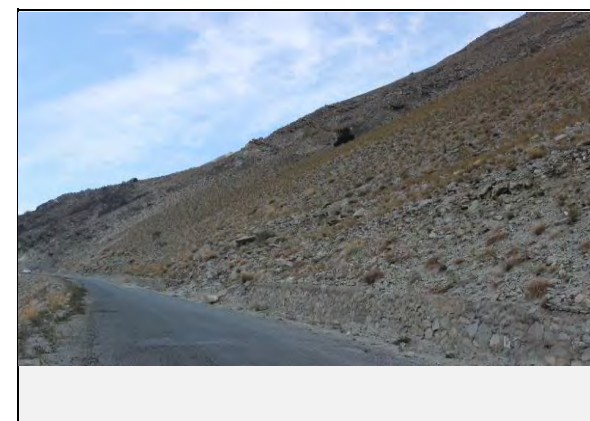
View of Multiple slope failure in the talus deposits

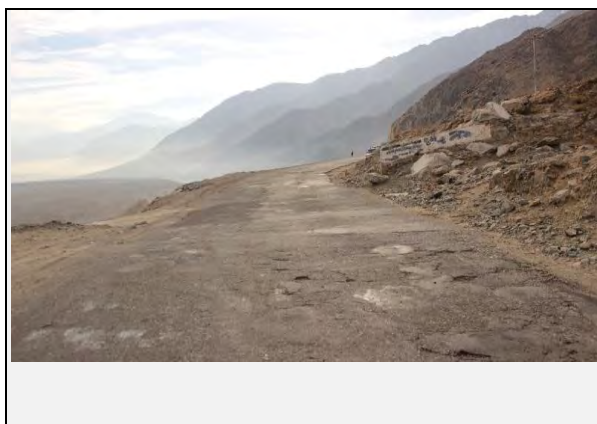
The crack on road has been observed

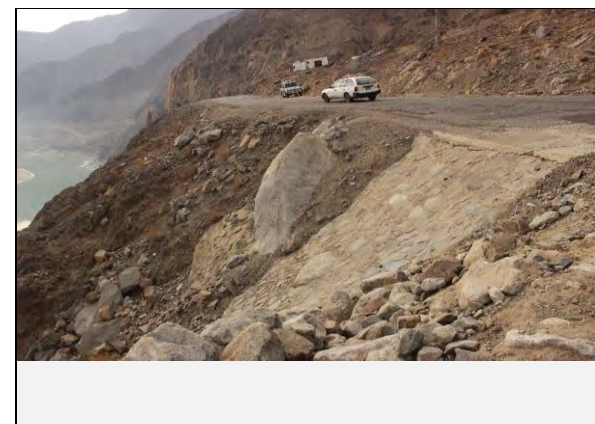
Existing countermeasures / anomalies: Retaining wall has been constructed at the toe of the Debris Flow

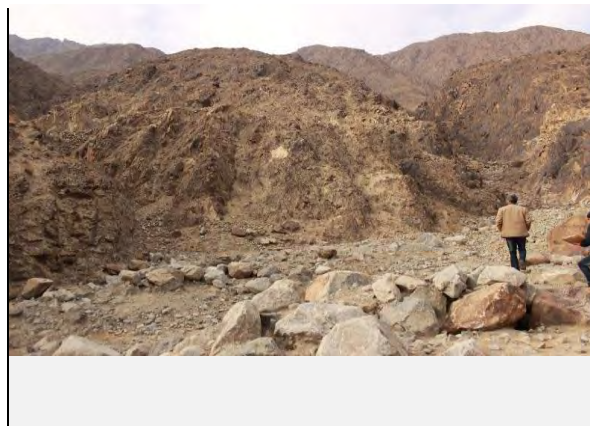
Boulders and Blocks along the Debris flow

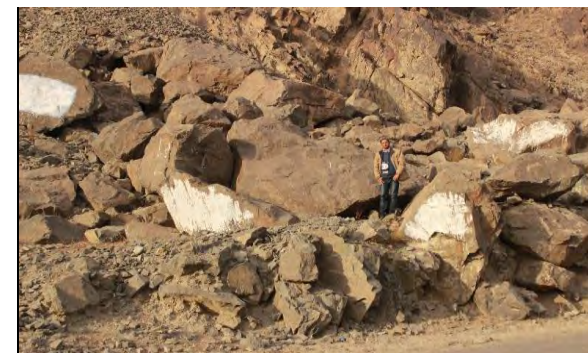
View of fallen blocks along the slope failure
