## Evaluation sheet (landslide)

| Road Name | | | | | Km | | | | |

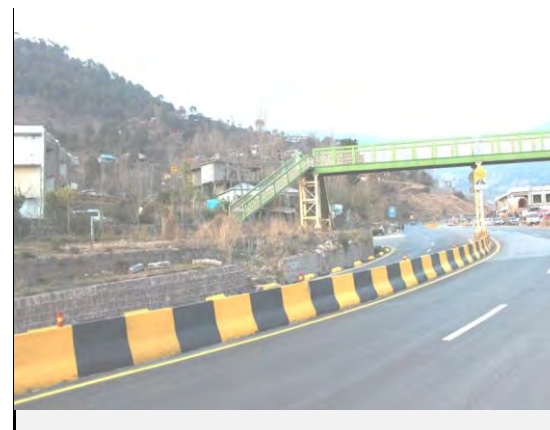
Road condition: Road passing through the center of the landslide

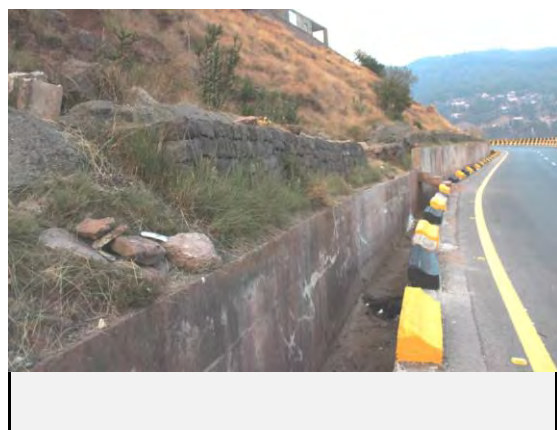
Existing countermeasures / anomalies: Retaining and gabion walls has been constructed to protect the road

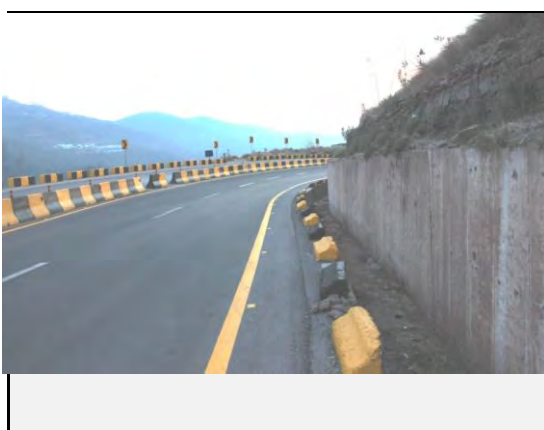
Existing countermeasures / anomalies: Upto 4 cm cracks were observed in the retaining wall

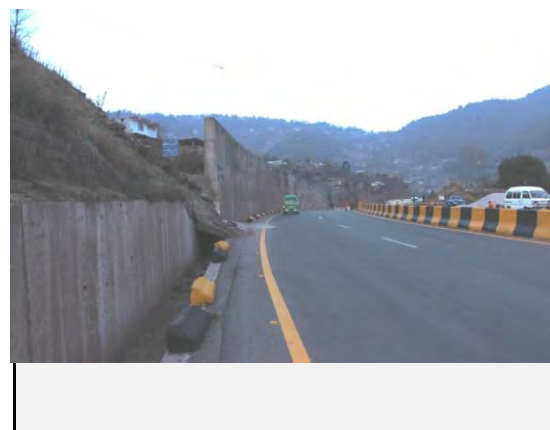
Existing countermeasures / anomalies: Retaining wall has been constructed

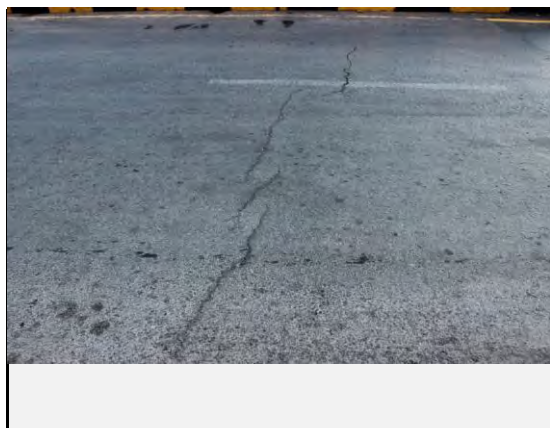
The crack on road has been observed

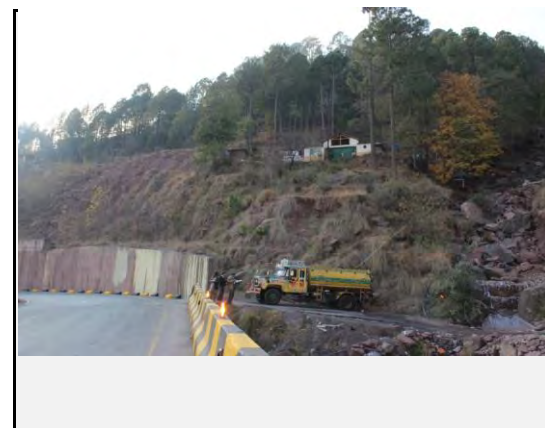
Existing countermeasures / anomalies: Retaining wall has been constructed at the toe of the slope failure

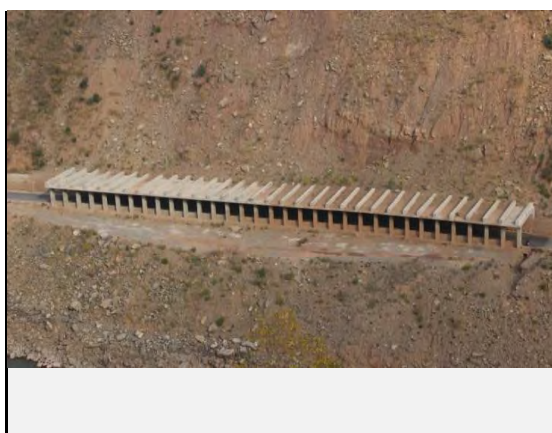
Existing countermeasures / anomalies: View of shed as counter measure

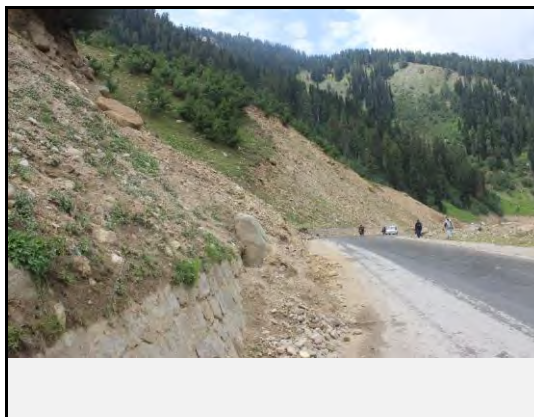
Existing countermeasures / anomalies: View of damaged Retaining Wall as counter measure

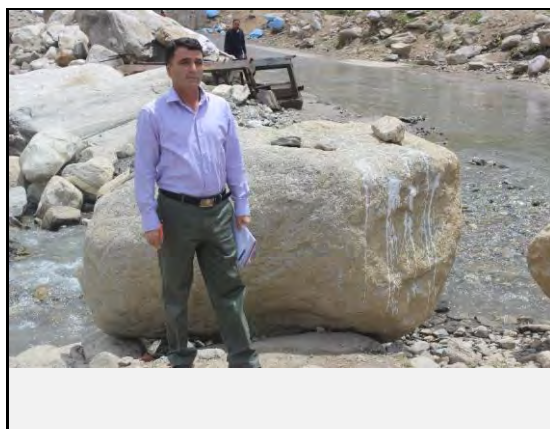
The boulder has been found along the debris flow

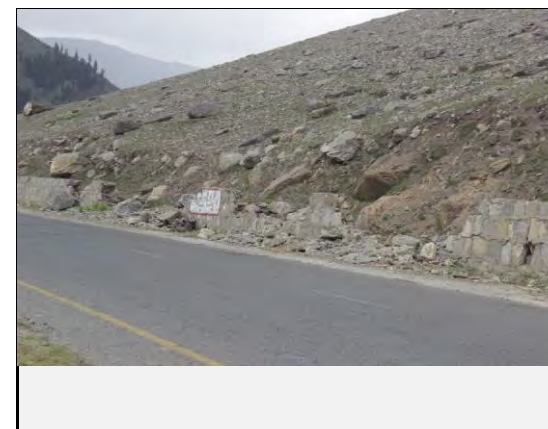
Existing countermeasures / anomalies: Retaining wall has been constructed along the Debris Flow which has been damaged by the debris material

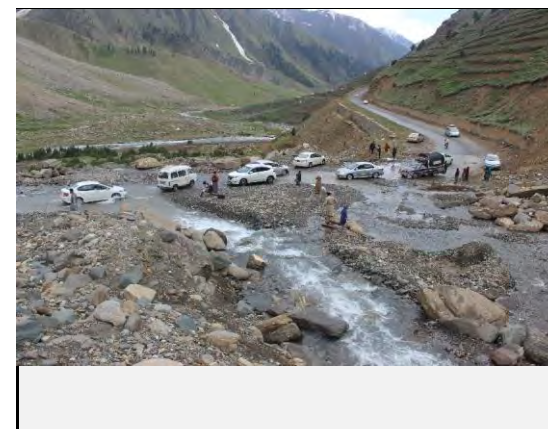
Debris flowing on road

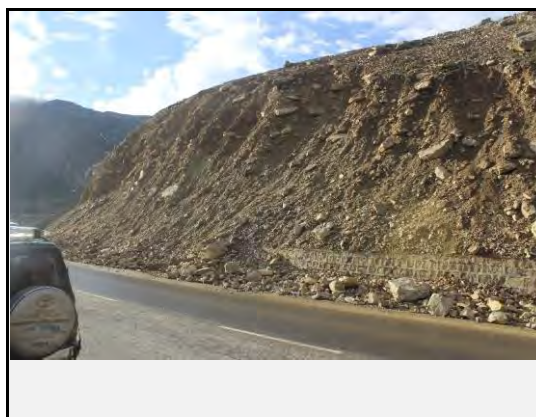
Existing countermeasures / anomalies: View of damaged Retaining Wall as counter measure

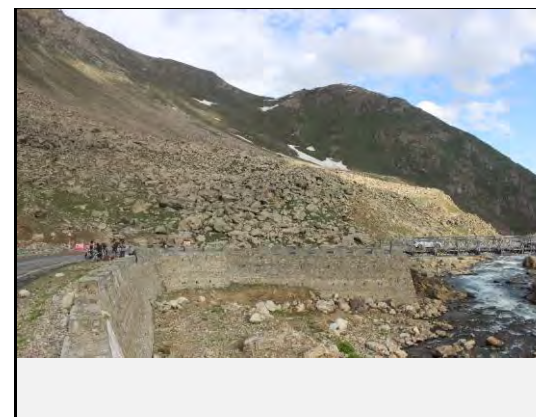
View of the toe of Landslide cut by the stream

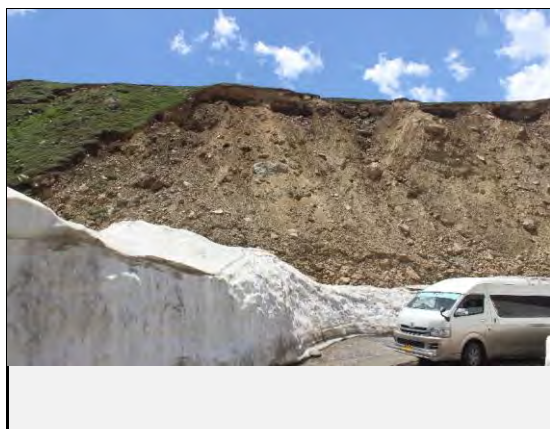
The new slope failures has been found along the debris flow

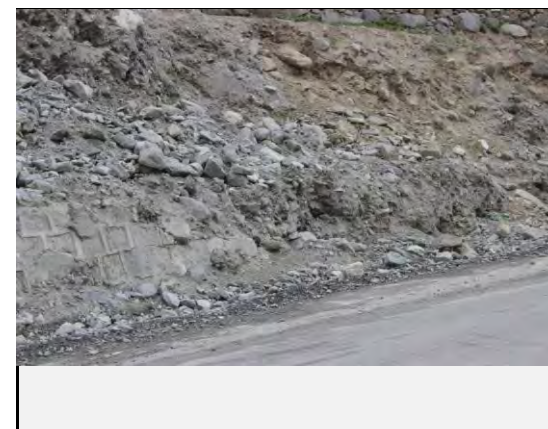
Existing countermeasures / anomalies: Retaining Wall (Damaged) has been constructed along the Debris Flow

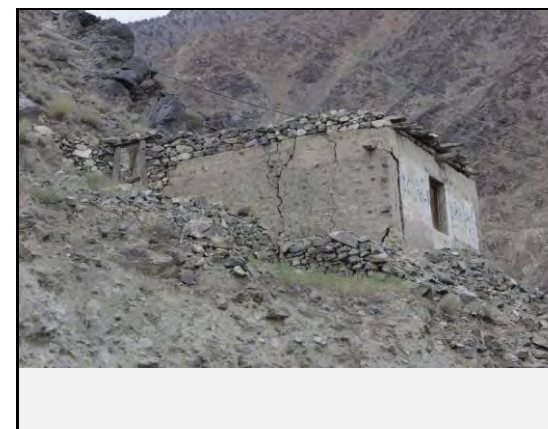
Existing countermeasures / anomalies: No Counter Measure. House has been damaged along the Debris Flow

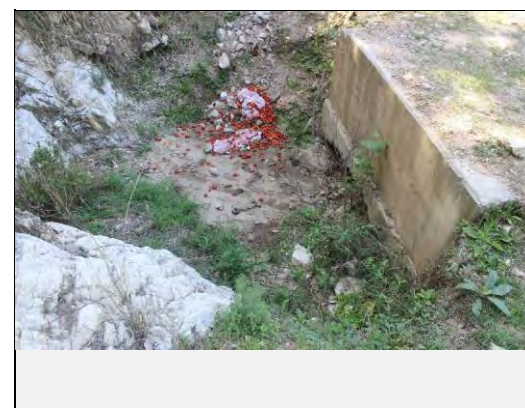
Existing countermeasures / anomalies: View of culvert inlet at the toe of slope failure

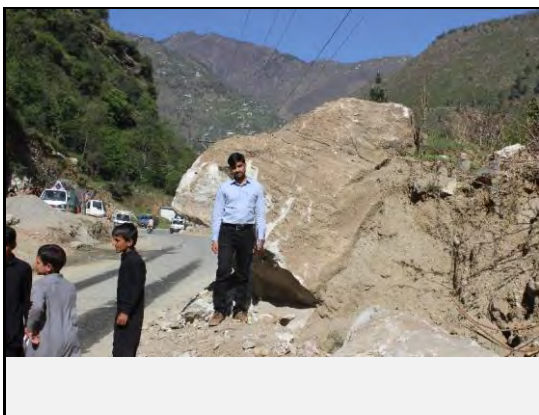
View of fallen block with the debris flow that can damage the population along the downstream.

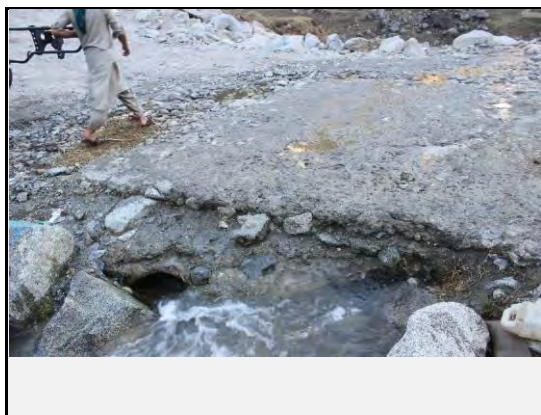
The damage on road has been observed with inlet of pipes for debris flow

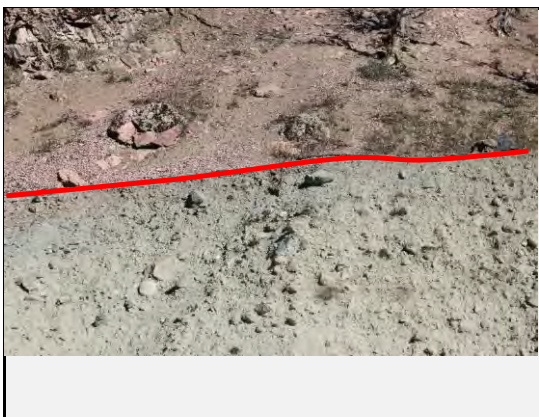
The existing road has been damaged. Red line shows the old road displaced by the debris flow.

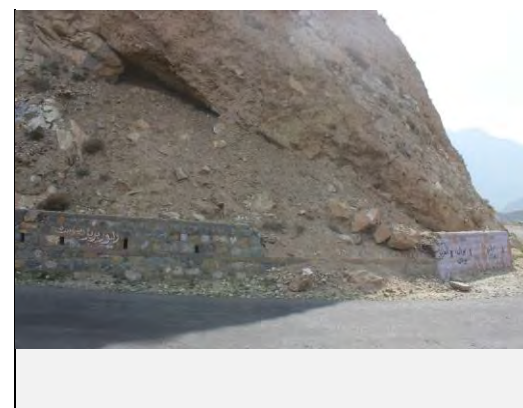
View of unconsolidated material with damaged retaining wall.
