Islamic Republic of Pakistan  
The Ministry of Communications, National Highway Authority (NHA)

# Data Collection Survey on Road Landslide Measures in Pakistan

## Final Report

January 2019

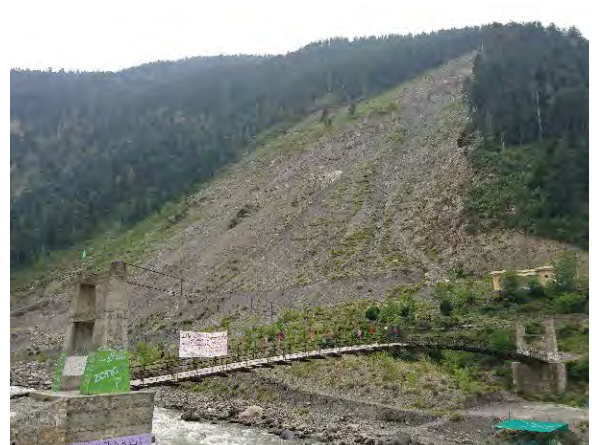
Photograph 6: Slope failure (N-15)

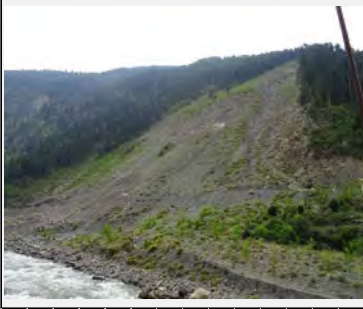
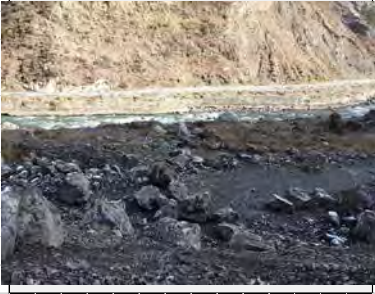
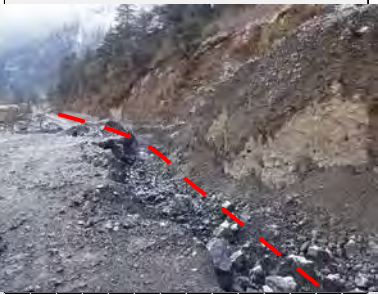
Code no.		Photo sheet										Date		
Region Office	Abbottabad	Coordinates		Latitude		N 34°39' 27"						Inspector	Makoto Tokuda	
Maintenance Unit	Balakot			Longitude		E 73°30' 4.2"								
		Road Name	N	1	5	Km	7	2	+	3	0	0

Overall view of the slope from the opposite site of the river. Talus deposited on whole surface of the slope failure area.	Valley side: Talus deposits can be observed on the valley side of the slope.	Road condition: Existing road is still buried 5m under the talus deposits.

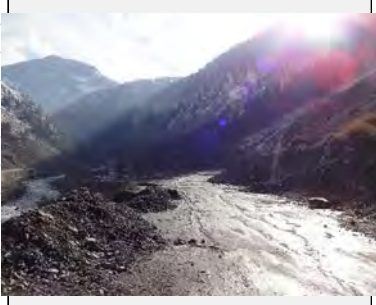
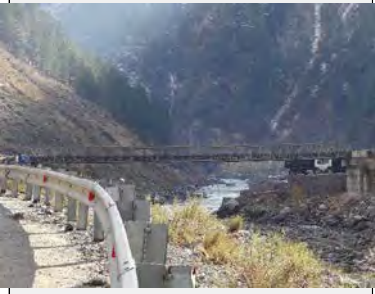
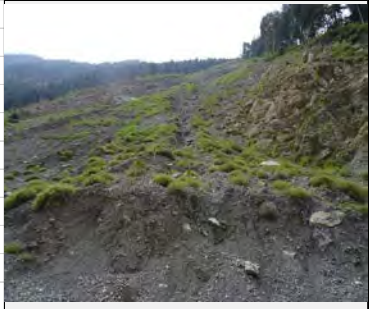
Existing countermeasures: Temporary access road used for the long-sized truck which cannot pass the road alignment on the bypass road.	Existing countermeasures: Bailey bridge is used as temporary on the bypass road.	Mountain side: Talus deposits can be observed throughout the slope.

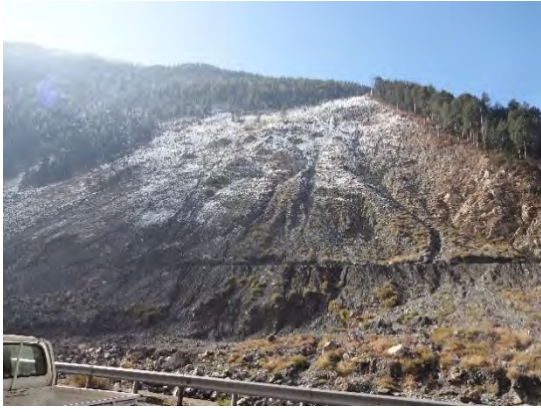
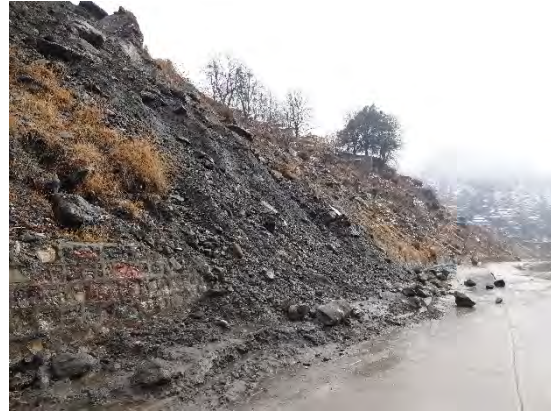
Figure 4.34 Slope Failure Affecting Road Traffic at N15 Source: JICA Survey Team

From the results of the field survey, slope failures are a common problem in N15. In particular, the priority is high for the slope failures on N15\_3 and N15\_6 as the scales of the disasters are massive and may affect the road traffic. The main cause of slope failure is the weathering and erosion by the severe climatic condition on the vulnerable slopes, which is formed by the orogenic activity. The seasonal condition (rainy and snow melting season) may be the triggering factor as the infiltration of the surface water into the soil (slope) and the groundwater rise, causing the slope to be more unstable. In addition, the inadequate construction of the road embankment (selection of the materials, lack of leveling and compaction, inadequate treatment of the cut slope boundary, etc.) is another triggering factor, weakening of the road embankment owing to groundwater rising within the embankment and subsidence of road concrete/asphalt.

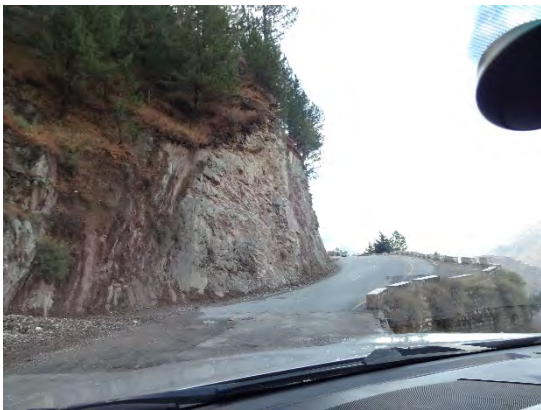
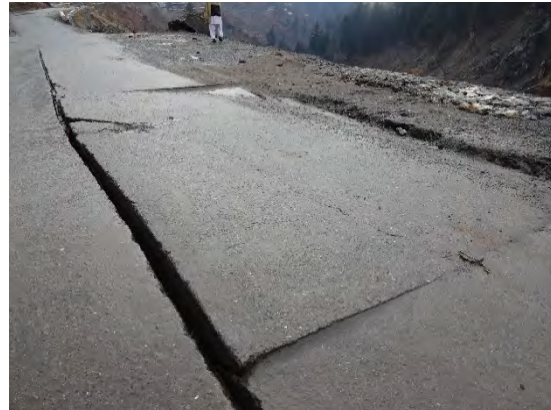
Figure 4.35 Example of Inadequate Angle of Cut Slope and Road Embankment

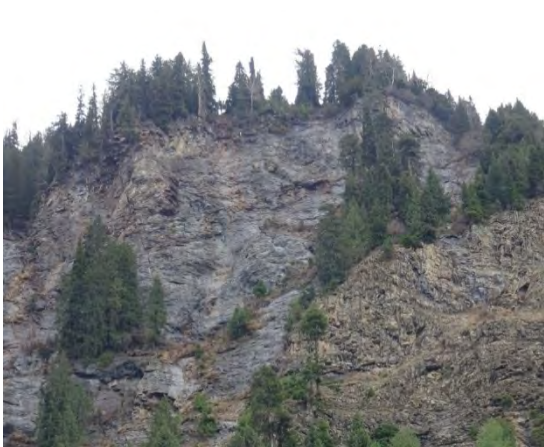
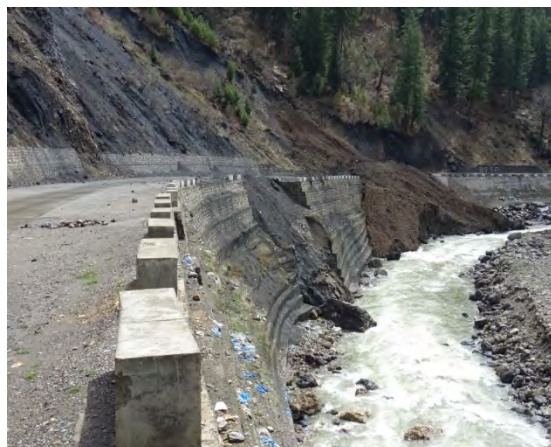
As for the N15\_9, the existing retaining wall on the valley side has collapsed partially owing to erosion of the base rock (fractured pelitic schist). The retaining wall stands on the slope, where the erosion is caused by attacks from the rapid flow of river water. As a result, the road side and embankment above the existing retaining wall have become unstable (tilting and deviation of the road side).

Figure 4.36 Vertical Slope of (N15\_8) and Collapsed Retaining Wall (N15\_9)

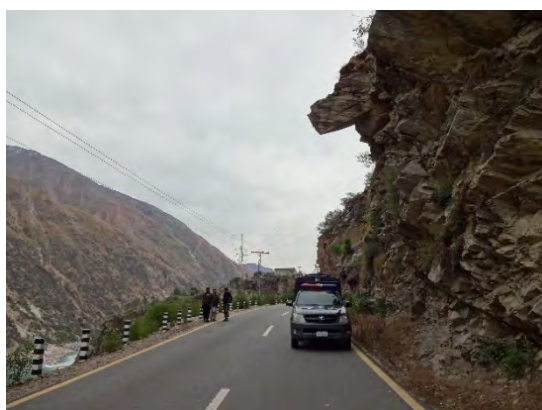
Detaching rock on top of the road (N35\_7)

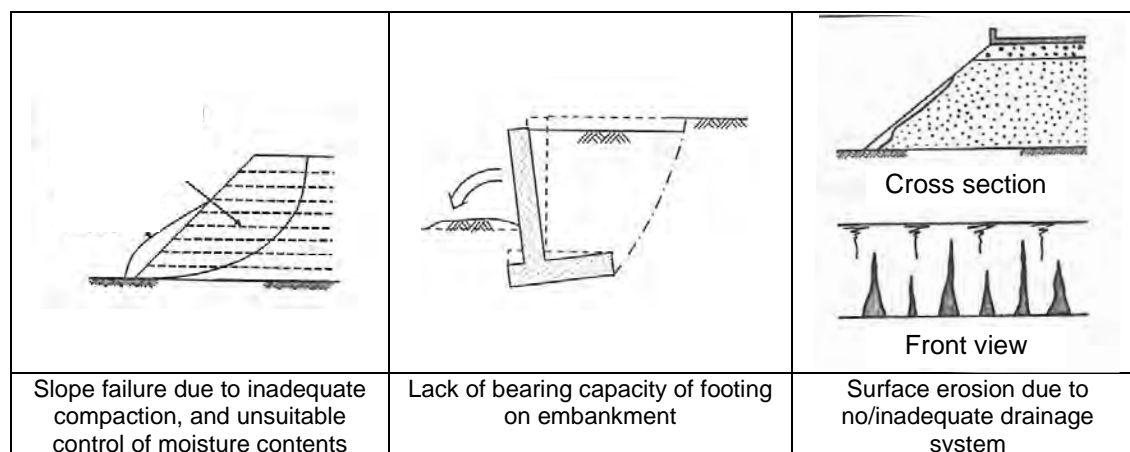
Figure 4.40 Examples of Inadequate Road Embankment

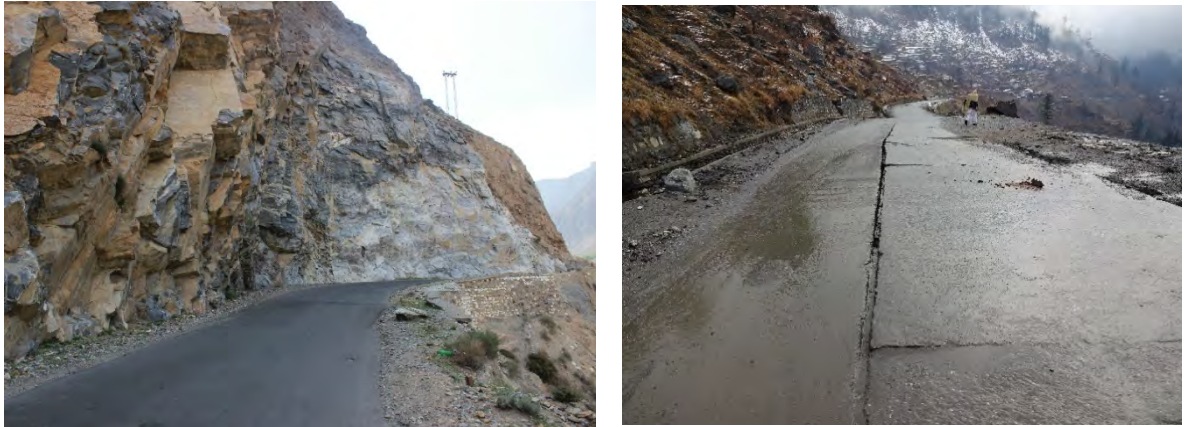
Figure 4.41 Inadequate Cut Slope Angle (Left) and Lack of Bearing Capacity of Embankment (Right)

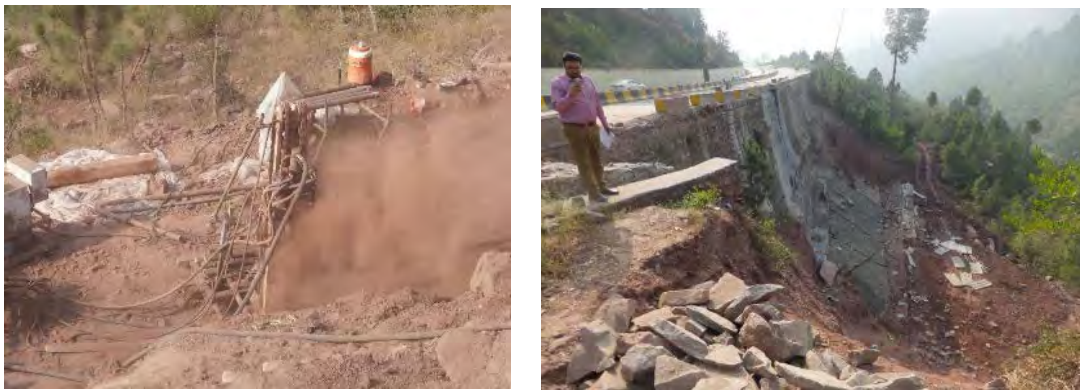
Figure 4.45 Insertion of Micropile (Left) and Failure of embankment in the valley side (Left)

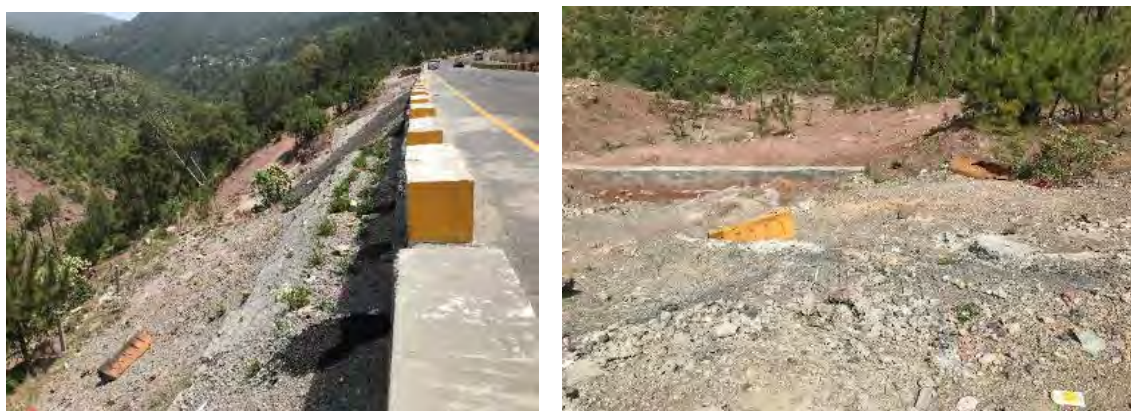
Figure 4.48 Inadequate Construction of Embankment on the Valley side Slope at N75

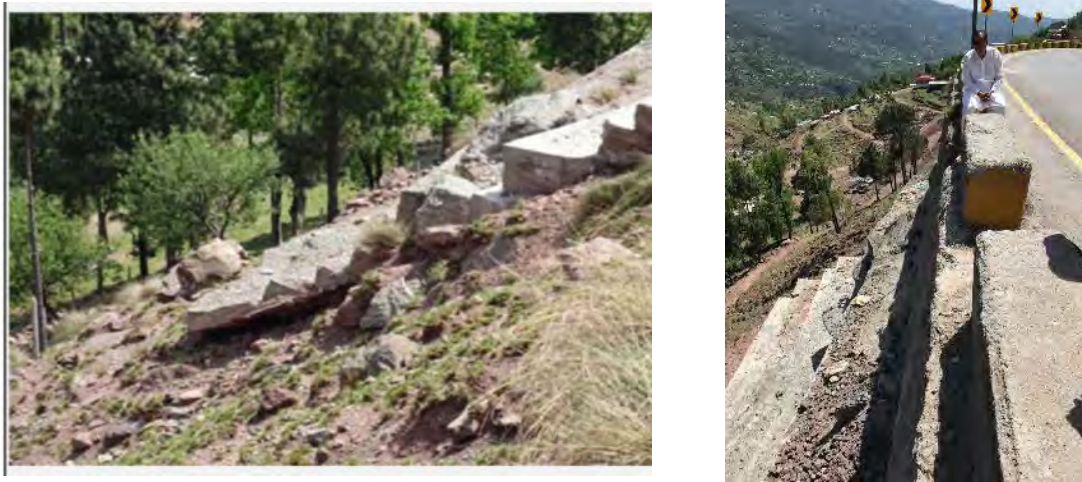
Figure 4.49 Inadequate Construction of Retaining Wall on the Valley side Slope at N75\_5

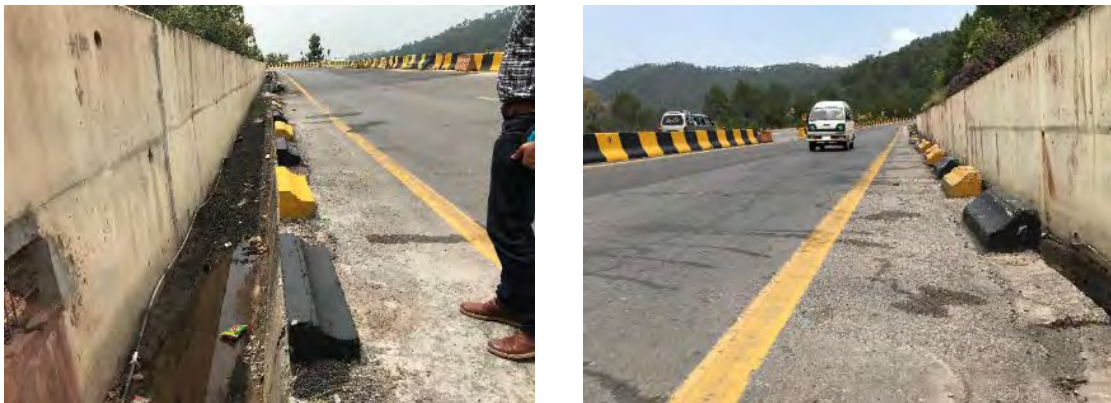
Figure 4.50 Puddle in the Ditch (Left), Situation of the Surface Drainage (Right) at N75\_2
