Appendix 2

Survey Result of Slope Chart

Code no.	N	1	5	-	1						
Region Office	Abbottabad										
Maintenance Unit	Balakot

Evaluation sheet (Slope failure/Rockfall)

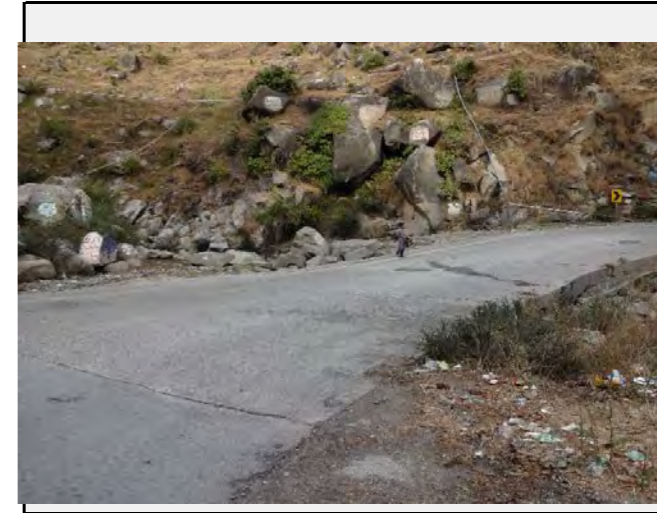
Valley side: Large boulders are deposited on the valley side.

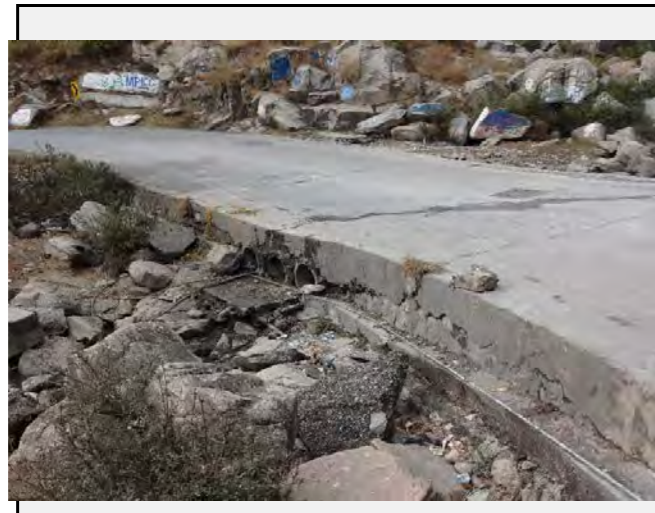
Road condition: The causeway is installed crossing the stream.

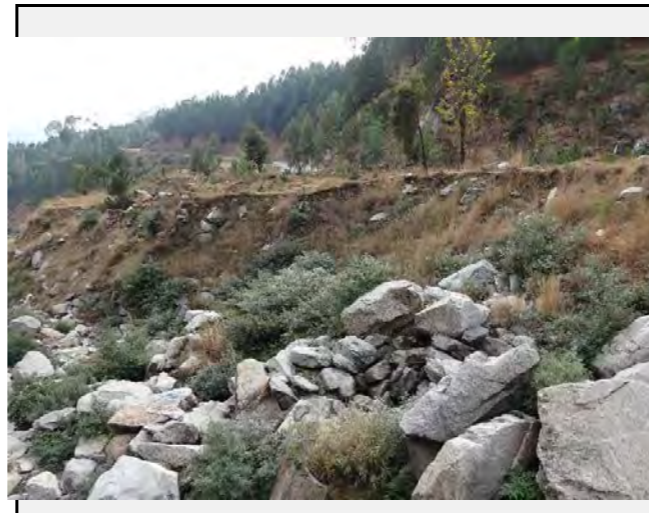
Existing countermeasures : Three pipe culvert are installed under the causeway.

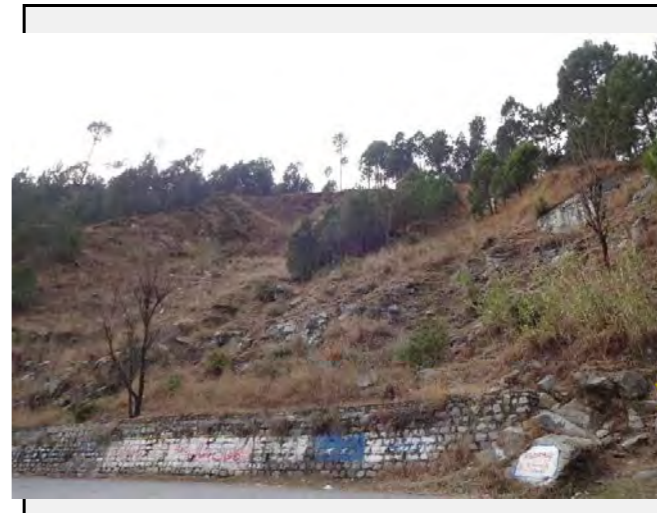
Existing anomalies: Some trace of the slope failure was observed on the valley side of the road.

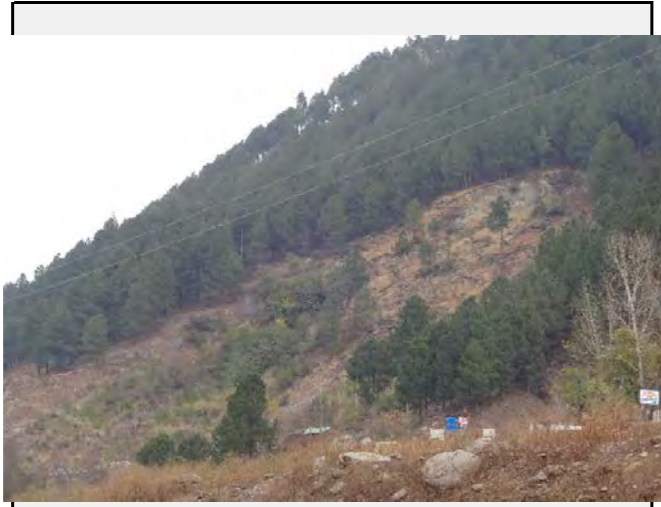
Mountain side: Scarp can be observed on the upper part of the slope. The slope is covered by tree and bushes.

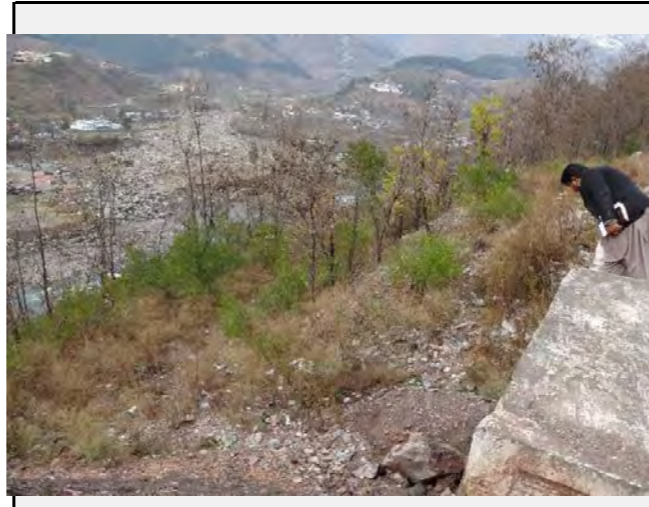
Valley side: The valley is covered by tree and bushes.

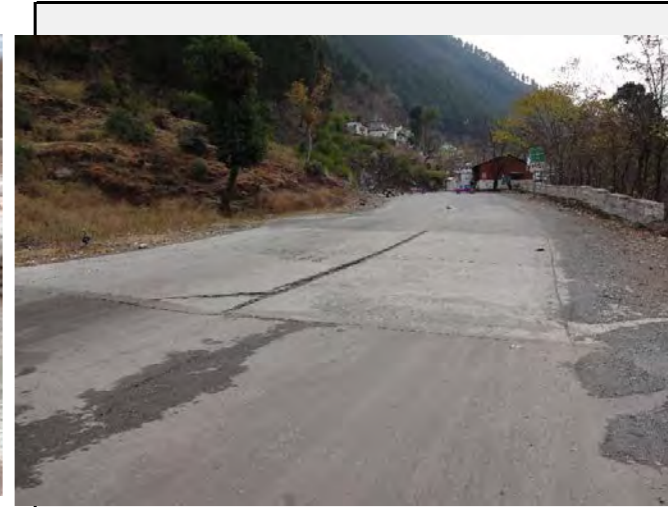
Road condition: Partial of the road were replaced due to subsidence.

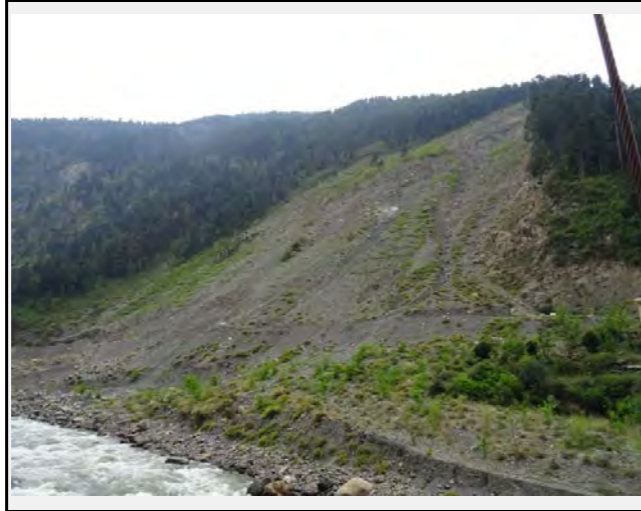
Overall view of the slope from the opposite site of the river. Talus deposited on whole surface of the slope failure area.

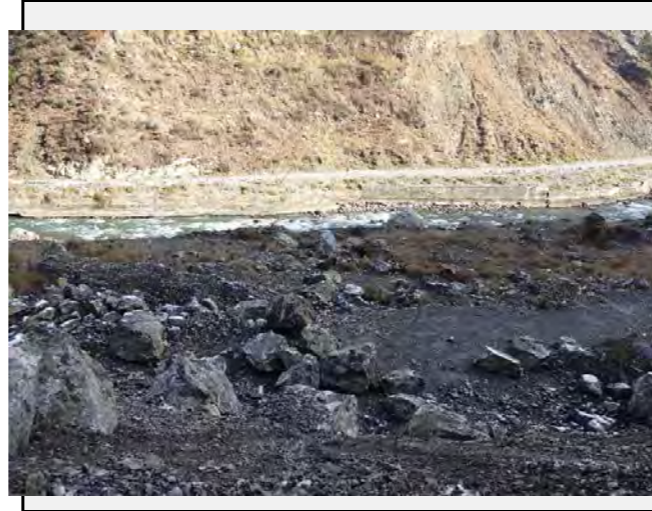
Valley side: Talus deposits can be observed on the valley side of the slope.

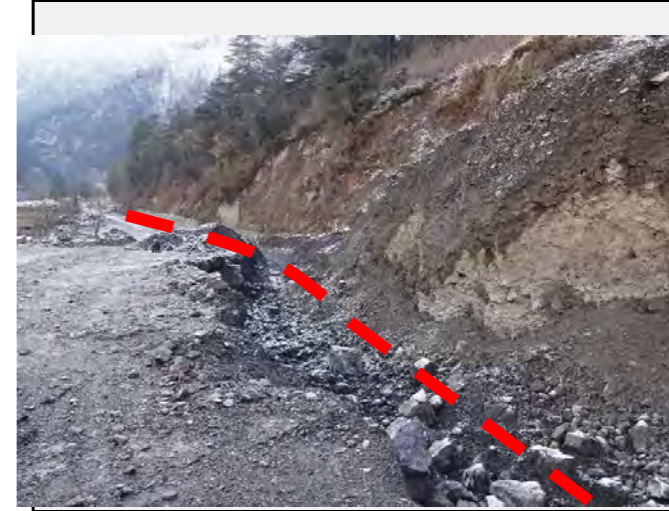
Road condition: Existing road is still buried 5m under the talus deposits.

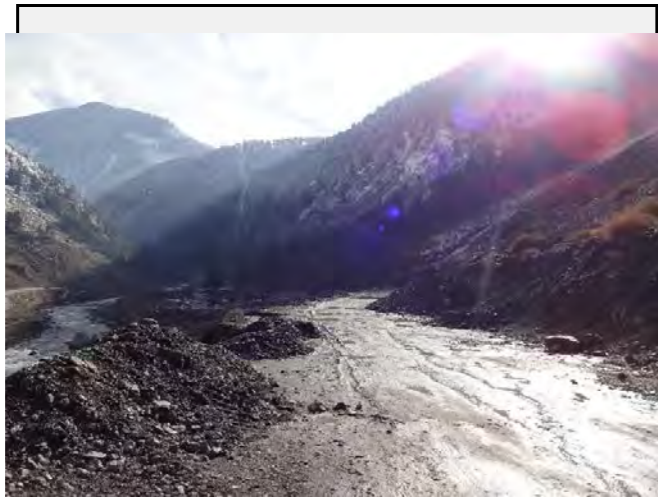
Existing countermeasures: Temporary access road used for the long-sized truck which cannot pass the road alignment on the bypass road.

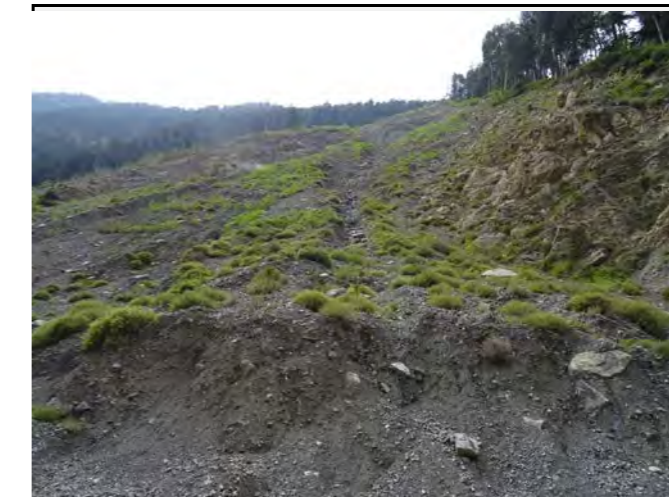
Mountain side: Talus deposits can be observed throughout the slope.

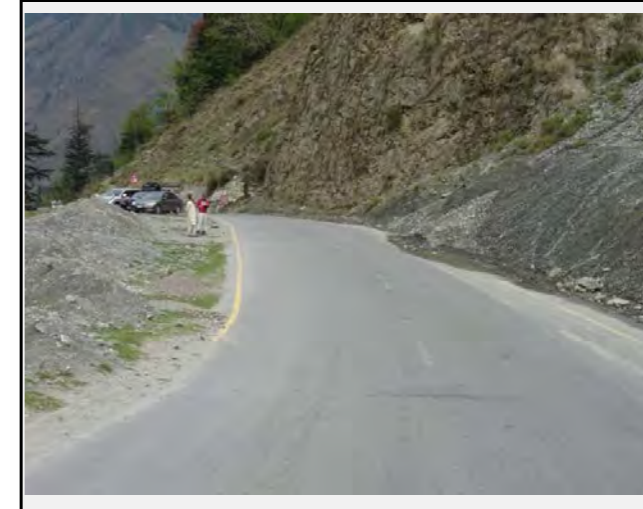
Road condition: road ditch is covered by debris

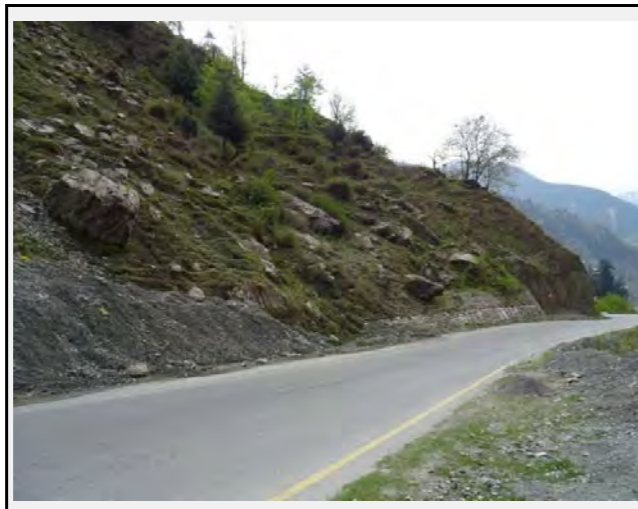
Existing countermeasures: Retaining walls are constructed partially on the mountain side. They are partially damaged by the slide

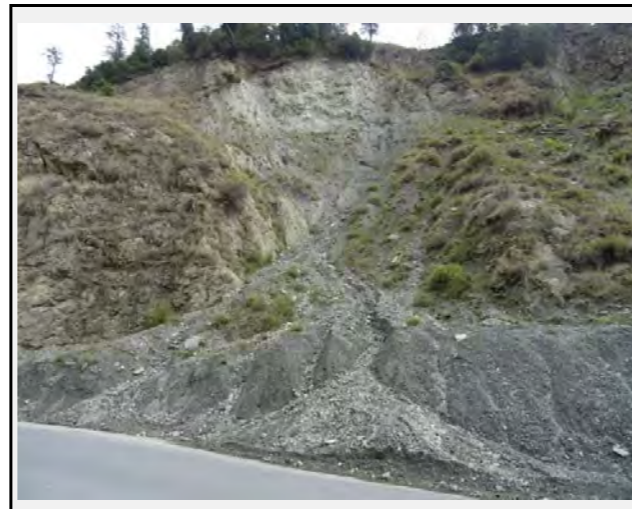
Part of the slope is highly eroded and shows multiple gullies

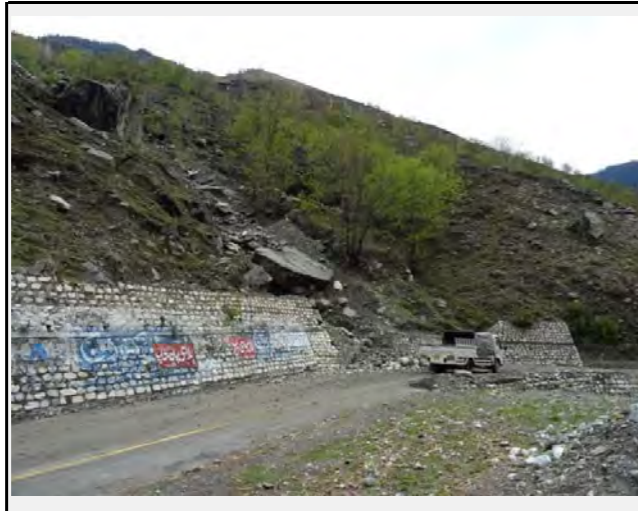
Mountain side: Big boulders (2~5m) can be observed at the exit of the stream on the mountain side.

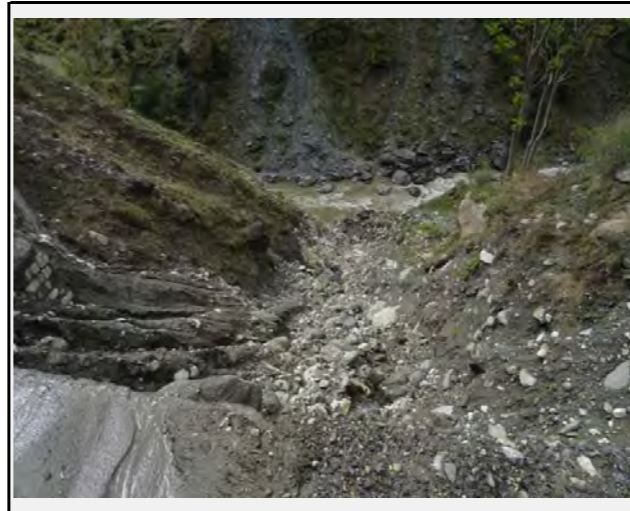
Valley side: The starting point of the stream on the valley side are narrow. Boulders can be observed on the valley side.

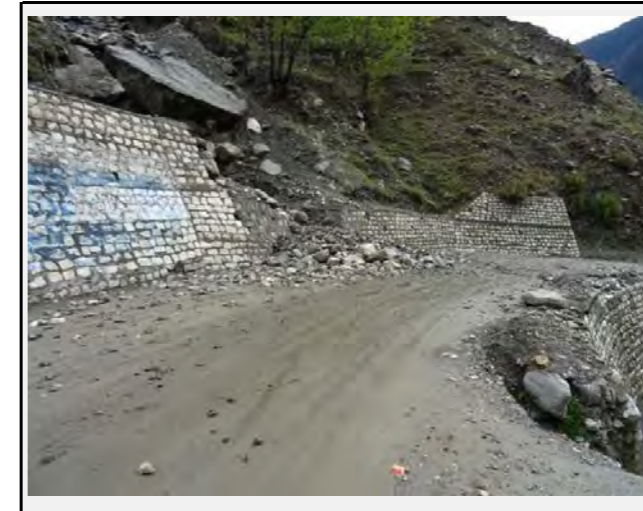
Road condition: there is mud and debris on the road and the road surface is damaged considerably

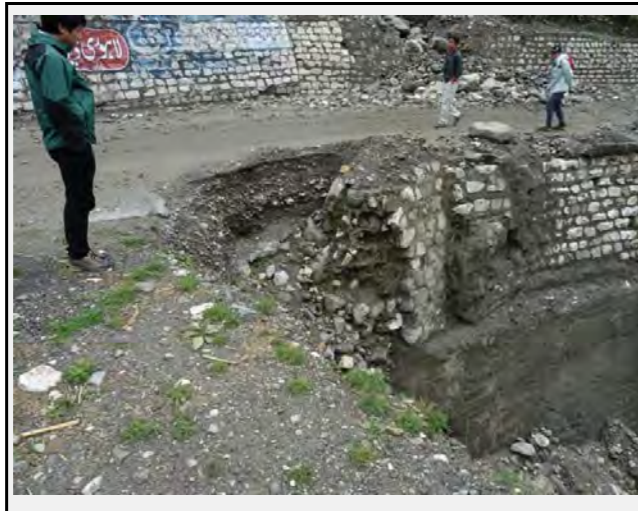
Existing countermeasures / anomalies: small damage (2m) of the retaining wall on the shoulder of the road (valley side) due to the debris flow.

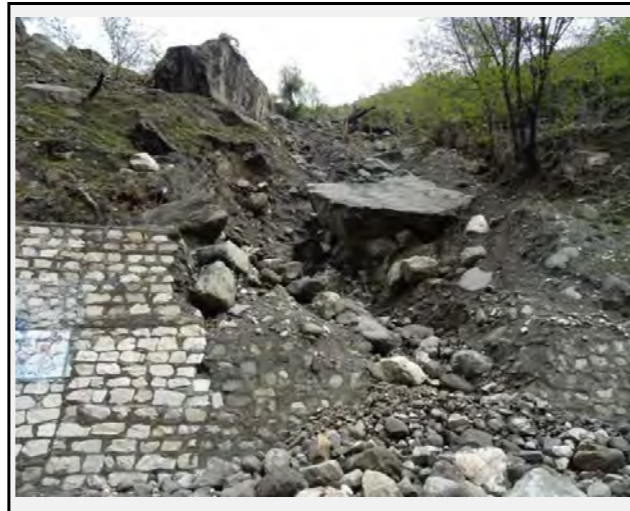
Existing countermeasures / anomalies: The exit of the retaining wall on the mountain side was re-shaped to allow the debris flow. However, this is resulting a steeper angle of the stream. The thickness of the sediment in the stream bed is around 2m

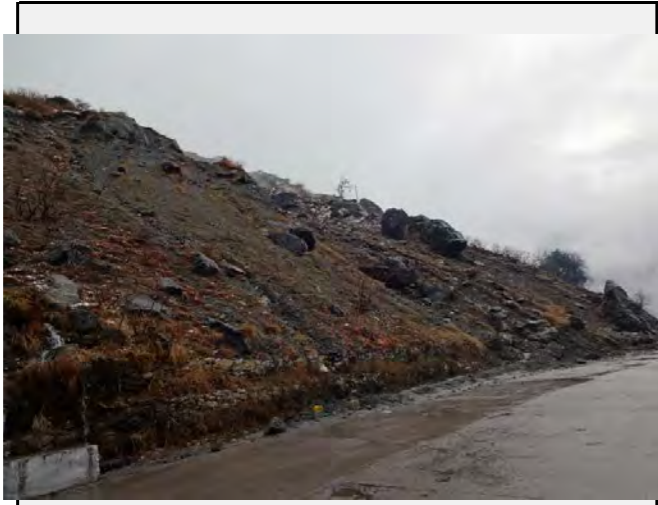
Mountain side: Talus deposit, boulders and outcrop can be observed on mountain side.

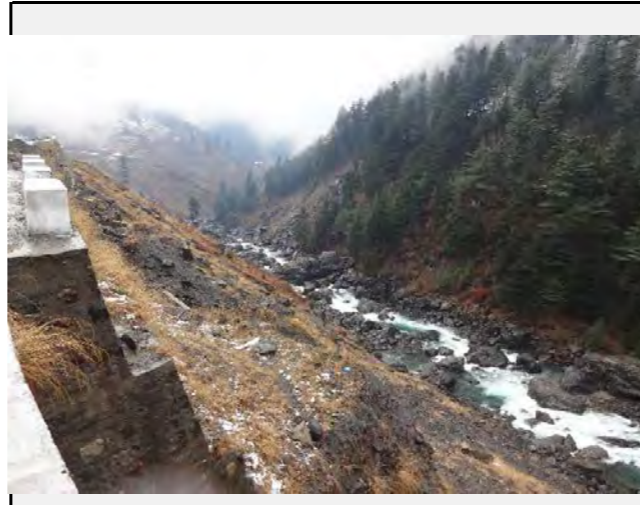
Valley side: Mostly talus deposit can be observed in the valley side.

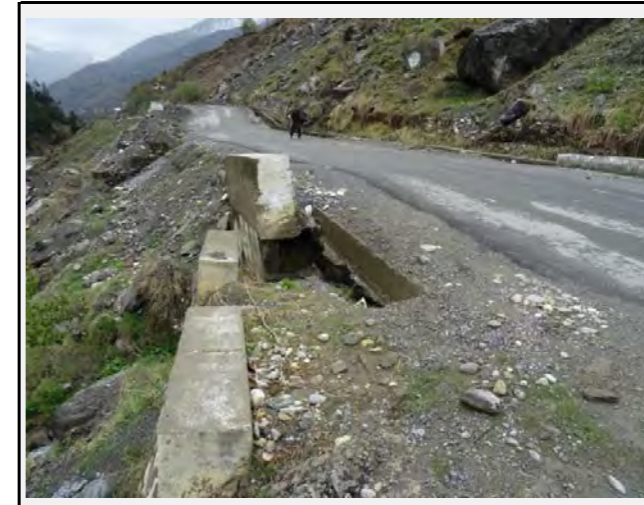
Road condition: Two area of the road subsidence was confirmed. There might be a cavity underneath the road.

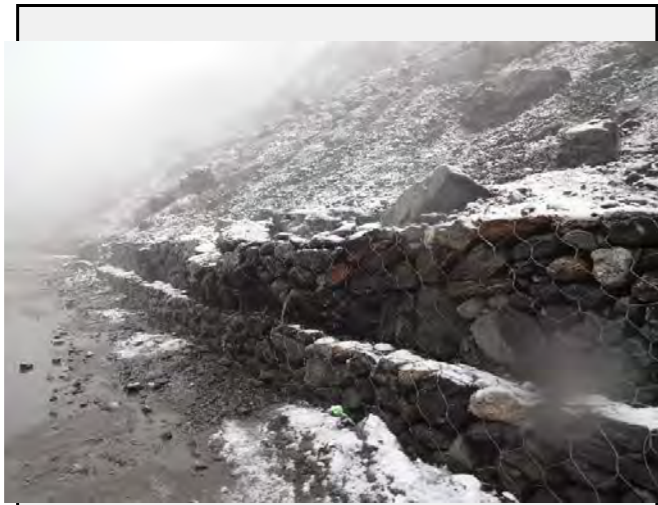
Existing countermeasures / anomalies: Several damages on the gabions was confirmed due to overload of the deposit.

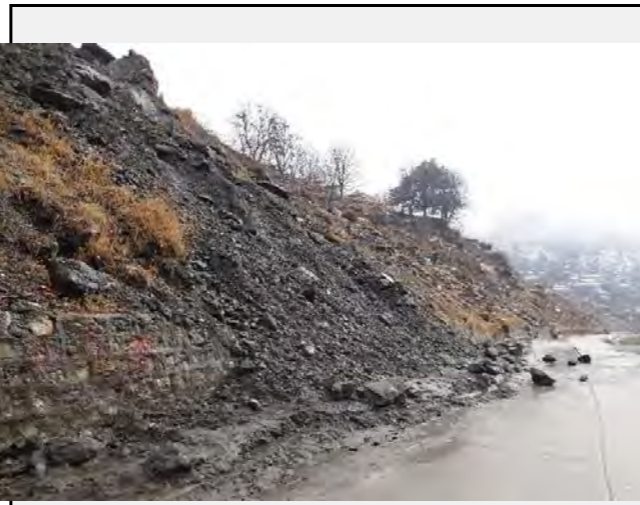
Existing countermeasures / anomalies: The slope failure is causing rocks on the road.

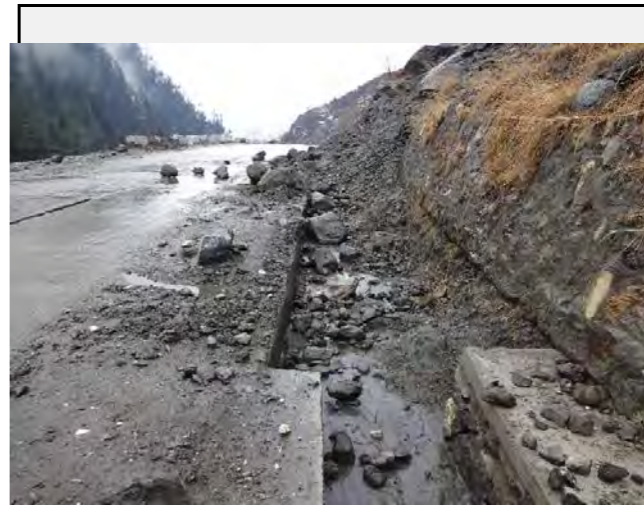
Existing countermeasures / anomalies: Some part of the water canal are filled with the debris.

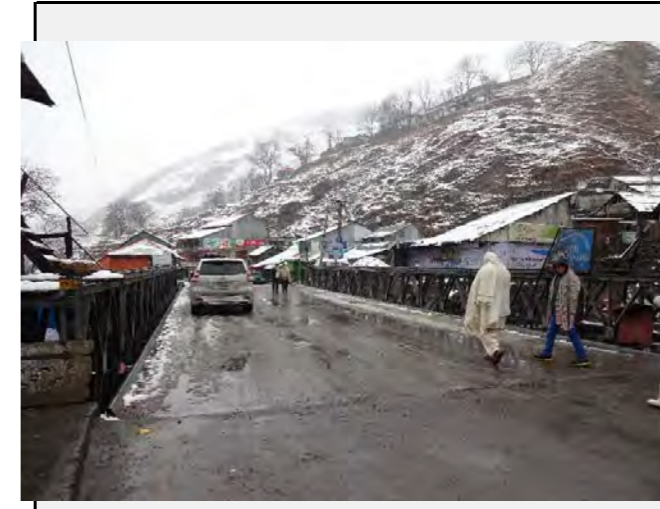
Road condition: No anomalies was confirmed on the road (bailey bridge)

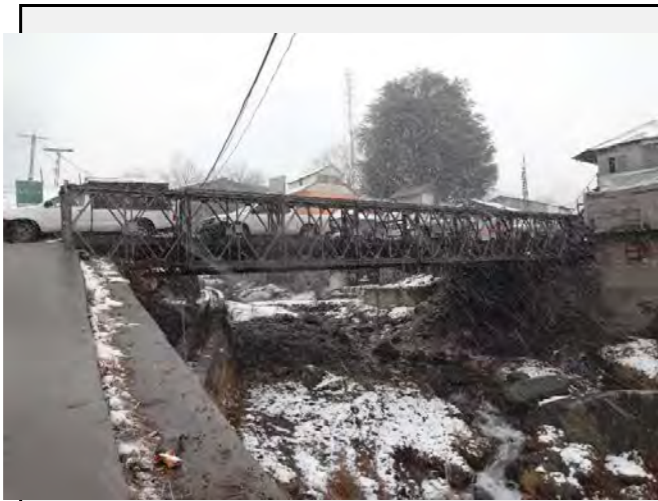
Existing countermeasures: The height of the bridge from the stream bed seems have enough capacity for debris flows at present.

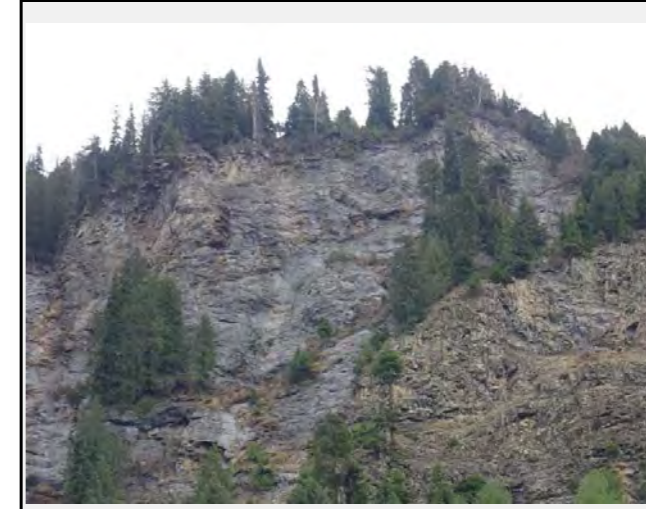
The vertical rock wall that produces the falls seems to have significant fractures

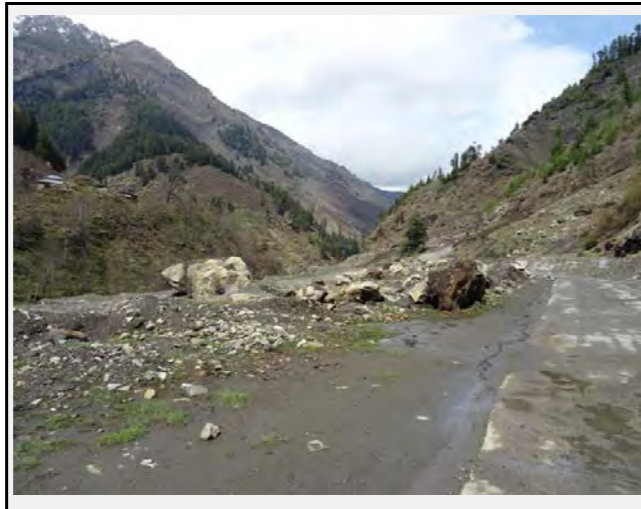
There is evidence of rock falls in the past that have been pushed to the valley side to clear the road

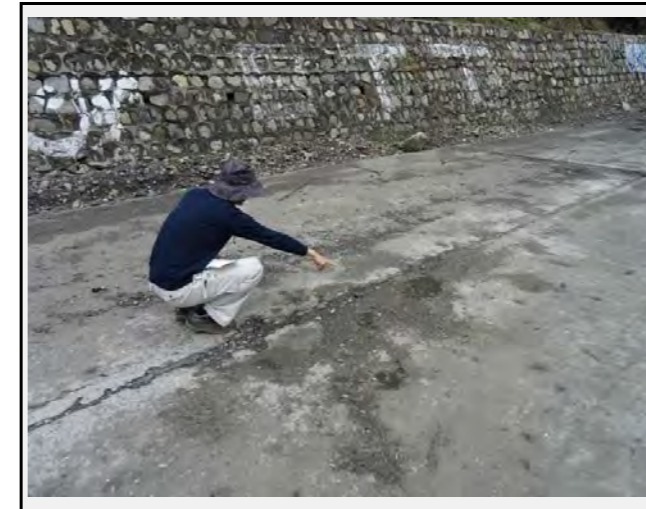
The rock falls cause damage on the road bed forming pot holes

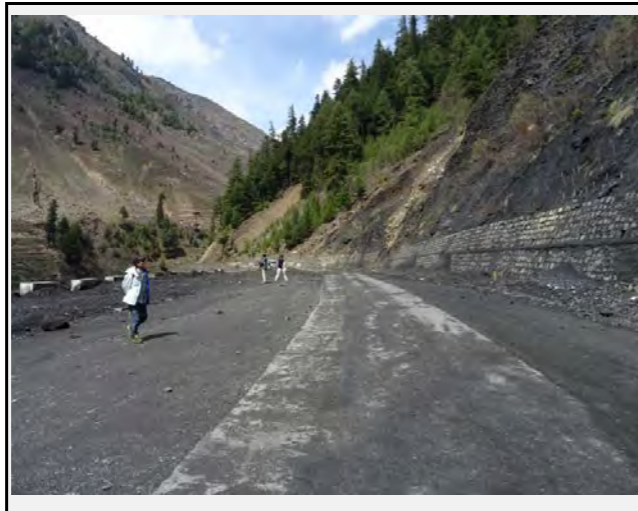
Condition of the road: the road needs to be cleared regularly due to constant collapse of the slope. The debris are removed to the valley side of the road.

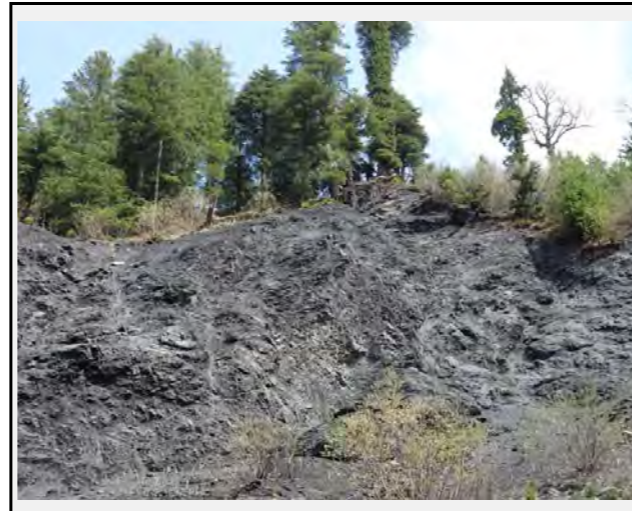
Outcrops of the base rock can be identified throughout the slope. The outcrops are highly weathered and fractured.

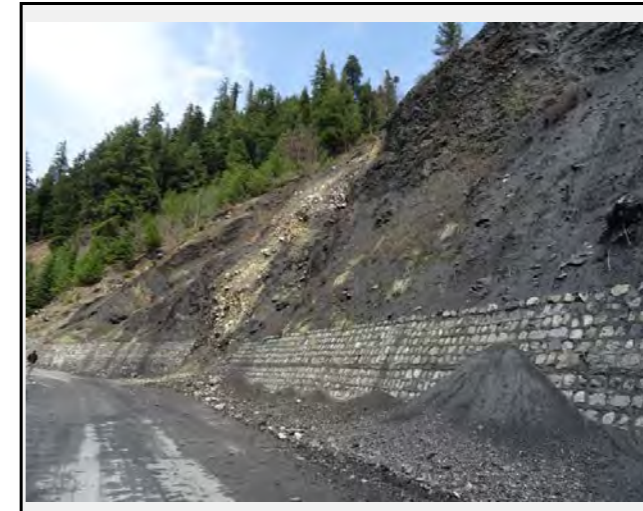
In some sections the retaining wall is damaged and the debris reach the road directly.

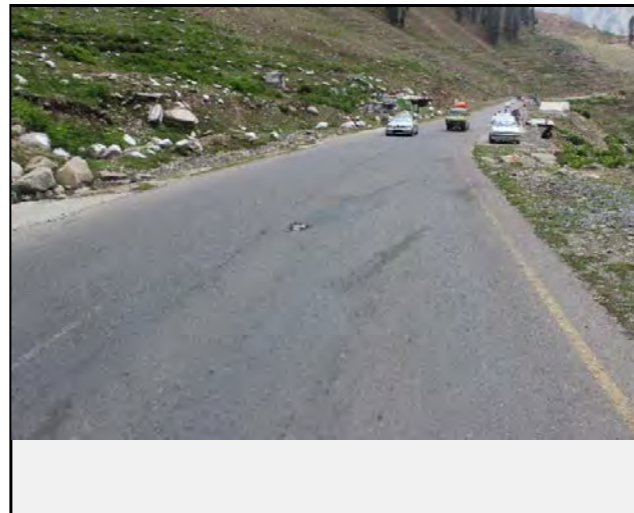
Road condition

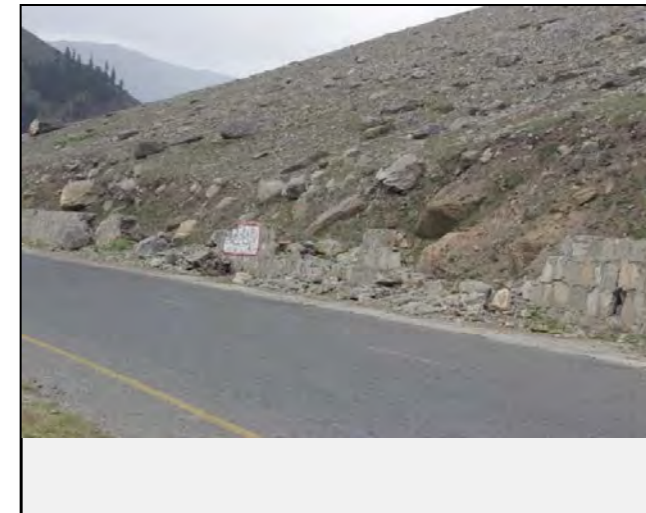
Existing countermeasures / anomalies: Retaining wall has been constructed along the Debris Flow which has been damaged by the debris material

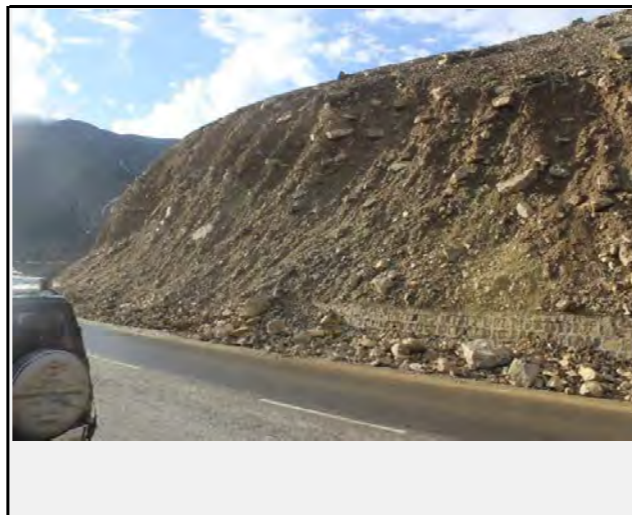
Existing countermeasures / anomalies: View of damaged Retaining Wall as counter measure

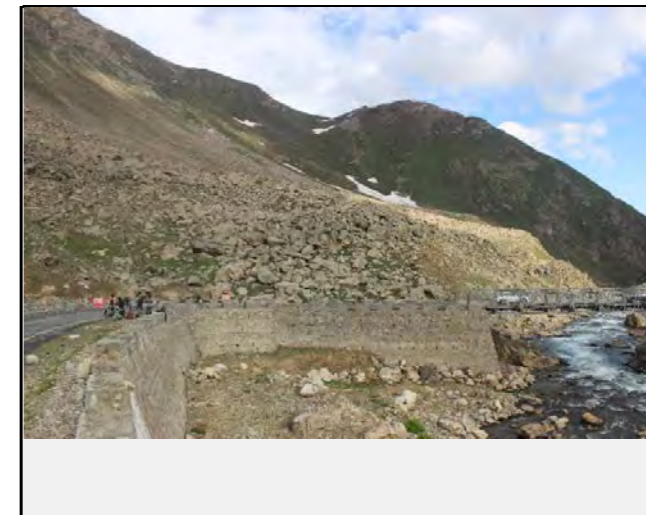
View of the toe of Landslide cut by the stream

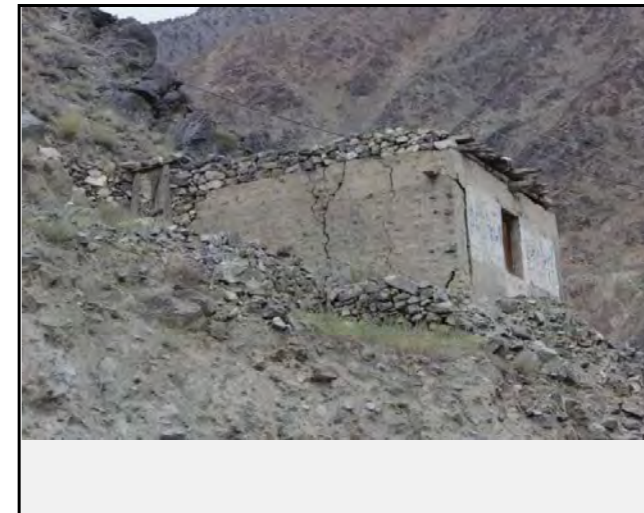
Existing countermeasures / anomalies: No Counter Measure. House has been damaged along the Debris Flow

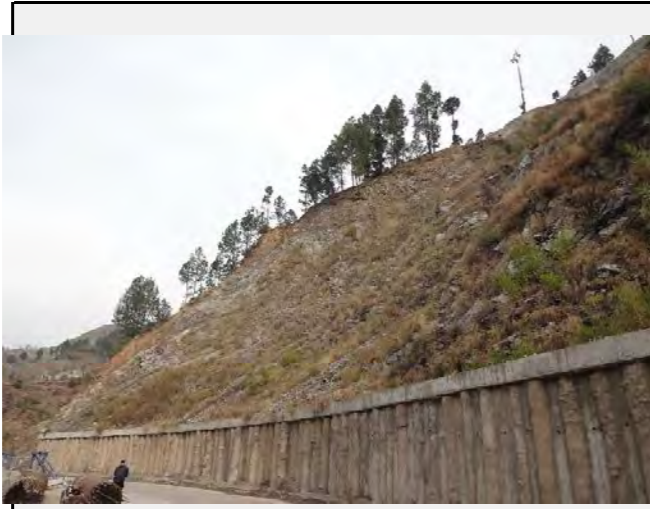
Mountain side: Outcrop and bushes can be observed on the body of the slope.

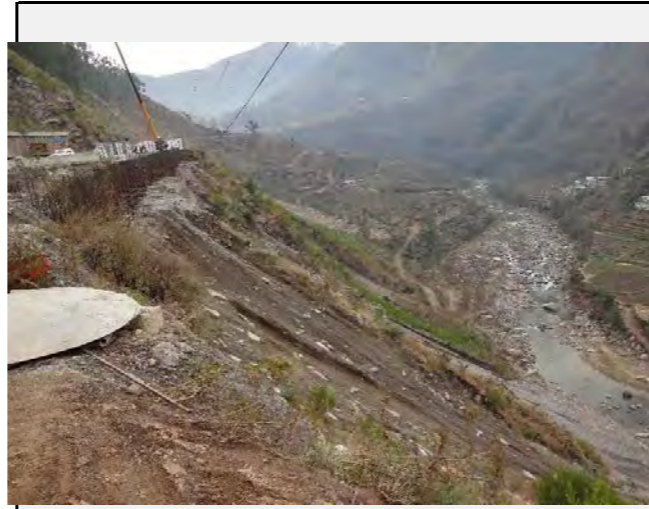
Valley side: Talus deposit can be observed on the valley side of the slope

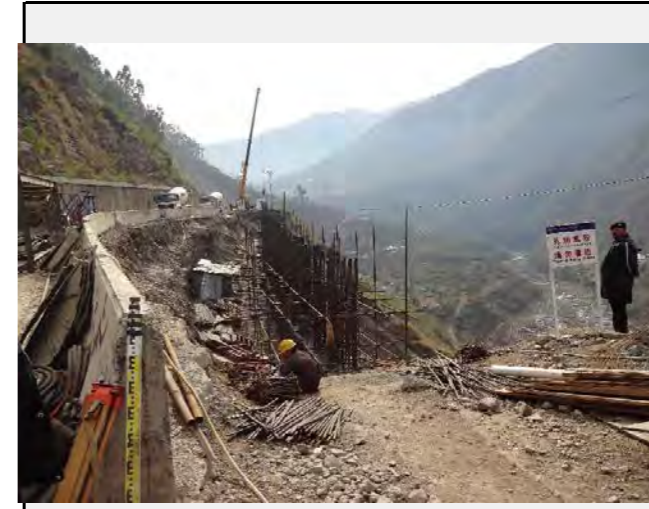
Road condition: Construction on shifting the road alignment to the valley side is being carried out by CPEC.

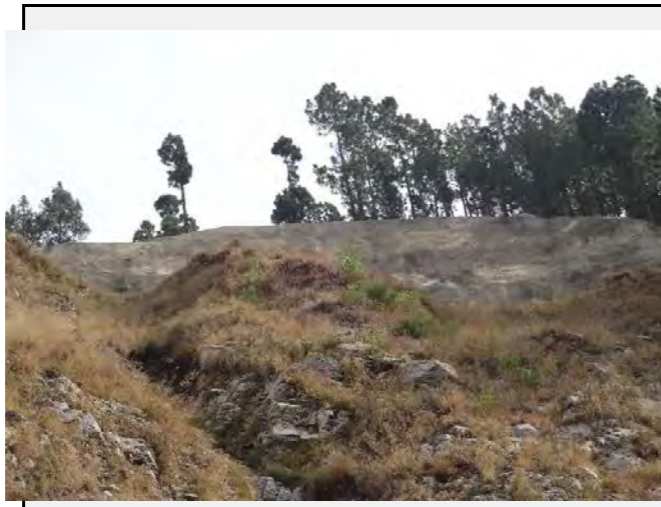
Existing countermeasures : Shotcrete was undertaken by FWO on the head of the slope to minimize the surface erosion.

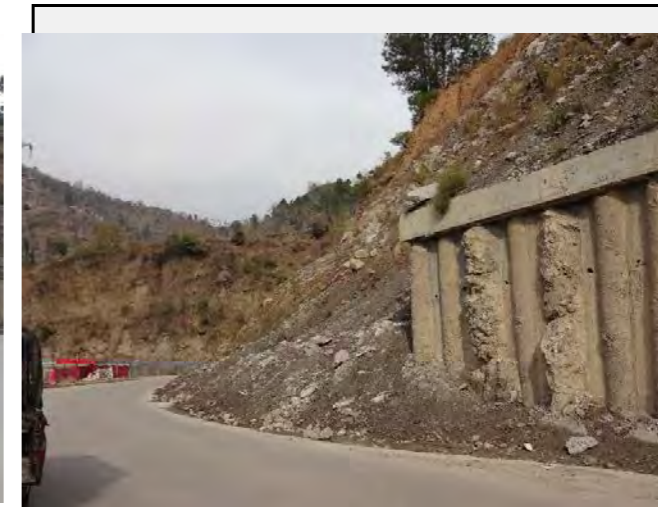
Existing anomalies: New slope failure was confirmed at the side of the previous slope where the talus deposit covered a part of the road. Some treatment maybe necessary.

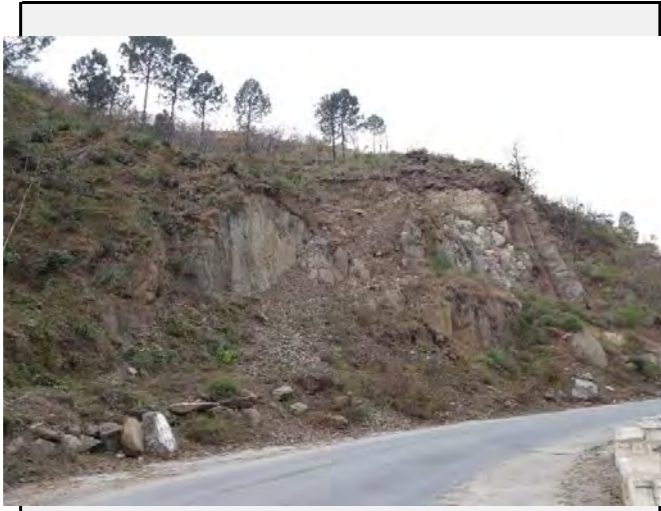
Mountain side: Both slope failure and rock fall was observed at this site.

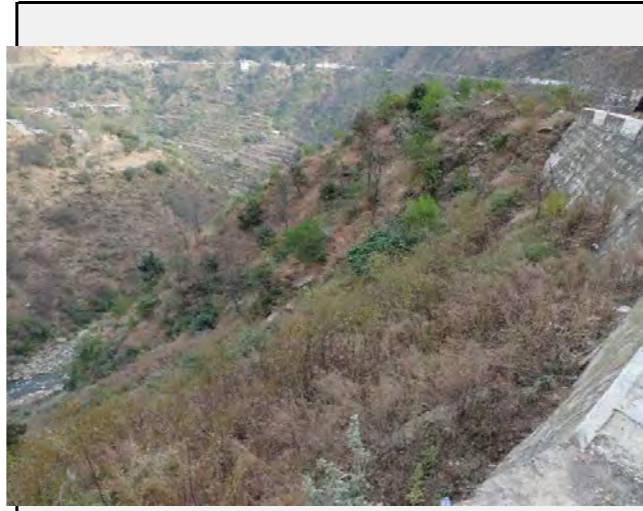
Valley side: The valley side is abundant with vegetation and no trace of slope failure was confirmed.

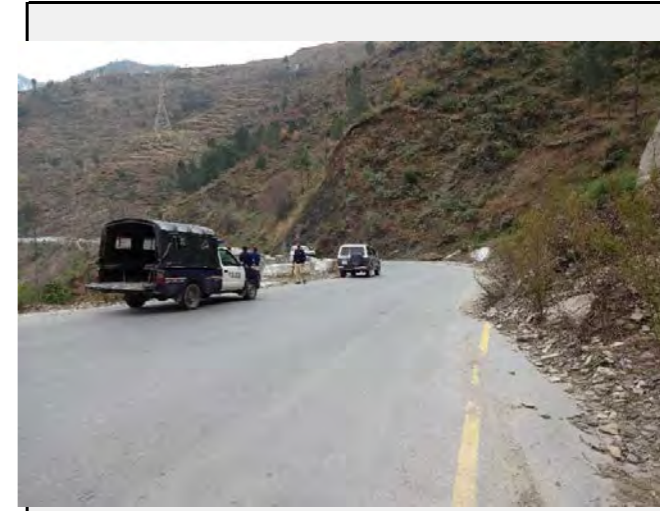
Road condition: No anomalies or damages was confirmed on the road though there was a small portion of talus deposit observed at the shoulder of the road.

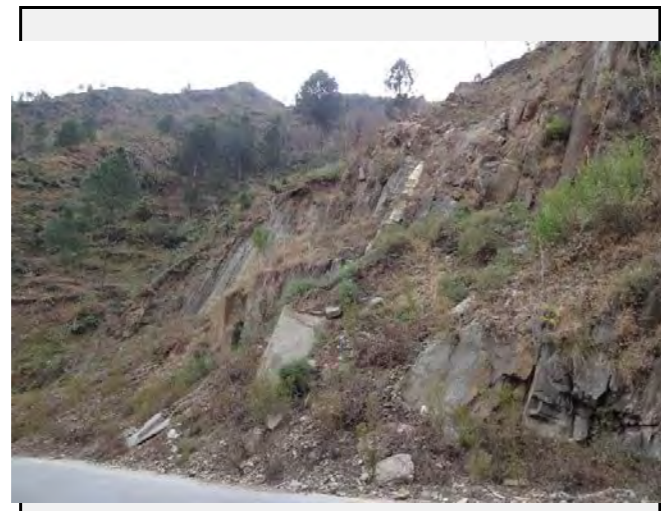
Existing anomalies: Dip slope of bedding towards the road can be observed on the slope.

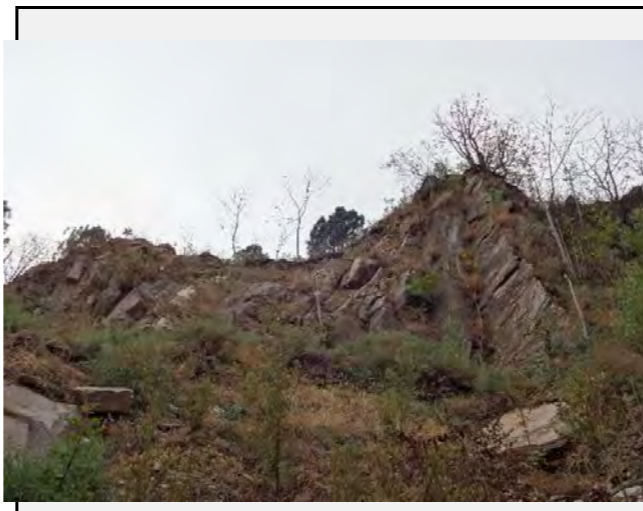
Existing anomalies: Unstable rocks can be observed at the top part of the slope. The stacks are also mostly vertical.

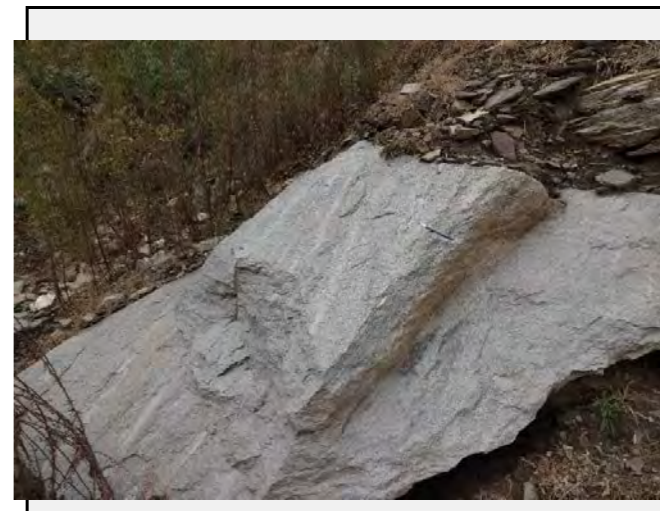
Existing anomalies: The size of the fallen rock is large enough to damage the road or cars.
