| Region Office | Abbottabad |

## Evaluation sheet (debris flow)

| Road Name | N 3 5 | Km 1 8 4 + 4 0 0 |

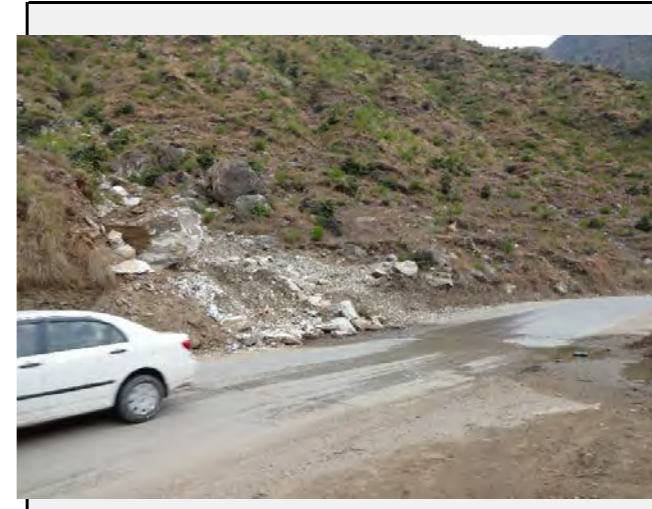
Valley side: Surface of the valley side is filled with the exavated materials from the other site.

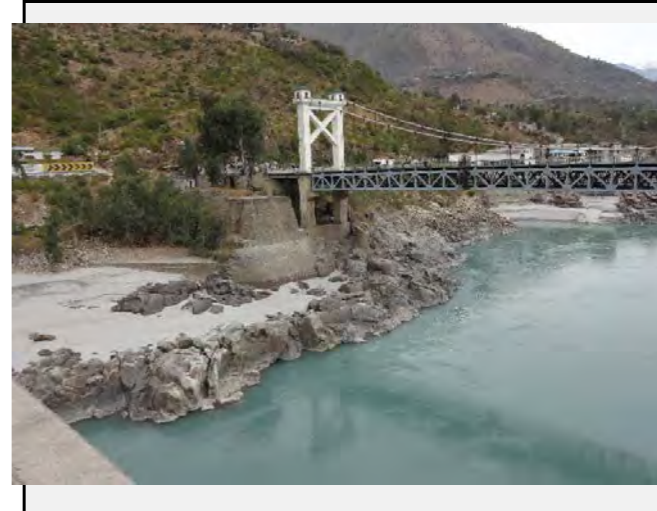
Existing countermeasures: The height of the both bridges is 30m from the water level surface.

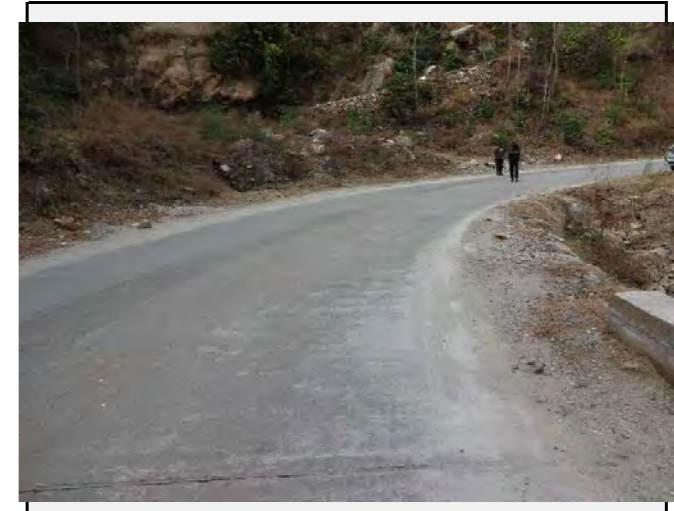
Valley side: Boulders are deposited on the valley side of the road

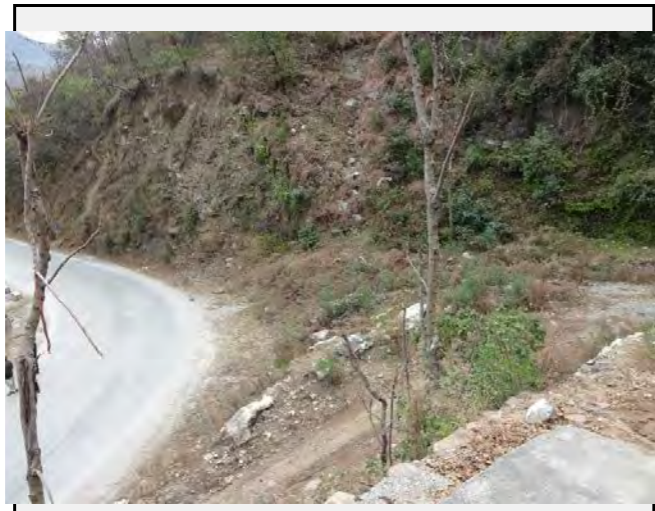
Road condition: No anomalies was observed in the causeway

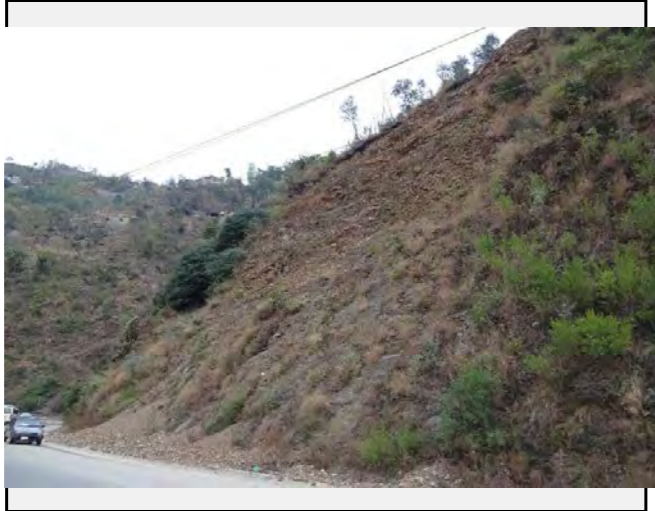
| Surface failure occurred two years ago where the talus deposit covered half of the road. Since that, small failure continues to occur though there is no obstacle to traffic. The angle of the slope is steep and many cracks was observed on the surface in which it is susceptible to weathering and erosion. Optical fibre cable is buried 1m at the mountain side of the road. The debris in the slope is thought to be stabilized given the condition of the vegetation but the outcrop in the upper part shows high weathering |

Mountain side: Surface failure was confirmed on the mountain side

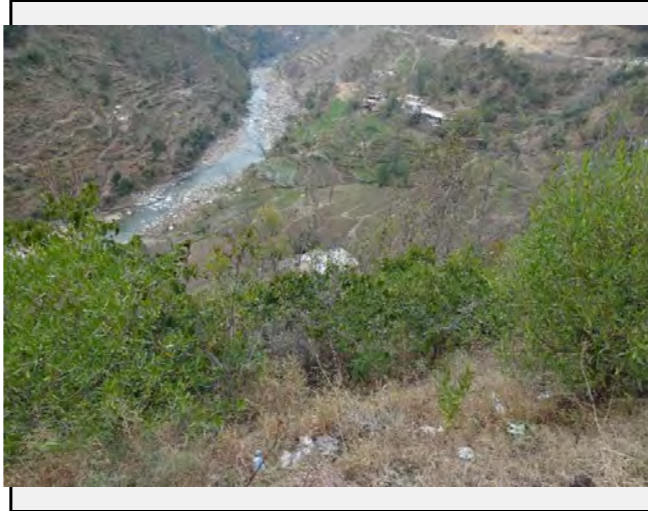
Valley side: The valley side is filled with vegetation and no trace of failure

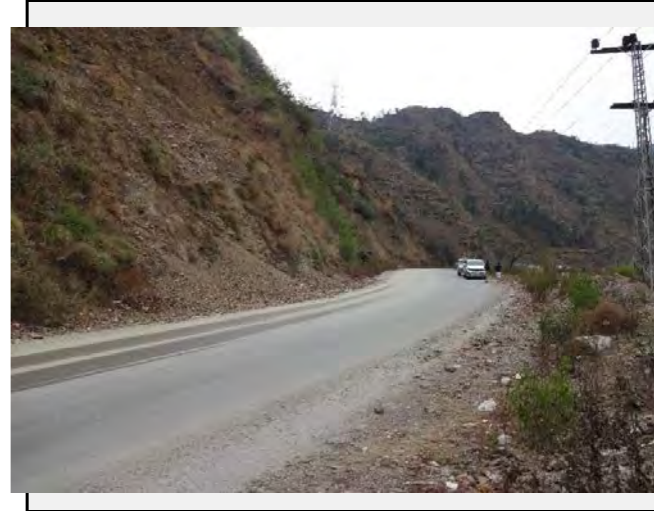
Road condition: No anomalies was confirmed on the road though there are small amount of talus deposited on the shoulder of the road.

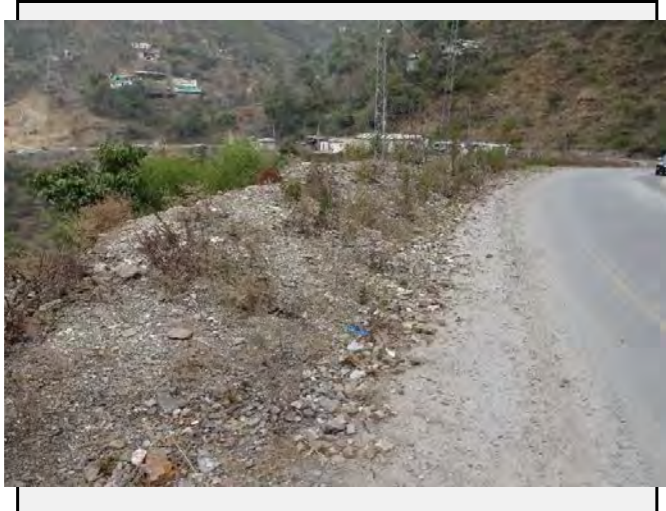
Existing anomalies: The fallen talus deposit is dumped on the valley side of the road.

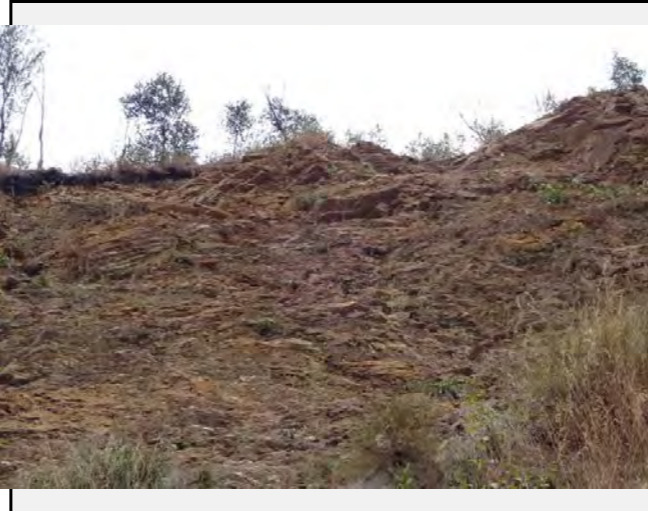
Existing anomalies: Cracks and steep angle accelerate the surface failure.

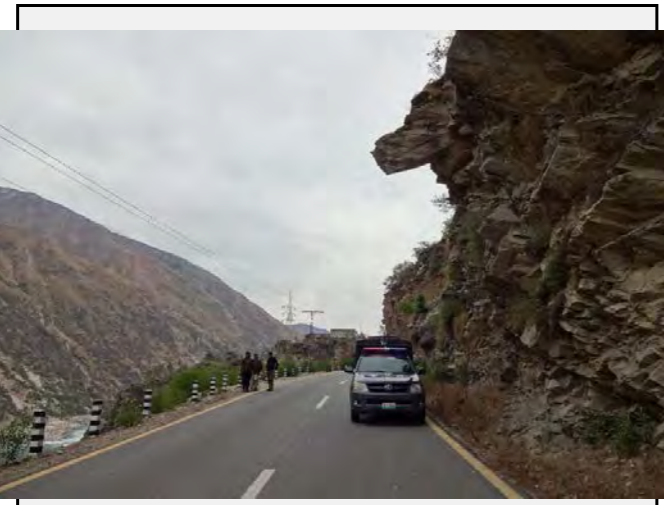
A very unstable rock is hanging on top of the road. The rockfall might be expected in near future. The removal of the rock or temporary closure of the mountain side road of the road is recommendable. Optical fibre cable is buried 1m at the mountain side of the road. An overhanging rock, dip slope and relatively high fractures can be observed

Existing anomalies: The rock is overhanging on top of the road on.

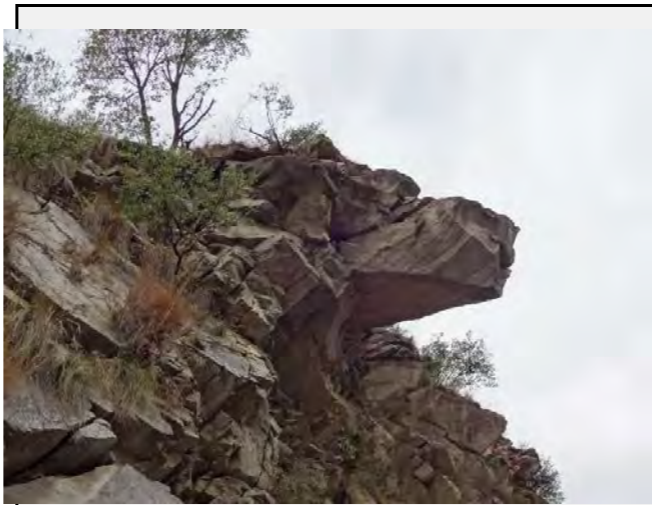
Existing anomalies: Cracks was confirmed on the upper part of the possible falling rock.

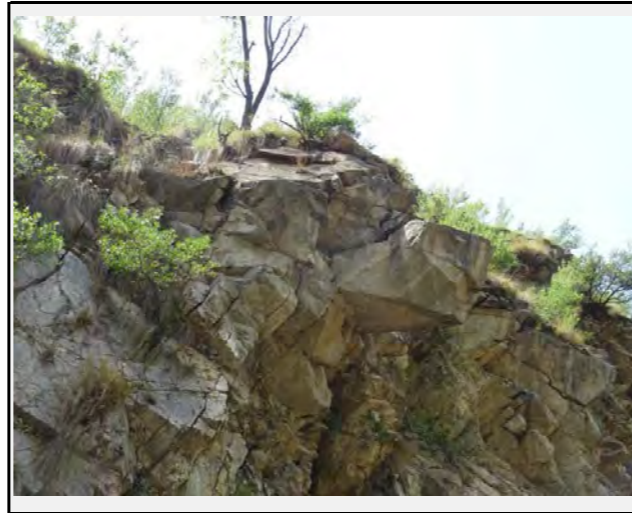
Overhangs can be observed in some spots

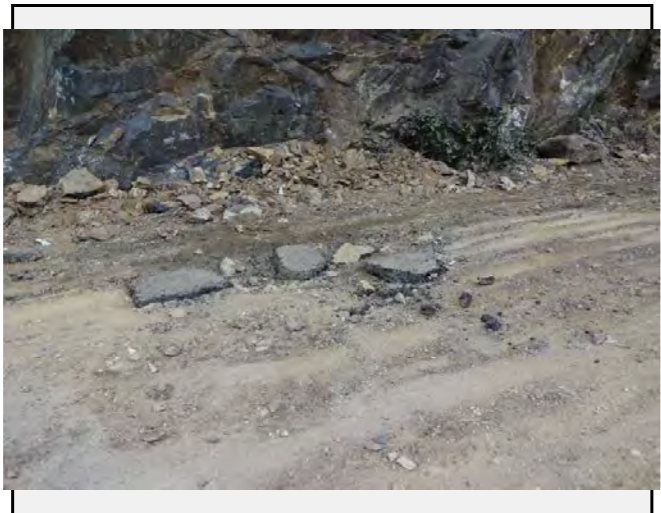
Existing anomalies: The fallen rock has damaged the road surface.

Several rock fall disaster (sized 6m<sup>3</sup> ~ 72m<sup>3</sup>) has occurred within two weeks. It may continue until every unstable rock is fall. Removal of the unstable rock or temporary closure of the mountain side road is recommendable. Optical fibre cable is buried 1m at the mountain side of the road. The scale is big and overhands, dip slope, highly fractured rocks can be observed

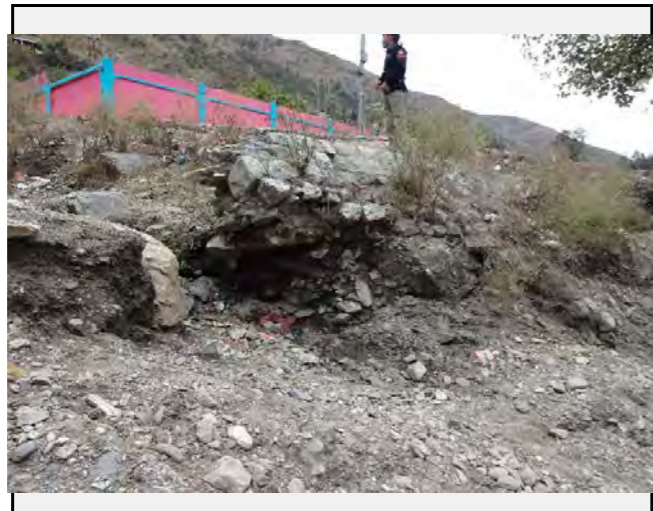
Existing countermeasures / anomalies: Damage of the retaining wall at the exit of the stream

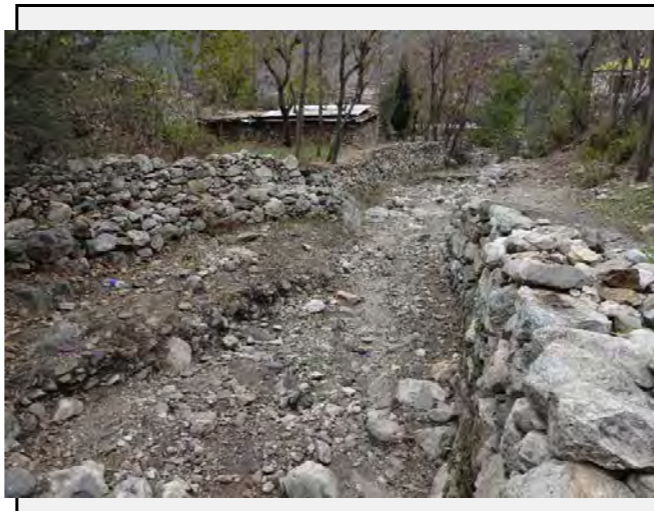
Existing countermeasures / anomalies: The retaining wall by boulders is minimizing the erosion of the bank. However, the stream bed is susceptible to the erosion.

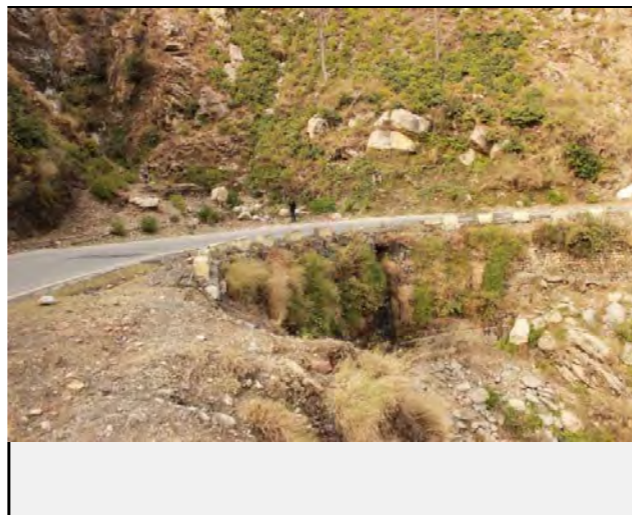
A seasonal stream crosses the highway at this location. Small catchment area with debris fall/rock fall material are present on the upstream. Small landslide was also observed along the stream which contribute in the debris volume. Granite is exposed along the stream. Various boulders of granite size more than 1 m<sup>3</sup> has also been observed. The culvert has been blocked due to debris material along this channel.

Existing countermeasures / anomalies: Inlet of the culvert is chocked by the debris.

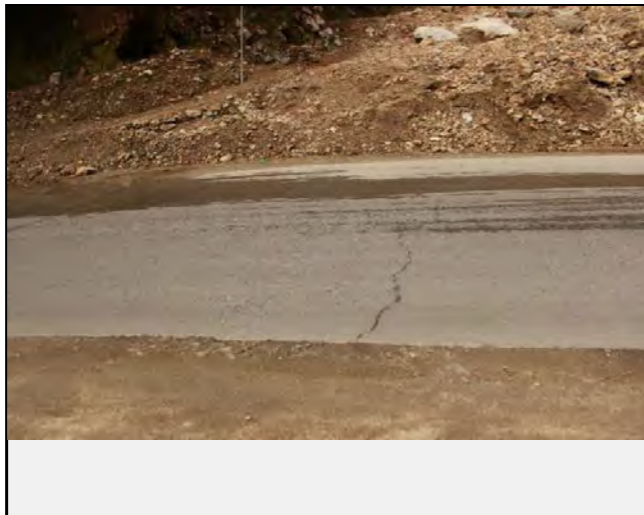
The crack on road has been observed

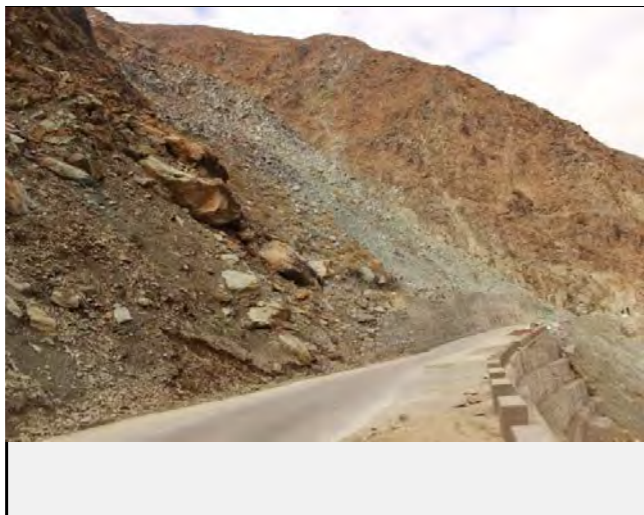
Existing countermeasures / anomalies: Retaining wall has been damaged due to slope failure
