Code no.	Sat	_	N	3	5	_	1	6	2
Region Office									
Maintenance Unit

Evaluation sheet (Slope failure/Rockfall)

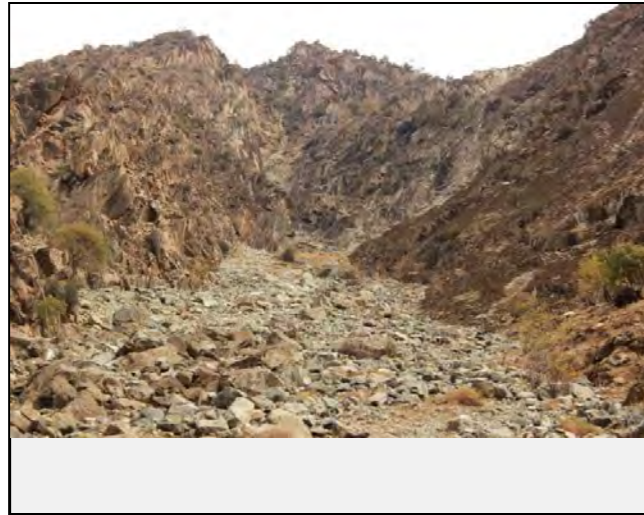
Full view of the slope failure

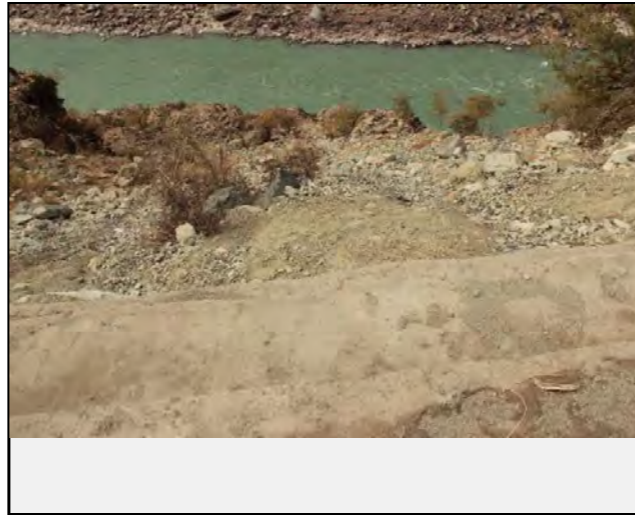
View of slope failure on Valley side:

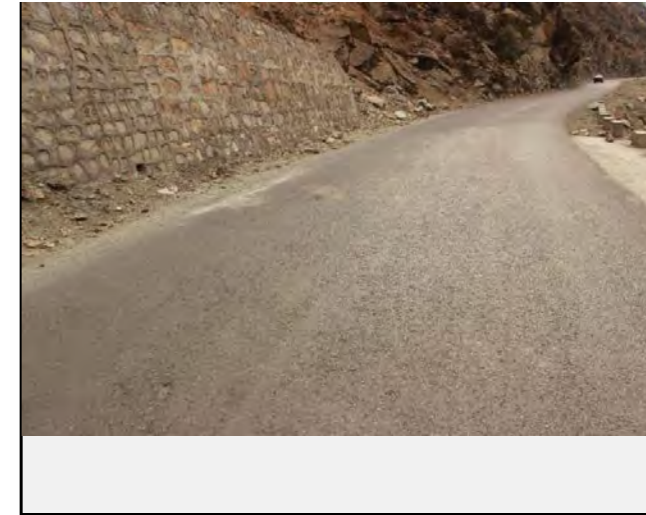
Road condition: Cut slope at the start point

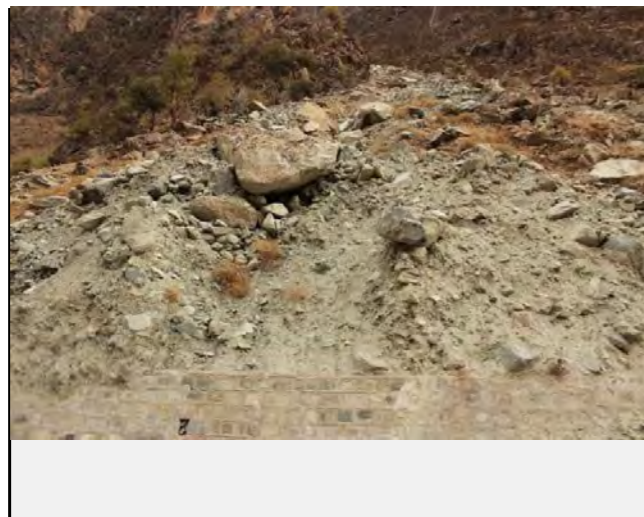
View of the slope failure at the middle point

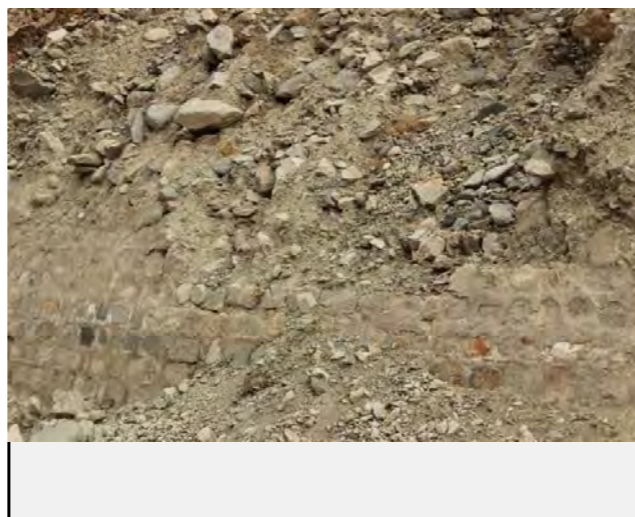
Existing countermeasures / anomalies: View of retaining wall as counter measure for slope failure

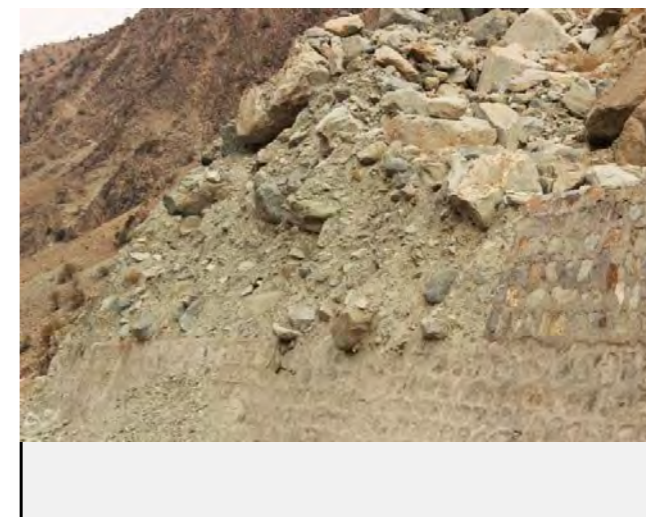
View of fallen blocks

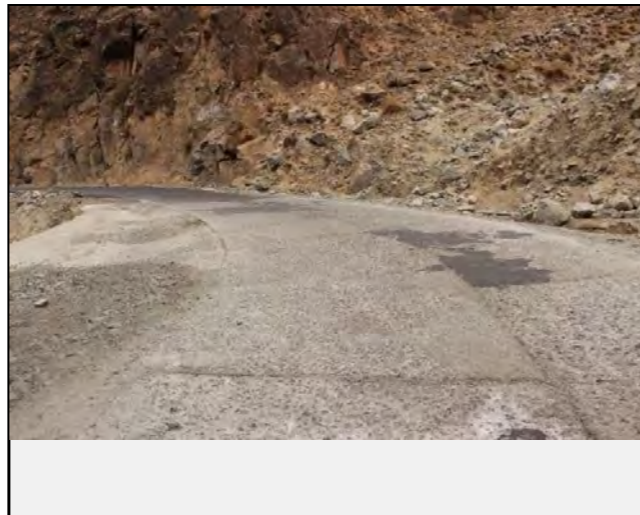
Existing countermeasures / anomalies: Retaining wall has been constructed for N-35 road

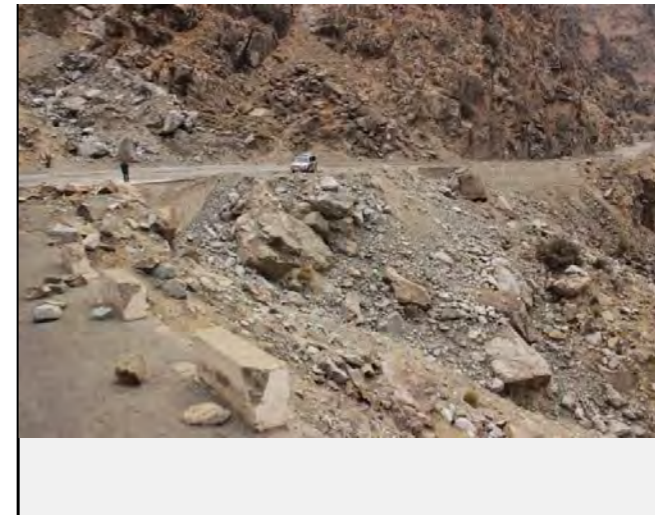
Existing countermeasures / anomalies: Retaining wall has been constructed for N-35

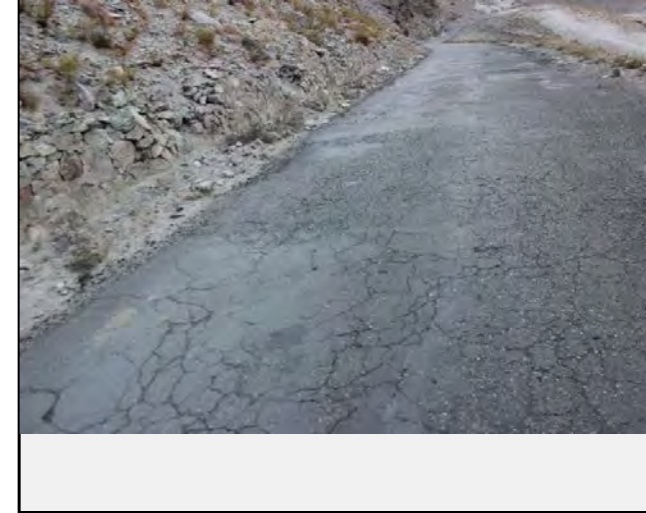
Road condition: Cut slope at the start point

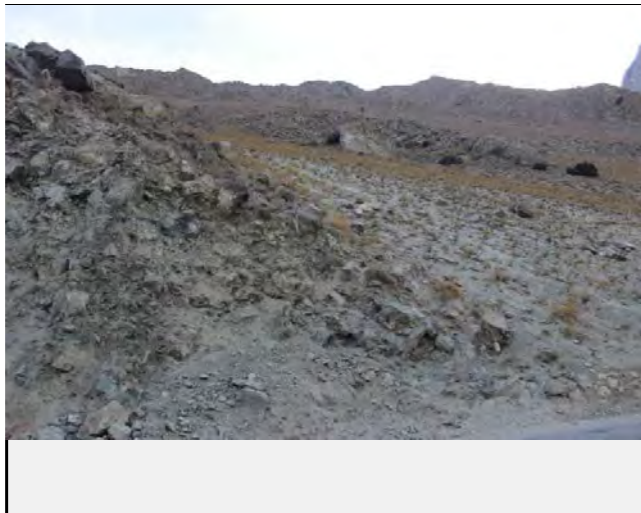
View of the slope failure at the middle point

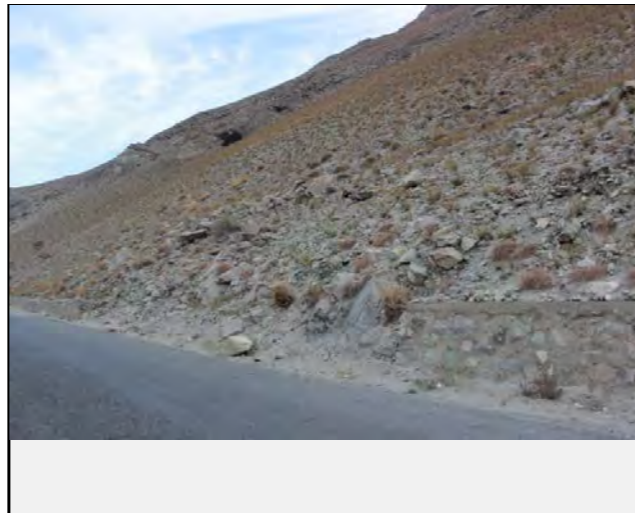
Existing countermeasures / anomalies: View of shed as counter measure

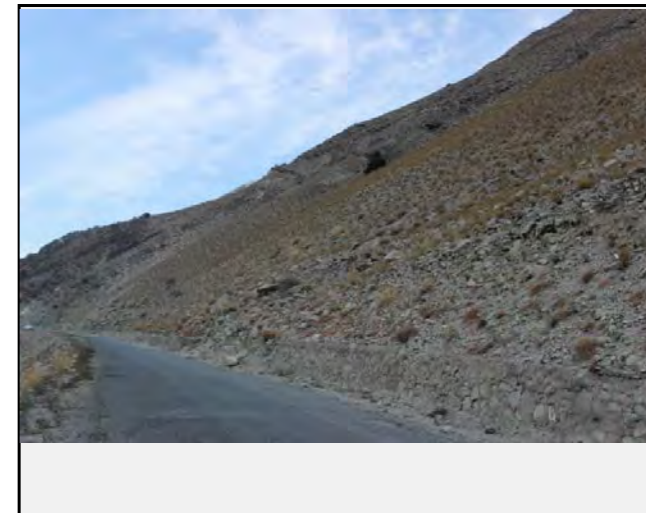
View of Multiple slope failure in the talus deposits

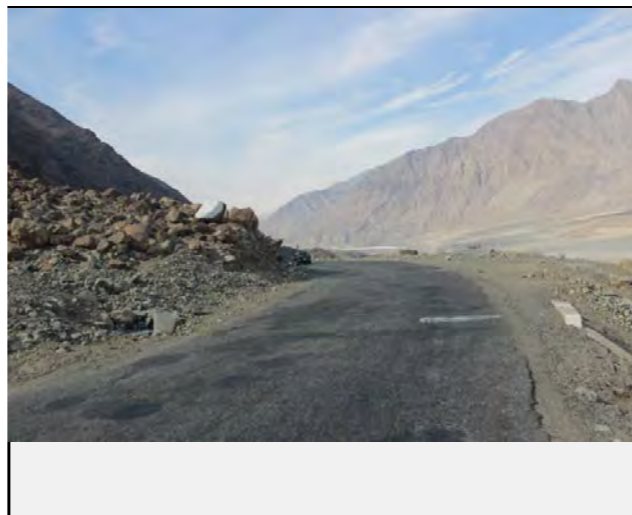
Road condition at the start point

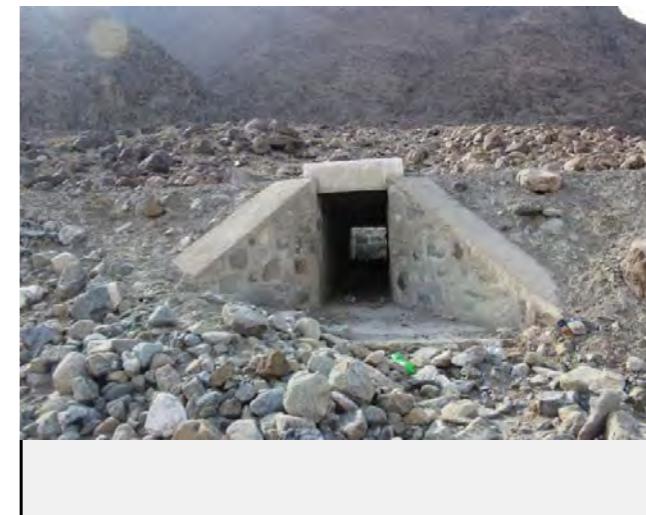
Existing countermeasures / anomalies: Culvert outlet view

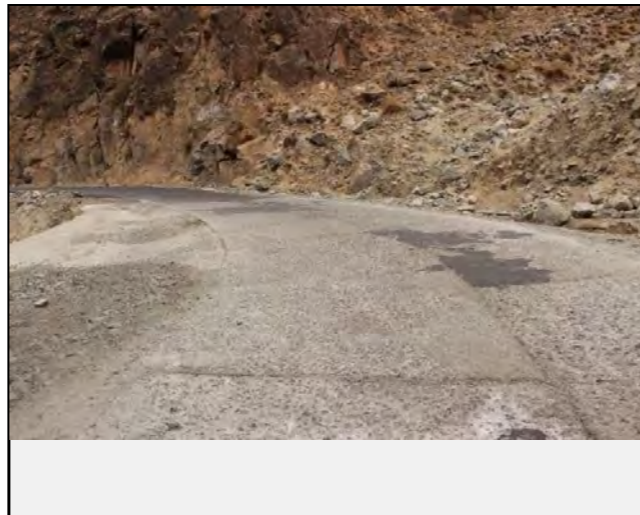
Existing countermeasures / anomalies: Retaining wall has been constructed for N-35 road

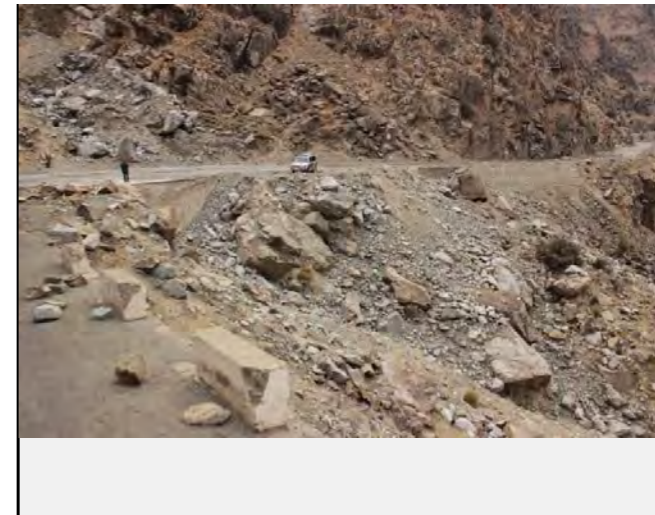
Existing countermeasures / anomalies: Retaining wall has been constructed for N-35

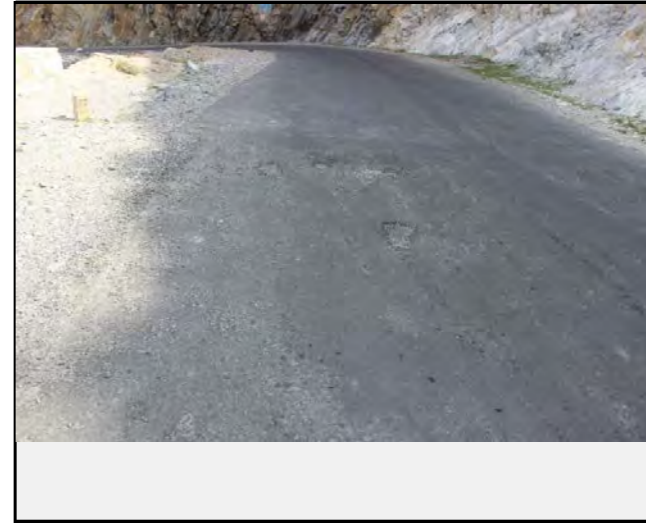
Road condition: Cut slope at the start point

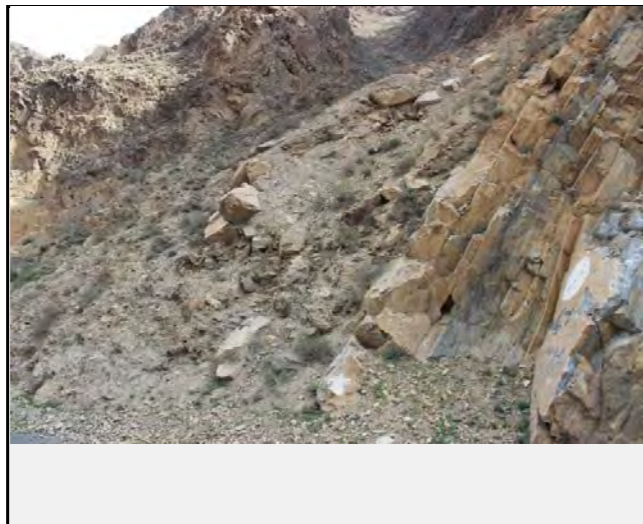
View of the slope failure at the middle point

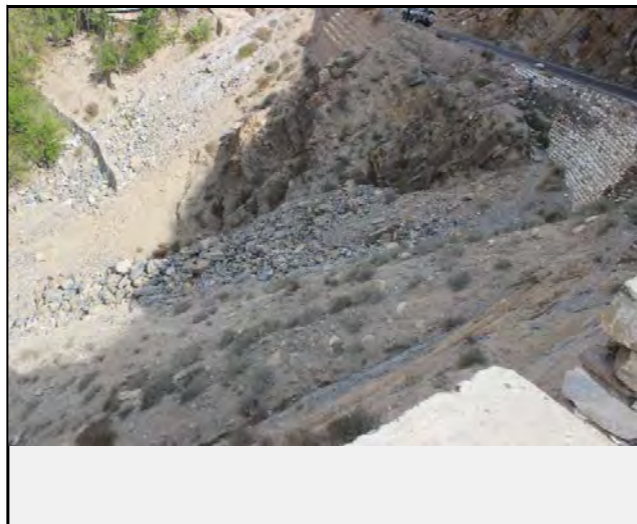
Existing countermeasures / anomalies: View of retaining wall as counter measure for N-45

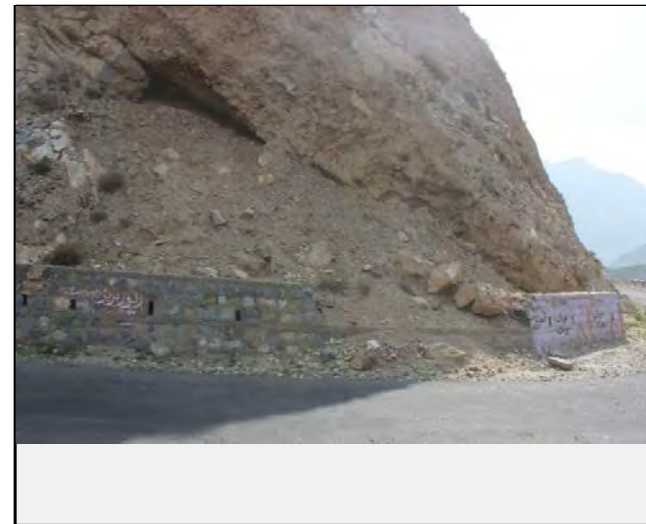
View of unconsolidated material with damaged retaining wall.

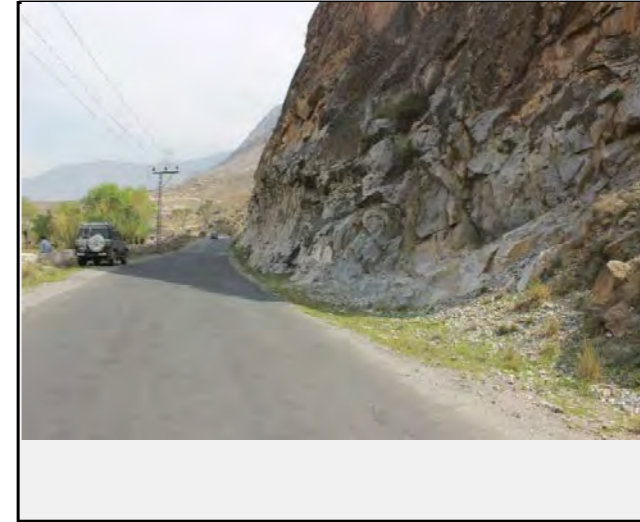
Road condition: Cut slope at the start point

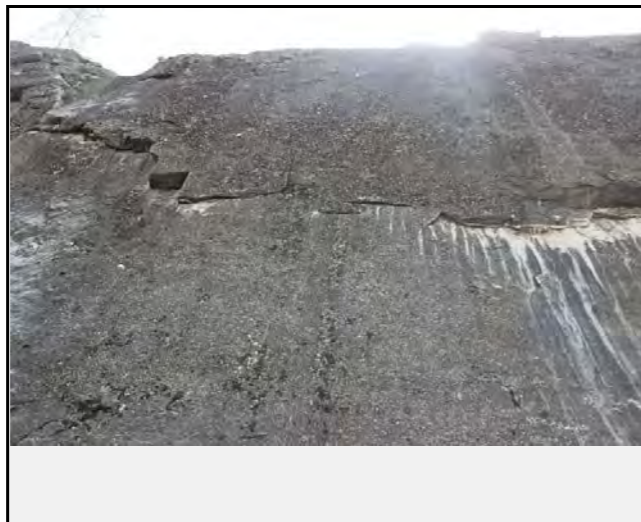
View of the slope failure at the middle point

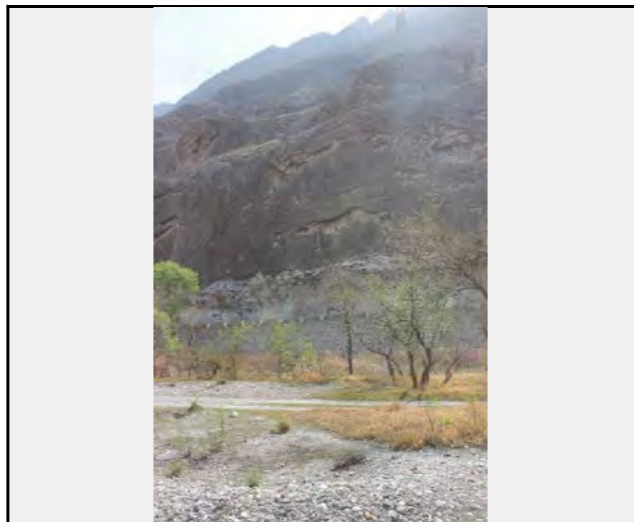
Existing countermeasures / anomalies:

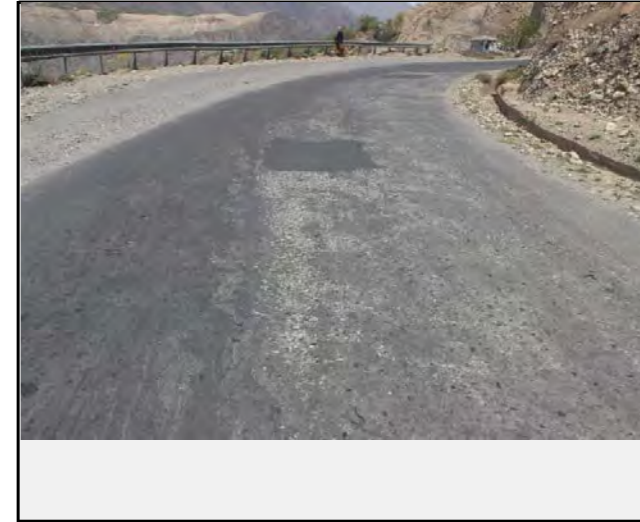
Road condition: Cut slope at the start point

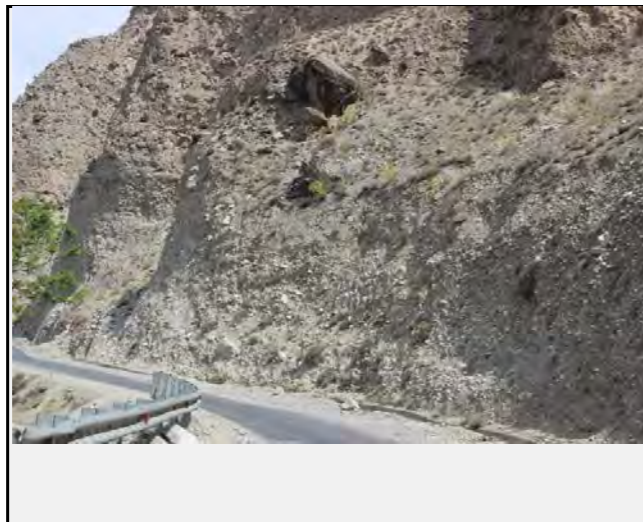
View of the slope failure at the middle point with boulder which threaten the road and traffic.

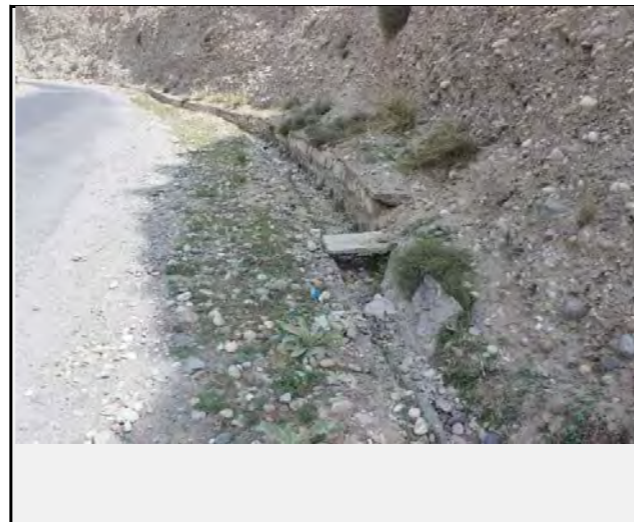
Existing countermeasures / anomalies: View of channel at the toe of Slope Failure

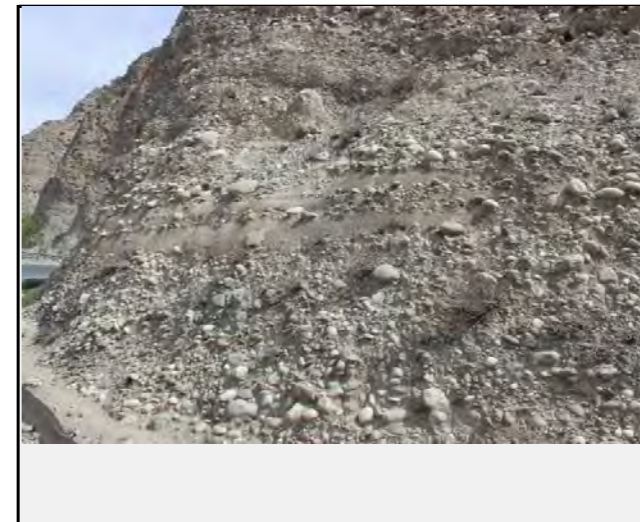
View of sandy layer in the alluvial deposits.

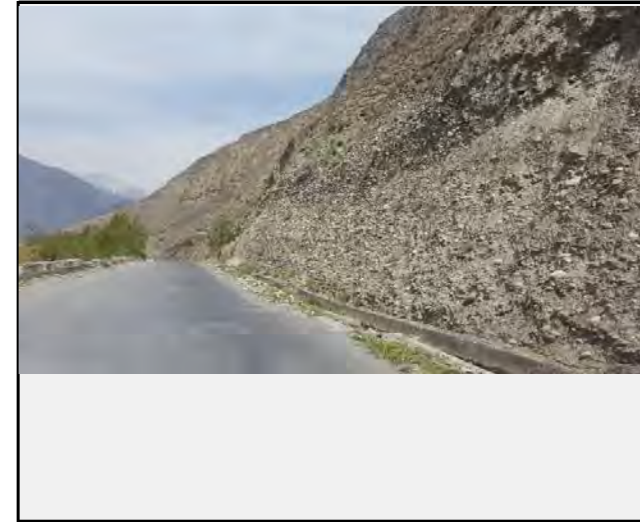
Road condition: Cut slope at the start point

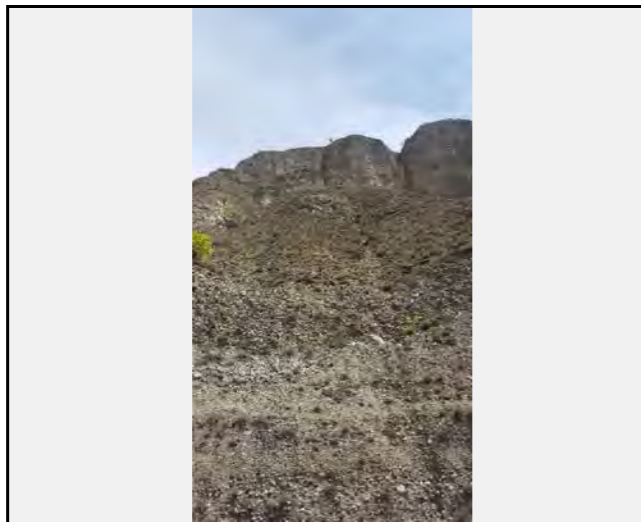
View of the slope failure at the middle point

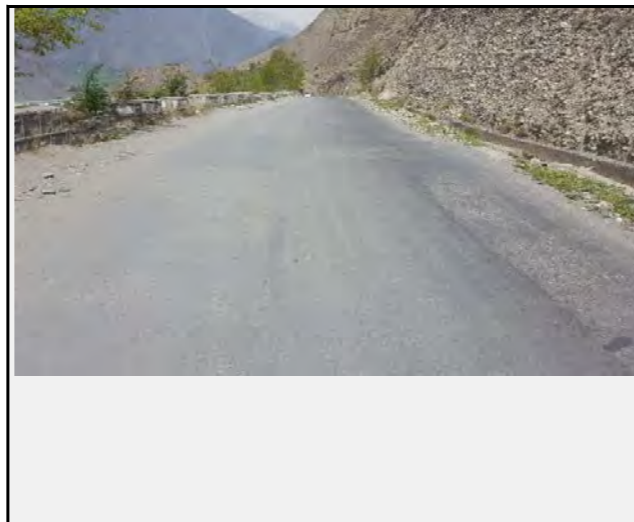
Existing countermeasures / anomalies: View of water channel at the toe of slope failure and parapit wall as counter measure

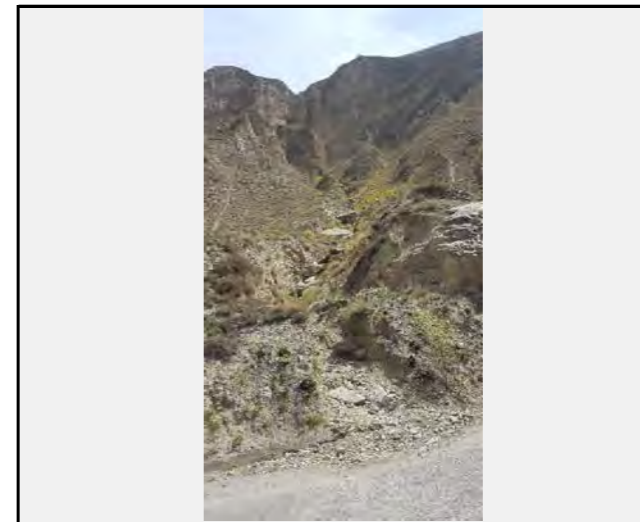
View of gully erosion in the middle of slope failure

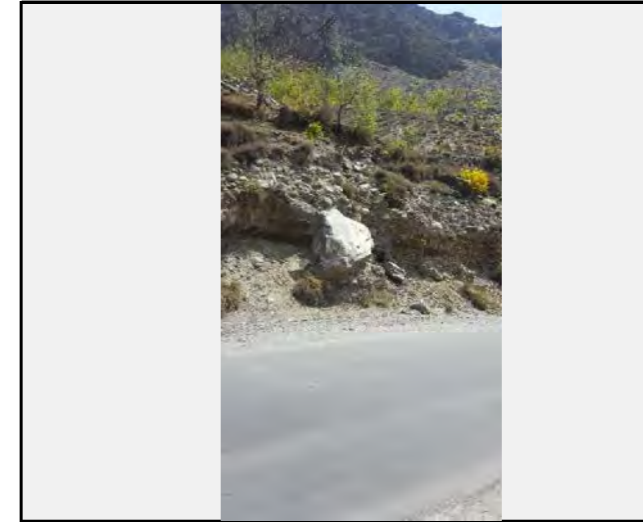
Road condition: Cut slope at the start point

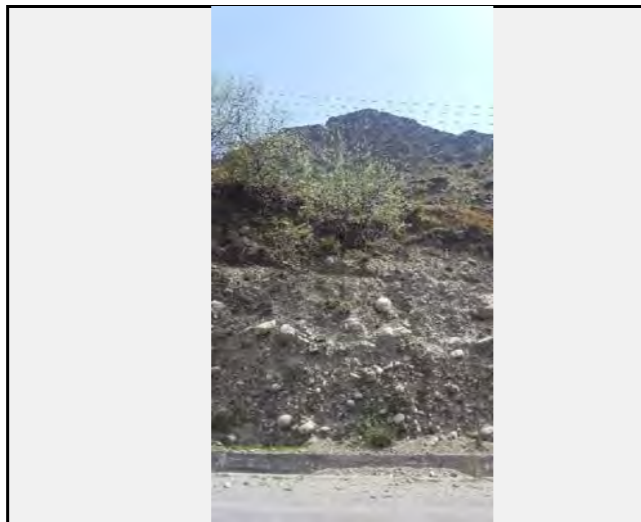
View of the slope failure at the middle point

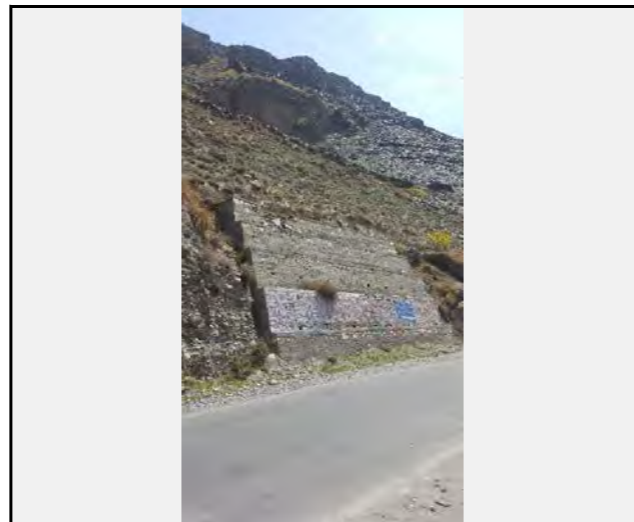
Existing countermeasures / anomalies: View of Stepped Retaining Wall as counter measure

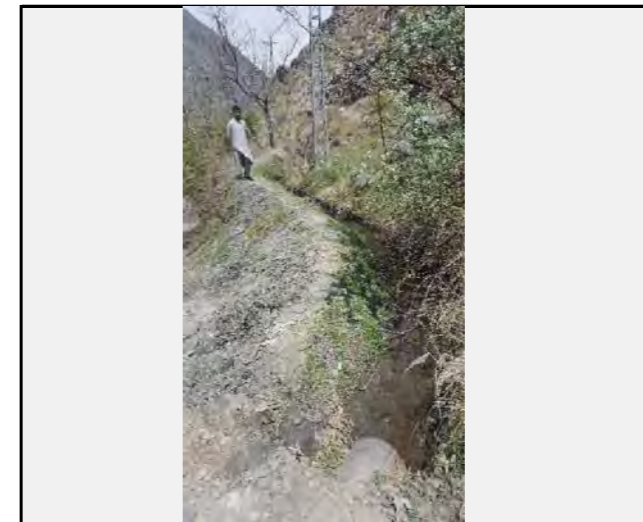
View of water Supply Scheme passing in the middle of the slope failure

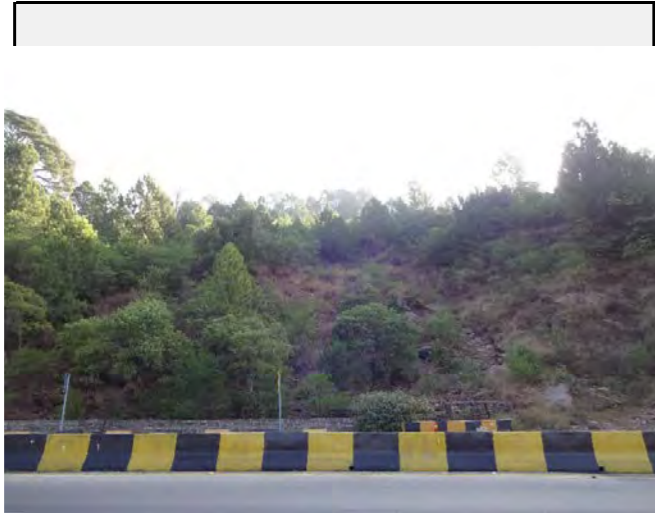
Mountain side: Trace of slope failure was observed at the mountain side

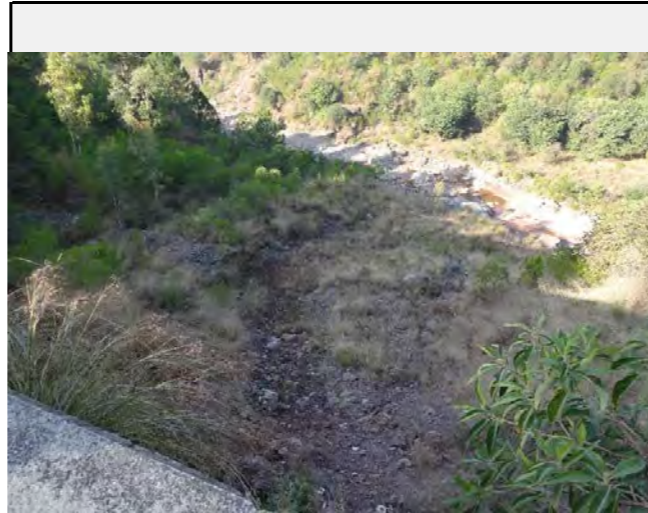
Valley side: Trace of debris flow was observed at the valley side.

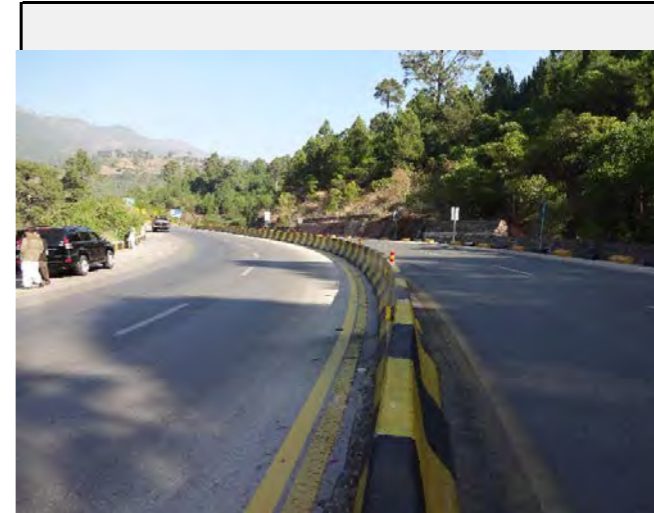
Road condition: No anomalies was confirmed on the road surface.

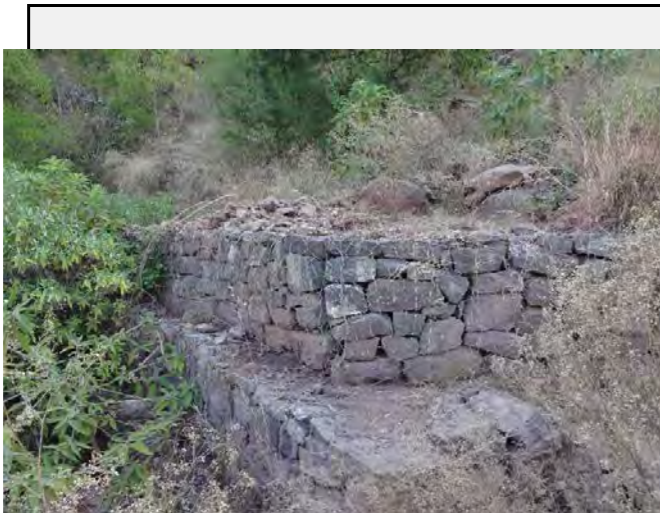
Existing countermeasures: Gabion works are undertaken at the toe of the mountain side. However, the debris is deposited on the top of the gabion and may outflow the gabion works in the future.

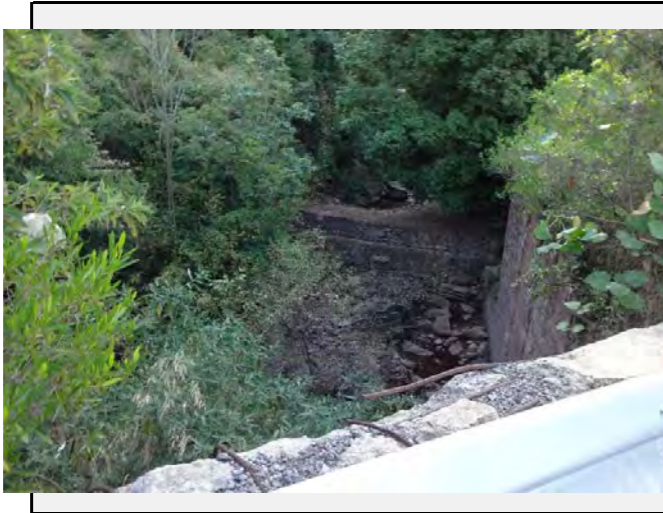
Mountain side: Boulders and deposits are mostly observed on mountain side. Gabion are constructed to minimize the gradient of river bed.

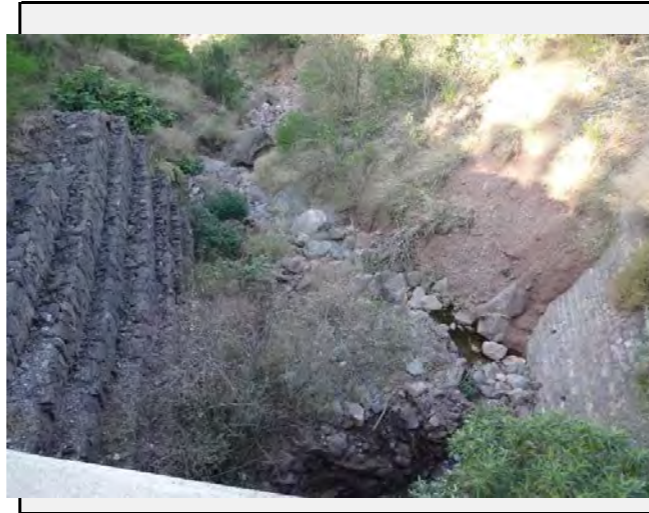
Valley side: Retaining wall and gabions are constructed at the both side of the bank on the exit of the box culvert.

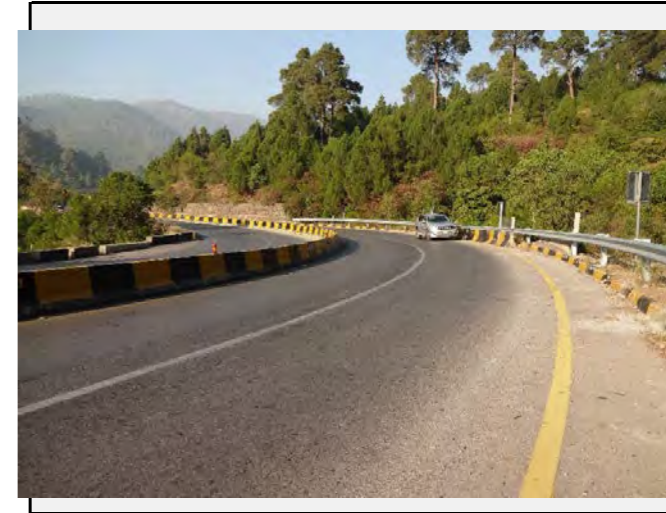
Road condition: No anomalies was observed on the road

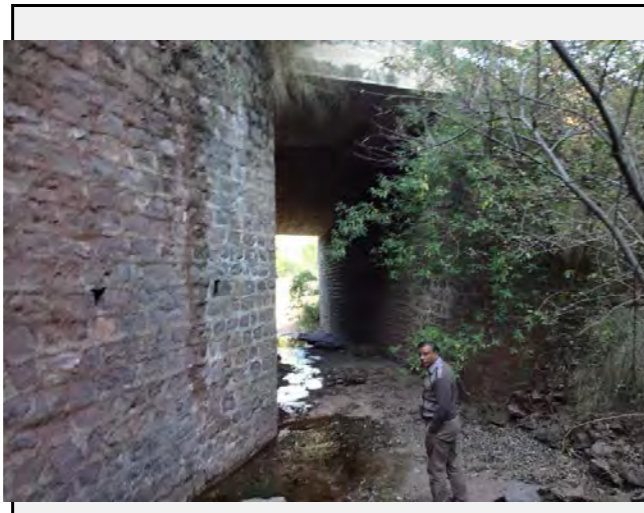
Existing countermeasures / anomalies: The box culvert are clear from any debris.

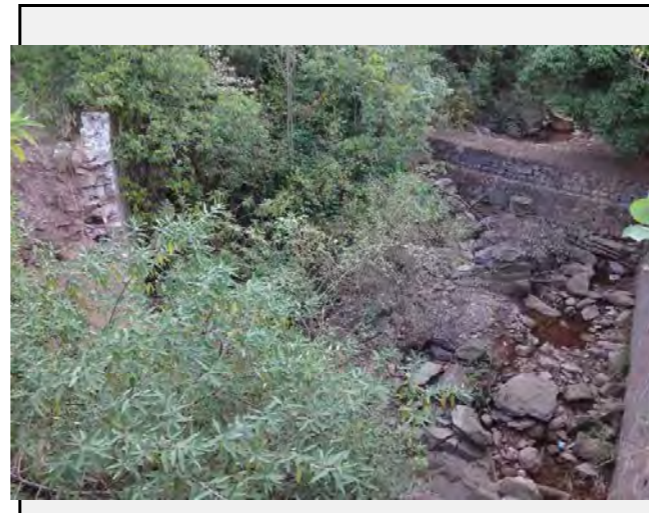
Existing countermeasures / anomalies: Damage on the retaining wall on the north side (undercut slope) on the mountain side.

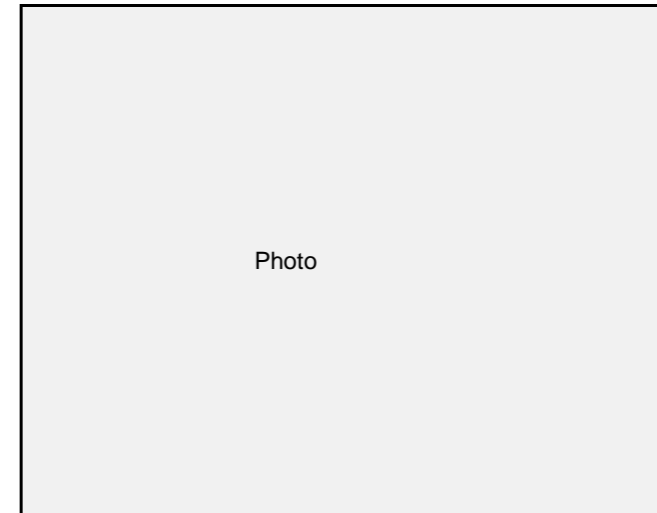
Existing countermeasures / anomalies:

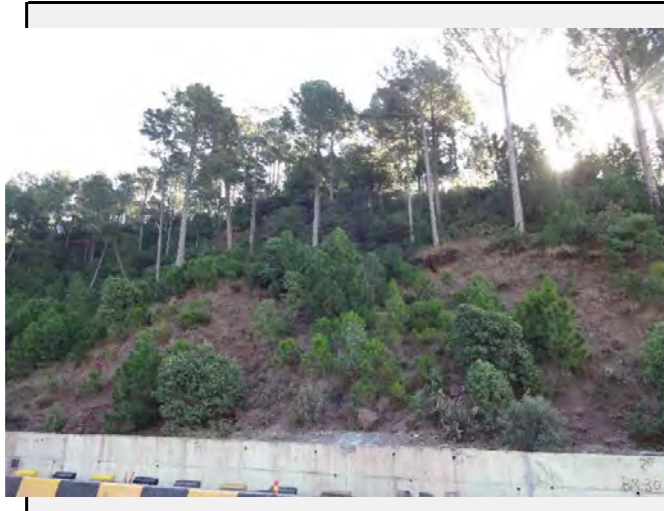
Mountain side: No anomalies has been observed in the mountain side.

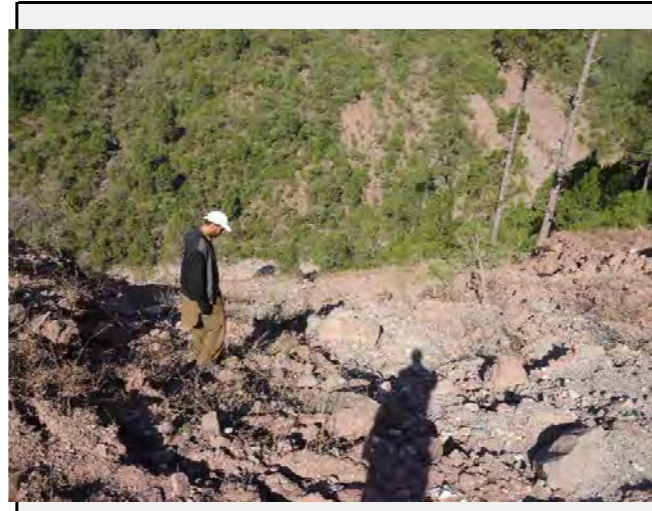
Valley side: Valley side are covered mostly by the debris and small rocks

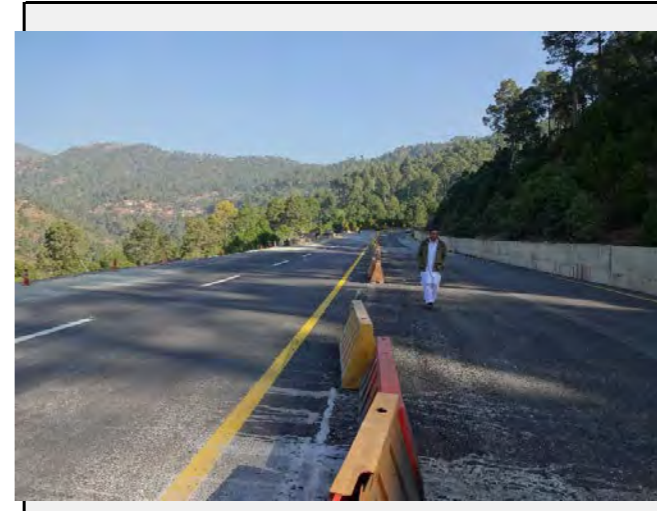
Road condition: Road has been repaired after the slope failure occurred in 2016.

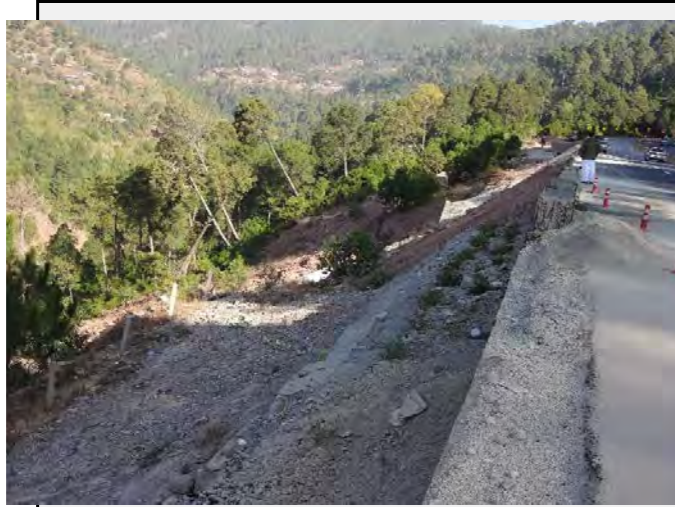
Existing countermeasures / anomalies: Surface erosion protection net are installed to minimize the surface erosion.

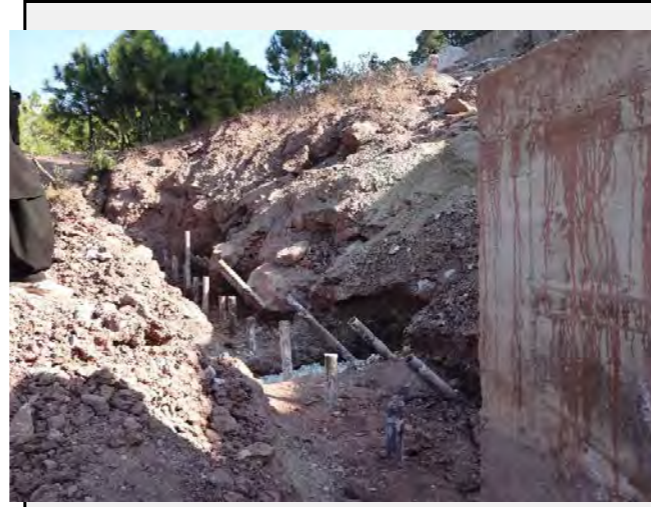
Existing countermeasures / anomalies: Micro piles are installed at the foundation of the lowest retaining wall (ongoing construction).

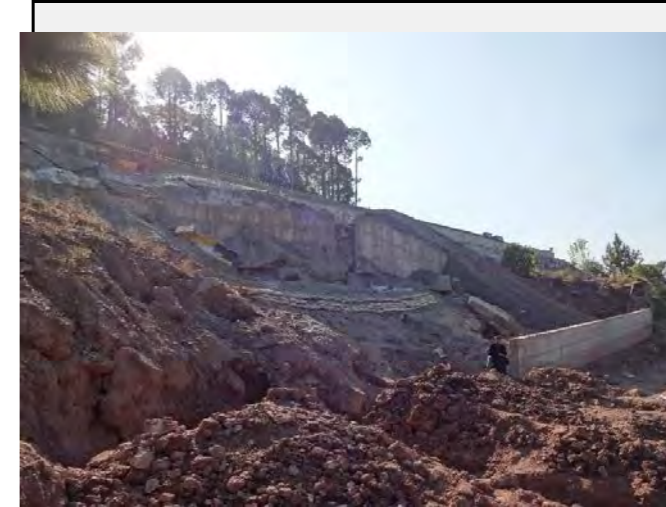
Existing countermeasures / anomalies: Retaining walls are constructed at the valley side of the road (ongoing construction).

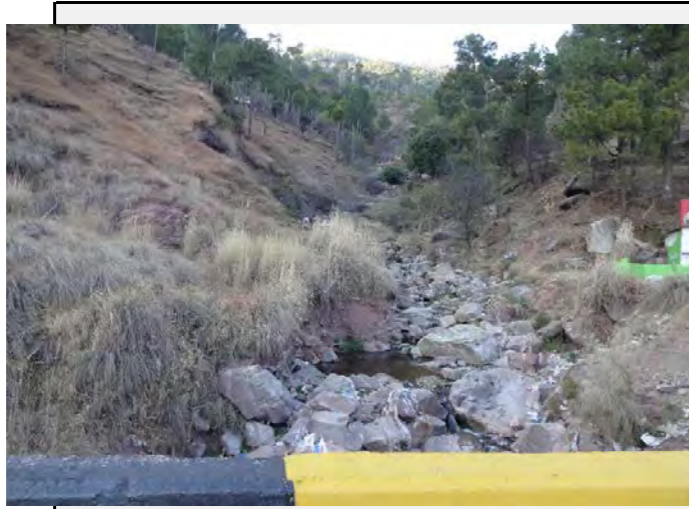
Mountain side: Boulders (1~2m) are observed on the river bed on the mountain side.

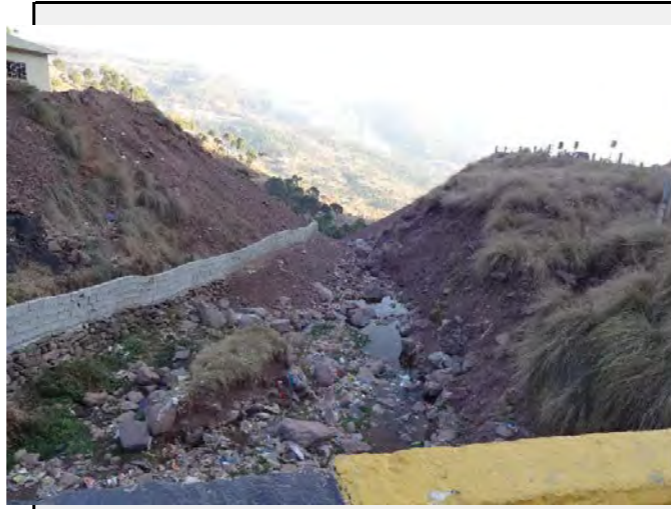
Valley side: Deposits in the valley side. Erosion on the bank may occurs in future.

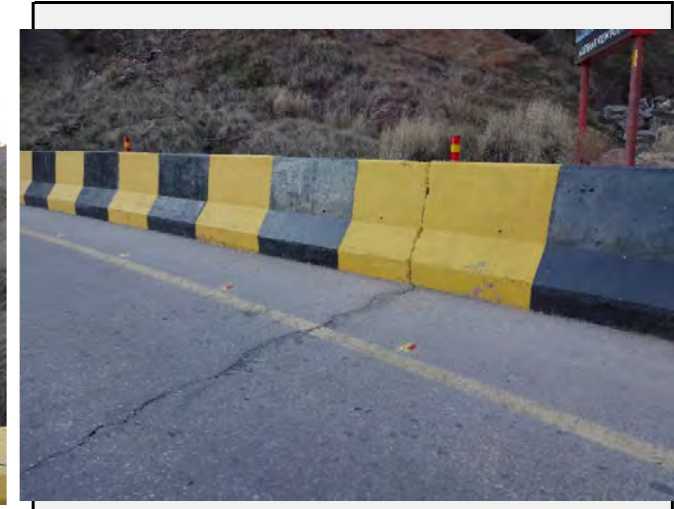
Road condition: Some cracks was observed at the joints of the bridge.

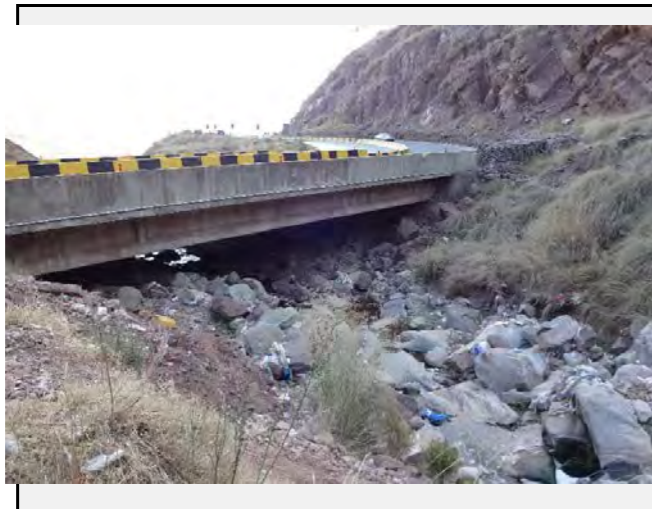
Existing countermeasures / anomalies: Dumping of the garbages around the bridge reduce the capacity to drain the debris to the valley side.

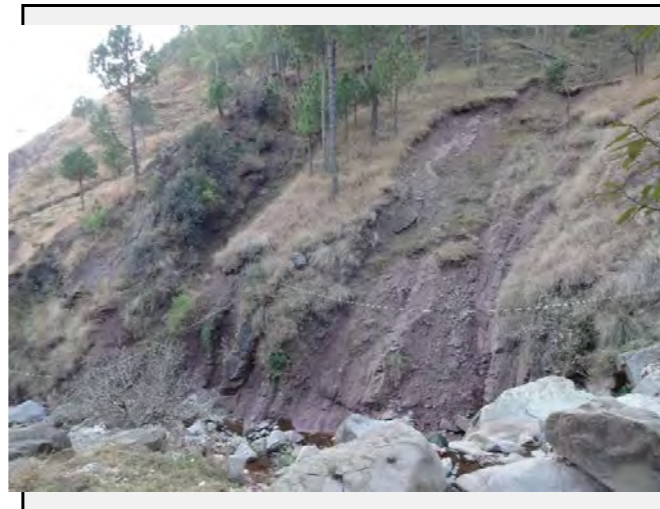
Existing countermeasures / anomalies: Several surface collapse can be observed on the west side of the slope on the mountain side.

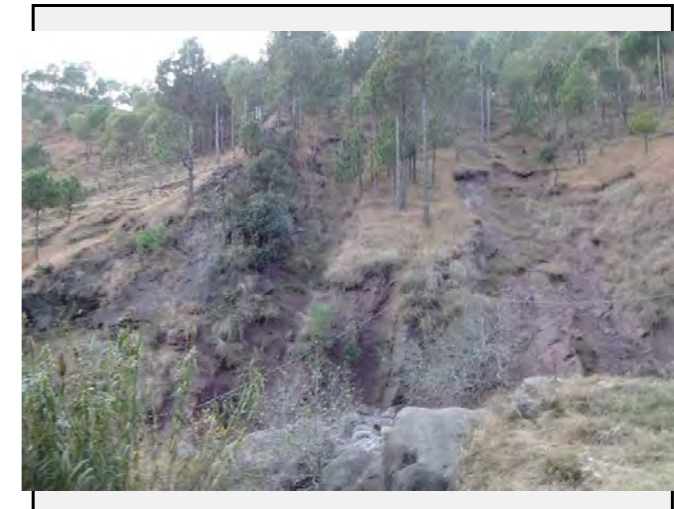
Existing countermeasures / anomalies: Several surface collapse can be observed on the west side of the slope on the mountain side.

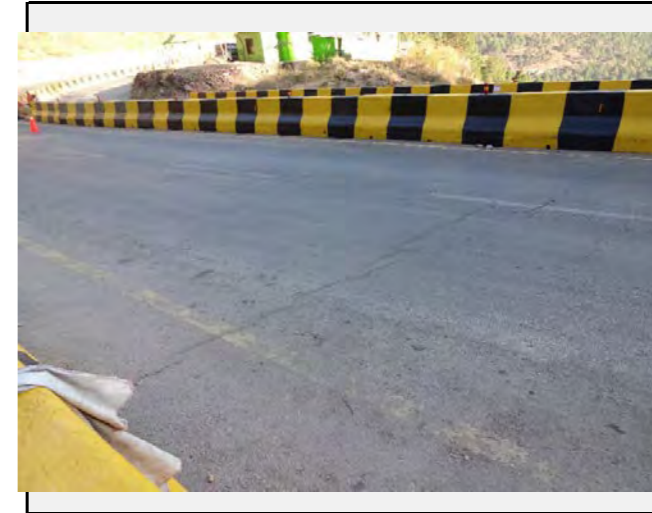
Road condition: Small cracks was confirmed at the joint section of the road and bridge.

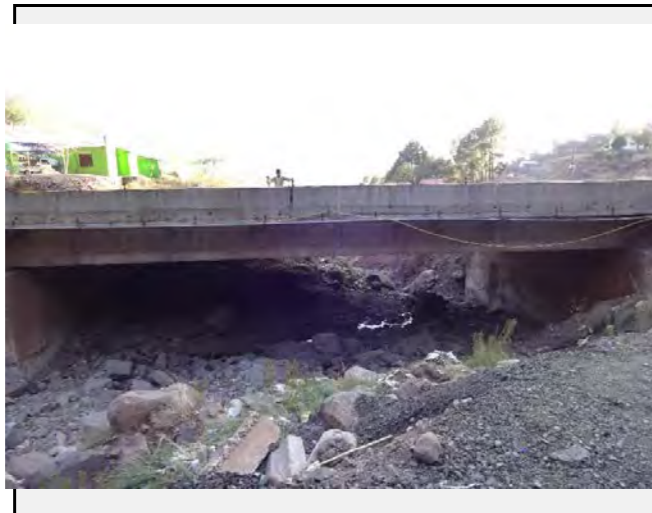
Existing countermeasures : The height underneath the bridge seems enough to clear the debris to the valley side.

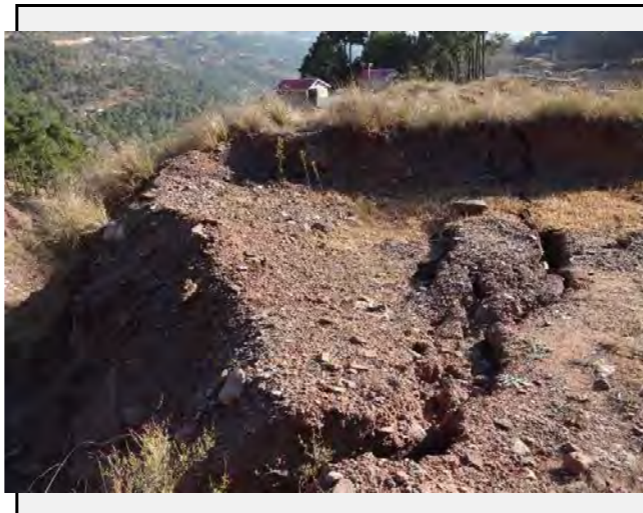
Existing anomalies: Cracks was confirmed on the bank of the valley side. It may collapse in near future due to the erosion.

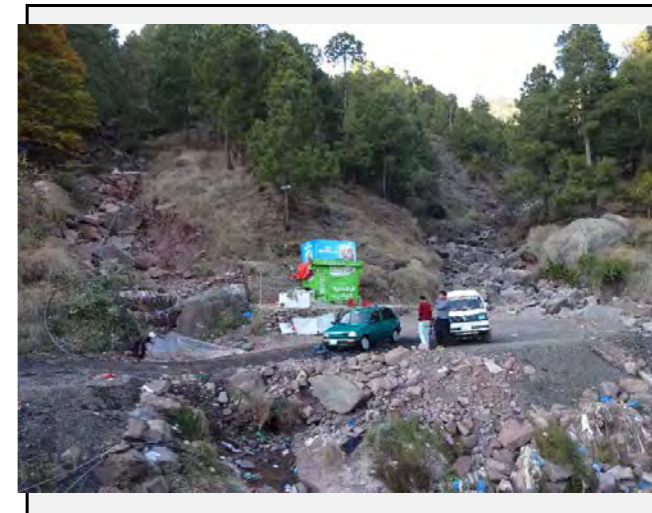
Others: Another small stream is flowing into this stream. This area is used as a carwash pit for the local people.

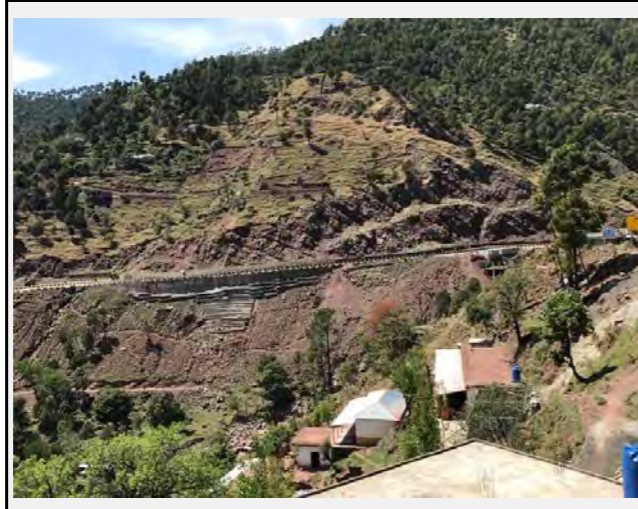
Overall view of the slope. Rock falls are expected in the mountain side and slope failure in the valley side.

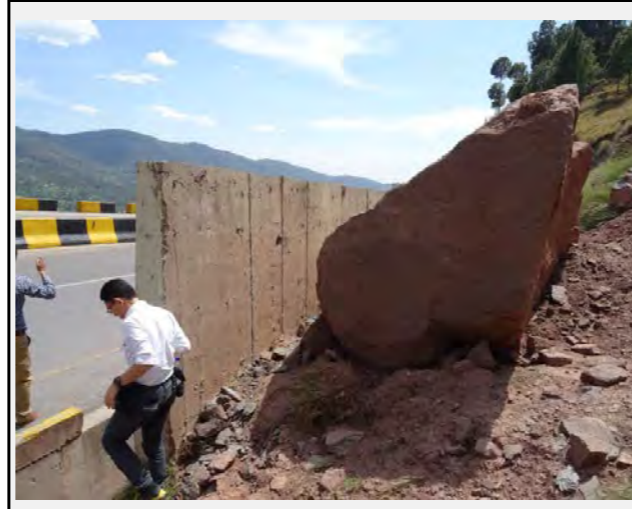
Rock falls of 2m³ have happened in the past reaching the road.

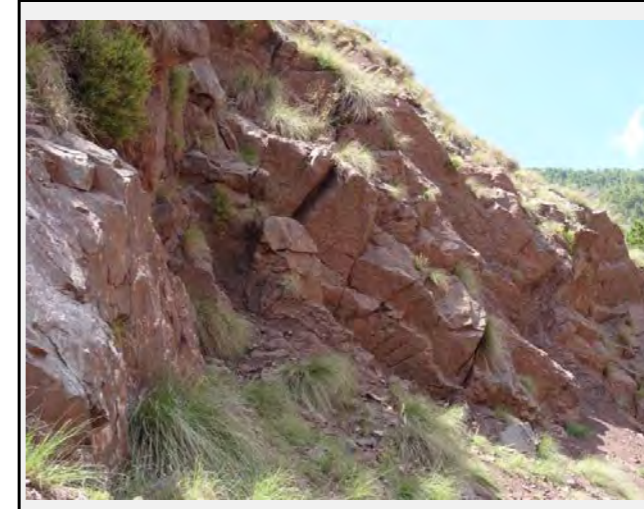
The base rock of the mountain side slope is highly fractured and some layers are highly weathered facilitating rock falls

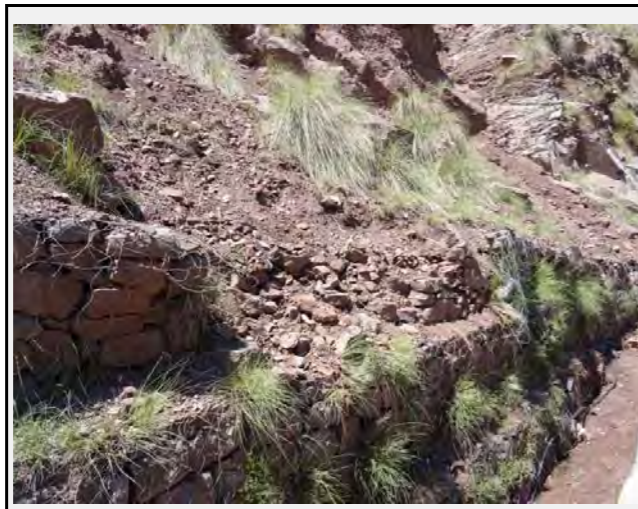
The gabion wall is damaged in many spots due to past rock falls and is thought not to operate properly as a countermeasure
