Code no.	Sat	_	N	3	5	_	1	6	2
Region Office									
Maintenance Unit

Evaluation sheet (Slope failure/Rockfall)

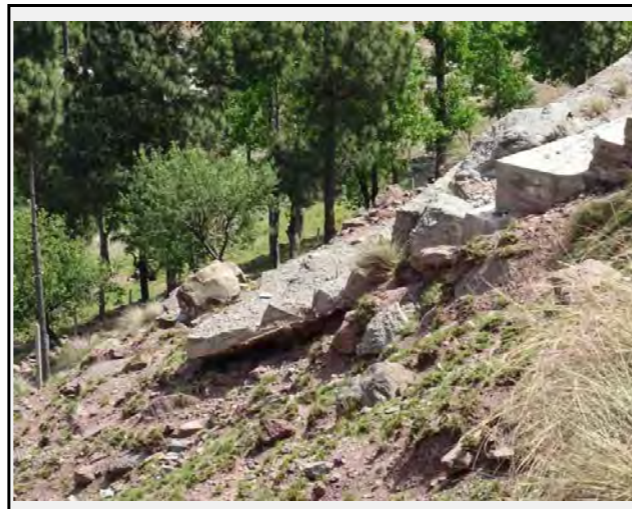
The retaining wall in the valley side is being damaged because the soil on which it is constructed is being washed away.

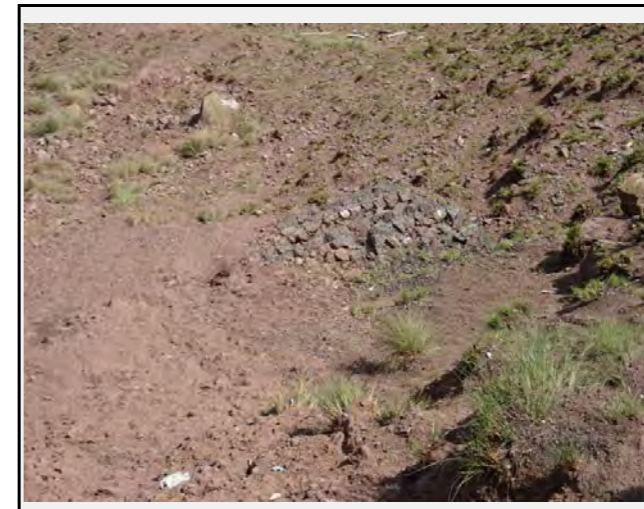
Slope failures have collapsed and damaged gabion walls constructed in the valley side as retaining walls for the embankment

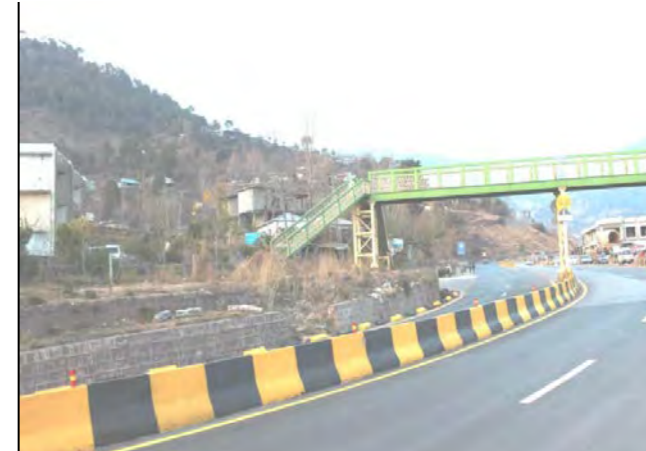
Road condition: Road is built through the landslide

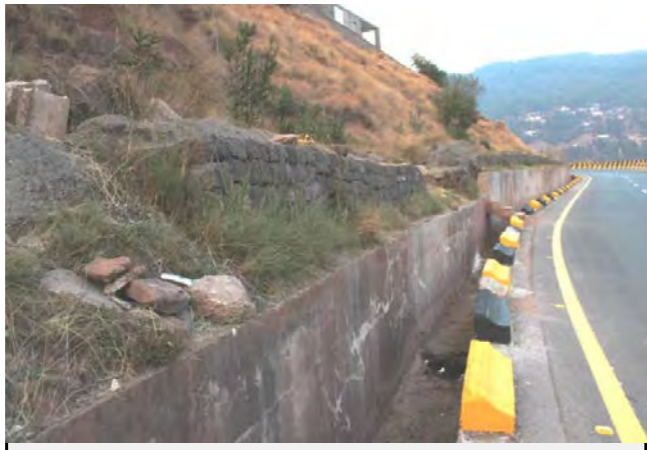
Existing countermeasures / anomalies: Retaining and gabion walls has been constructed to protect the road

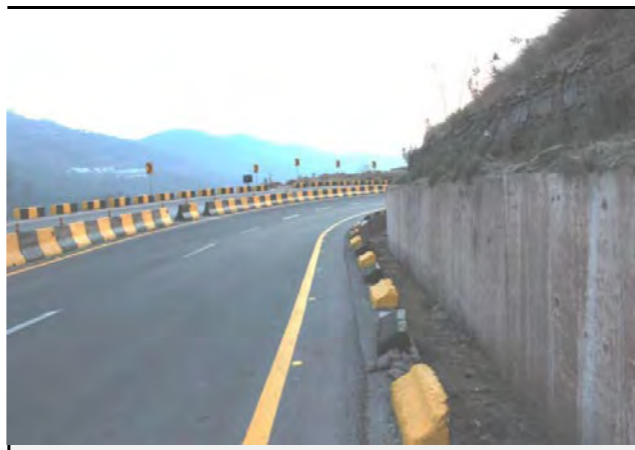
Existing countermeasures / anomalies: Upto 4 cm cracks were observed in the retaining wall

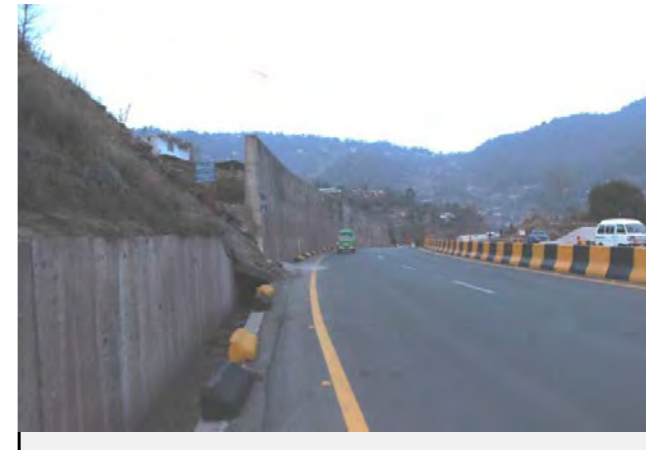
Existing countermeasures / anomalies: Retaining wall has been constructed

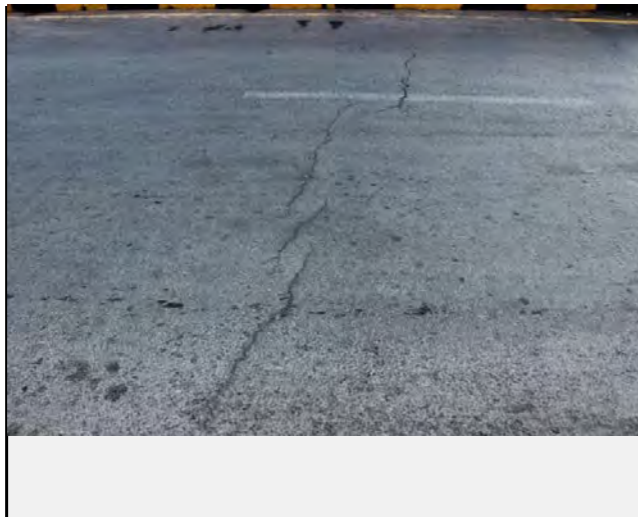
The crack on road has been observed

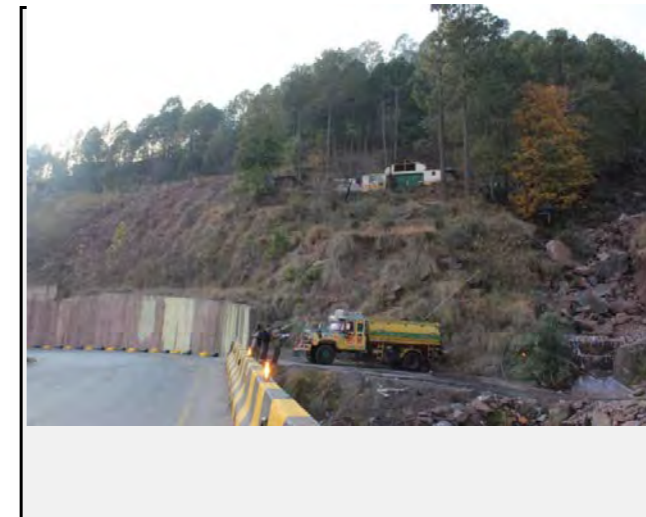
Existing countermeasures / anomalies: Retaining wall has been constructed at the toe of the slope failure

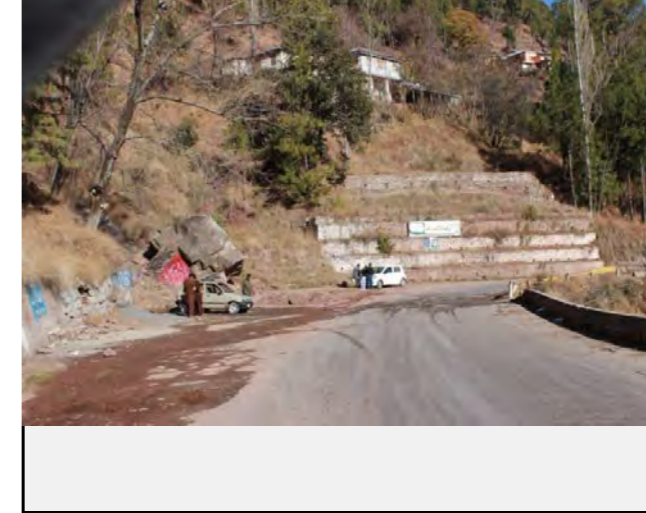
Road condition at location and the retaining wall to protect the road

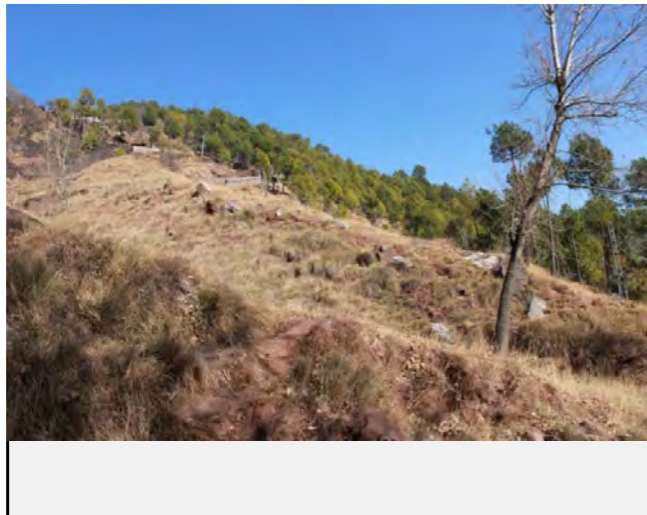
Future potential landslide. Vegetation and trees on the main body of landslide

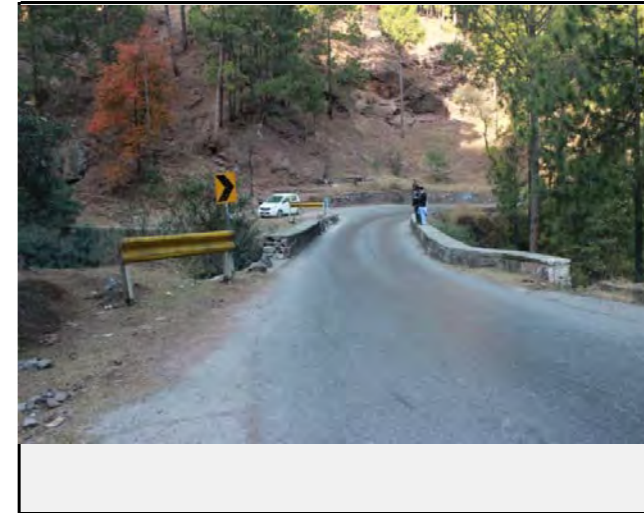
Road condition at the site

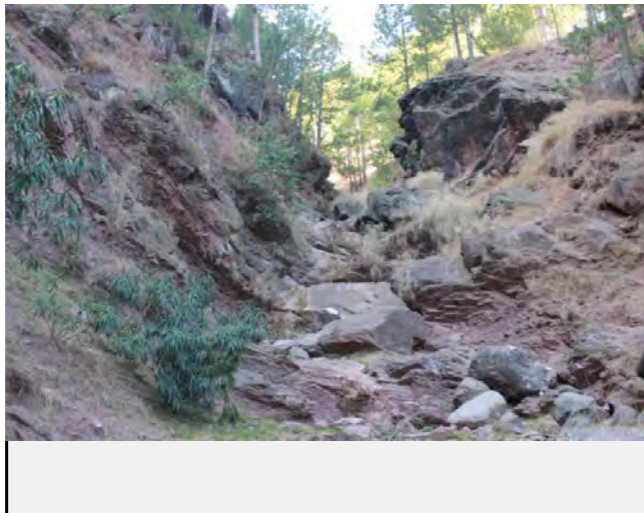
Rock bed dipping towards the channel

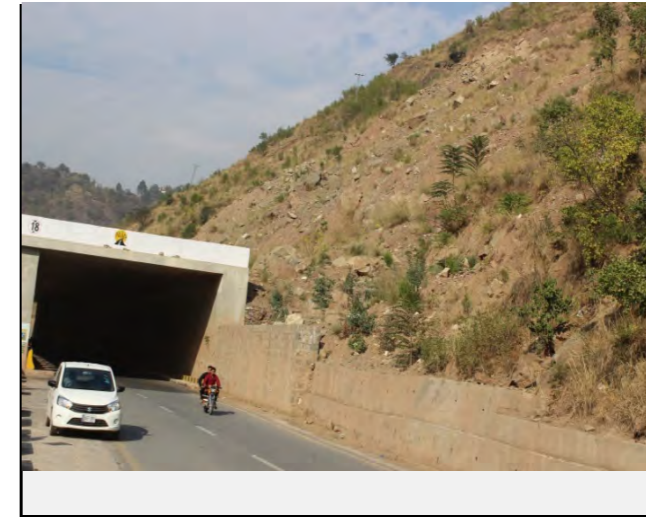
Road condition: Cut slope at the start point

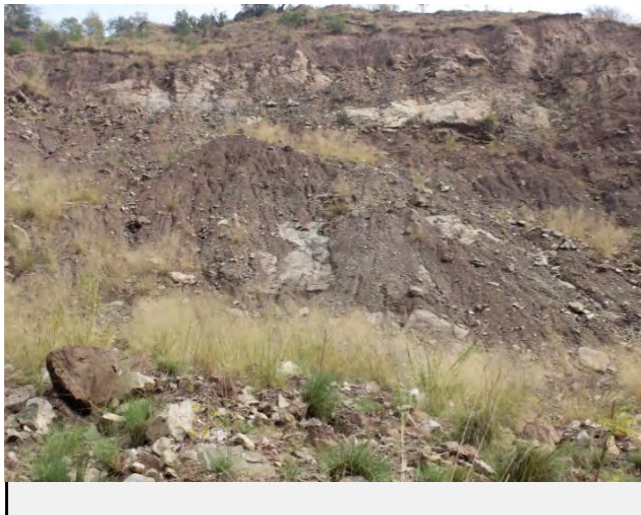
View of the slope failure at the middle point

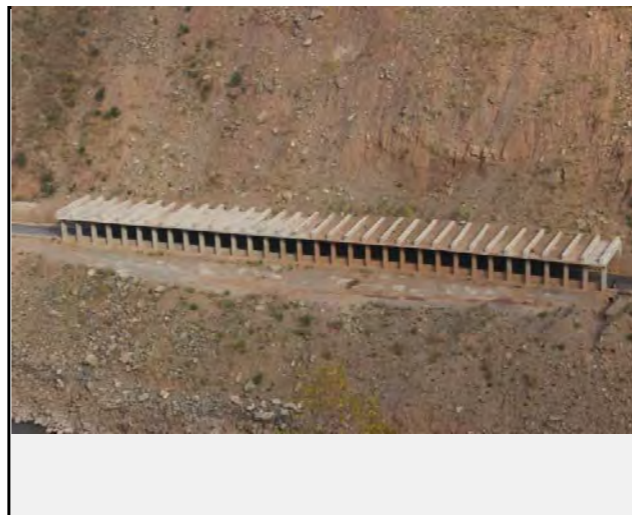
Existing countermeasures / anomalies: View of shed as counter measure

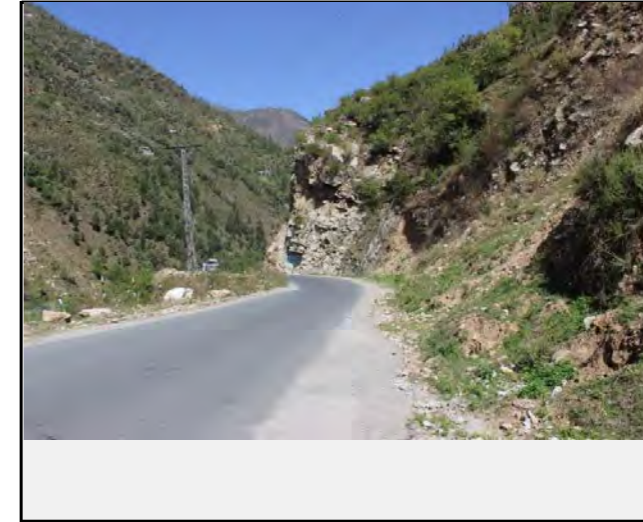
Road condition: Cut slope at the start point

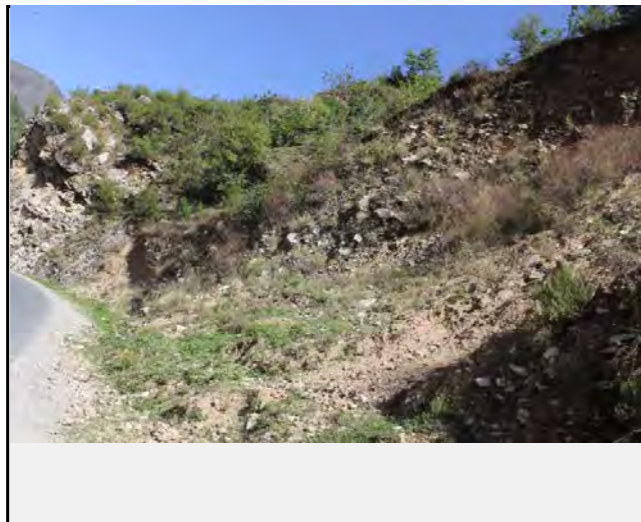
View of the slope failure at the middle point

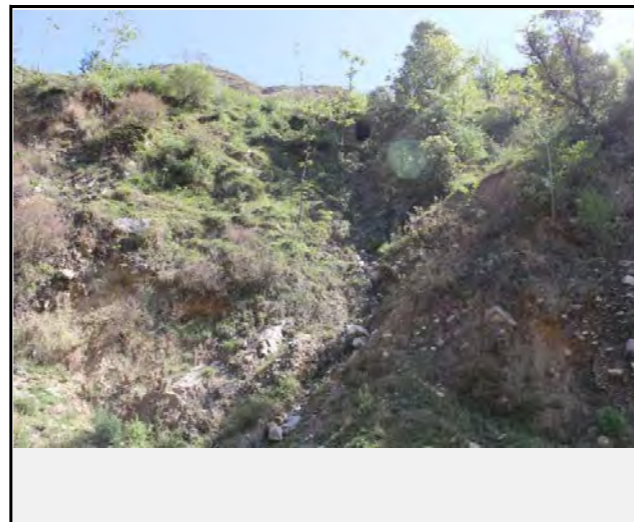
Existing countermeasures / anomalies: View of shed as counter measure

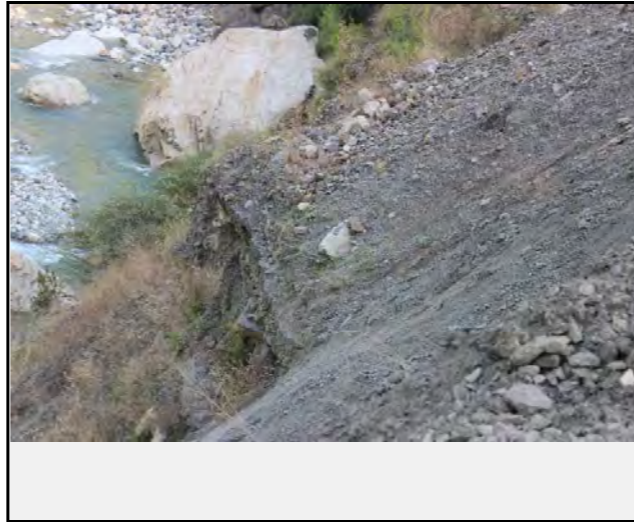
View of landslide on Valley side and existing road damage can be seen

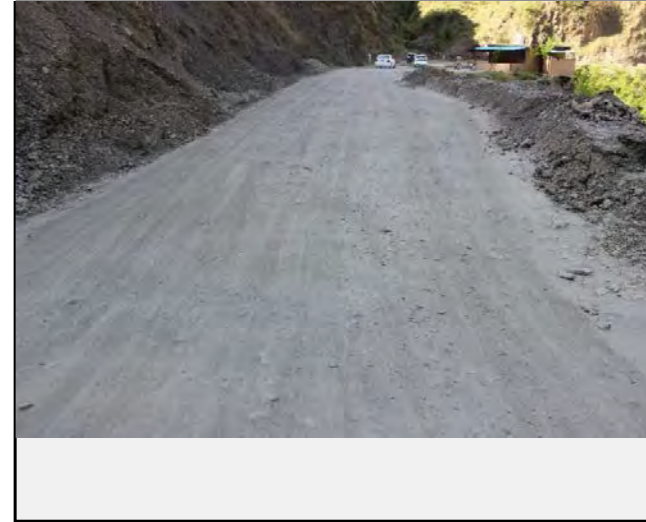
Road condition: Cut slope at the start point

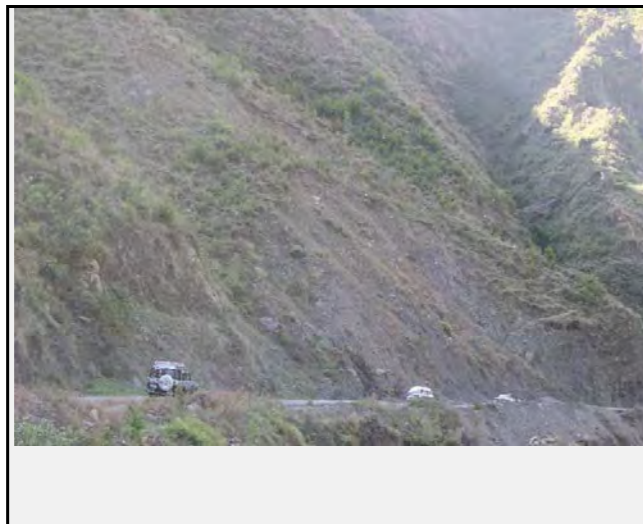
View of the slope failure at the middle point

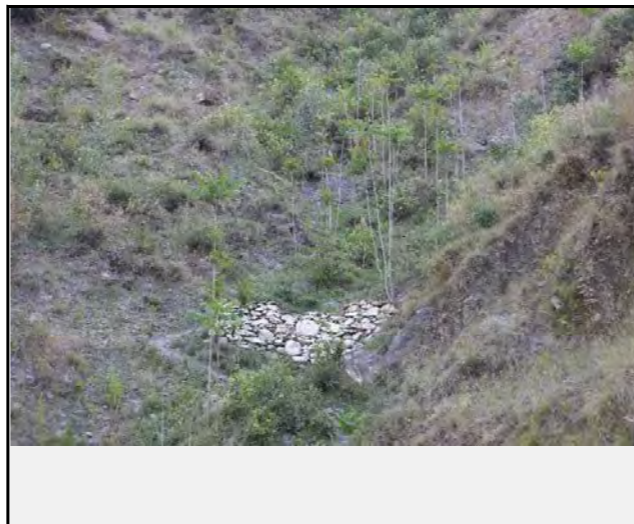
Existing countermeasures / anomalies: View of check dam as counter measure

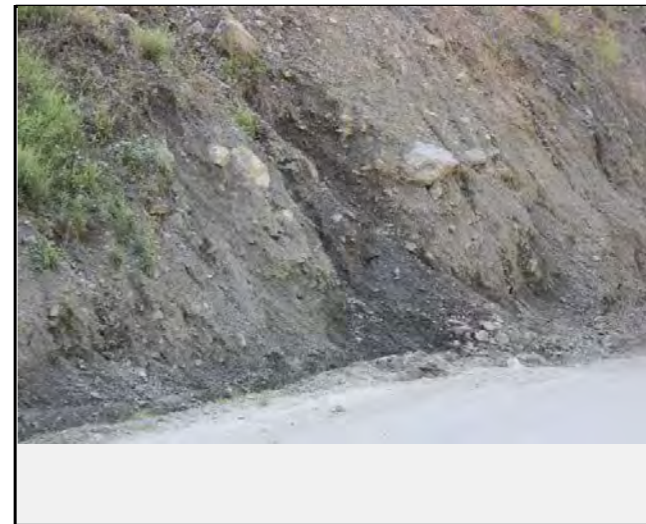
View of seepages in the slope failure

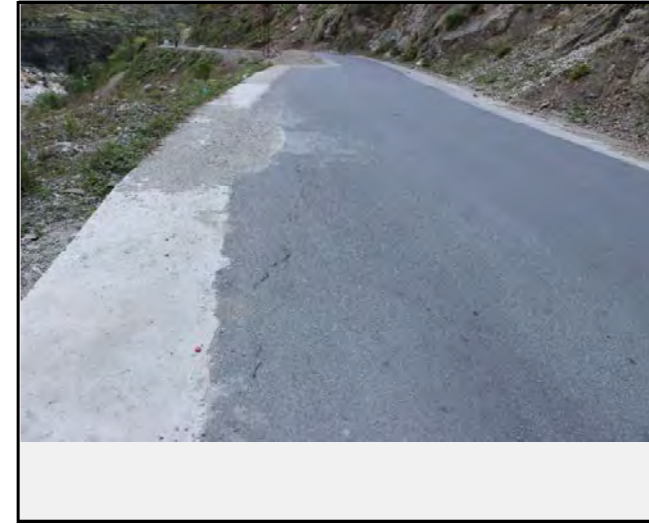
Road condition: Cut slope at the start point

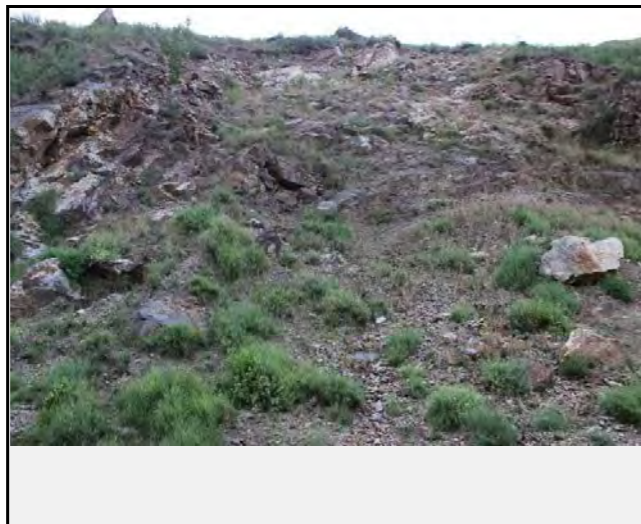
View of the slope failure at the middle point

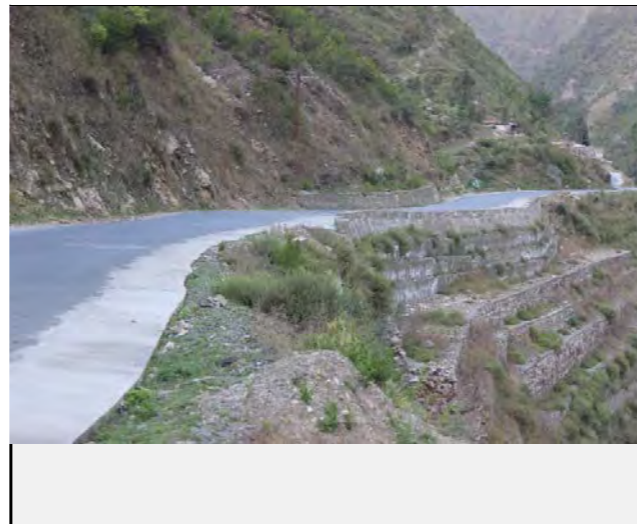
Existing countermeasures / anomalies: View of Retaining Wall as counter measure

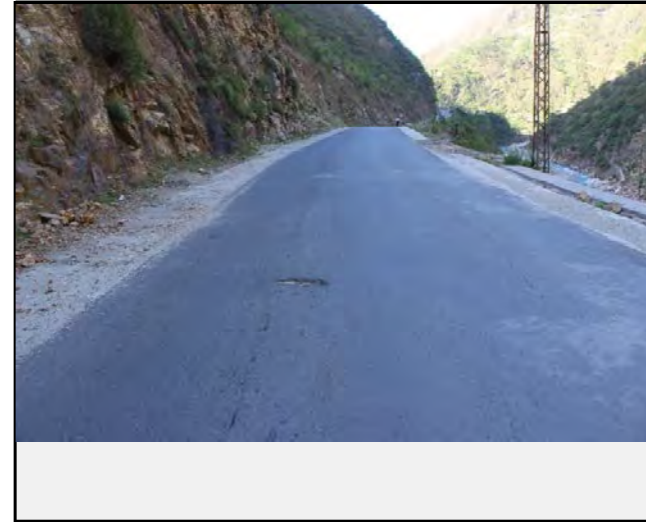
Road condition: Cut slope at the start point

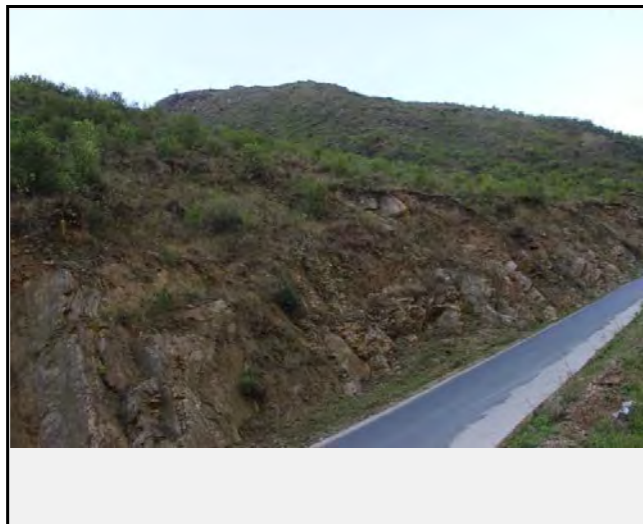
View of the slope failure at the middle point

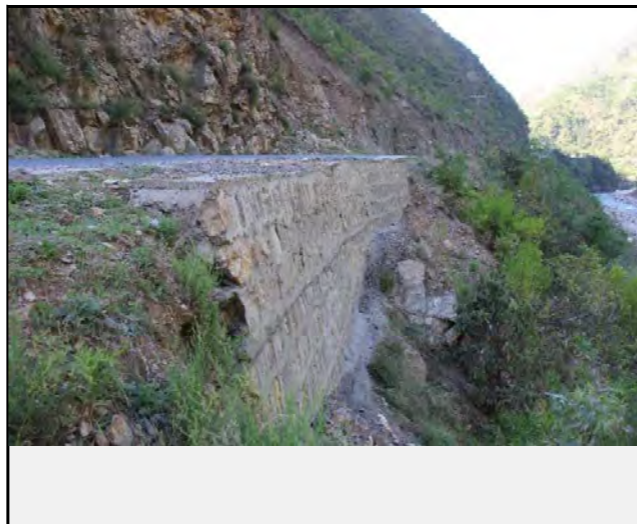
Existing countermeasures / anomalies: View of Retaining wall as counter measure

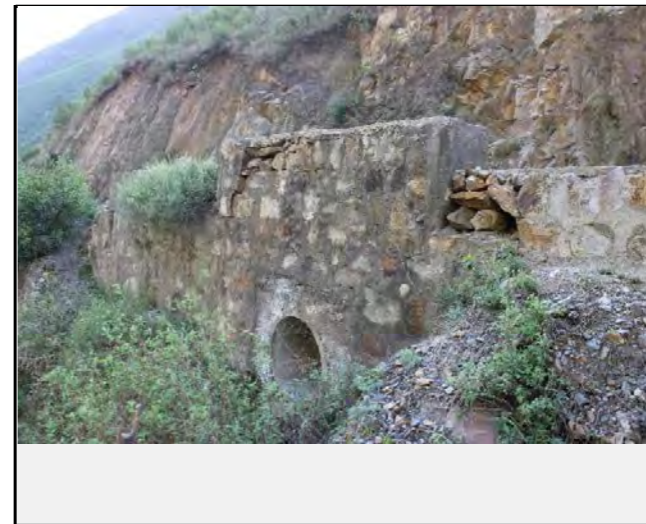
View of Drainage pipe and damaged retaining wall

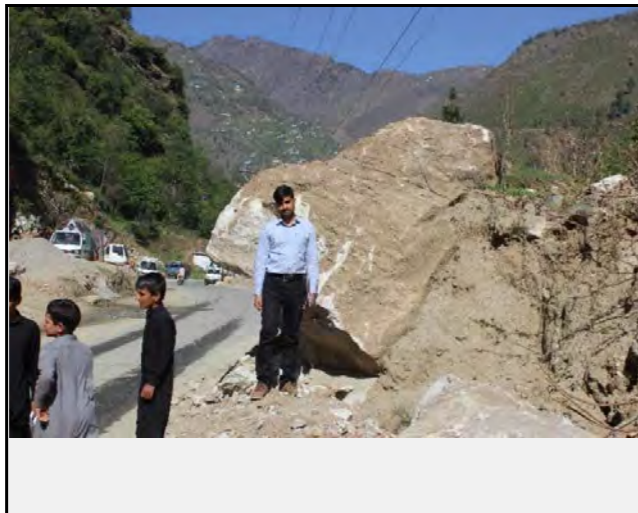
View of fallen block with the debris flow that can damage the population along the downstream.

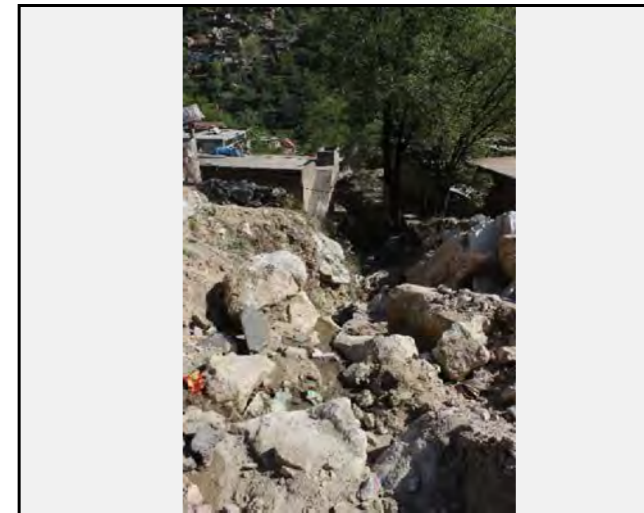
Existing countermeasures / anomalies: Drainage conversion by the locals to avoid the damages from the debris flow in future.

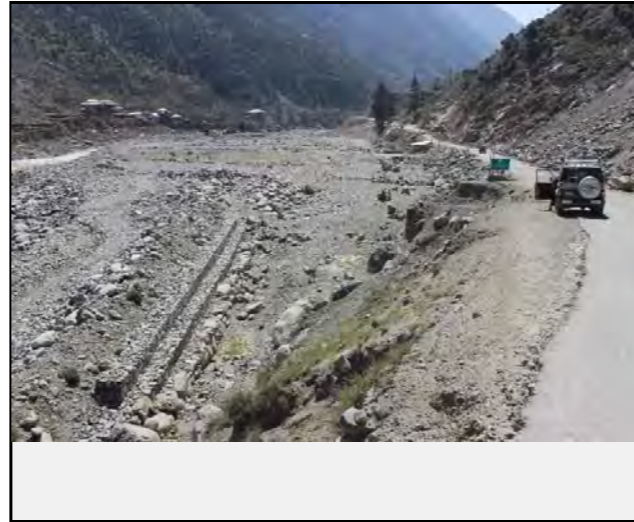
View of landslide on Valley side and a river diversion structure built on the toe of the slope failure

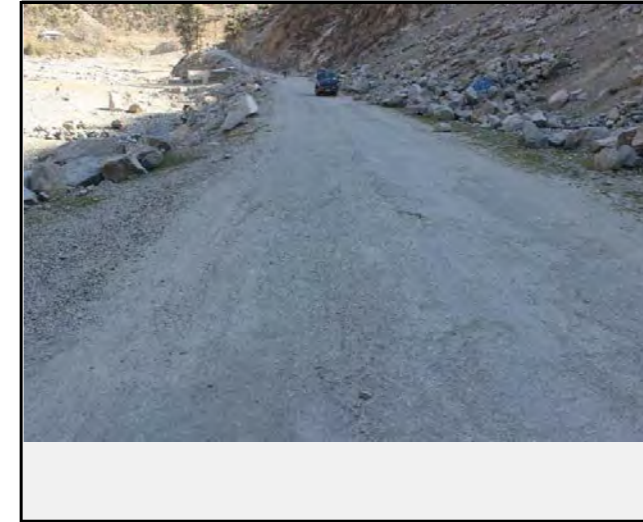
Road condition: Cut slope at the start point

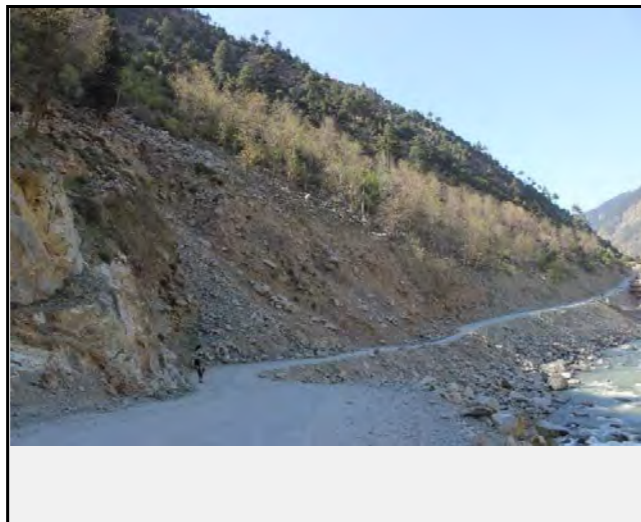
View of the slope failure at the left flank

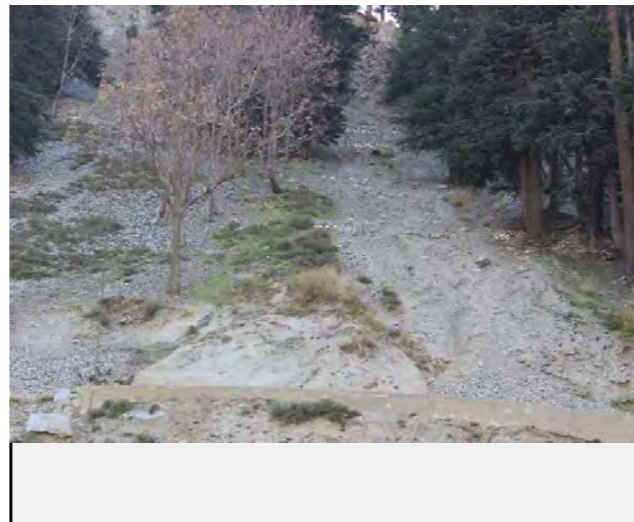
Existing countermeasures / anomalies: View of check dams as counter measure

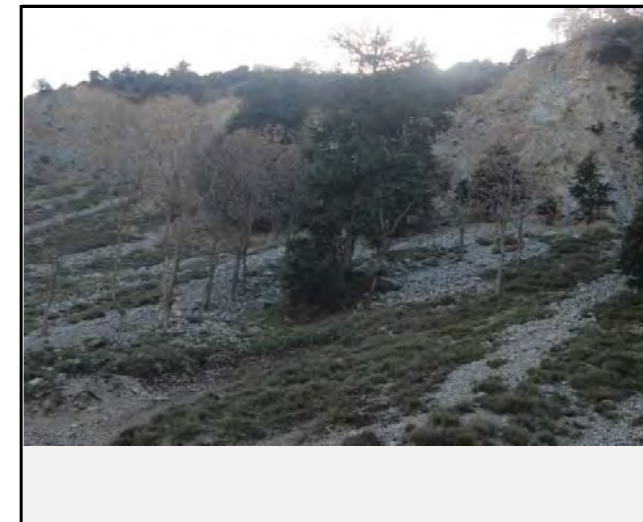
View of scarp of the slope failure

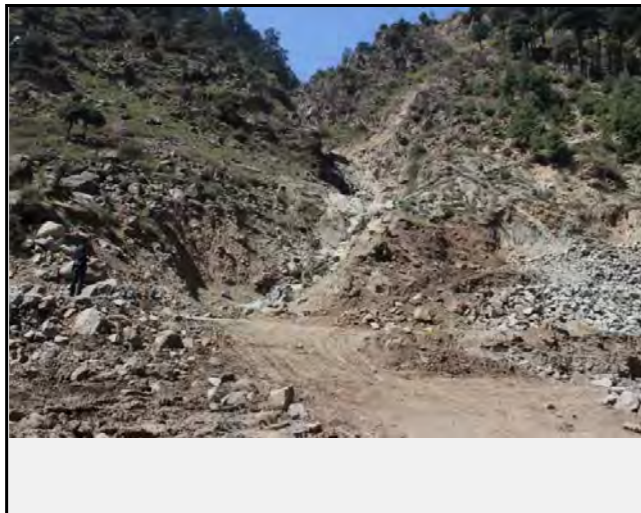
A view of slope failures along the debris flow

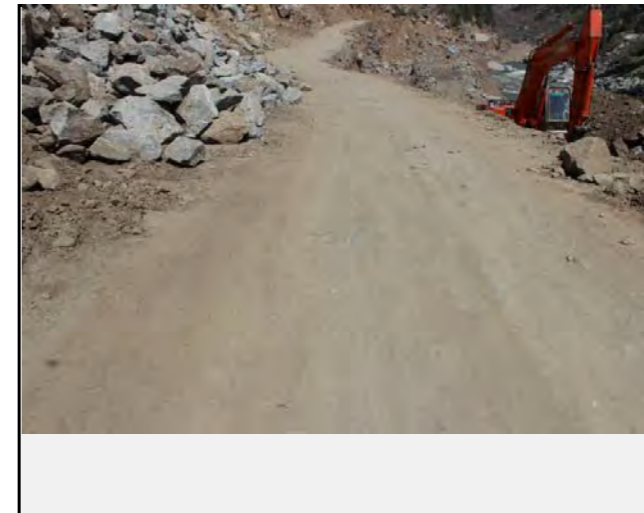
Existing countermeasures / anomalies: Retaining wall is being constructed at the toe of the debris flow

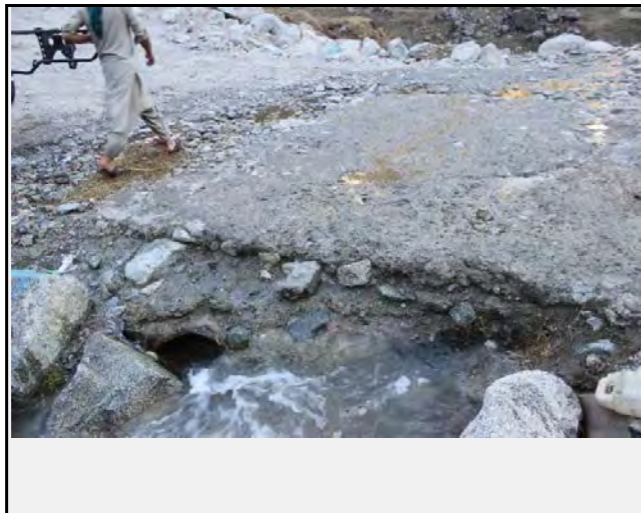
The damage on road has been observed with inlet of pipes for debris flow

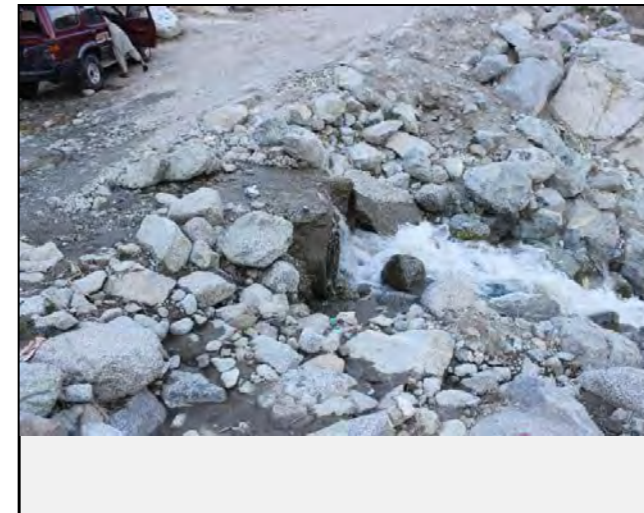
Existing countermeasures / anomalies: Culvert / Pipes has been installed at the toe of the debris flow

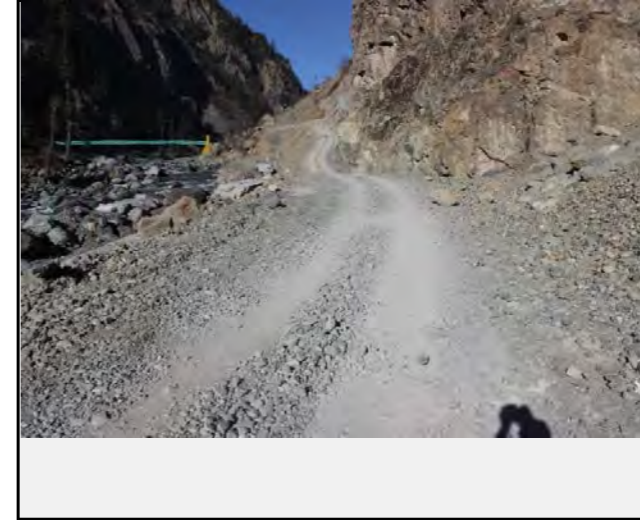
Road condition: Cut slope at the start point

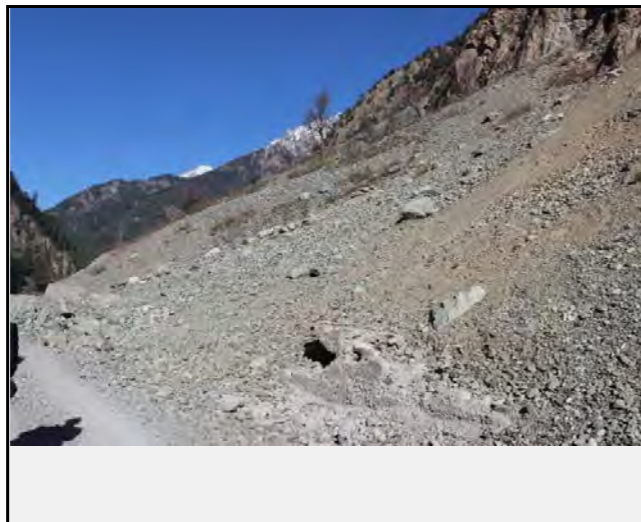
View of the slope failure at the middle point

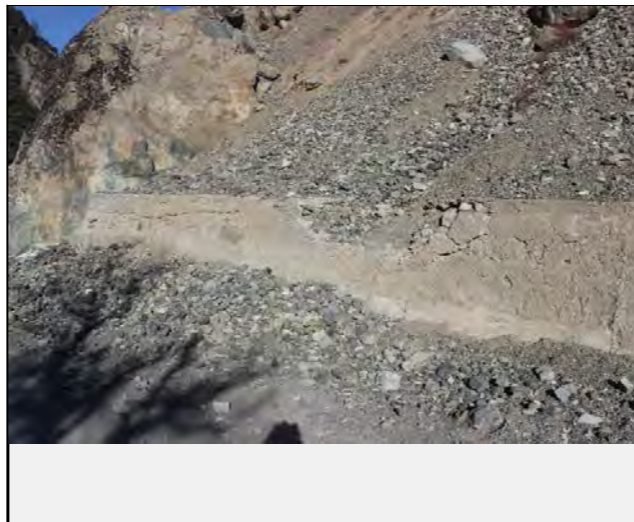
Existing countermeasures / anomalies: View of Retaining Wall as counter measure

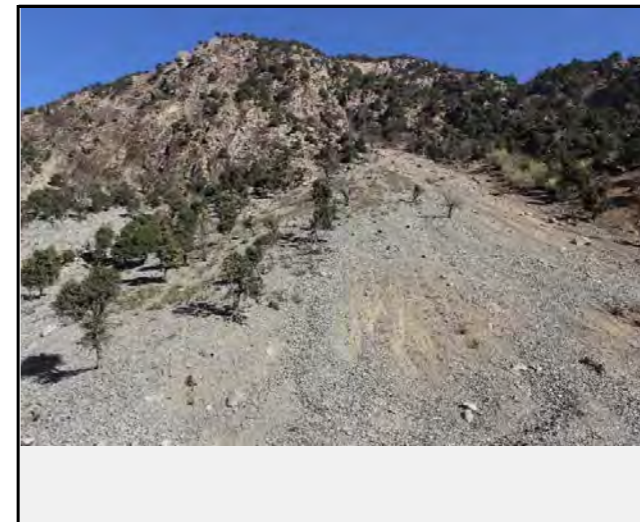
View of gully developed in the slope failure

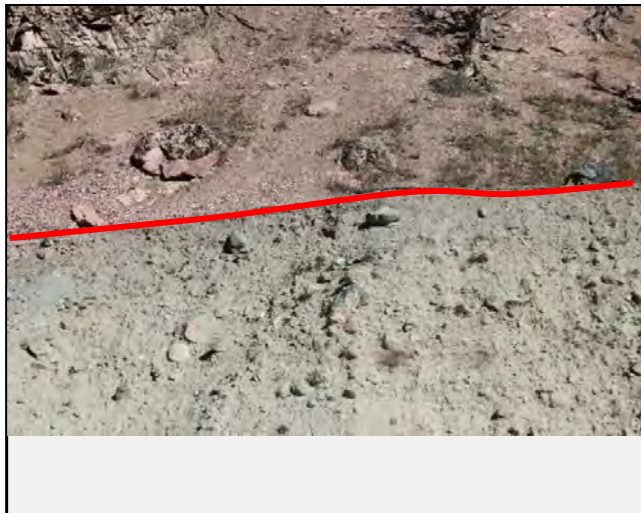
The existing road has been damaged. Red line shows the old road displaced by the debris flow.

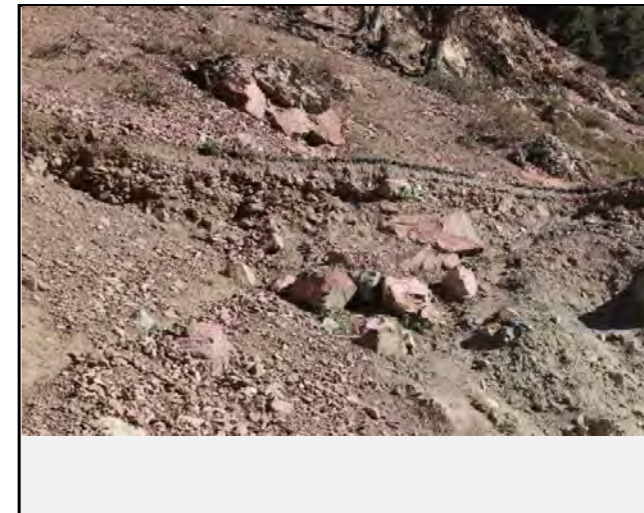
View of debris material and old road
