Appendix 6

Survey Result of Restricted Area

SLOPE FAILURE ANALYSIS ALONG THE MAJOR ROADS NETWORK IN NORTHERN PAKISTAN

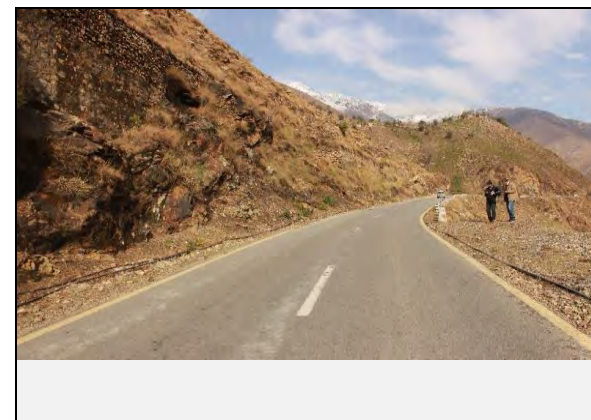
Road condition: Cut slope at the start point

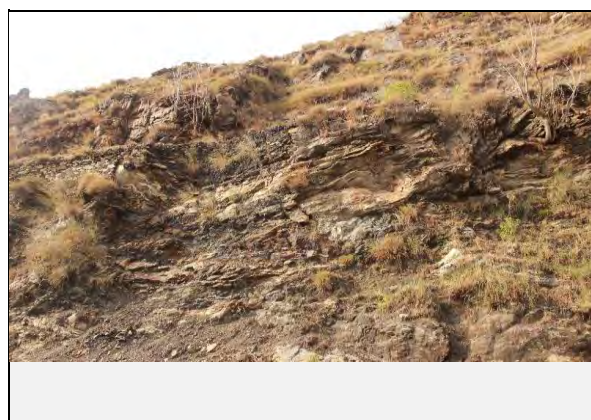
View of the slope failure at the middle point

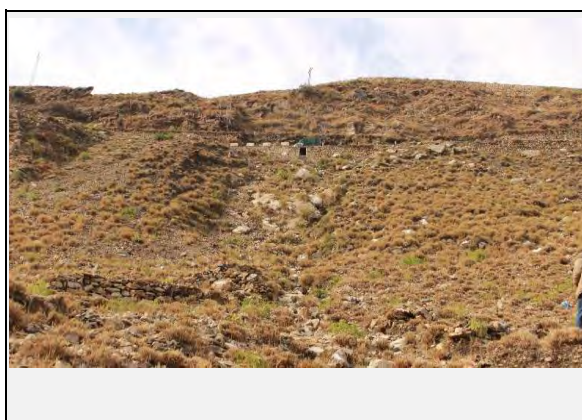
Existing countermeasures / anomalies: View of Culvert outlet as counter measure and retaining wall for N-35

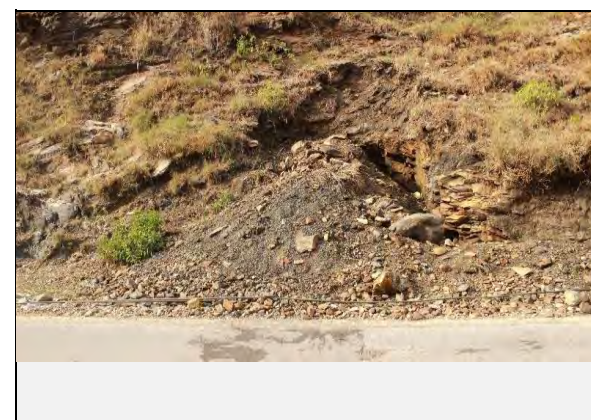
View of new slope failures with the N-35-1

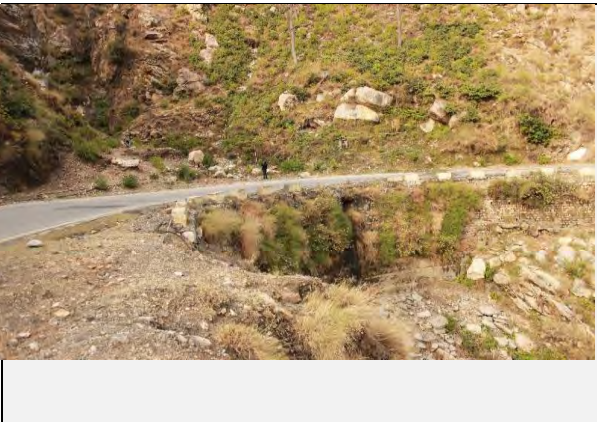
Existing countermeasures / anomalies: Inlet of the culvert is choked by the debris.

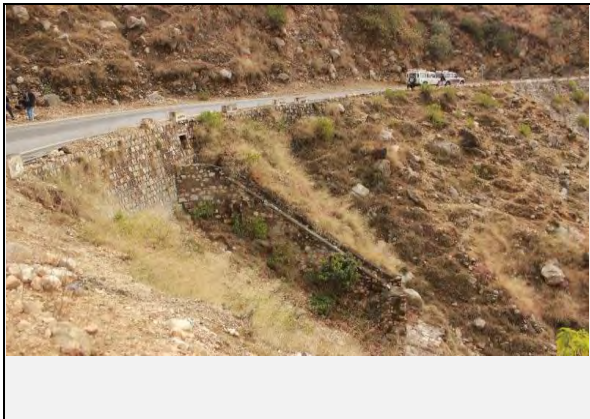
Existing countermeasures / anomalies: View of Culvert as counter measure and retainin wall

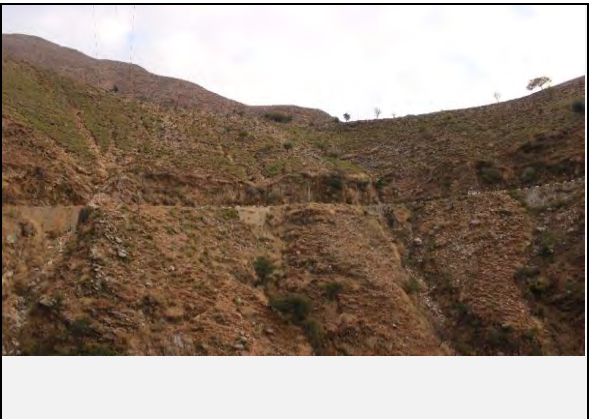
Close View of slope failure

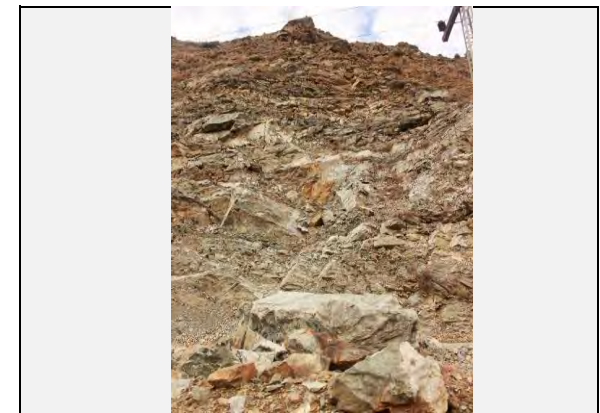
View of fallen blocks along the slope failure which threaten the household at the toe of the slide

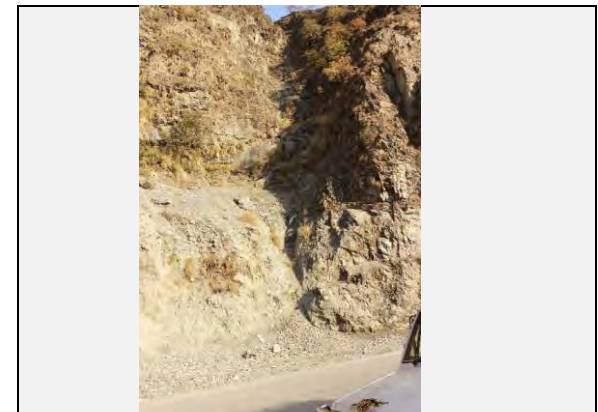
View of Gully erosion along the slope failure

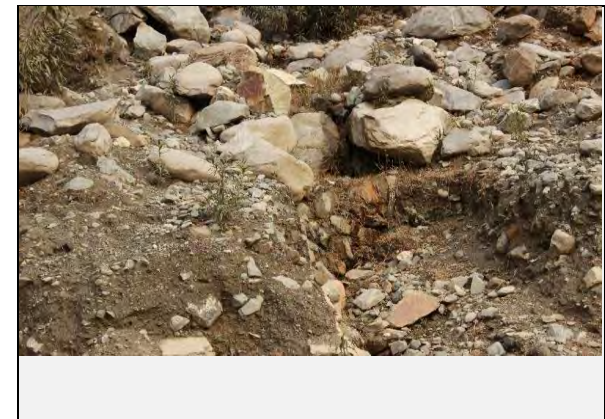
View of fallen blocks along slope failure

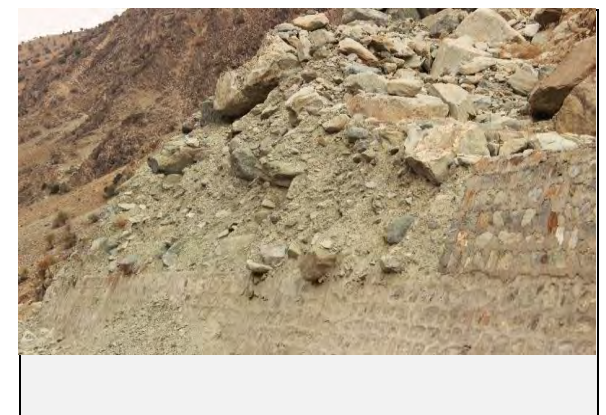
View of fallen blocks

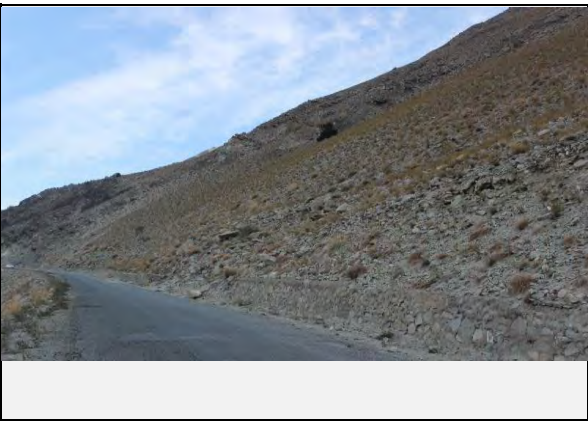
View of Multiple slope failure in the talus deposits

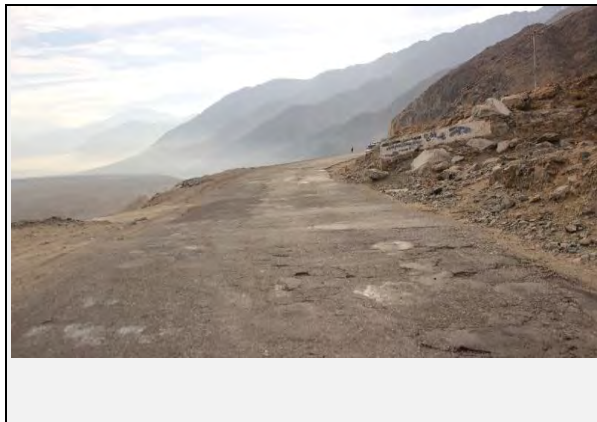
The crack on road has been observed

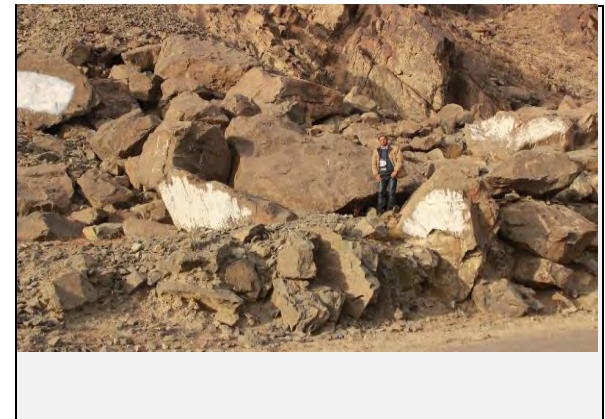
View of fallen blocks along the slope failure
