Evaluation sheet (landslide)

Code no.	N	7	5		7			
Region Office								
Maintenance Unit

Date	12/9/2017
Inspector	asharat, Yasir, Sajid, Shafi

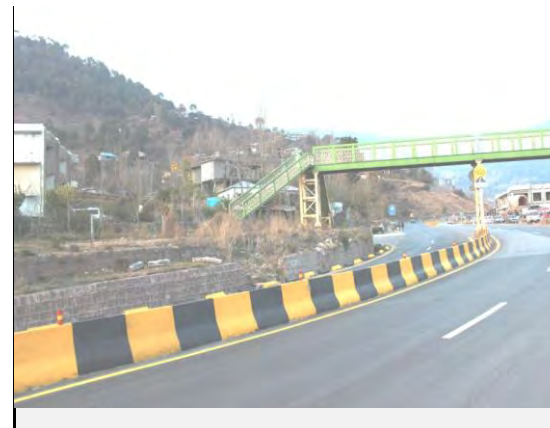
Valley side view of landslide

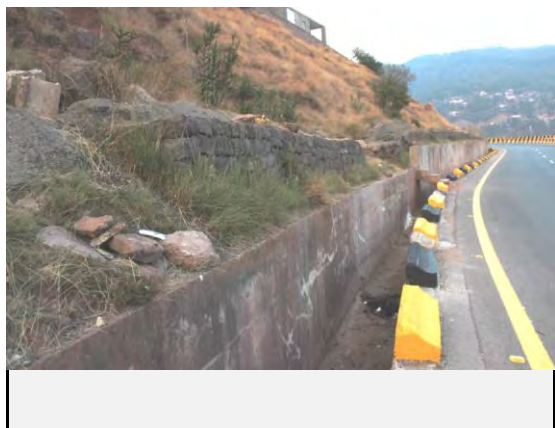
Road condition: Road passing through the center of the landslide

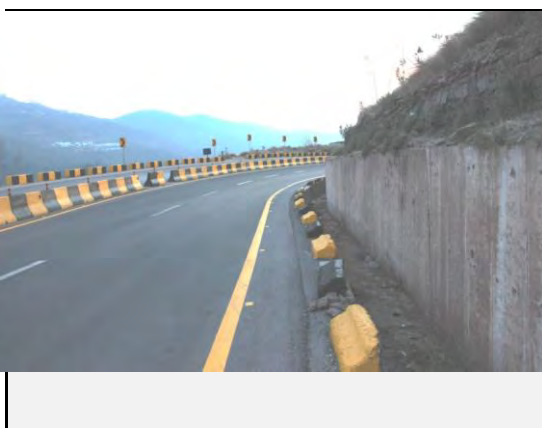
Existing countermeasures / anomalies: Retaining and gabion walls has been constructed to protect the road

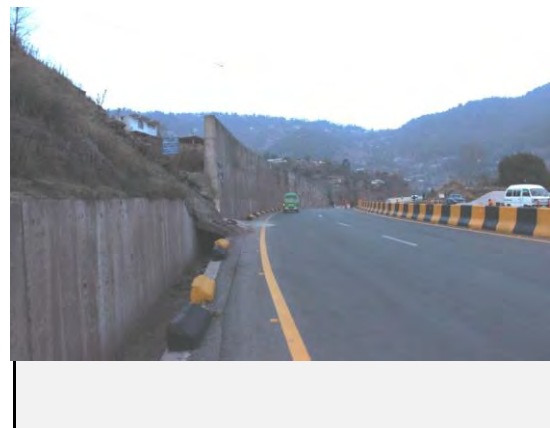
Existing countermeasures / anomalies: Upto 4 cm cracks were observed in the retaining wall

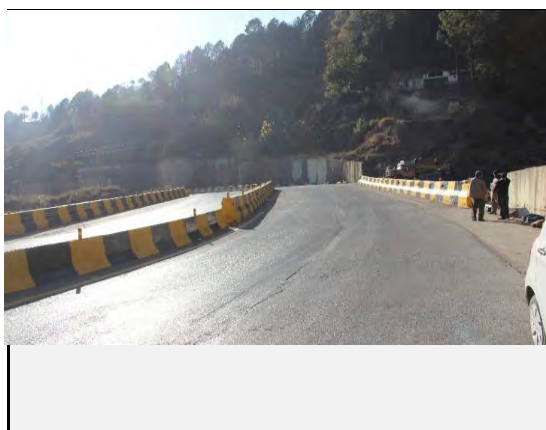
The crack on road has been observed

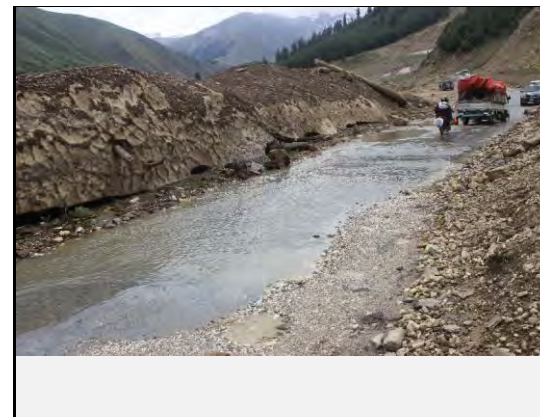
Existing countermeasures / anomalies: View of damaged Retaining Wall as counter measure

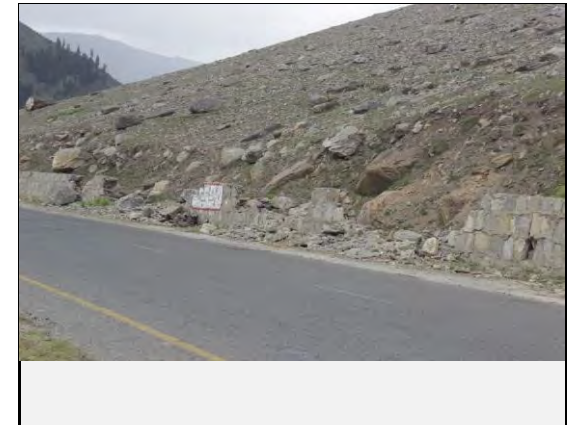
Road condition

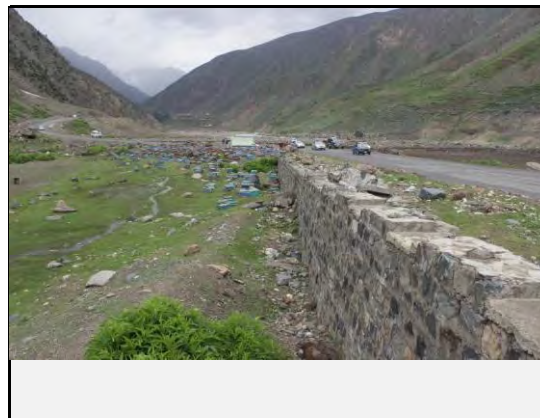
Existing countermeasures / anomalies. Damaged retaining Wall

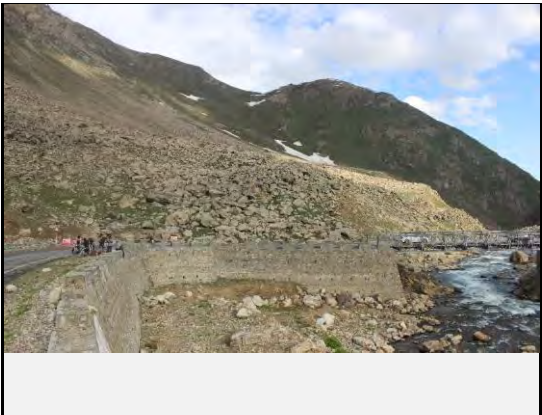
Existing countermeasures / anomalies: View of damaged Retaining Wall as counter measure

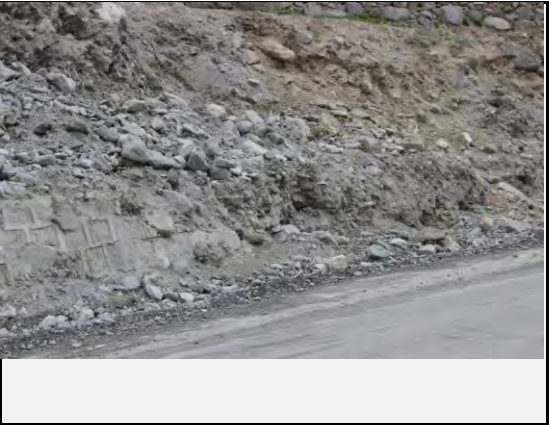
Existing countermeasures / anomalies: Retaining Wall (Damaged) has been constructed along the Debris Flow

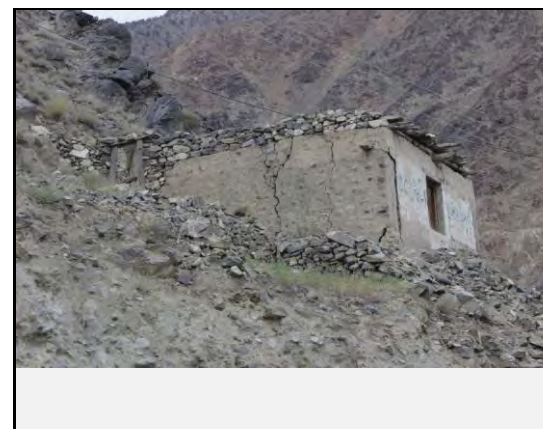
Existing countermeasures / anomalies: No Counter Measure. House has been damaged along the Debris Flow

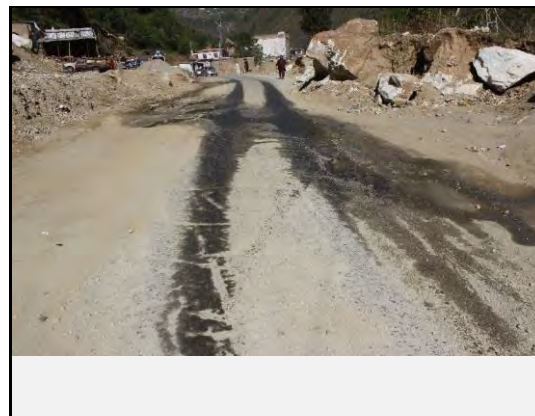
View of fallen block with the debris flow that can damage the population along the downstream.

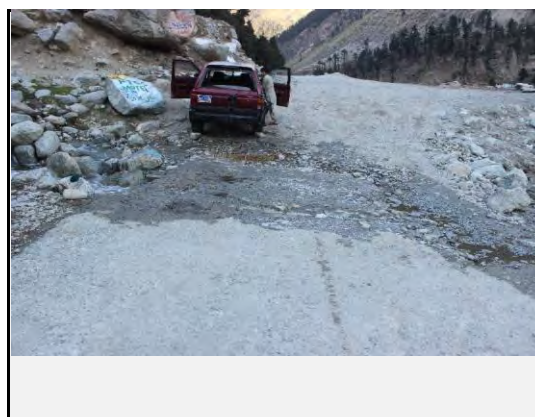
The damage on road has been observed with inlet of pipes for debris flow

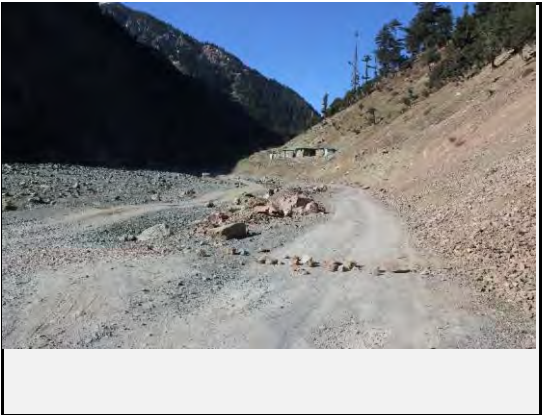
The existing road has been damaged. Red line shows the old road displaced by the debris flow.

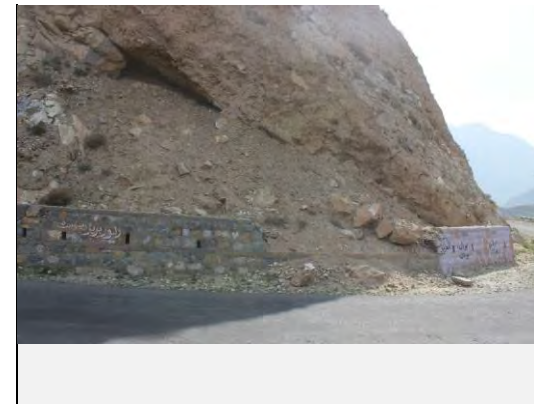
View of unconsolidated material with damaged retaining wall.
