DATA COLLECTION
SURVEY
ON
DISASTER RISK REDUCTION

Input from JICA for
Sulawesi Reconstruction Master Plan

FEBRUARY 2019

JAPAN INTERNATIONAL COOPERATION AGENCY
(JICA)

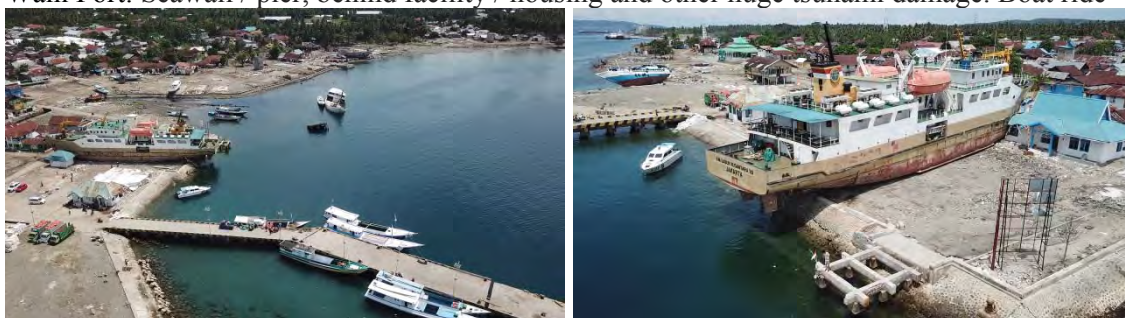
Wani Port: Seawall / pier, behind facility / housing and other huge tsunami damage. Boat ride

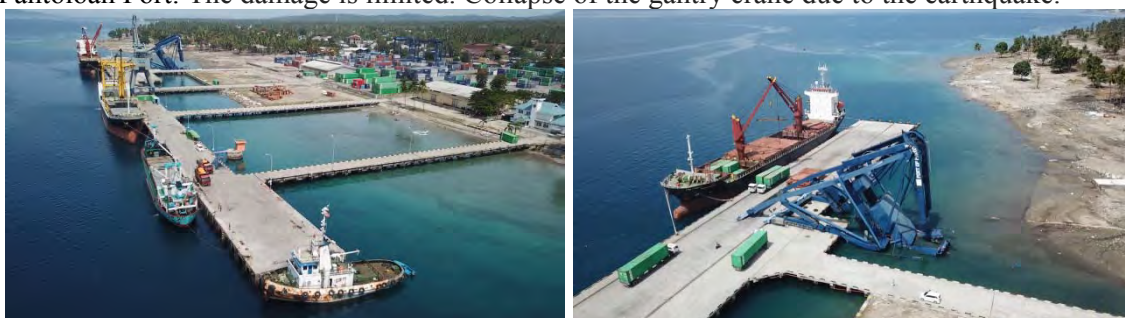
Pantoloan Port: The damage is limited. Collapse of the gantry crane due to the earthquake.

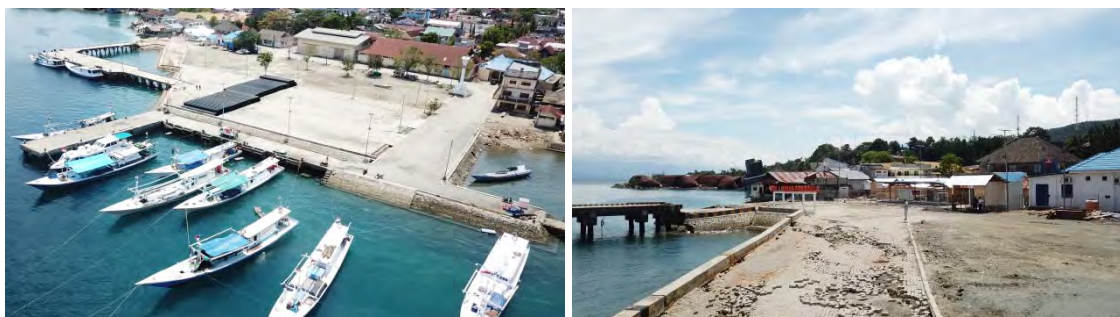
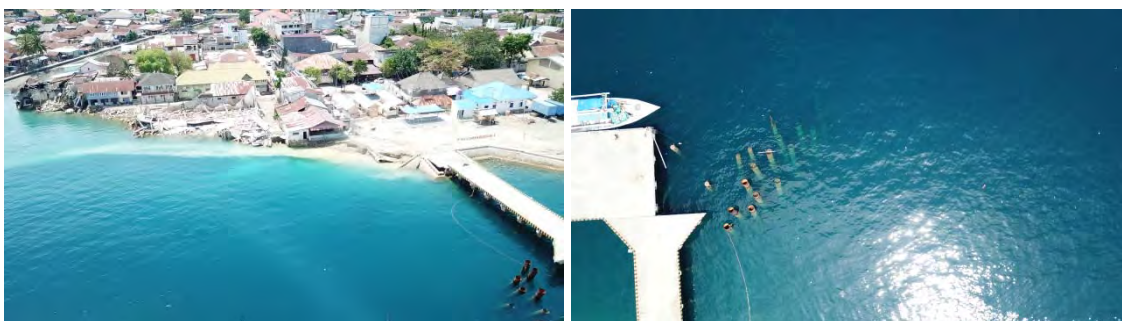
● Donggala Port:

The former pier in the 1950s construction (by the Netherlands) was slightly damaged. Liquefaction in the landfill in recent years, traces of lateral flow. In addition, a part of the newly constructed harbor and pier collapsed due to large-scale collapse of the ground which is thought to be caused by liquefaction.¹

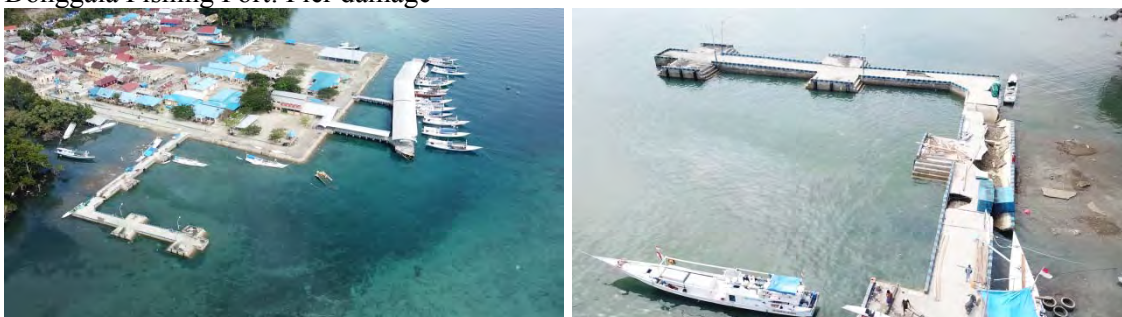
Donggala Fishing Port: Pier damage

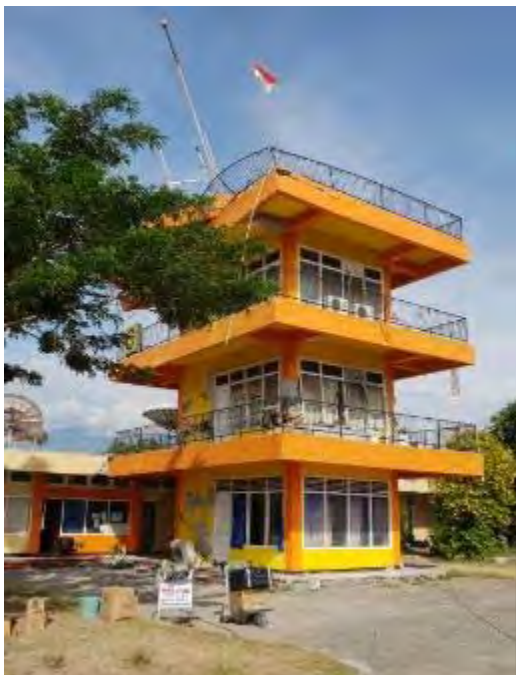
1) Airport control tower

Due to earthquake, the control tower had critical damages

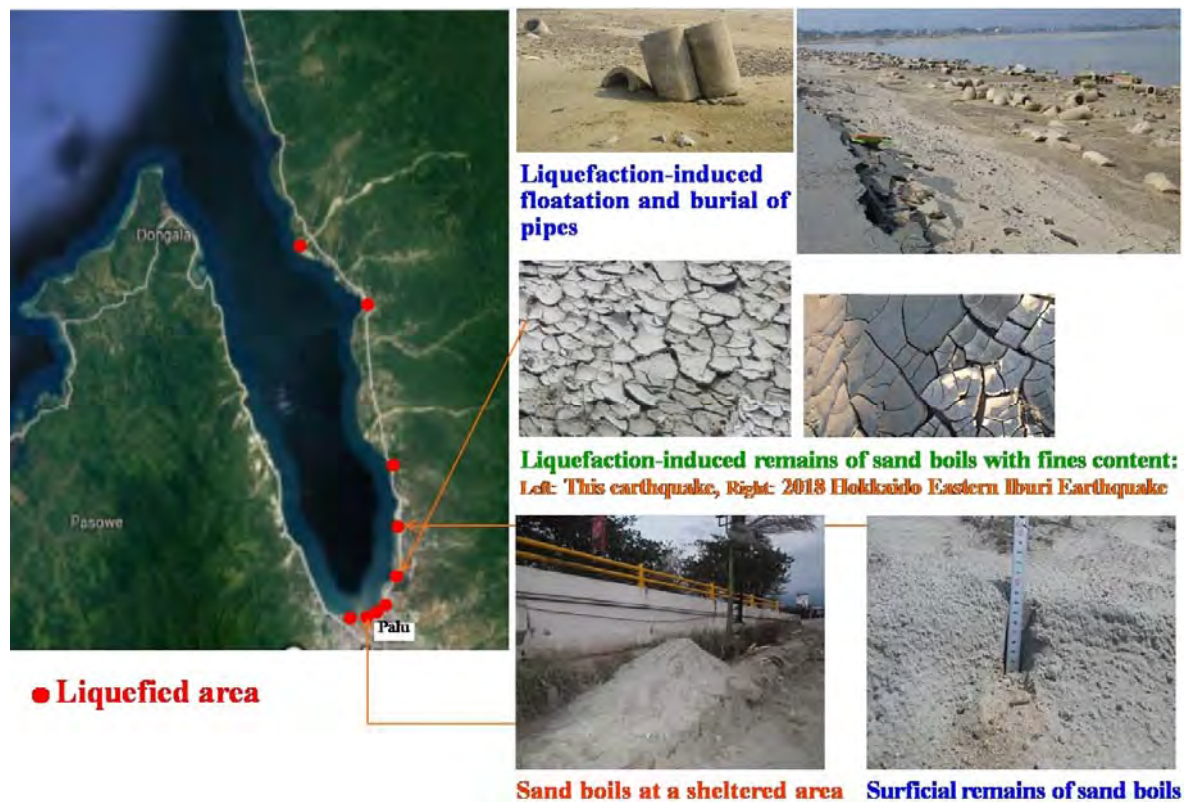
Figure 20 : Extensive Liquefaction in Coastal Areas

Furthermore, the photograph at the bottom right is a large spray sand trace directly behind the structure that is not affected by sediment transport by the tsunami, and it shows clearly the fact that liquefaction occurred in the ground. The lateral photograph is the sand deposit layer directly above the original ground.

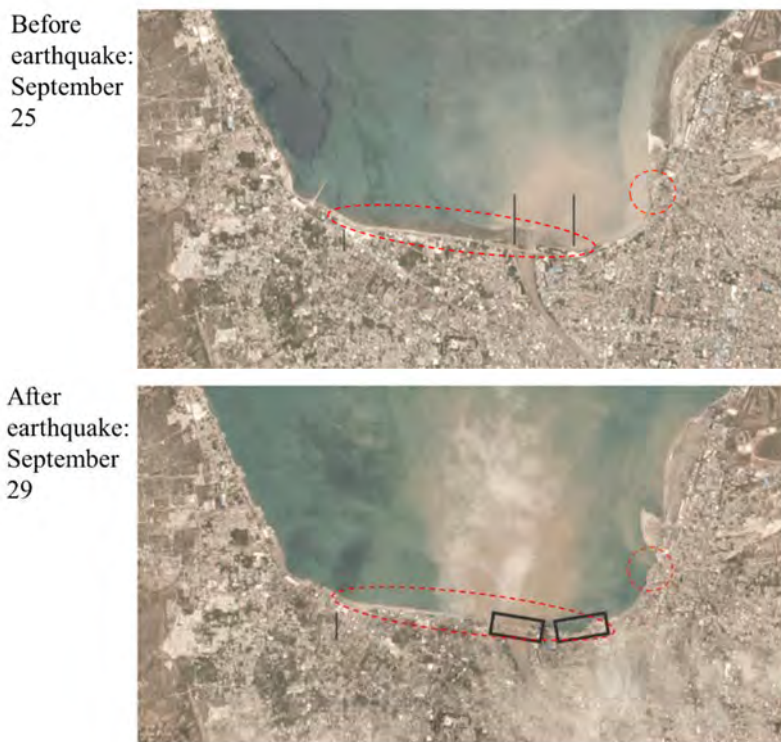
Figure 22 shows the situation immediately before and after the earthquake in the Palu river estuary area. It can be confirmed that the coastal land collapsed / flowed over a wide area of about 2.5 km along the coast and about 200 m in the shore-off direction. The cause of this phenomena would be liquefaction.

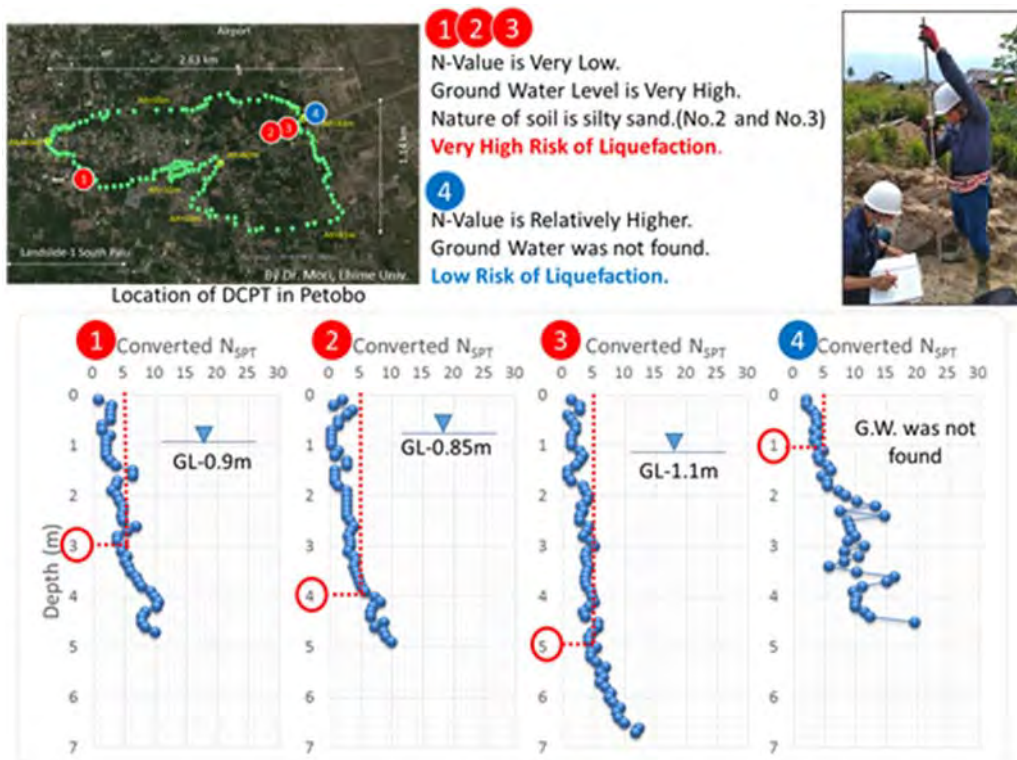
Figure 33 : Cone Penetration Test in Petobo

JICA conducted geotechnical survey, cone penetration test, in Petobo and Jono Oge in order to confirm the assumption. The result of test tells no contradiction to the assumption, however further investigation is necessary in order to prove the assumption. For example, there must have been a lot of confined aquifer under Jono Oge. Without that, such an enormous flood never occurred, and some people say water rose up to dozens meters height just after the earthquake.

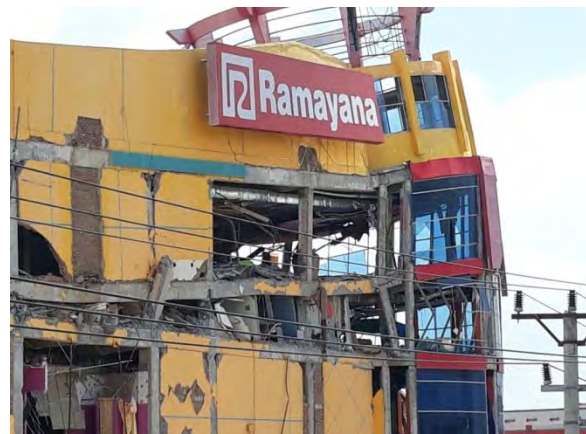
Figure 57 : Inappropriate design of column and material

- Collapsed buildings doesn't seem to set suitable position of main reinforced bars, for example, in Mall Tatura (Figure 57).
- Supervision might be insufficient during construction work, due to the system or shortage of finance.

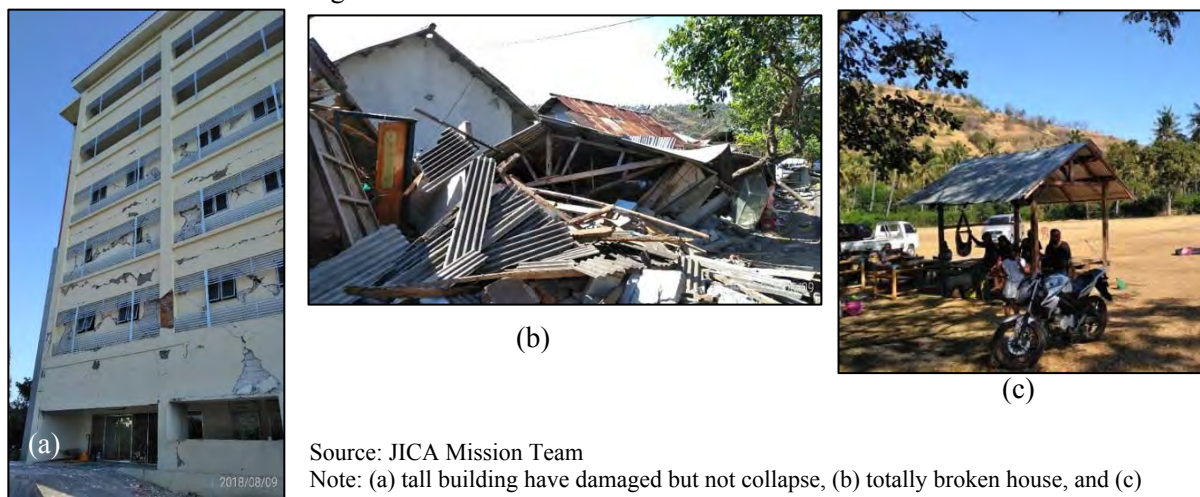
A series of quakes including a powerful 6.9 magnitude tremor struck Lombok Island. This earthquake trigger landslide in some area. There are completely broken houses and non-damaged houses in the same place in Lombok as shown in Figure 41.

Source: JICA Mission Team
 Note: (a) tall building have damaged but not collapse, (b) totally broken house, and (c) simple structure house with no damage

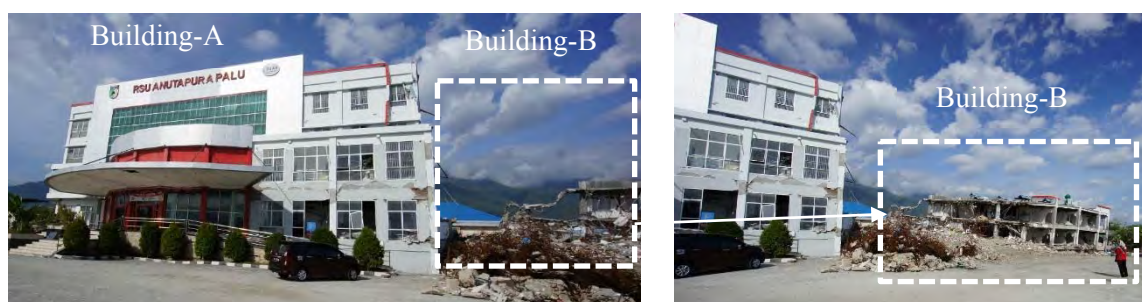
b. Different kind of Foundation applied for same building

Building-B was slide away around 50m from the original position due to Earthquake and totally destroyed.

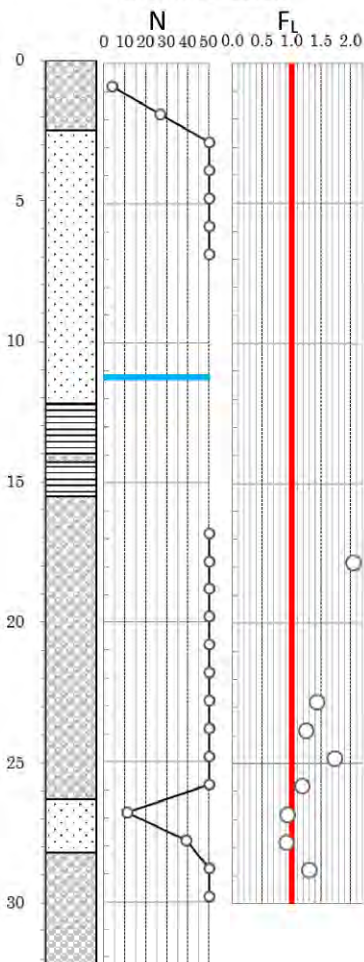
LP-2 At the south-end of Inside of landslide area
Moved deposition is identified up to approx. 2m

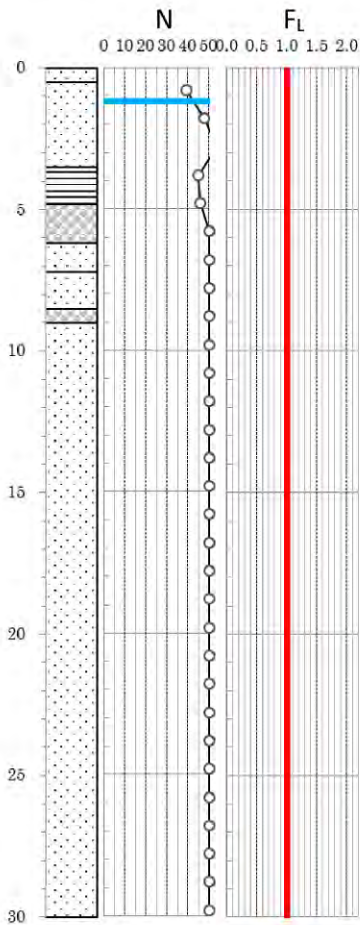
J-5 Outside of landslide area
Cracks are identified (ZRB3)

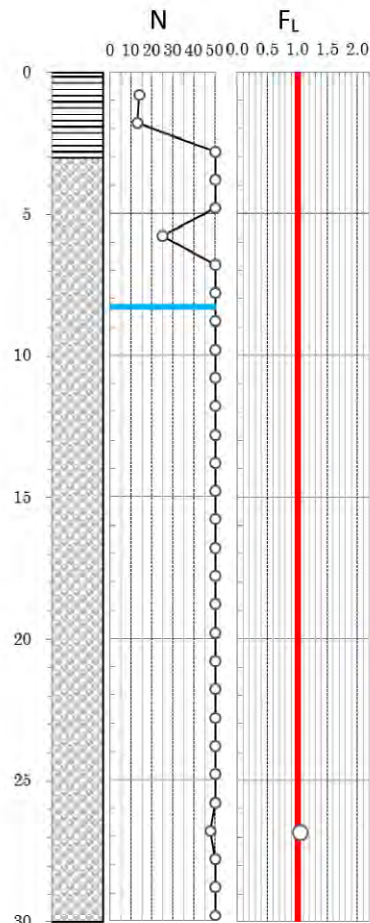
J-10 Outside of landslide area
Cracks are identified (ZRB3)
