**Attachment 9: Kigali City Reservoir Inventory
Survey Results**

REPORT OF THE RESERVOIR SURVEY IN KIGALI

**THE PROJECT FOR STRENGTHNING OF NON-REVENUE
WATER CONTROL KIGALI CITY WATER NETWORK**

KYOWA ENGINEERING CONSULTANTS Co., Ltd/ WASAC Ltd

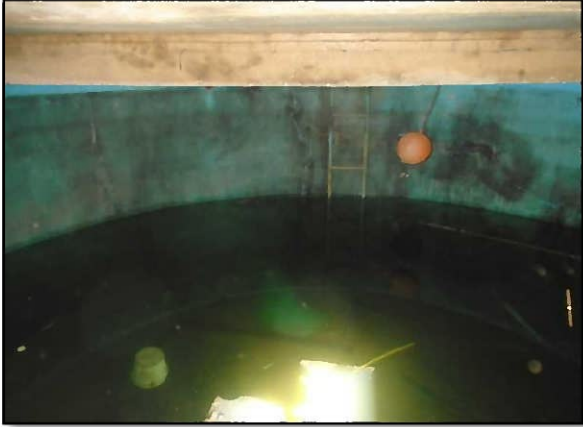
Floater Valve need Repairing or replacement

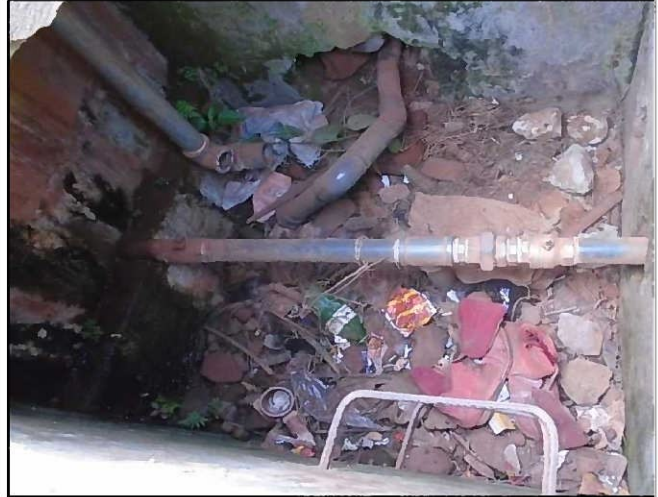
Outlet manhole need rehabilitation, cover and pipe reconnection

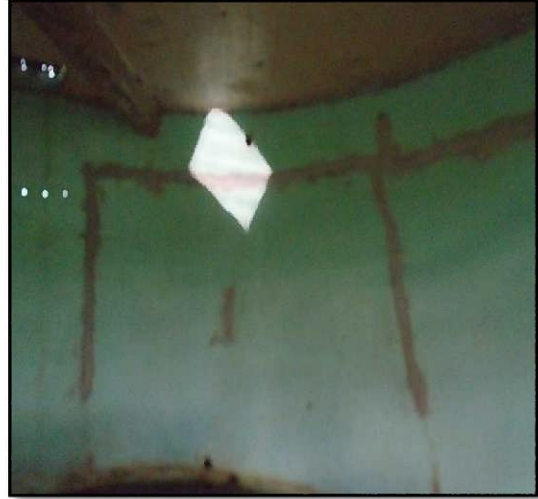
Cracks on the wall and need

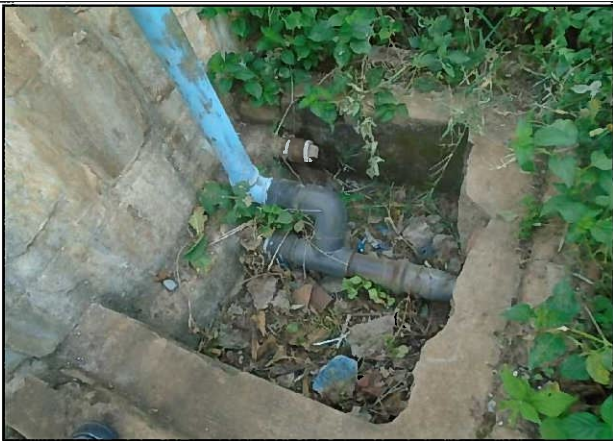
Overflow and Drain Pipe manhole need maintenance

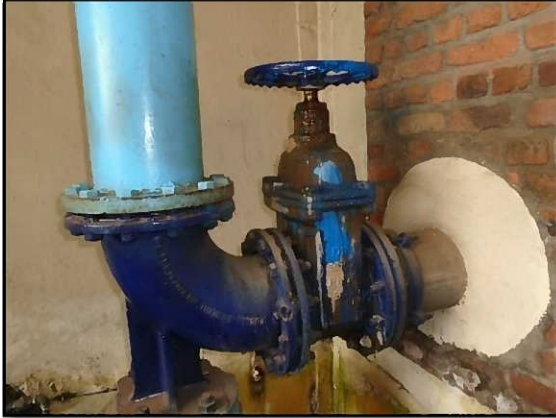
Leaking inlet Valve Res. 1

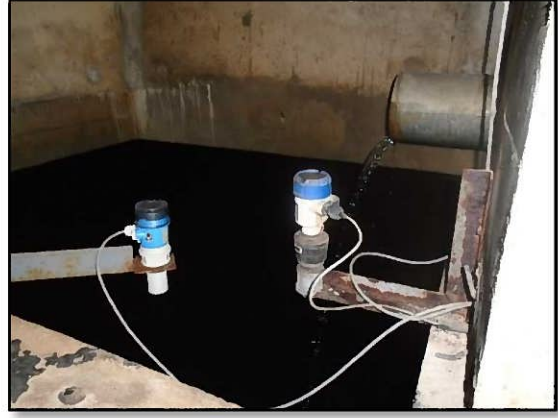
Water level indicator not working (Defective)

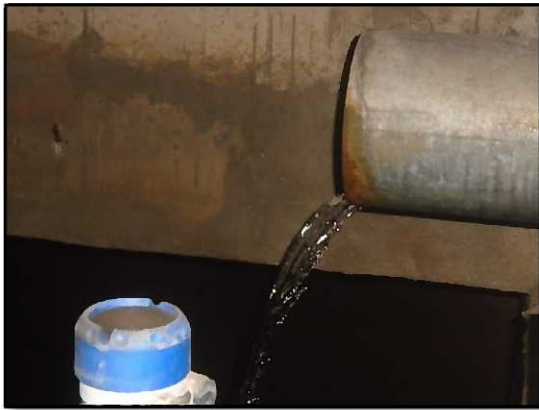
No Floater Valve installed

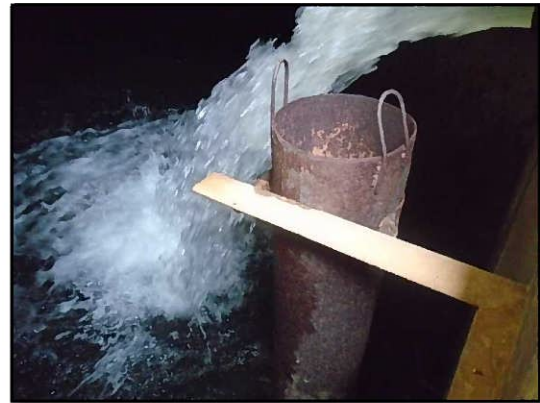
Overflow Pipe defective (if possible replacement is recommended)

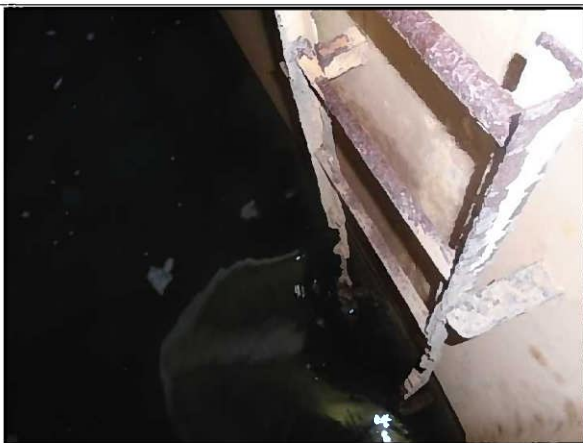
Stairs need replacement

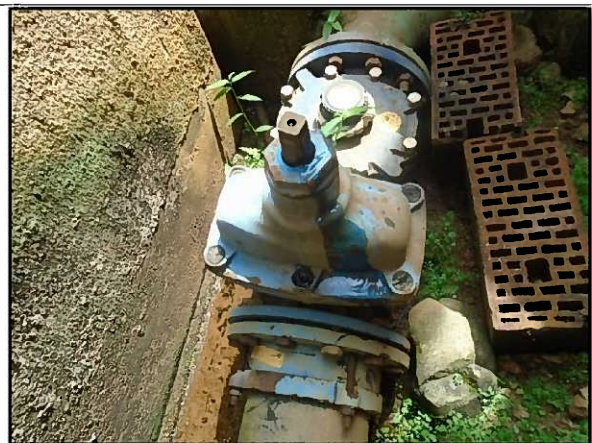
Inlet valve Res.2 need replacement

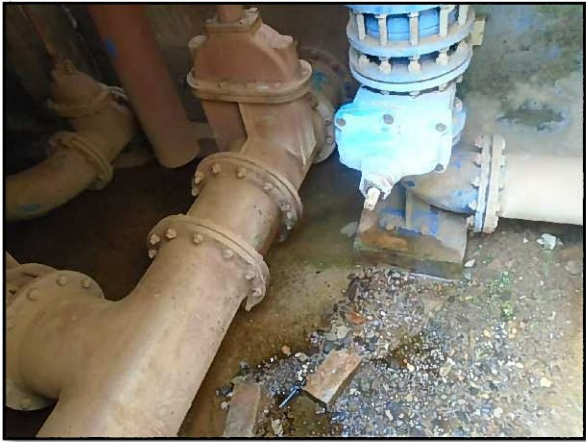
Defective Leaking vertical valve

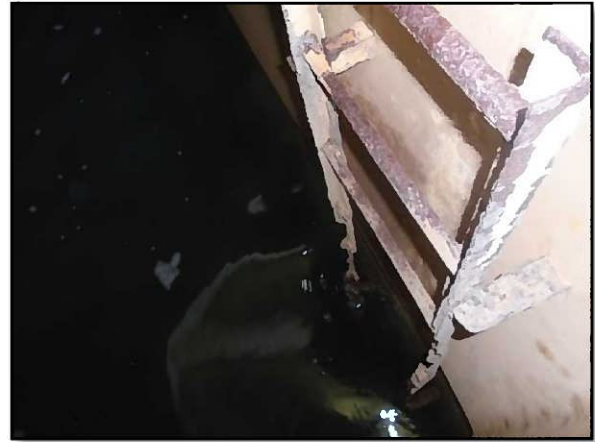
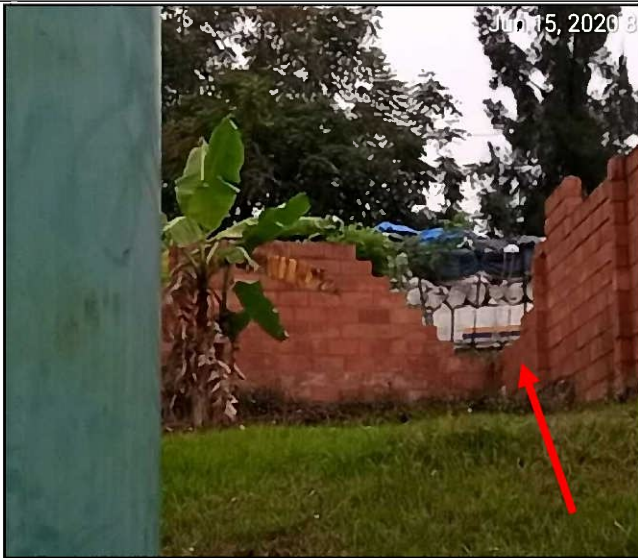
The fencing wall has fallen on upper and lower side of the station, this resulted in intrusion by passerby and theft of valve handle and now they have only one piece, if stolen consequences will be bad, meaning that the fence repairing is also a priority.

These fallen part of fence are being used by thieves and intruders

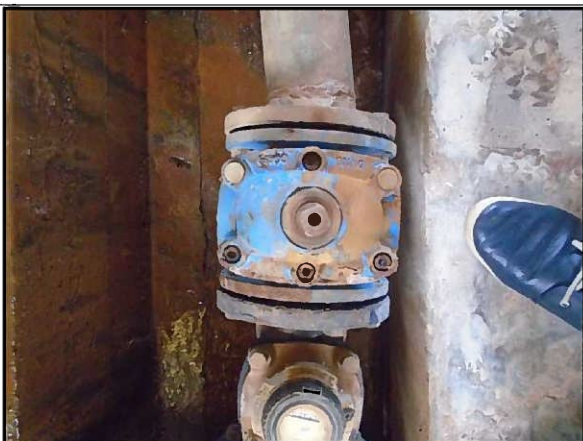
Pump outlet valve need replacement DN80

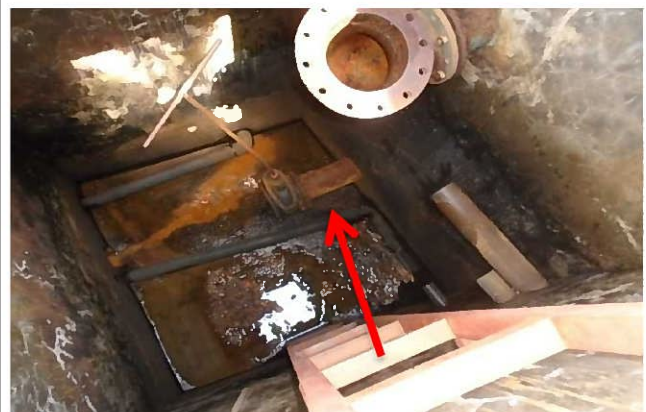
Drainage Valve (Leaking but not to much)

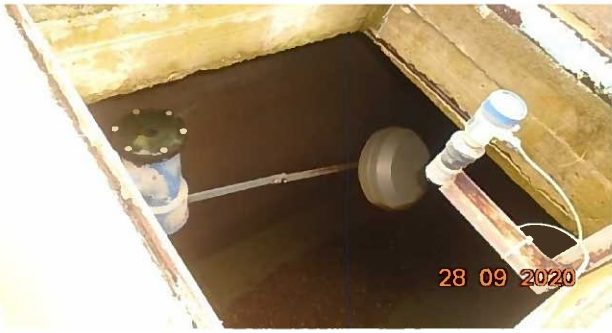
Defective Floater

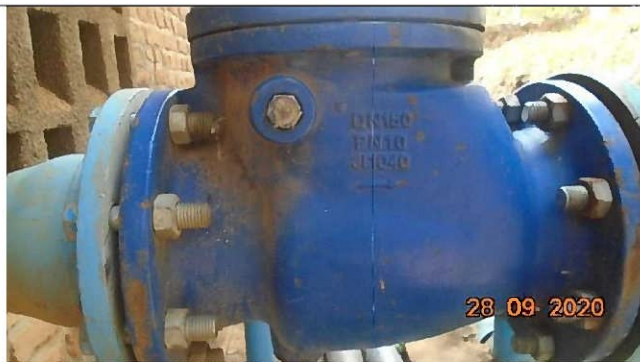
Replacement of existing check valve, Outlet valves need replacement.

Replacement of non-functioning Check Valve

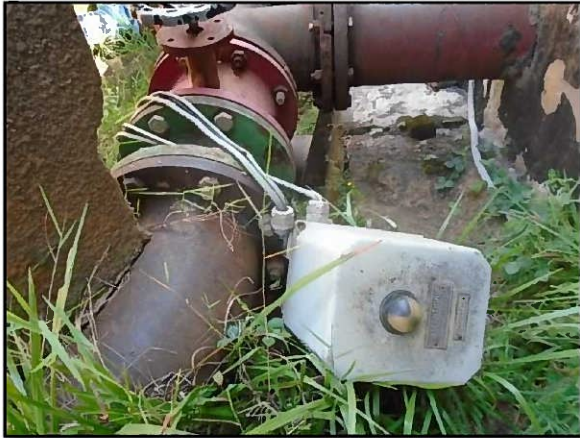
Defective Electrovalve

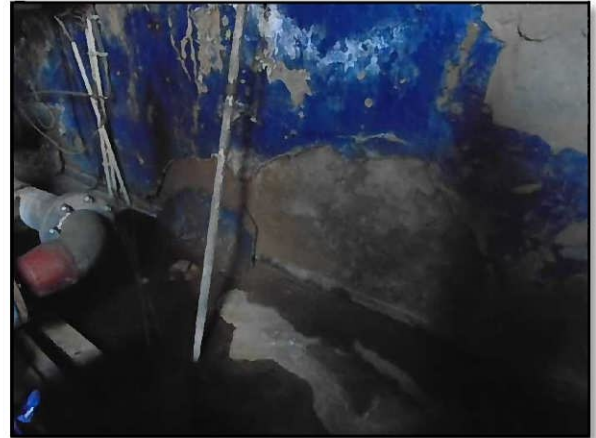
The pump house Pump house need rehabilitation (urgent), gate not closing, no lighting, Operator house leaking.

Rehabilitation needed for pump house

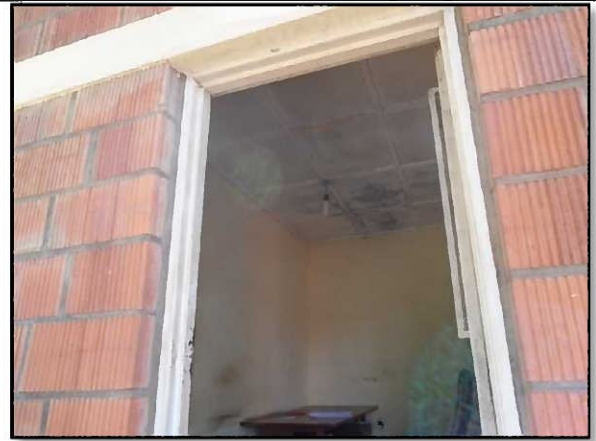
Operator house leaking

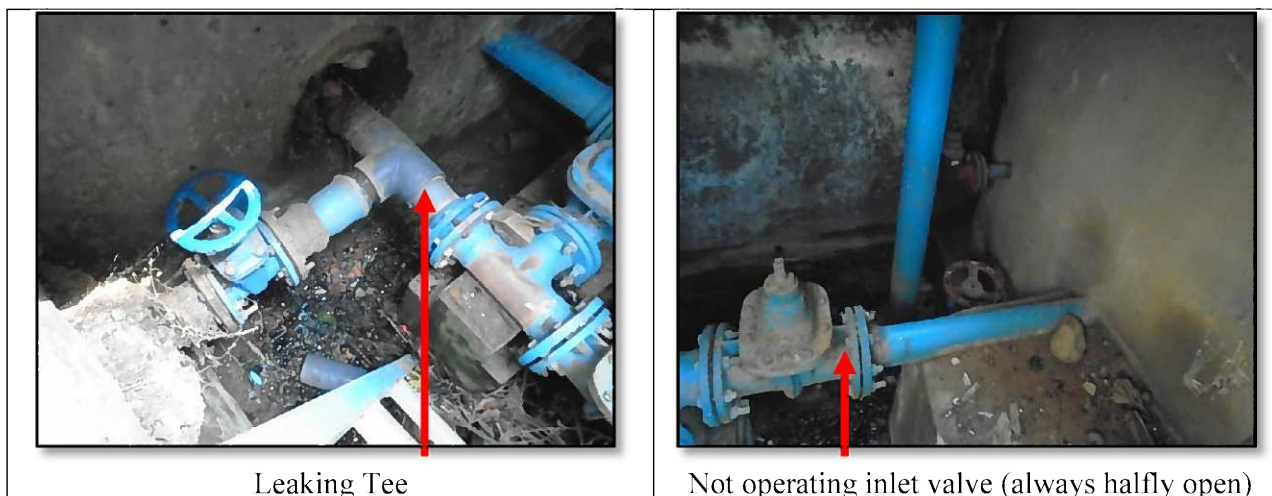
The reservoir receives water from Nzove via Ntora, and it serves FAWE GS and the nearby areas. There is a leaking Tee and Valve.

Leaking Tee

Not operating inlet valve (always halfly open)

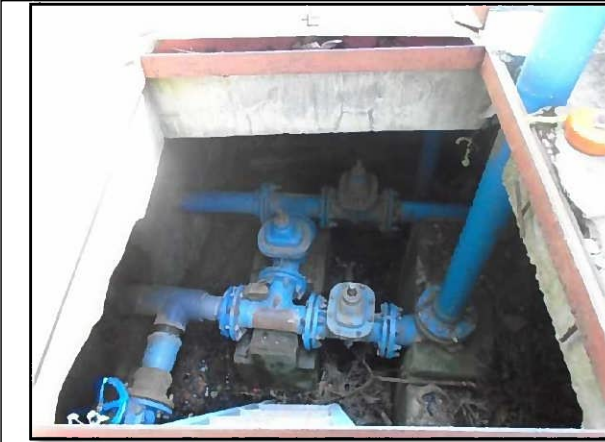
Manhole cover replacement

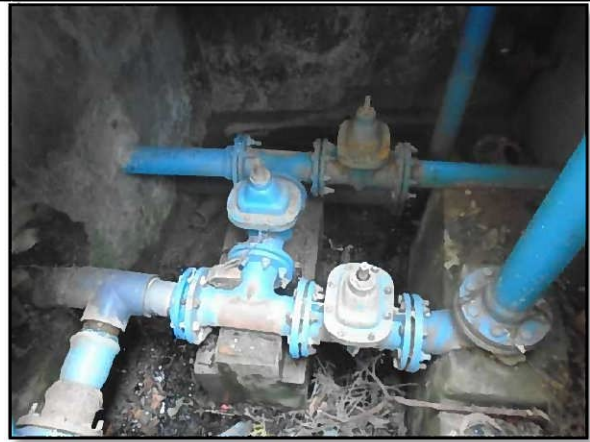
General cleaning works needed.

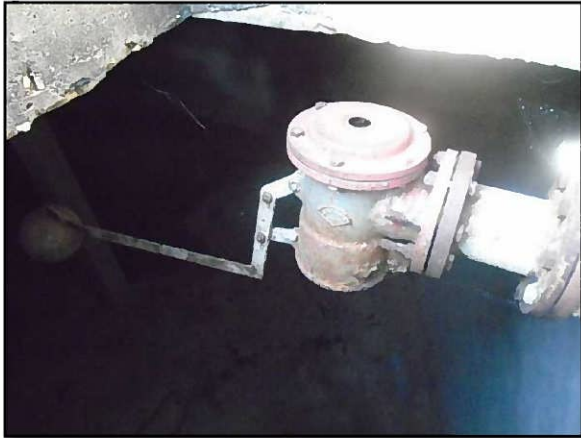
Defective floater valve

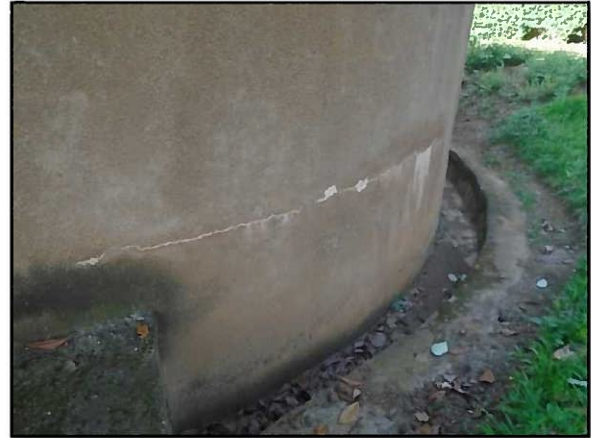
The reservoir was receiving water from Nzove via Ntora, after its reception it was discovered that it leaks profusely on walls and bottom and the branch decided to abandon it, bypass it.

Rehabilitation needed to waterproof it as it was abandoned because it was leaking on walls and base

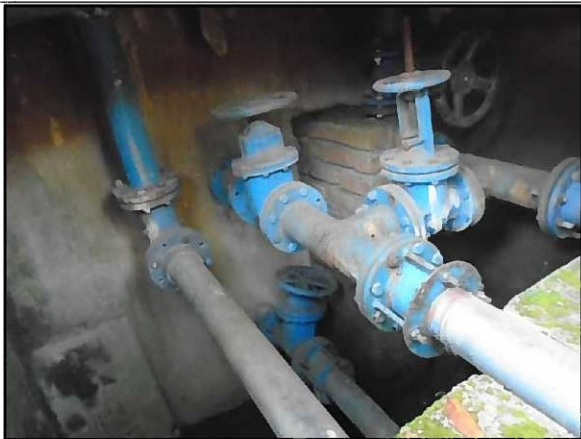
Replacement of all 4 valves

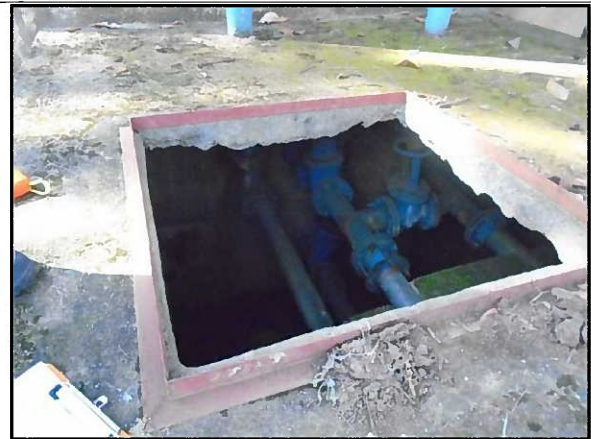
New covers needed for manhole and Reservoir

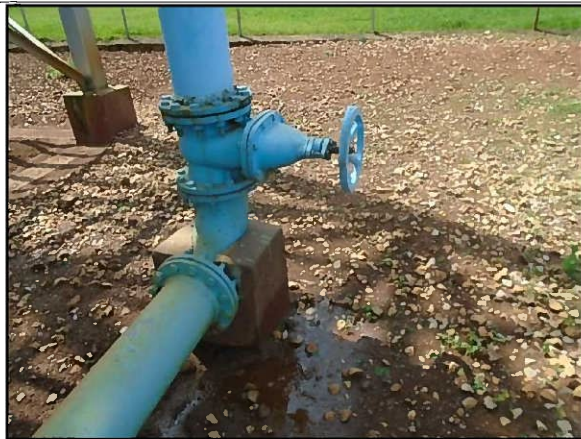
Defective inlet valve

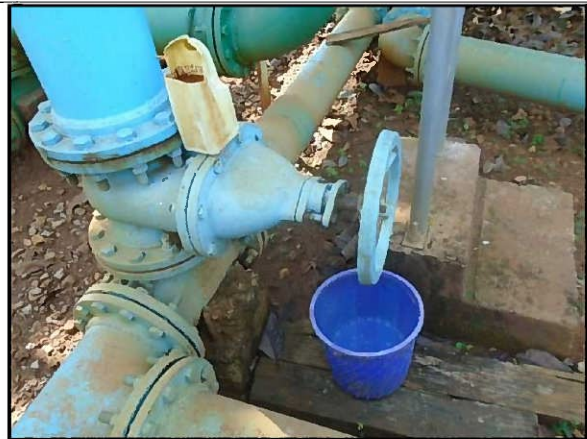
Defective Outlet valve

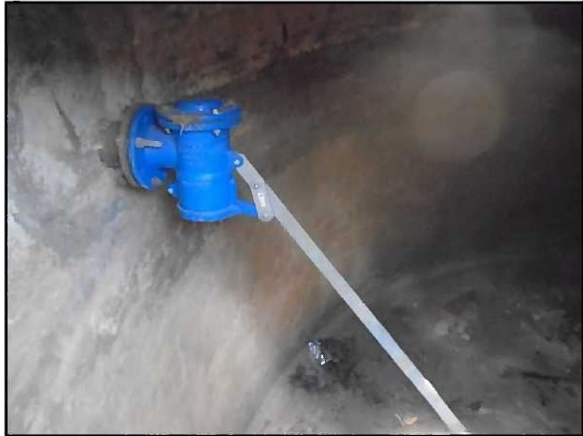
Defective floater valve

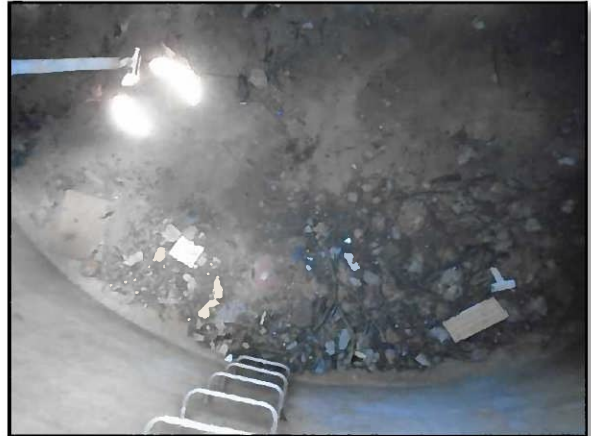
General rehabilitation is needed

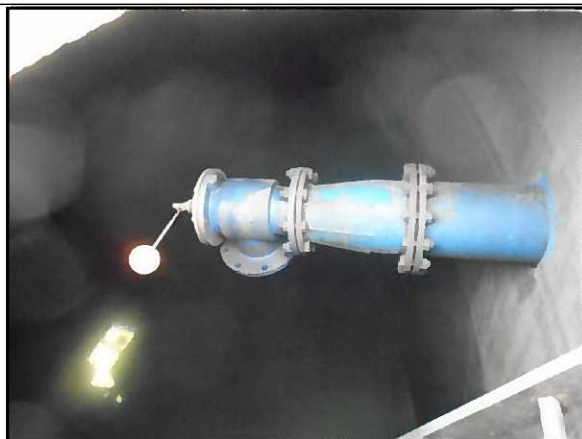
Floater doesn't open for low pressure inlet water

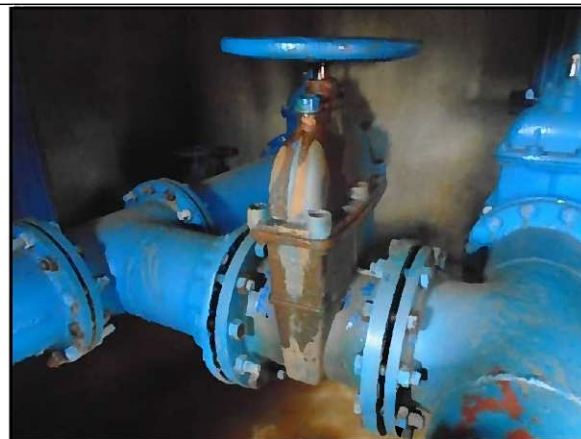
Bypass valve leaking

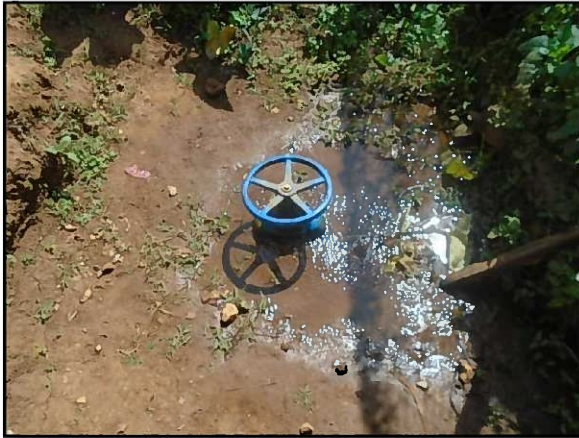
Inlet valve leaking

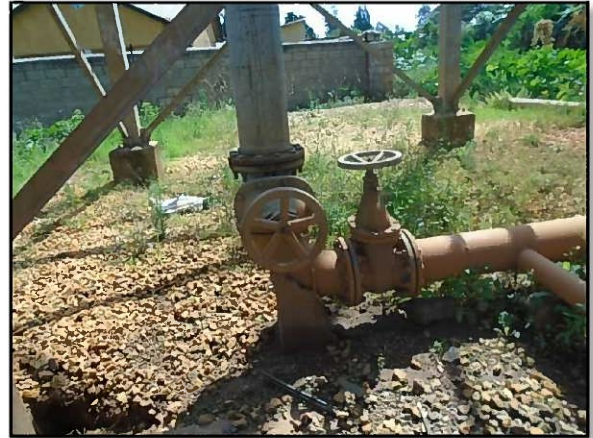
Outlet valve not operational

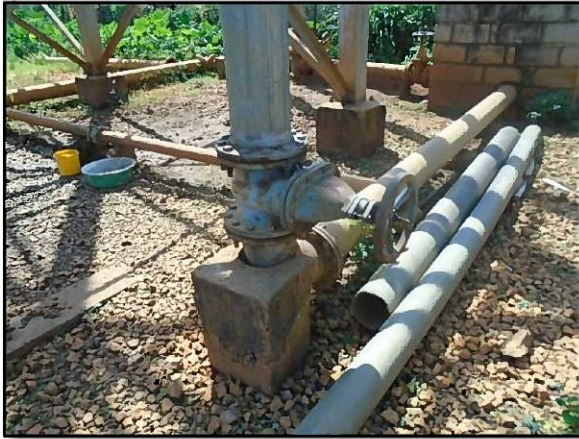
Drainage valve need replacement

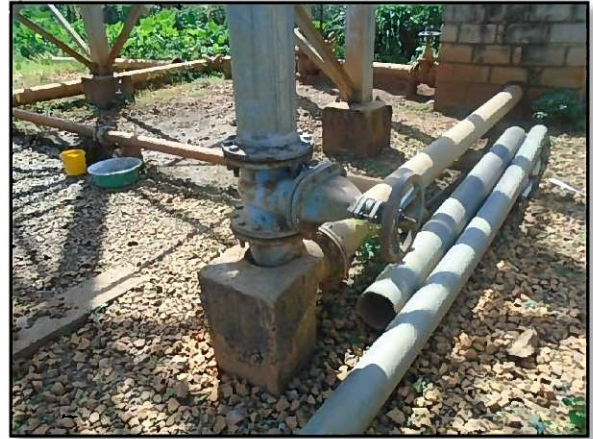
Valve support of thrust blocks (all) need rehabilitation.

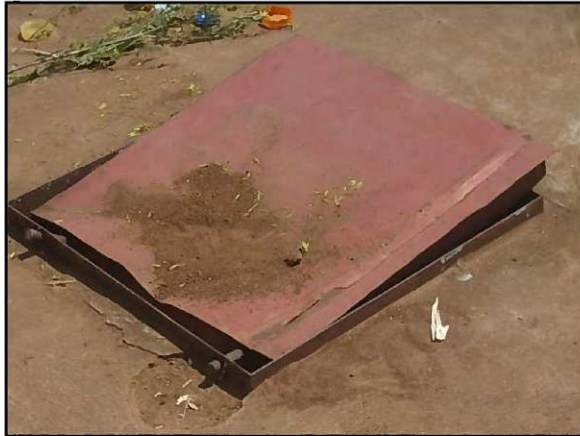
Defective cover

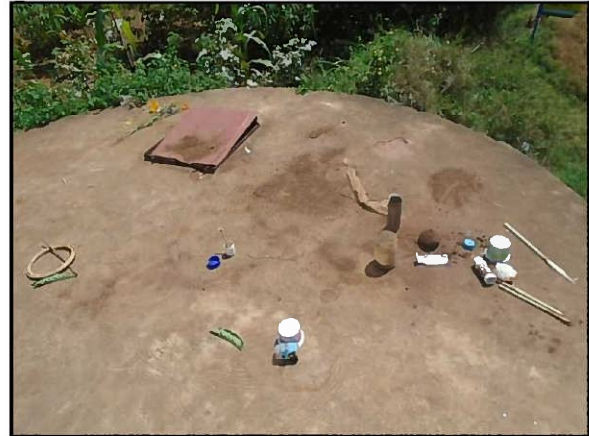
Kids play on top, in and outside of it

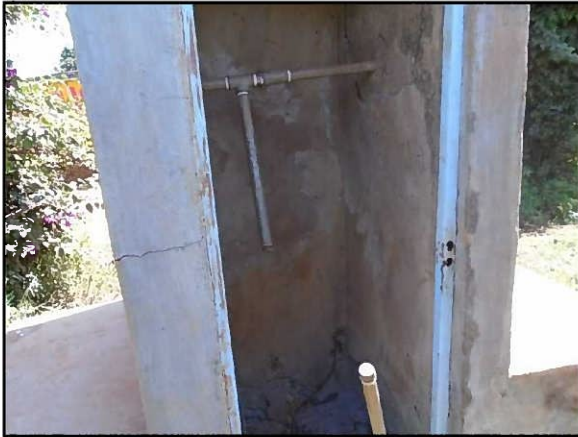
Water tap reconnection recommended

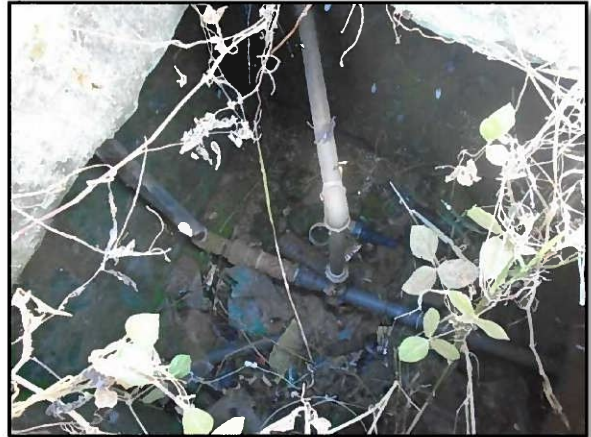
Inlet and outlet manholes need covers

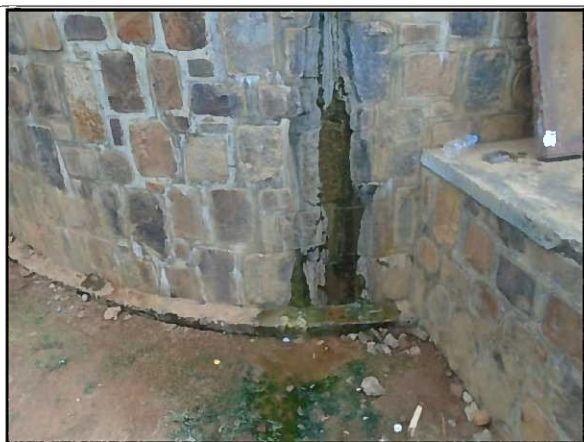
Wall leaking

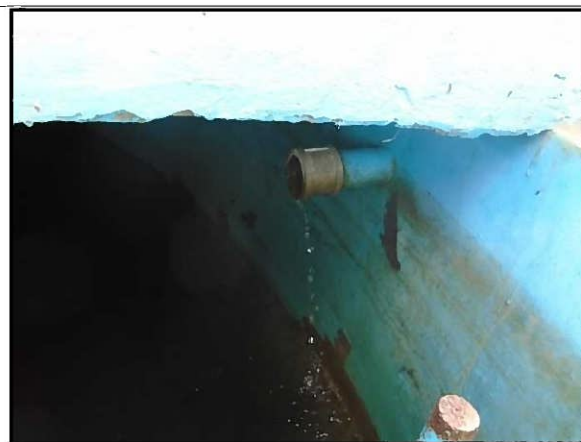
Floater valve needed

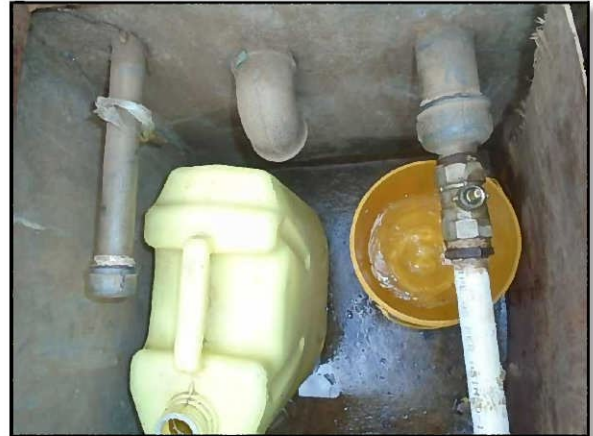
Replacement of outlet valve

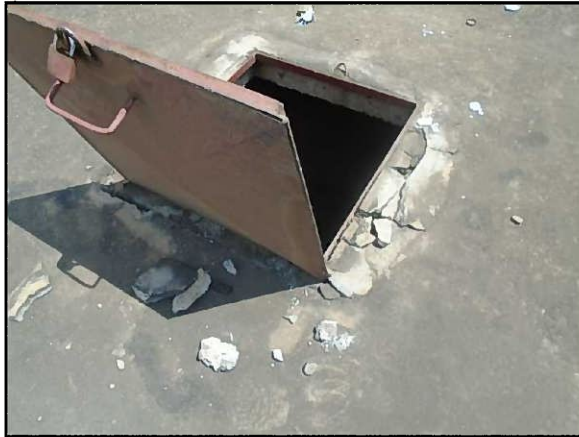
Cover protection maintenance needed

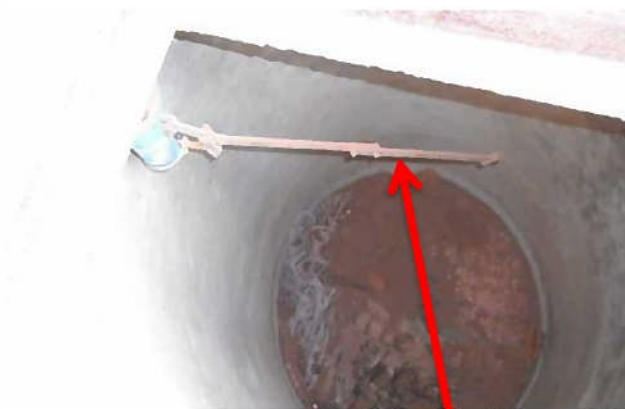
Float Valve Defective

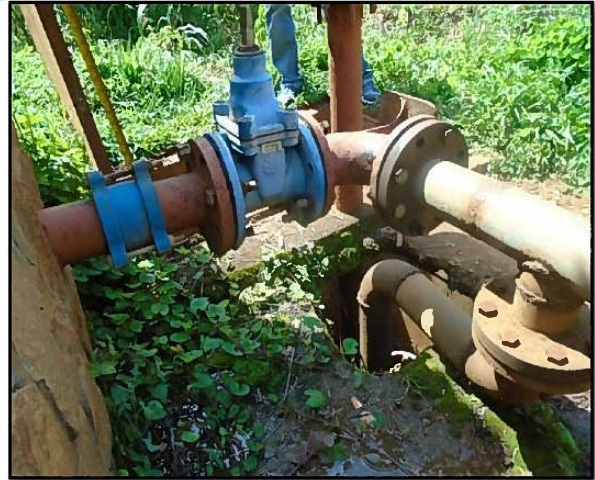
Wall leaks at the connection of the manhole

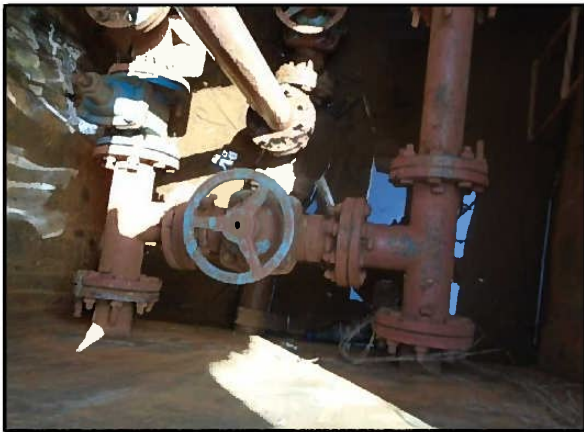
All the existing valves not functioning

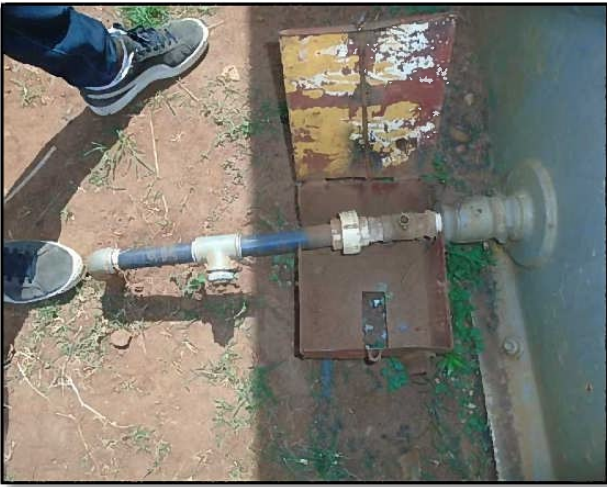
Outlet valve need to be replaced.

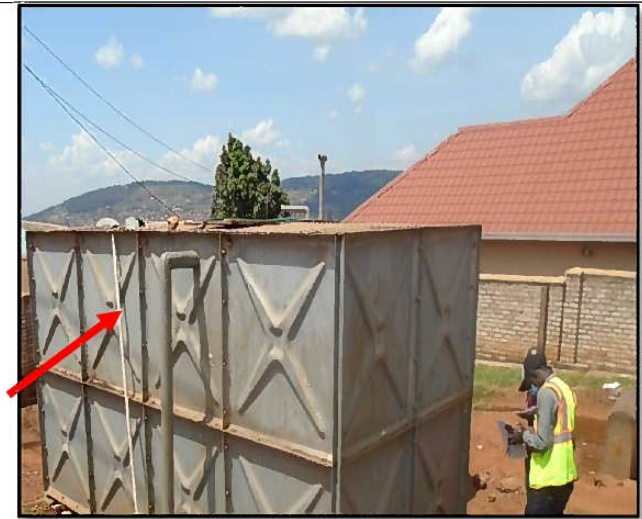
Inlet pipe need to be fixed and connected to the roof opening of the tank.

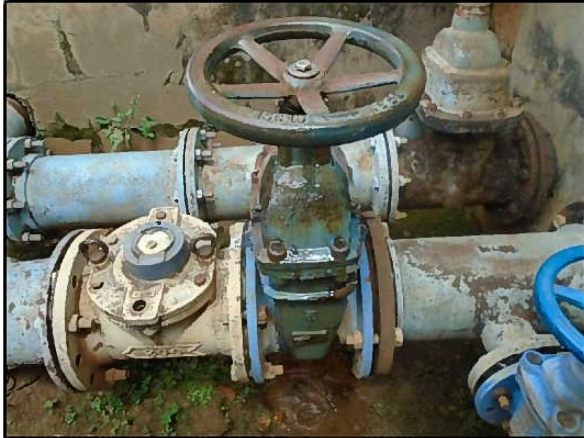
Leaking Outlet Valves

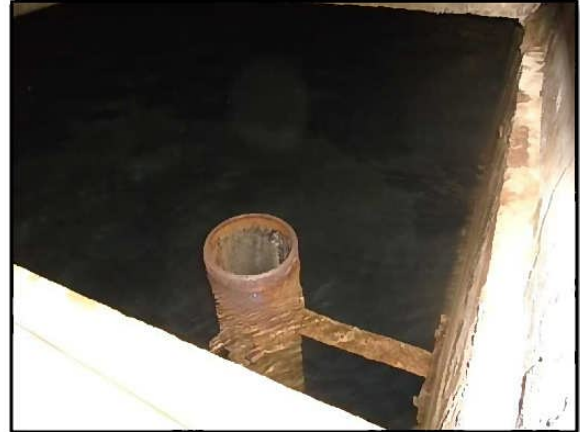
General accessories cleaning needed as soon as possible
