FINAL REPORT ON THE RESERVOIR SURVEY IN NYAMIRAMBO BRANCH

**THE PROJECT FOR STRENGTHNING OF NON-REVENUE
WATER CONTROL KIGALI CITY WATER NETWORK**

Final report of the reservoir survey in REMERA Branch/KEC Co., Ltd/ WASAC Ltd/ JICA

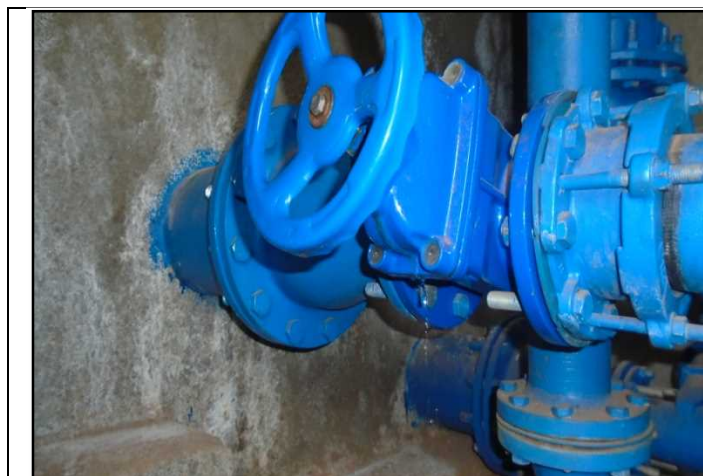
Outlet Valve DN100 leaking.

Leaking Outlet Valve

Action	Requirements
<ul style="list-style-type: none">Replacement of Outlet Valve	<ul style="list-style-type: none">1 Valve DN100

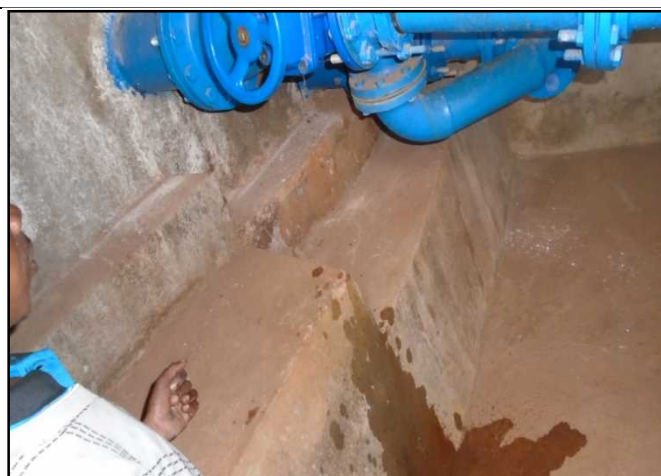
Valve leaks when opened

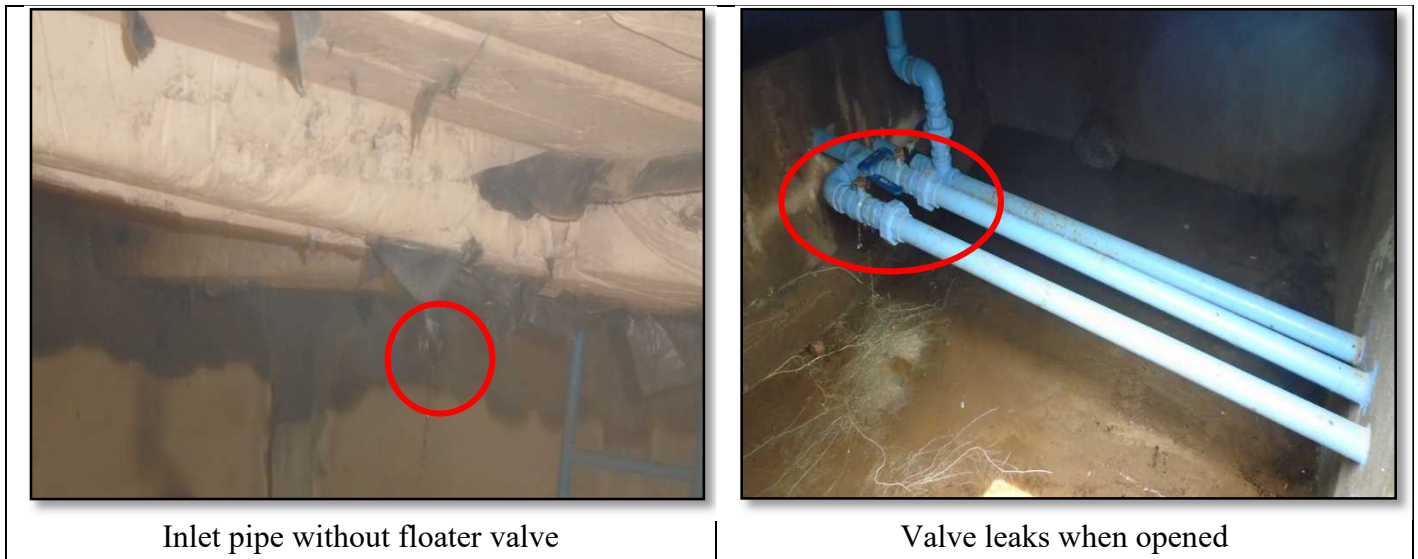
No Floater valve, Outlet valves leaking.

Inlet pipe without floater valve

Valve leaks when opened

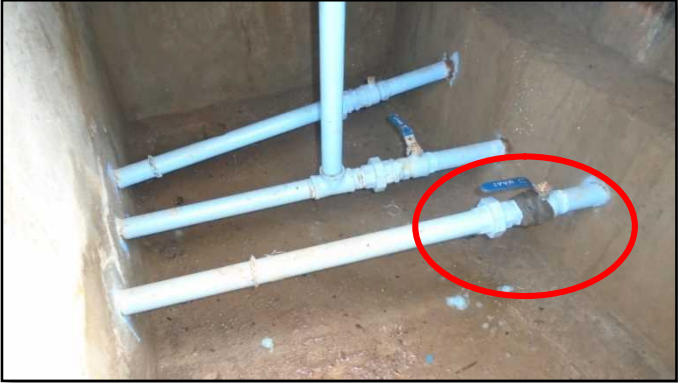
No Floater valve, Outlet valve leaking.

<p>Can't open the reservoir to take a picture of the inlet without a floater</p>
<p>Leaking Outlet Valve</p>

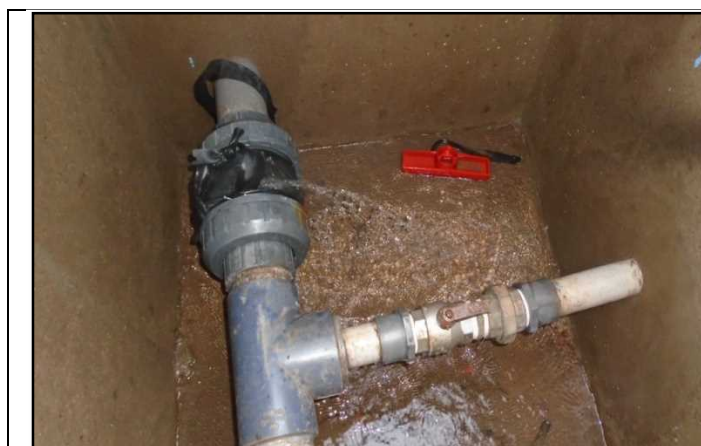
PVC Valve 110 leaking, no floater valve installed.

Leaking Inlet PVC Valve

Can't open the reservoir to take a picture of the inlet without a floater

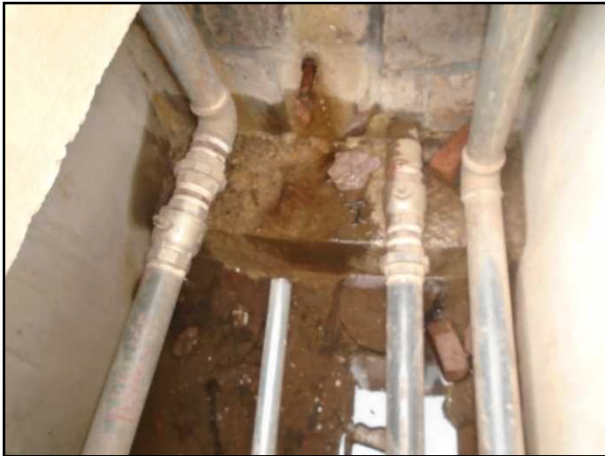
Outlet towards Public Water Tap Leaking

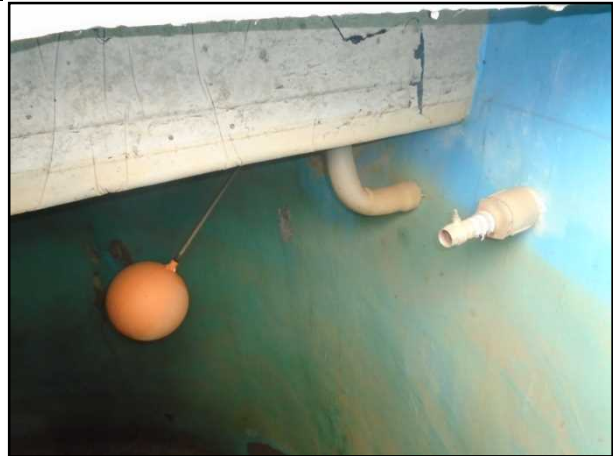
Installed floater not working

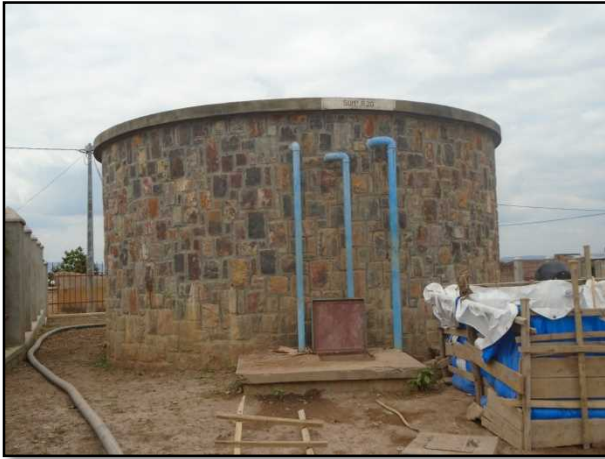
Cracks on the wall leaking.

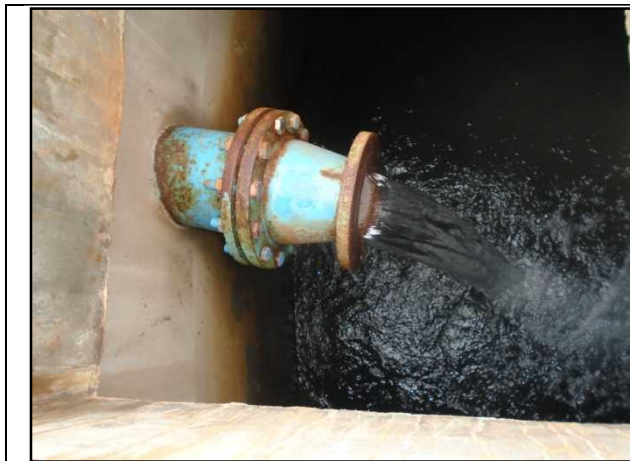
Floater valve needed

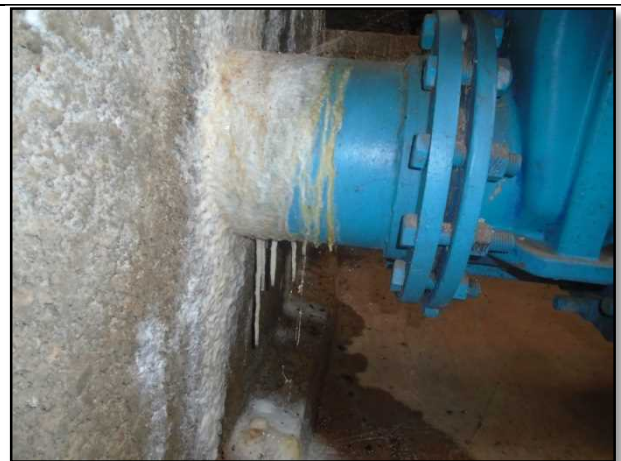
Leak at the bottom of drain pipe need fixing

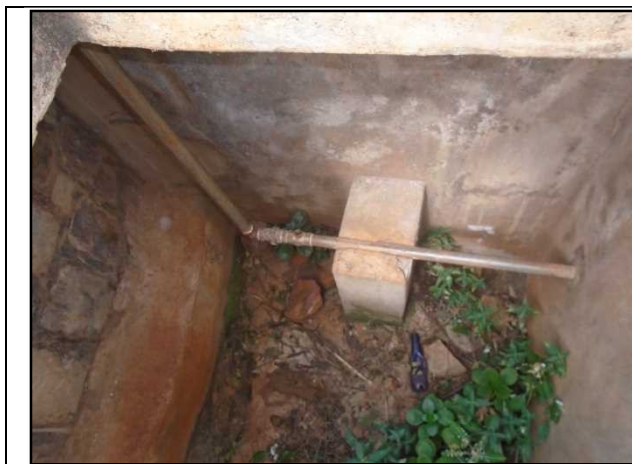
Inlet valve need to be replaced

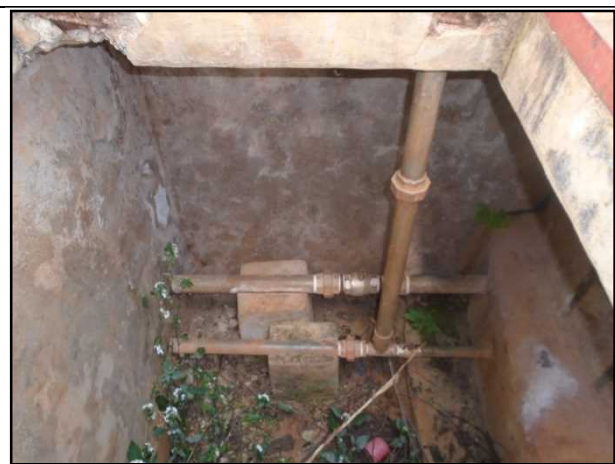
Manhole need a cover

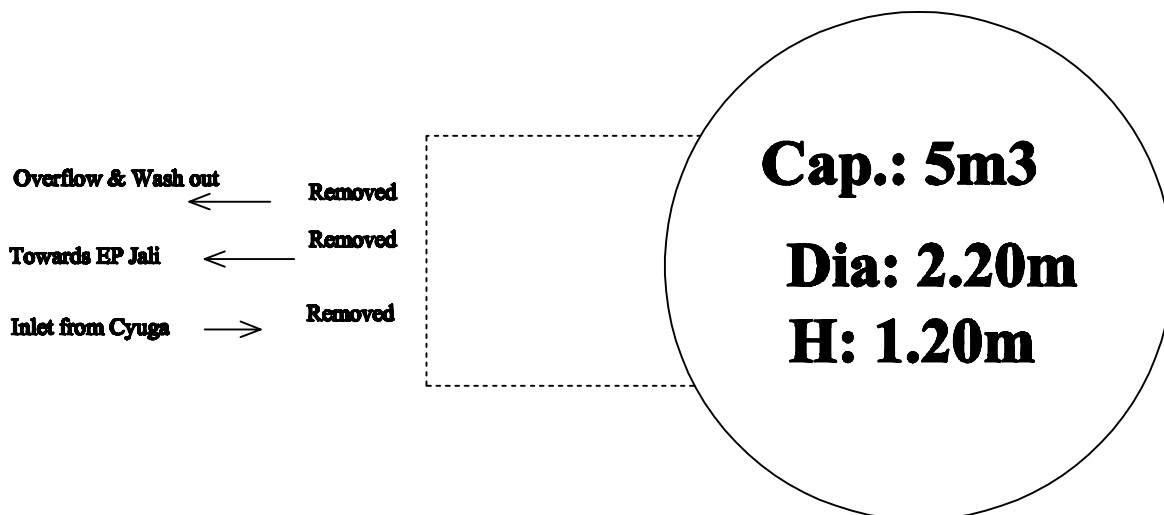
ABANDONED

- 1- The tank was abandoned.
- 2 - Total replacement is recommended as per visual and physical assessment.

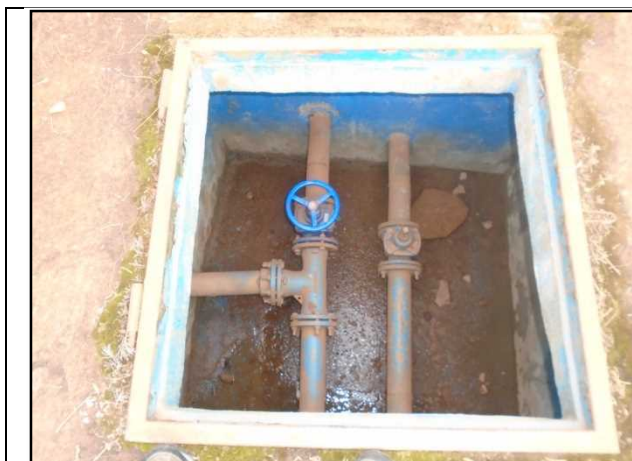
Leaking bypass valve

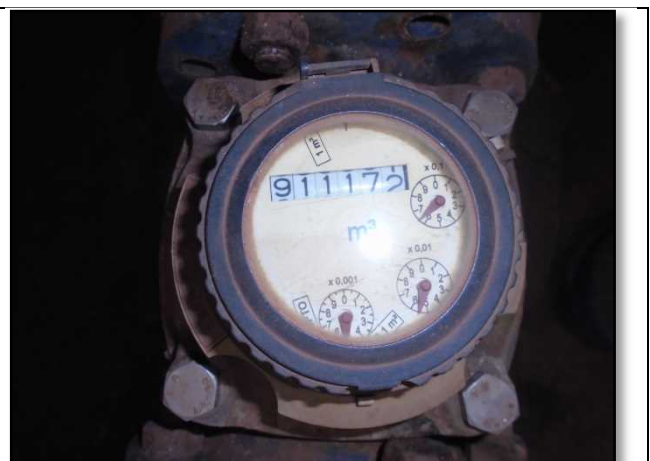
Meter on Ntora pipe need checking

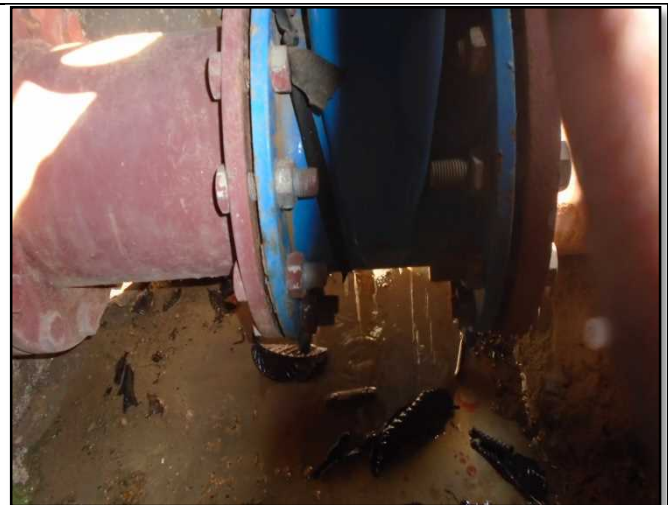
Leaking Valve

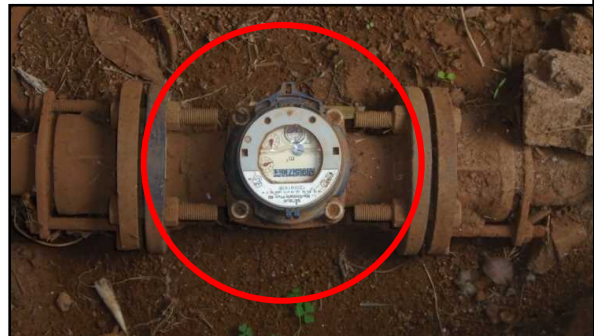
Defective Meter

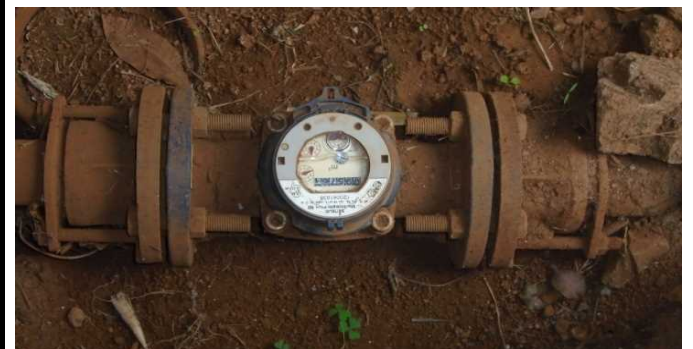
Meter (Defective)

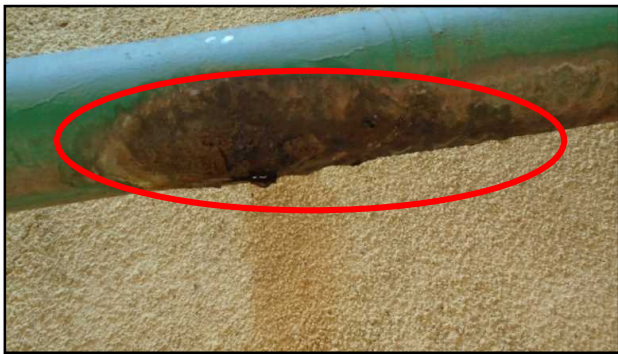
Leaking pipe to be replaced

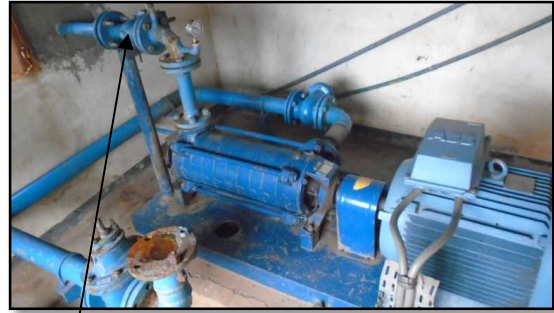
Check valve to replace

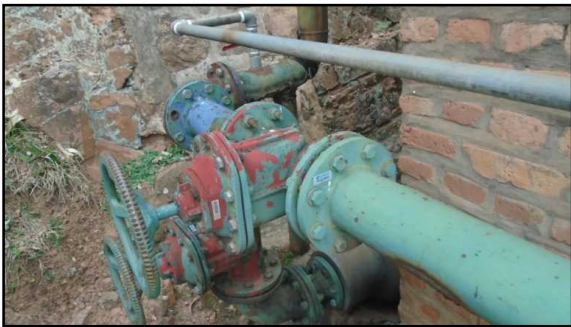
Accessories to replace

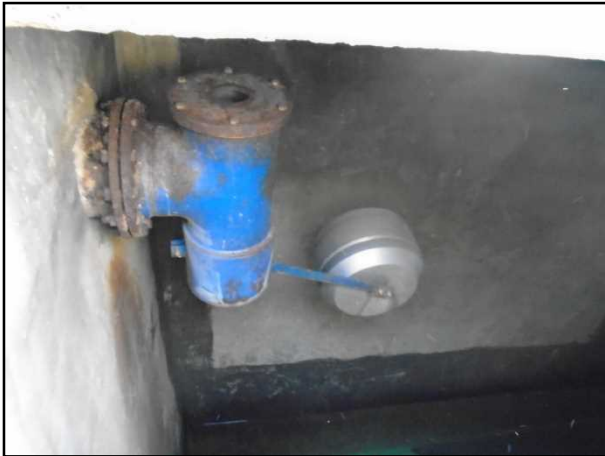
Defective floater valve

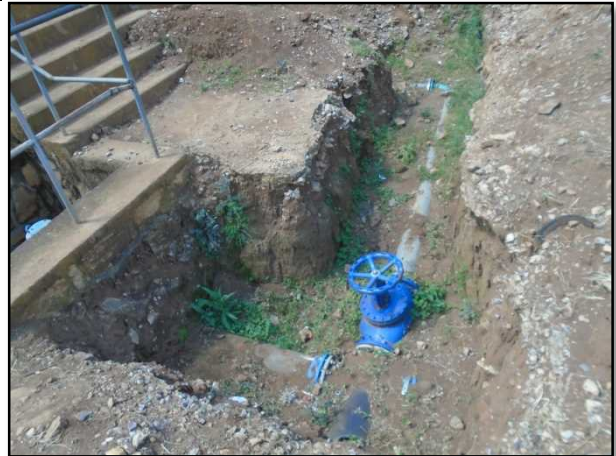
Backfilling and construction of a protection manhole is needed

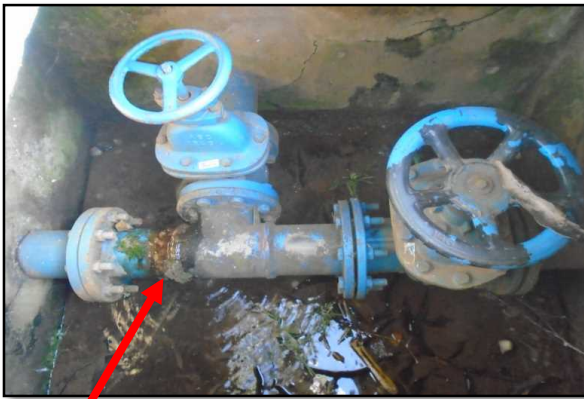
Leaking Tee

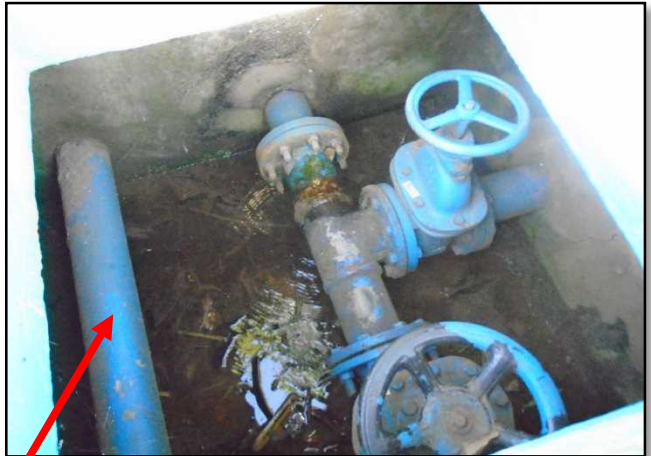
Inlet pipe without drainage

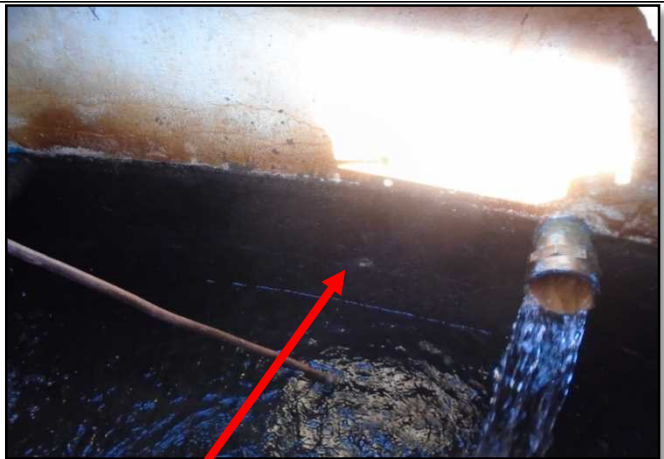
Crack on the wall (entrance of flood water)
