**DATA COLLECTION SUEVEY ON
WATER SUPPLY IN TEGUCIGALPA
IN
THE REPUBLIC OF HONDURAS**

FINAL REPORT

DECEMBER 2021

**JAPAN INTERNATIONAL COOPERATION AGENCY
(JICA)**

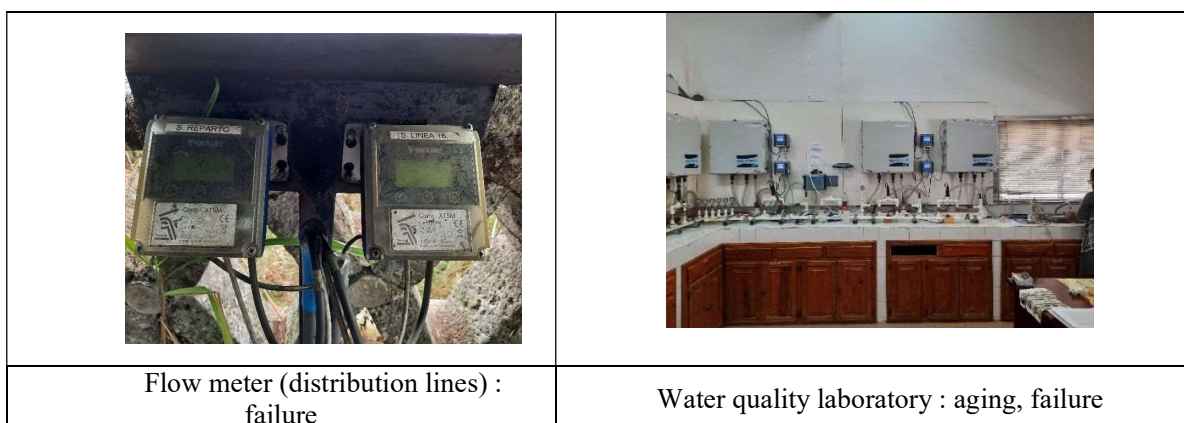
Figure 3-3-26 Status of Major Facilities and Equipment of Picacho Water Treatment Plant

<p style="text-align: center;">Lime hydrate dosing pump</p>  	<p style="text-align: center;">Polymer dosing device</p>  
<p style="text-align: center;">Filtration tank (suspended)</p>  	<p style="text-align: center;">Filtration tank air washing blower</p>  
<p style="text-align: center;">Chlorine dosing device : aging</p>  	<p style="text-align: center;">Transformer</p>  
<p style="text-align: center;">Main electrical generator failure</p>  	<p style="text-align: center;">Chemical dosing equipment control panel</p>  
<p style="text-align: center;">Sand Filtration Tank Control Panel</p>	<p style="text-align: center;">Flowmeter (raw water, purified water and pipeline) failure</p>

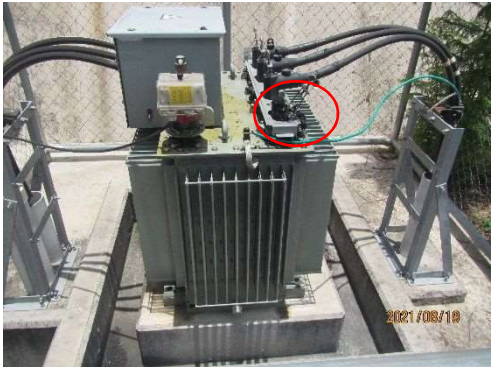
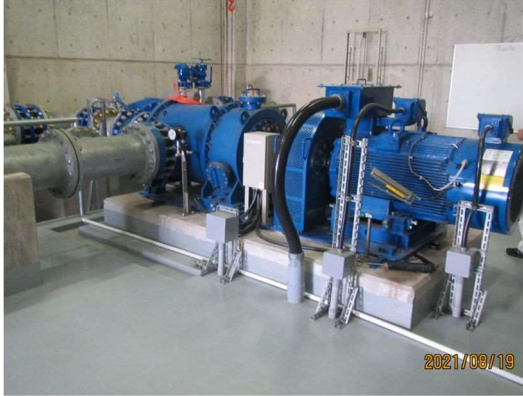
The El Picacho micro hydroelectric plant is installed in one of the nine distribution pipelines coming from the El Picacho Water Treatment Plant, on the L22 system line, with a diameter of 400 mm. In August 2021, the transformer suffered a malfunction and the micro hydroelectric plant is not working. When the survey was conducted on August 19, 2021, the flow rate was 186 L/s. This flow is within the range of flows between 120-300 L/s that allow power generation, and therefore, if the transformer is repaired, power can be generated. Regarding the repair, according to the interview with UMAPS, it can be repaired at a cost of HNL 196,225.00. The electrical generator is in good condition with no damage observed.

<p>Transformer (damage to neutral and ground terminal)</p>	<p>Electric generator</p>

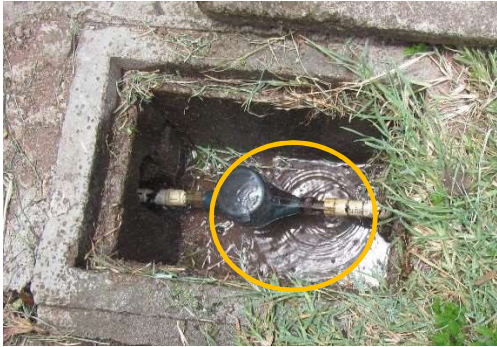
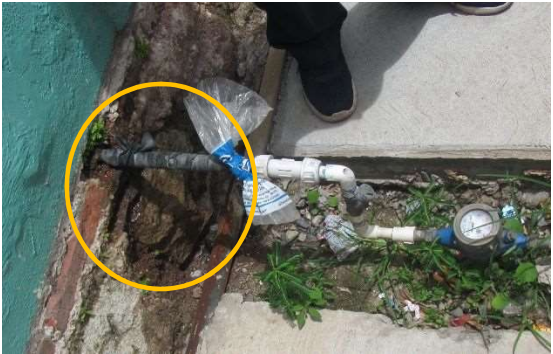
<p>Water leakage from the meter (connection on the utility company side)</p>	<p>Water leakage from the meter (connection on the user's side)</p>

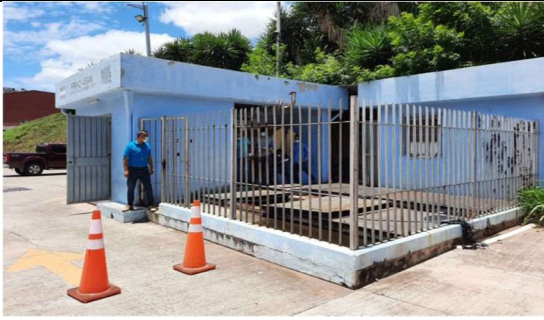
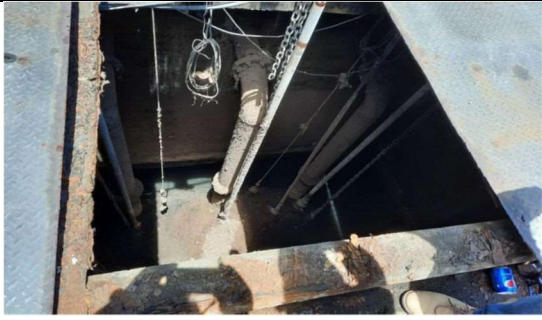
<p>Sewage pump station -1</p>	<p>Submersible pump of this station (suspended due to failure, buried in the sand).</p>

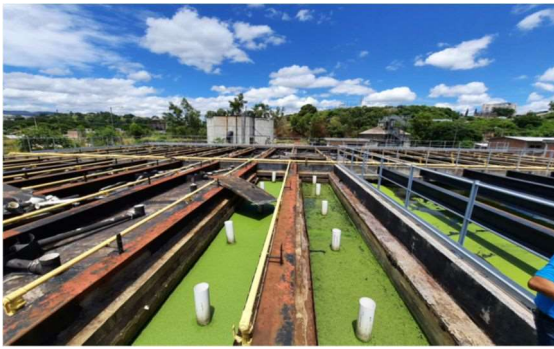
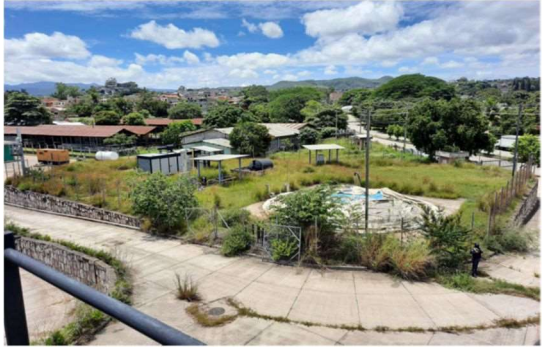
<p>Top of UASB reactor (concrete corrosion and damage)</p>	<p>Digestion gas tank (made of rubber), gas-fired electric generator</p>
