Ministry of Public Works and
Ministry of Agriculture and Fishery
Democratic Republic of Timor-Leste

**THE POST SITUATION AND DATA
COLLECTION SURVEY
FOR
THE FLOOD COUNTERMEASURES
IN DILI**

**Final Report
(Summary)**

December 2022

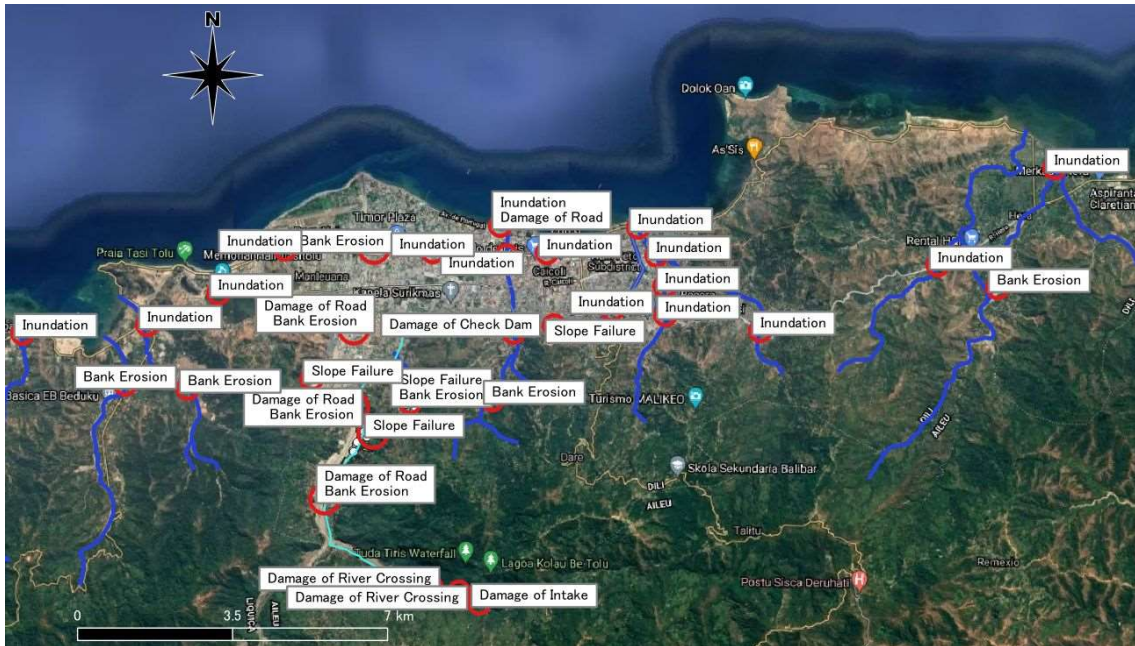
Figure 3.1-3 Damage around Dili Municipality caused by the April 2021 floods

Regarding the April 2021 floods, damage occurred in various places around Dili Municipality as shown by Figure 3.1-3.

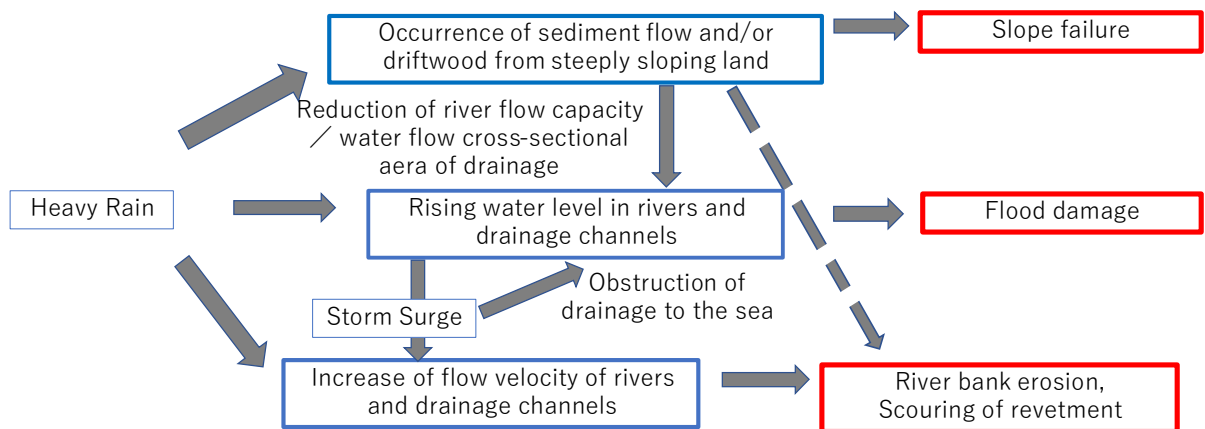
Figure 3.1-4 Disaster occurrence mechanism of the April 2021 floods

It is assumed that sediment and water flooding occurred in the small river area of Dili during the April 2021 floods. With respect to the Comoro River, there was no overflow, but it is assumed that mudflow flowed down the river channel, which caused riverbank erosion, scouring of revetment foundation, outflow of revetment blocks and collapse of the revetment.

In the Bemós River, there was evidence that flood flow carried rocks and driftwood, which is thought to have caused enormous damage at the intake facility.

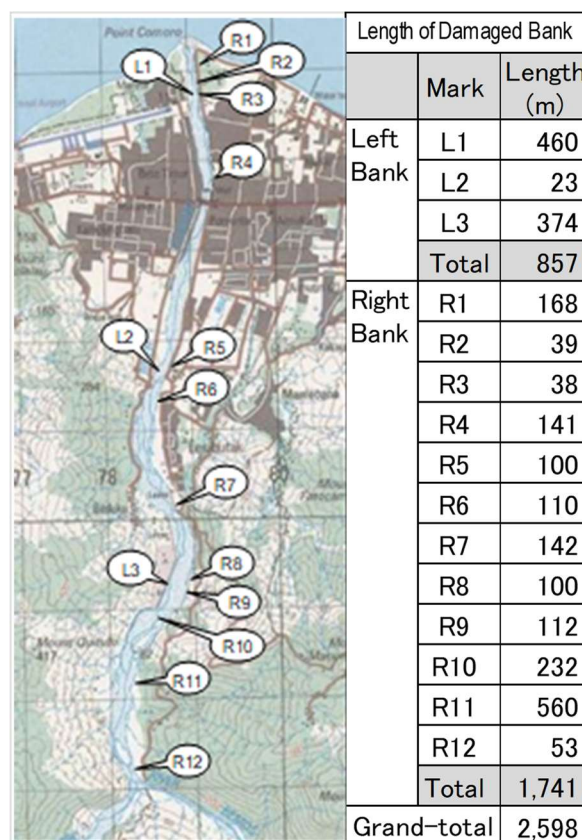
Figure 3.2-2 Location of Damaged Revetment

The damage to the revetment of the Comoro River from the river mouth to the upstream of the confluence with the Bemós River are shown in Figure 3.2-2. The damage to the revetment is concentrated on the right bank, and the number of damaged locations is four times that of the left bank and the length of the damaged revetments is twice that of the left bank. In particular, the revetments constructed after 2013 have been continuously damaged on the right bank (R7 to R12) upstream of 5.5km. On the other hand, on the left bank side of the same section, the road on the riverbank is cut off in the middle, so the land development is not progressing, and the revetment is limited.

Concept of rehabilitation of 15 retaining walls in Figure 3.2-2 is described in Table 3.2-2. The priority of rehabilitation is shown in the table according to the influence by damage to the critical infrastructures such as an airport, a national road bypass, etc. The damaged retaining walls should be rehabilitated promptly and surely by securing enough budget according as the priority.

Left/ Right bank	No	Distance from river mouth	Length	Description for rehabilitation	Priority H:high M:middle L:low
Left Bank	L1	0.7km	460m	For about 200m near the runway of the airport, which is critical infrastructure, more stable type such as L-shaped retaining wall is adopted and rehabilitated on a priority basis.	H
	L2	3.8km	23m	Because it is a limited damaged, wet masonry type is adopted same as the up/downstream of it. For exposure of foundation of revetment, filling it with gravel to prevent scouring. Backland of the site is filled ground by gravel company.	L
	L3	6.3km	374m	This site was originally the land filled in the riverside and so may not be so durable against erosion. It is possible to proceed bank erosion but less property to be protected is here.	L
Right bank	R1	0.3km	168m	For this reach, new dike or elevating the riverbank are needed for the river plan. If more time is required for land acquisition in construction of design cross section, temporary rehabilitation is implemented by gabion mattress, etc. to protect a bypass road on the riverbank.	M

R2	0.5km	39m		M
	R3	0.6km	38m		M
	R4	1.6km	141m	Revetment of 2-steps is adopted because the riverbank height is more than 7m. The site is just downstream of the groundsill No.1. Because the damage of the revetment is in danger of influencing the groundsill, the site is rehabilitated on a priority basis.	H
	R5	3.8km	100m	The middle part with 100m is damaged of gabion mattress with 570m in total. Riverbank height is about 10m, so 2-steps revetment type consisting of retaining wall (lower) and concrete block (upper) is adopted. Because the collapsed gabion pulls the neighboring proper gabions, the priority of rehabilitation is high.	H
	R6	4.1km	110m	Riverbank height is about 8m, so 2-steps revetment type consisting of retaining wall (lower) and concrete block (upper) is adopted. Collapse of riverbank expanded to the bypass road that houses exist along the road as of May 2022. Therefore, the priority of rehabilitation is high.	H

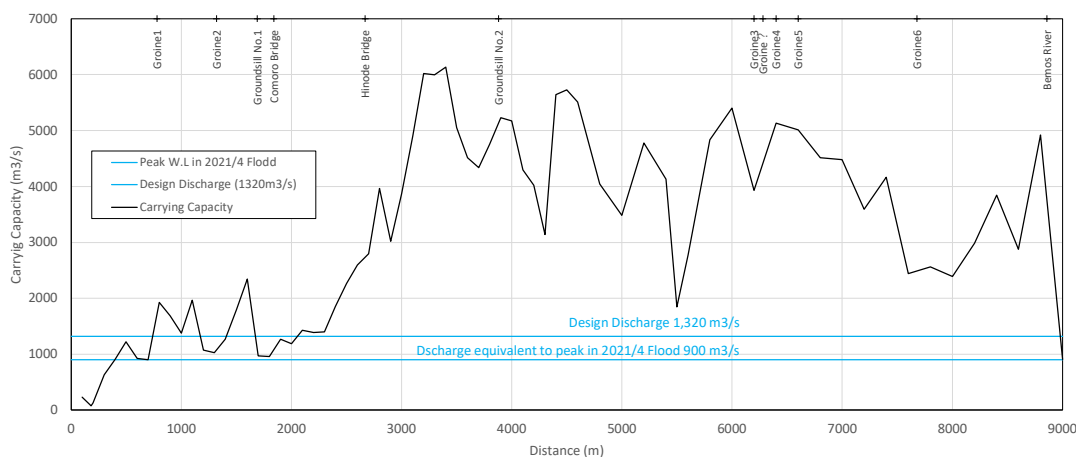
Figure 3.2-4 Carrying Capacity of Existing Comoro River

Figure 3.2-2 shows the existing longitudinal profile of the Comoro River prepared from cross-sections obtained by topographic survey implemented in this survey. The figure also illustrates the river width in green line and calculated water level of 1,400 m³/s. Carrying capacity of the existing river is estimated by non-uniform flow as shown in Figure 3.2-4.

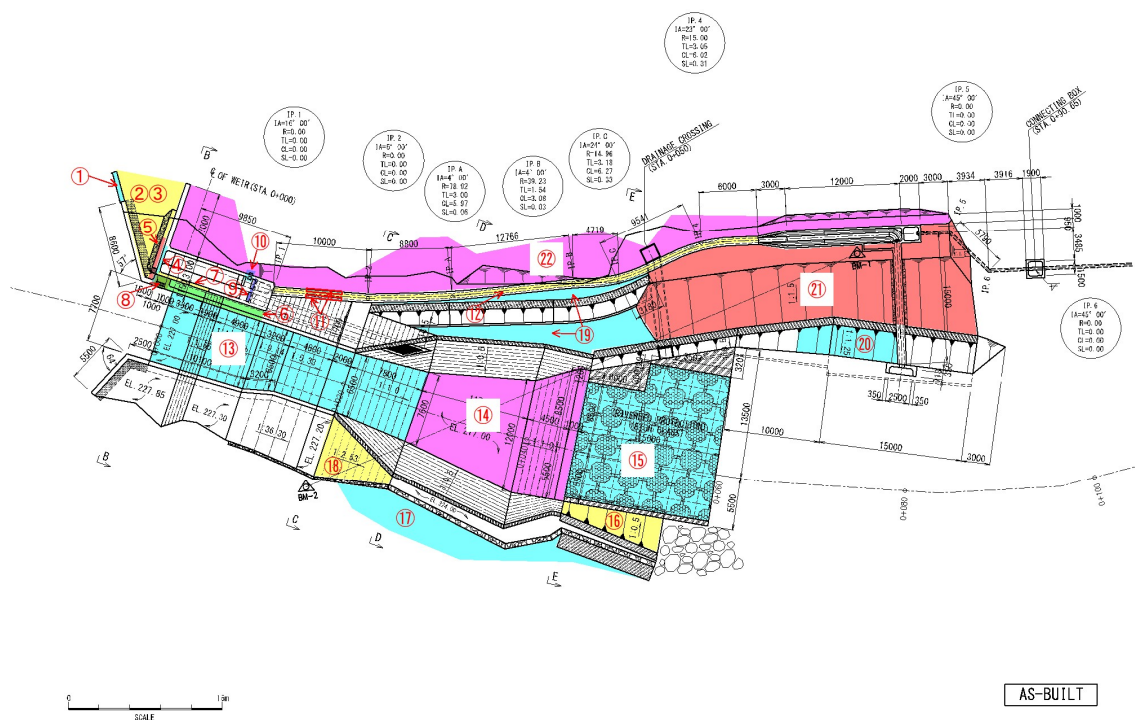
The water intake facility was damaged, and the structure and revetment were damaged, and the surface was abraded and cracked.

The water conveyance Pipe was severely damaged, especially at the crossing of the river, and the pipe itself was washed away and could not function. Some other parts have also been washed away.

As with the BTL repair plan, the intake works shall be reinforced and repaired without changing the structural section of the current facility. The repair plan is summarized in Figure 3.3-1 and Table 3.3-3. The repair plan shown in Table 3.3-3 can be roughly classified into reinforcement, restoration (re-installation or replacement), and repair. Reinforcement refers to the strengthening of the structure to make it tougher, restoration refers to the restoration of the original structure, and repair refers to minor repairs such as surface repair. In the table, the reinforcement to a tougher structure applies to ①, ②, ⑤, ⑥, ⑰, ⑳, and ㉓, and the structure is less likely to be severely damaged by a flood of the same level. In this disaster, falling rocks from the top of the facility and rocks from upstream were one of the factors that caused damage to the facility. In order to prevent rock fall, the slope will be protected with concrete up to the planned water level. As for measures to prevent rocks from flowing down rivers, protection works and erosion control dams are assumed to reduce the flow of sediment. Although berms can prevent small rocks from flowing downstream, they are almost ineffective when large rocks flow downstream, as in this case, and the berms themselves are likely to be damaged, resulting in serious damage to the facilities. In addition, erosion control dams, including permeable dams, are not expected to be included in this restoration plan because of their high construction cost, the need to remove rocks after each rainy season, and the possibility of collapse depending on river flow. In the future, it will be desirable to consider a river improvement plan and implement measures for revetment and stone runoff.

№	Structural Classification	Target Facilities	Damage	Reconstruction Policy	Classification
①	Water intake	Wing walls	Megalithic deposition	Extension of wing wall	Reinforcement
②				Raising of RC at the top of wing wall	Reinforcement
③				Removal of rocks and other sediments	Restoration
④		Inlet side wall	Total damage	Front wall reinstallation	Restoration
⑤				Front wall strengthen	Reinforcement
⑥				Reinforcement of gravity type retaining wall at side wall	Reinforcement
⑦				Repair of side wall above the opening (removal and restoration)	Restoration
⑧		Water Intake	Damage	Reconstruction	Restoration
⑨	Channel of approach	Slew gate	Damage	Gate replacement (including guide)	Restoration
⑩		Waterway	Step breakage	Step replacement	Restoration
⑪			Damage to the top	Reconstruction upper 50cm of side wall	Restoration
⑫			Falling lid	Reinstallation of approach channel lid	Restoration
⑬	Fixed weir	Water flow section	Wear	Re-placing high-strength concrete	Restoration

⑭		Still water pond	Stone accumulation	Sediment removal	Restoration
⑮			Drifting away (from the floor)	Re-placing of floor protection works	Restoration
⑯	Right bank revetment	Protection of Stillwater Pond	Damage	Restoration by masonry blocks	Restoration
⑰			Slope protection	Concrete up to bedrock line	Reinforcement
⑱		Top concrete	Partially damaged	Re-placing high-strength concrete	Restoration
⑲	Left bank revetment	Bank protection top edge concrete	Damage	Demolition and high strength C restoration	Restoration
⑳		Stone retaining wall at the bottom of the Stillwater pond	Partially damaged	Restoration with RC leaning retaining wall	Reinforcement
㉑		Upper level of the stairs at the Pond	Damage	Restoration by masonry	Restoration
㉒			Slope protection	Concrete up to bedrock line	Reinforcement
㉓	Whole	Whole	Crack	Epoxy injection	Maintenance
㉔			Surface deterioration	Repair with high-strength mortar	Maintenance

㉕		Basin, channel, on top of concrete	Sedimentation	Removal of rock and sand	Restoration

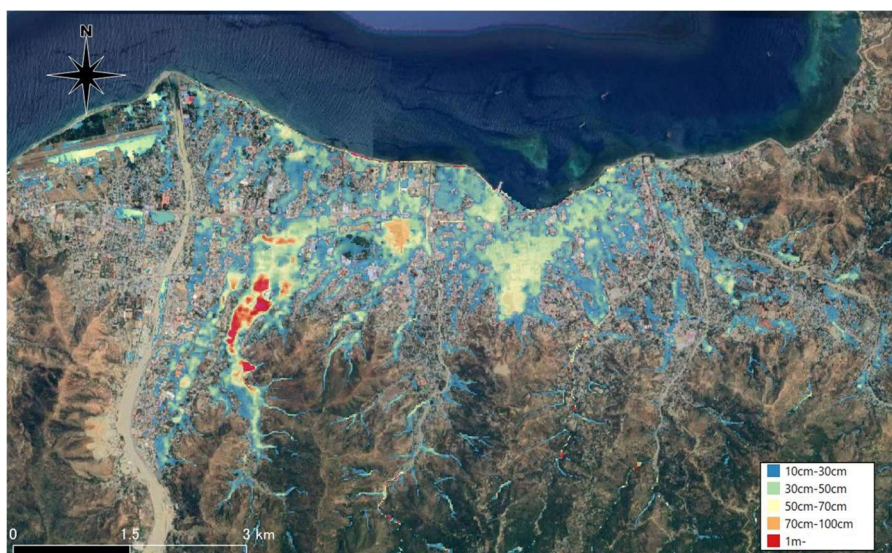
Figure 3.5-1 Flood map at the time of the April 2021 floods (Estimated results)

Regarding Dili's flood map, a flood analysis was carried out by considering various small river and drainage channels referring to the pseudo-drainage channels created in 3.5.1, the drainage channel network planned by DDIUP. Figure 3.5-1 shows a map of the estimated flooded area for the April 2021 floods.
