**THE POST SITUATION AND DATA
COLLECTION SURVEY
FOR
THE FLOOD COUNTERMEASURES
IN DILI**

Final Report

December 2022

JAPAN INTERNATIONAL COOPERATION AGENCY (JICA)

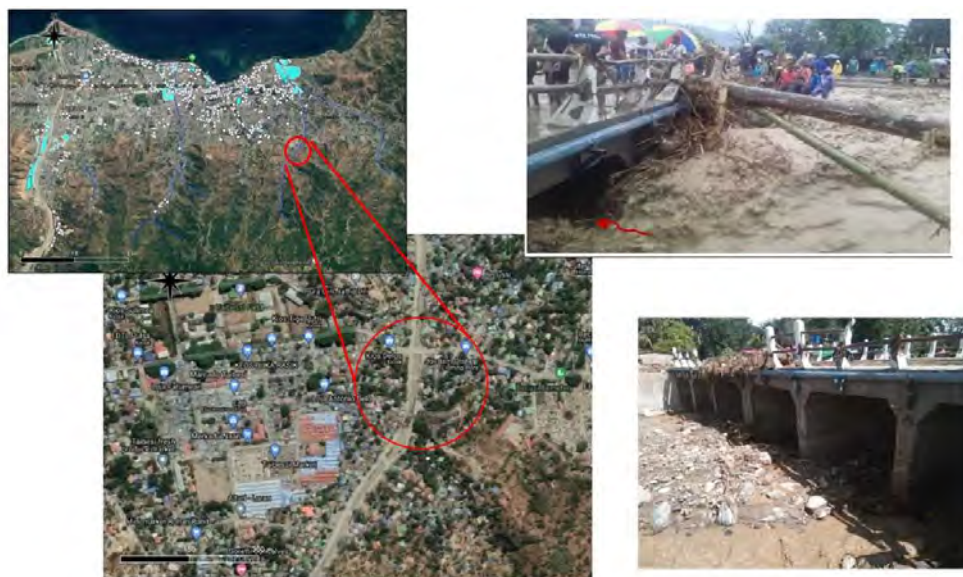
It is reported that Sediment accumulation in the Taibeshi River channel reached 1-2m and overflow occurred near the Bekushi Bridge on the Taibesi River. It is supposed that the box culvert, which does not have sufficient height, accumulated driftwoods and rocks, caused the blockage of river channel.

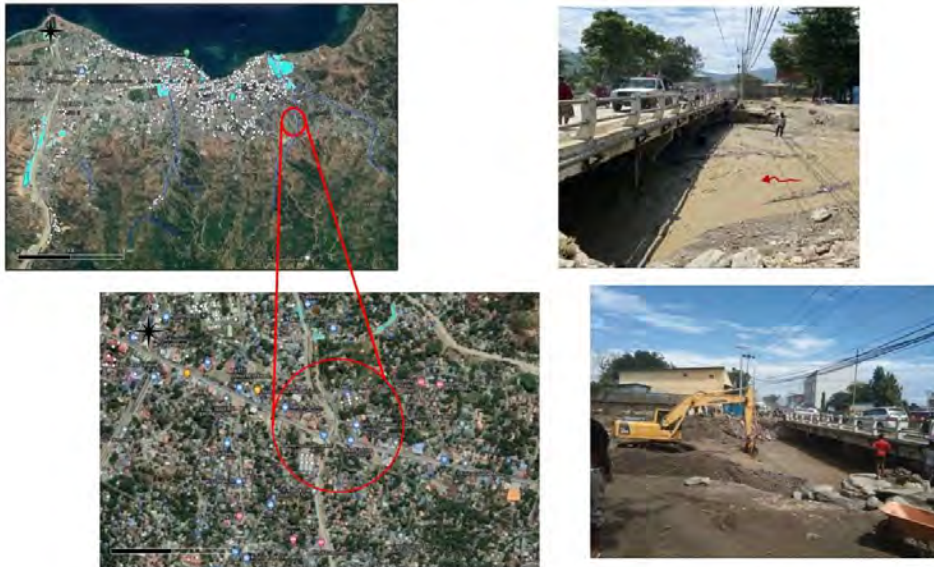
At the Maufelu bridge on the Taibesi River, it is reported that sediment accumulation in the river channel reached 1-2m and flooding occurred, and the mud flow reached 50-70cm.

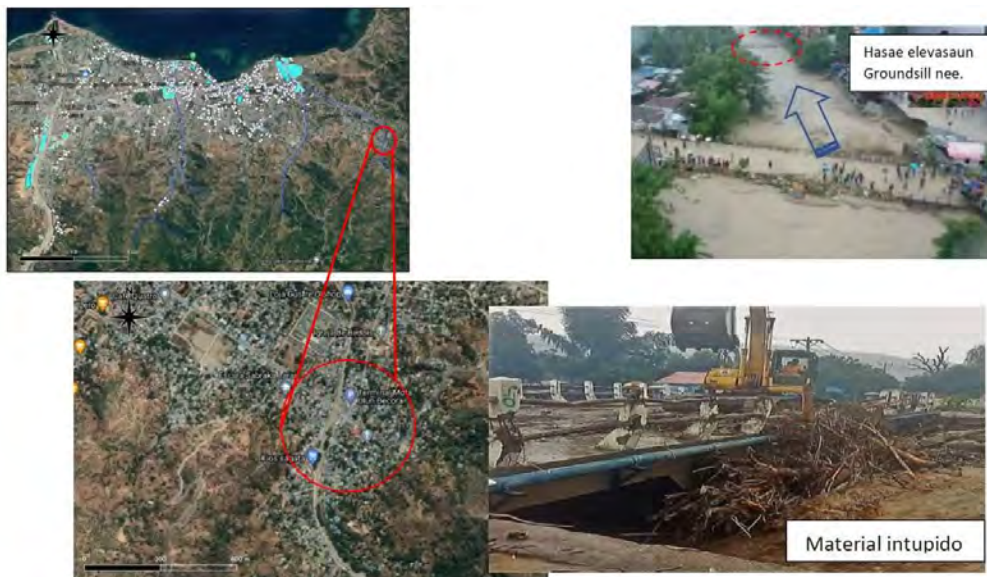
In the vicinity of the bus terminal along the Becora River, the riverbed rose 1-2m due to the sediment accumulation and driftwoods in the channel, which caused flooding. It is reported that mudflow reached 50-70cm.

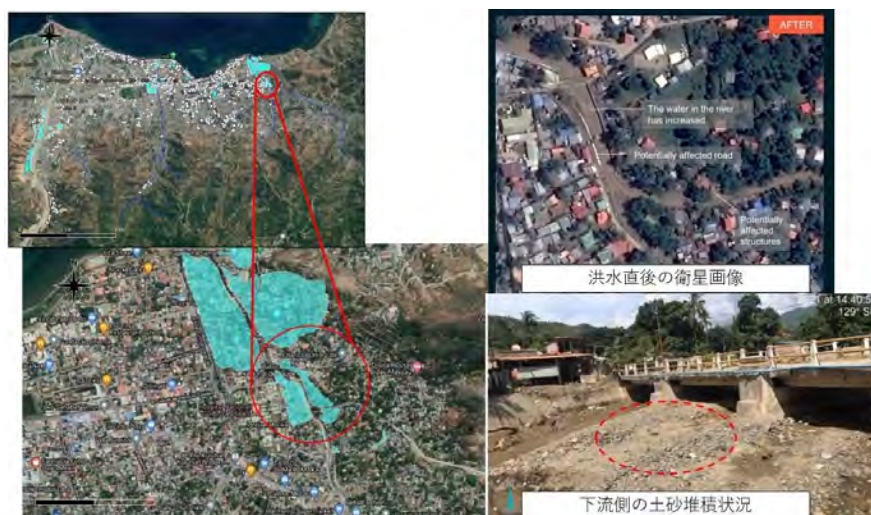
No major damage was reported downstream from the vicinity of the bus terminal, Becora River. On the other hand, near Bidau Massaur bridge on the Santana River, where the Taibesi and Becora River merged, sediment accumulation in the river channel reached 1.5-2.0m and overflow was occurred. It is reported that mud thickness is range from 50cm to 70cm. In addition, it is reported that seven houses were washed away and several locations of roads and retaining walls were damaged.

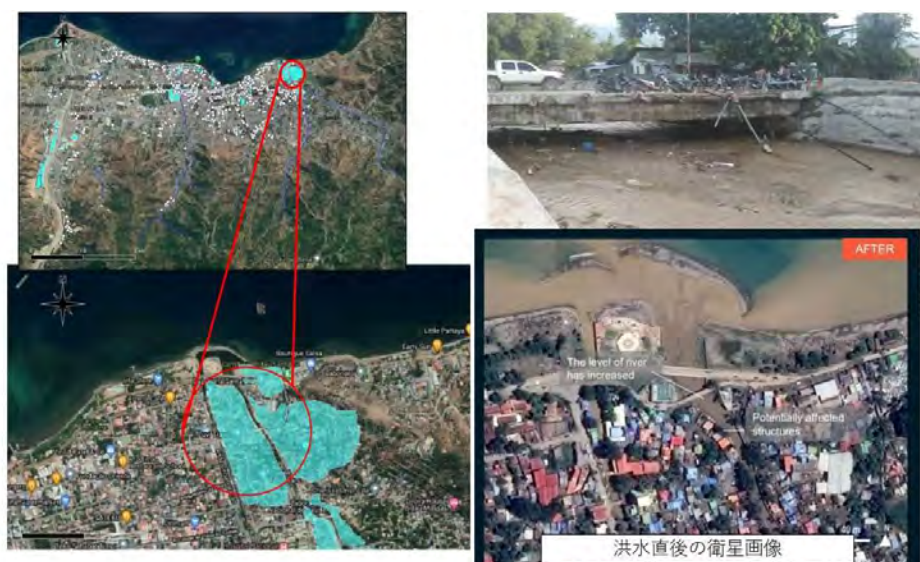
At the mouth of Santana River, sediment accumulation in the river channel reached 1.5m-2m and overflow was occurred. The mud thickness of the overflow water is reported to range from 50cm to 70cm. It is also reported that several points of road along the river and retaining walls were damaged.

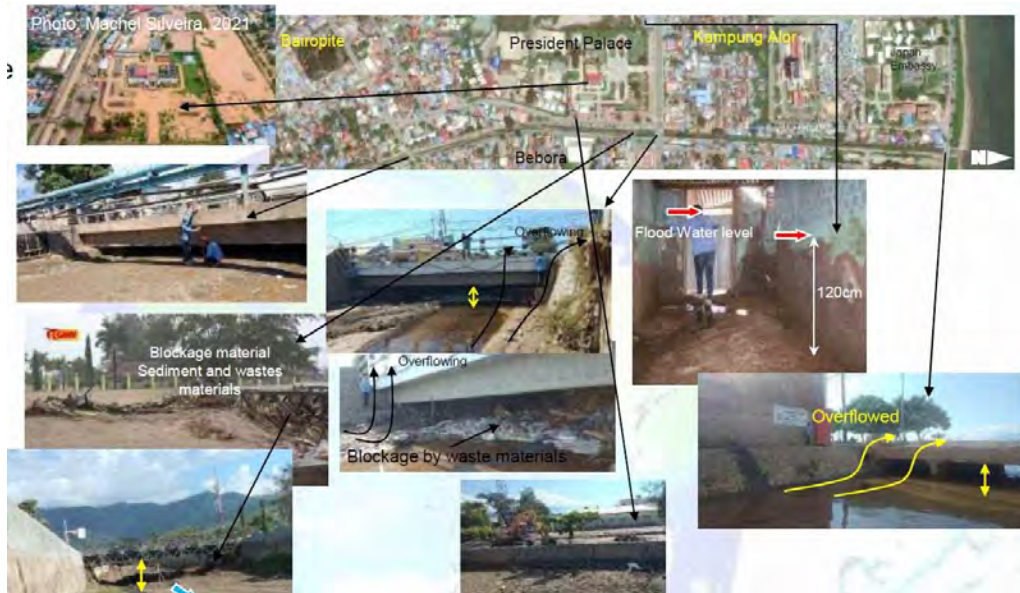
The downstream of Maloa River flow through the low-lying area of central Dili, but as shown in Figure 3.1-36, it is reported that the river channel was blocked by sediment and waste, causing enormous inundation damage.

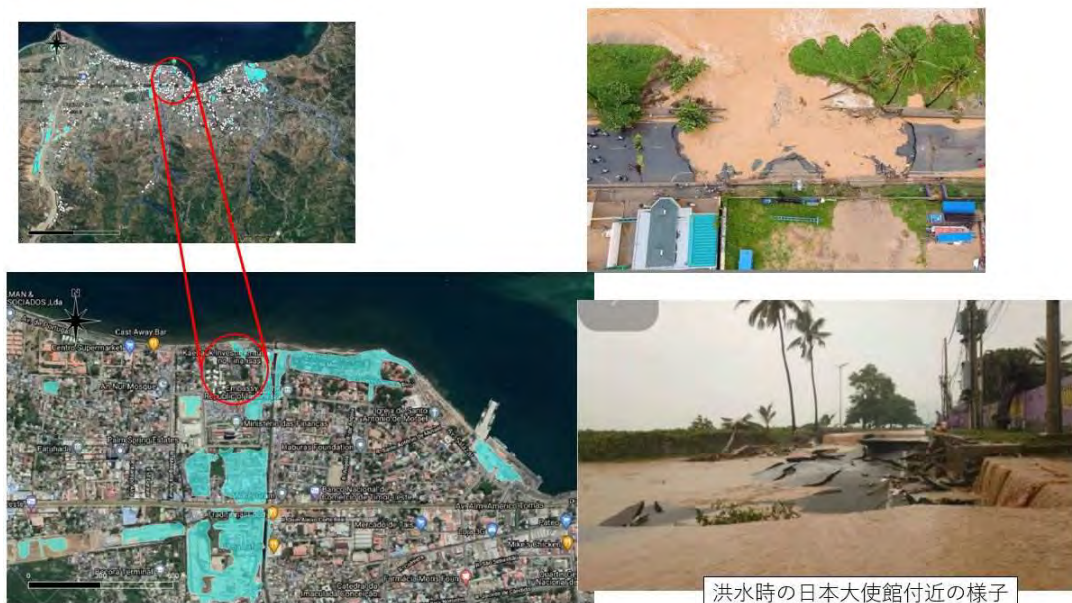
Figure 3.1-37 shows the damage of the Japanese embassy located near the mouth of Maloa River. Road on Portugal Street had been reported to be damaged.

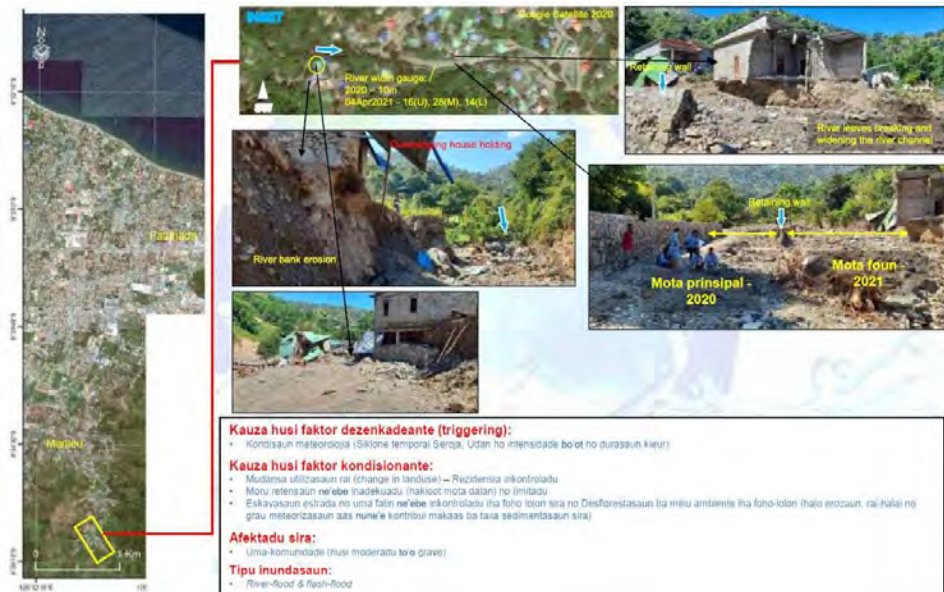
It is reported that a debris flow occurred in the upstream of Manleu-ana River, which is located between the Comoro and the Maloa River, which caused riverbank erosion and some dwellings were outflowed.

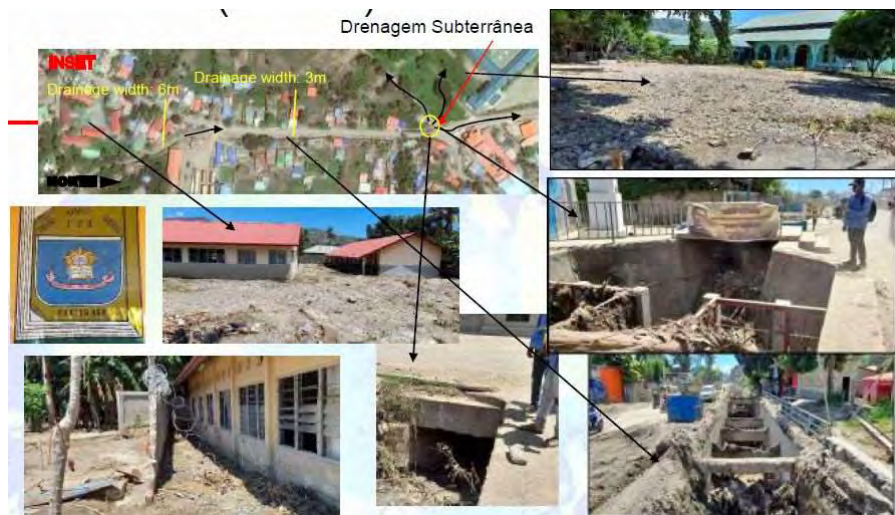
The drainage of Manleu-ana River is suddenly narrowed across the road, and it is reported that excessive sediment accumulation in the channel caused the flood damage.

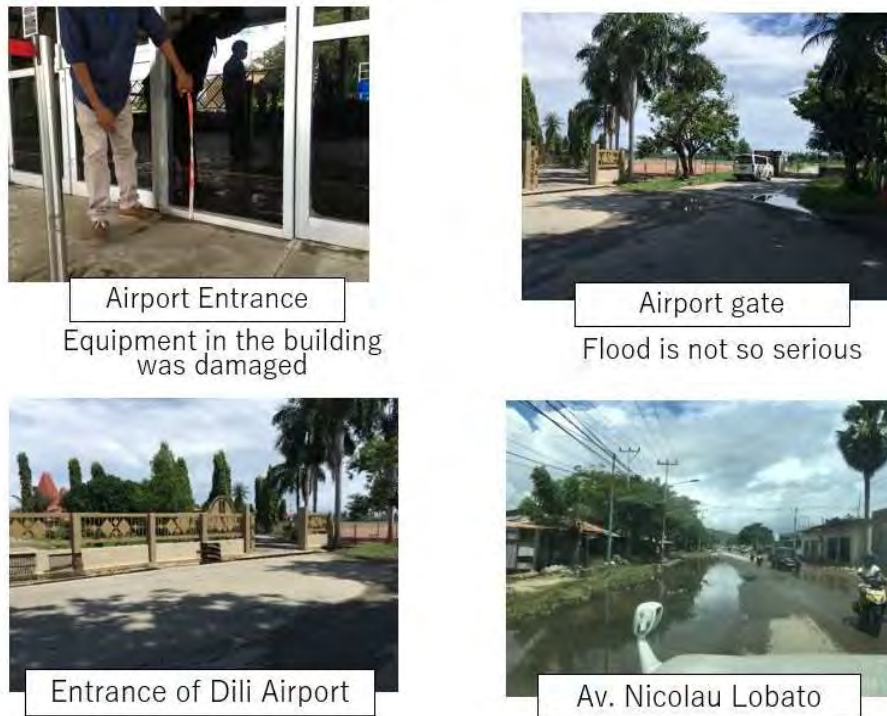
In the vicinity of Dili airport, it has been confirmed that flood damage occurred on the road in the south side of the airport and airport building located in a lower area than the surrounding area.

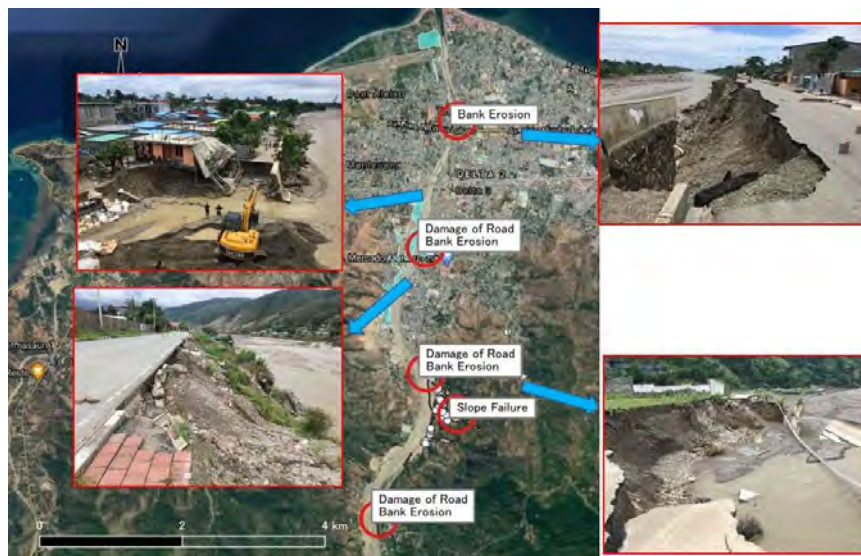
Major damages have been confirmed at the locations as shown in Figure 3.1-43. It is presumed slope failure occurred in the high risk area, because the right bank near the confluence point is a steep slope. In addition, scouring and sucking out due to floodwater are considered to be the causes of the damage, because inundation has not occurred though the road damage and riverbank erosion have been confirmed at several points.

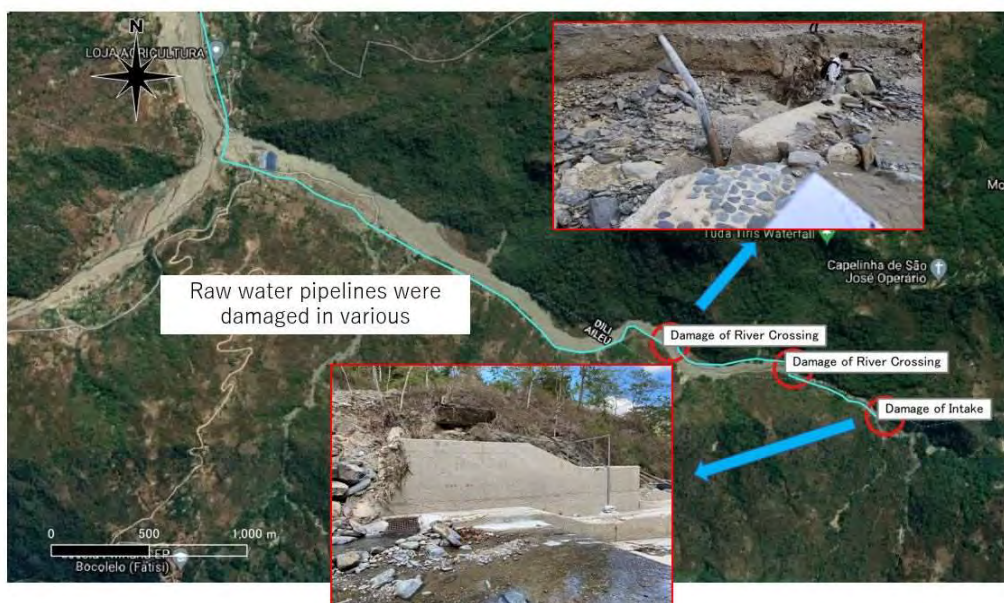
Damage has been confirmed at the locations shown in Figure 3.1-44. The Bemós River, which is the main disaster area, is surrounded by steep slopes and is considered to be vulnerable to floods. The raw water pipeline had been buried to prevent flood damage, but it was exposed and damaged in various places due to the unexpected heavy rain.

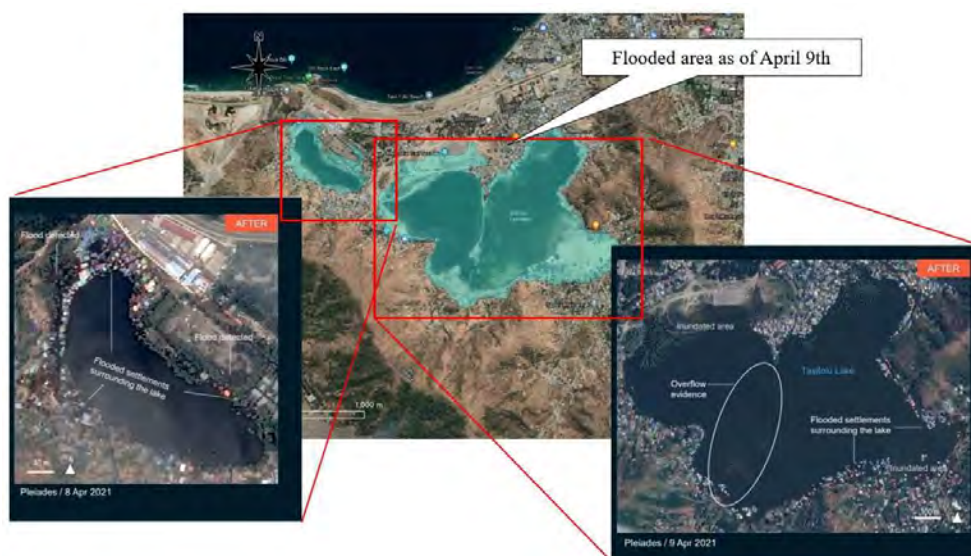
Figure 3.1-45 shows the damage situation around Lake Tasitolu during April flood. It has been reported that the water level of Lake Tasitolu has risen and which caused the inundation damage to the extent that the inundation depth in the surrounding dwellings reaches about 1m. Local people say the flood damage lasted for about one month.

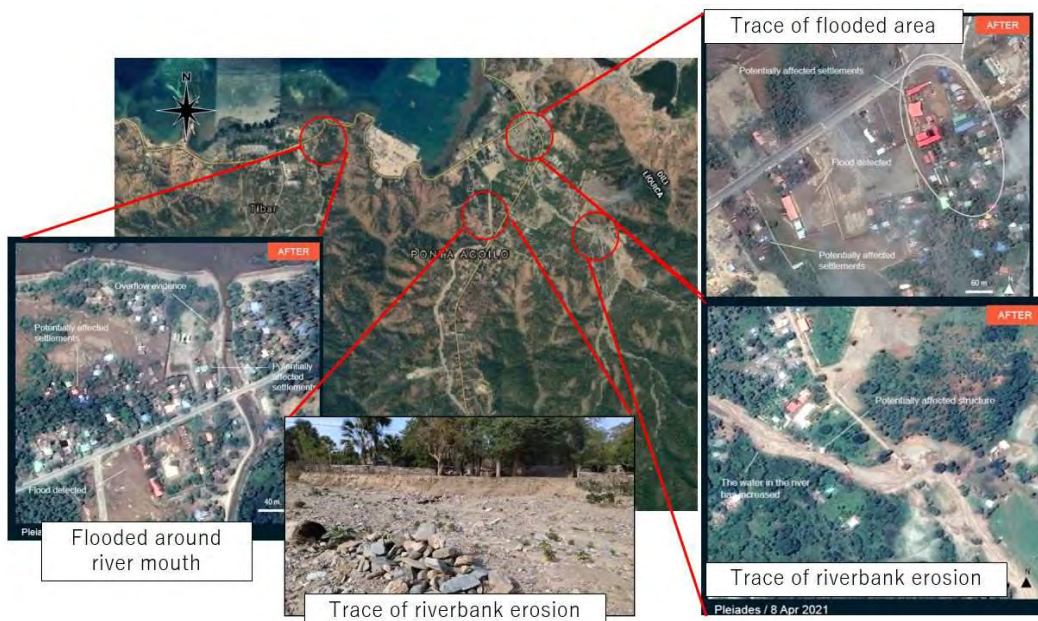
Figure 3.1-47 shows the flood damage in Tibar. From the satellite images, it was confirmed that flood damage occurred near the intersection of channels and the road, and the near the river mouth. Traces of riverbank erosion were also confirmed at several locations.

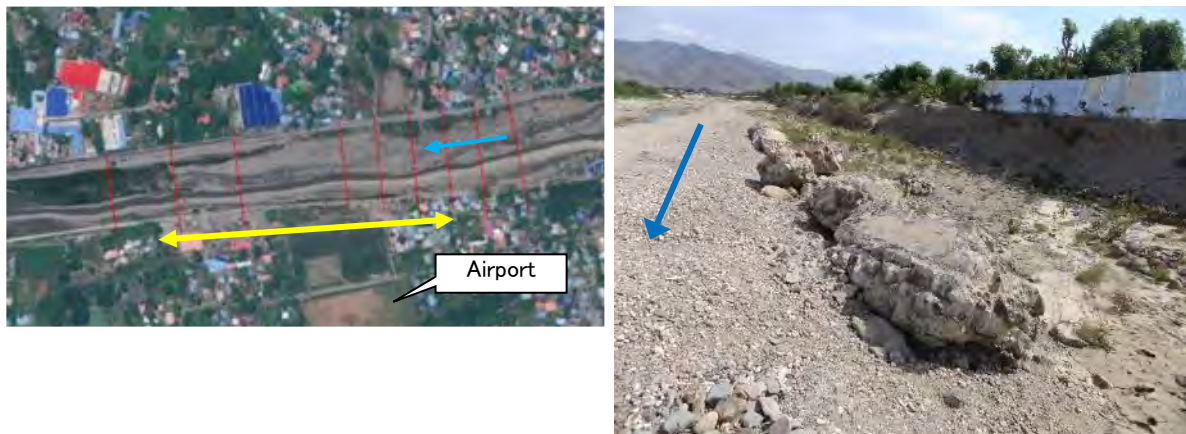
The riverbank of this section is located about 180m from the runway end of the airport. From the viewpoint of reducing the disaster risk of the airport, which is a critical infrastructure, the priority of restoration of this section is high.

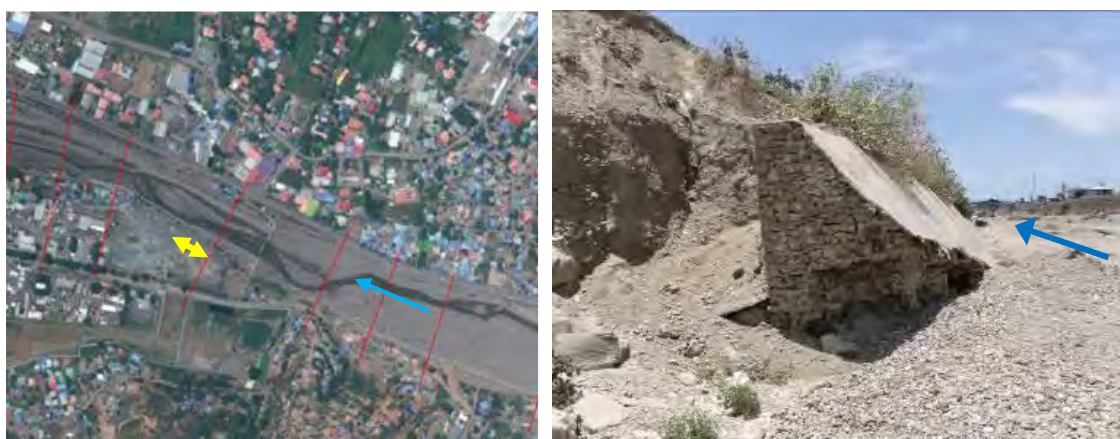
The low water revetment on the left bank 100m downstream of the check dam has been washed away by 23m. The structure is wet masonry, and the surface is finished with mortar. The height of the revetment is about 2m from riverbed. It seems that gravel is artificially piled up on foot of slope, and the situation before the disaster is unknown. There is no lateral strip in the remaining revetment. With the construction of the check dam 100m upstream in 2019, there is concern that sediment movement from the upstream will be suppressed during floods and the riverbed will decline. The back of the revetment is the site of a construction company (soil storage area).

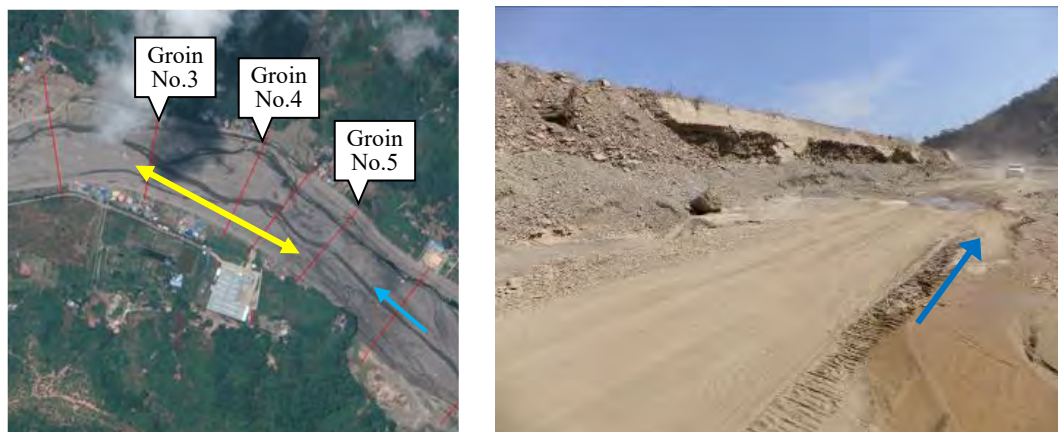
However, the revetment has collapsed even in the same section where the groins are installed (R8, R9), and the groin did not protect the riverbank in this flood.

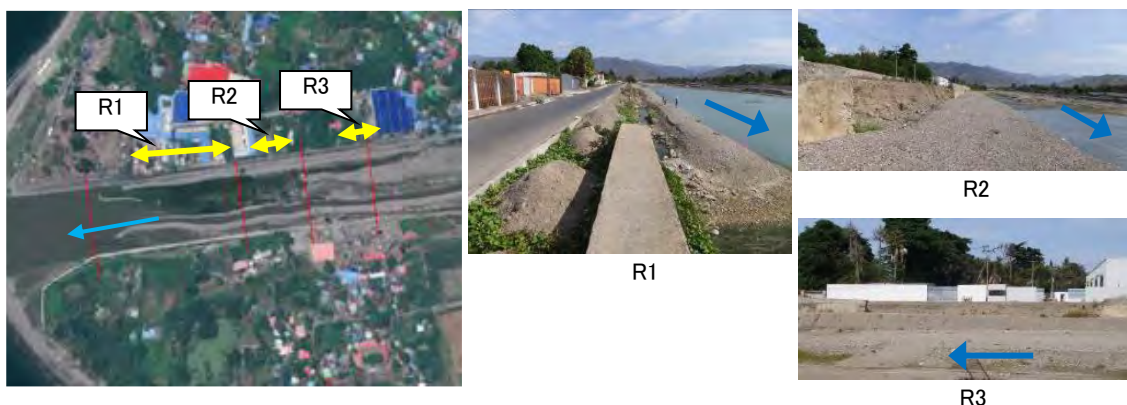
It is an intermittent revetment collapse section of 0.3km to 0.6km from the river mouth. The length of the damaged section is R1 168m, R2 39m, R3 38m. Since the satellite images before the 2021 April flood show the flow course near the riverbank, it is inferred that the revetment foundation was washed away by the flood flow and collapsed. But no trace of the causes because no revetment left in these sections, and small embankment with a width of 5 m to 10 m is filled in the foot of slope.

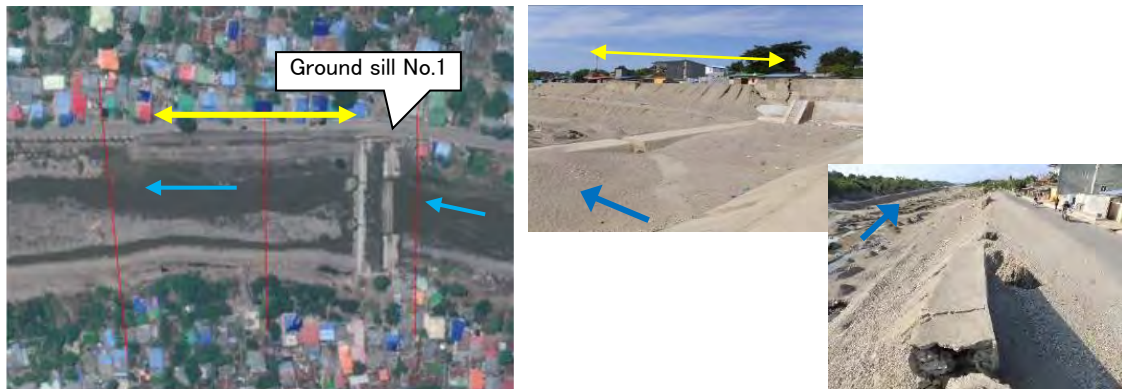
bare slope because the revetment has disappeared, the flood flow falls from the ground sill with a head of about 5 m and the flow is disturbed in the same section. Therefore, it is desirable to restore the revetment as soon as possible or to lay a protection block on the embankment.

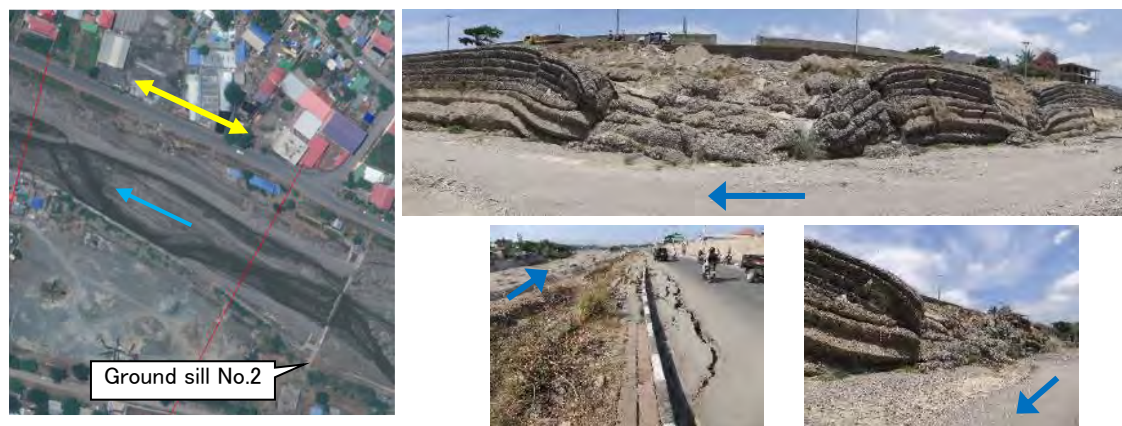
Of the 570m long revetment with gabion mattress section, the revetment has collapsed and fell in the 100m section near the middle. This damaged reach has narrow width, and so flow velocity in flooding was high and caused suction of revetment backfill and local scouring. Ten gabion mattresses are piled up on the riverbank with a height of about 10m to form a revetment. The shape of the bottom layer is also deformed in the remaining section. When the riverbank height is high, it is required to adopt gentle slope or to provide a small step in the middle of the height. The slope collapse has spread to the road on the riverbank, and it is currently forced to pass one way. Restoration of the section is urgent from the viewpoint of ensuring safe traffic.

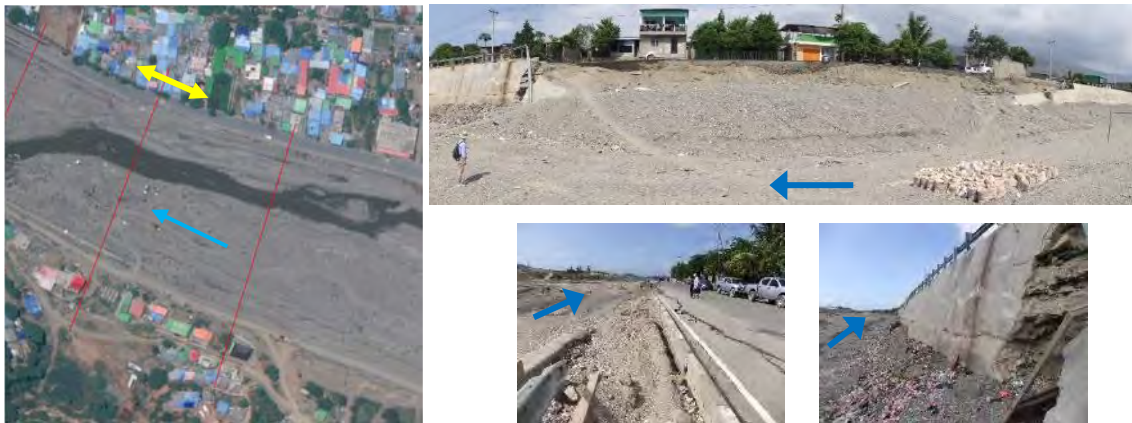
A retaining wall with a height of about 7m has collapsed over 110m. As a first-aid measure, gravel is piled up in front of the riverbank to protect the slope. The width of the river narrowed from 140m to 115m from the upstream point of 230m, so it is possible that the faster flow velocity caused the revetment collapse. Similar to R5, the road on the riverbank has cracks and depressions, making it one-sided. Restoration of the section is urgent from the viewpoint of ensuring safe traffic.

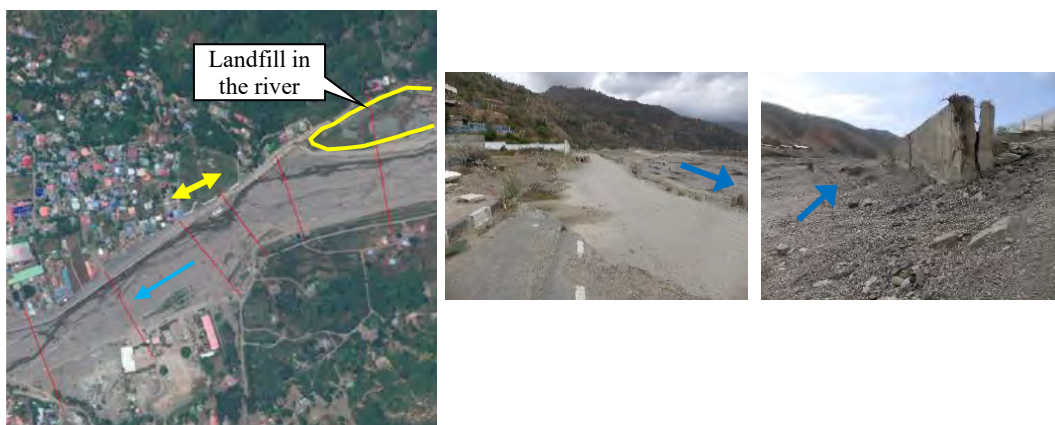
The road surface of both lanes has been washed out on the riverbank road, and vehicles are passing at a position about 2 m lower than the original road surface. Although the urgency of reconstruction is high, countermeasures need to be considered together with countermeasures for upstream landfill activities.

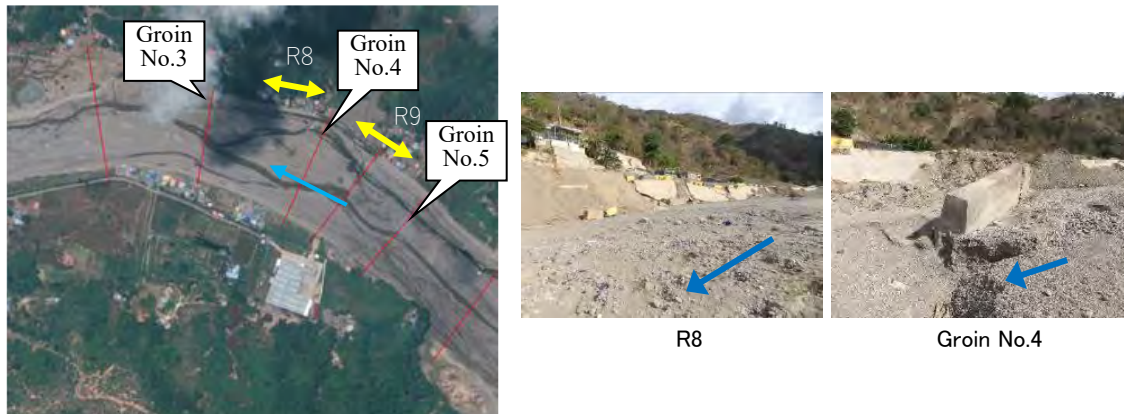
Three groins are installed in the section located on the outer bank side of the curved part. The installation interval is about 200m, but the retaining wall revetment is damaged over 100m (downstream side, R8) and 121m (upstream side, R9) in each section. Since the revetment on the left bank, which is the inner bank of the curved part, is also damaged, it can be said that the groin functions to shift the flow direction toward the river center. It is possible that the flow over the groin during the flood directly hit the revetment and caused the scouring of the revetment foundation because the direction of the groin is not perpendicular to the revetment alignment but toward the downstream side. Of the three groins, two on the downstream side are severely damaged, so it is desirable to consider renovating the groin when restoring the revetment.

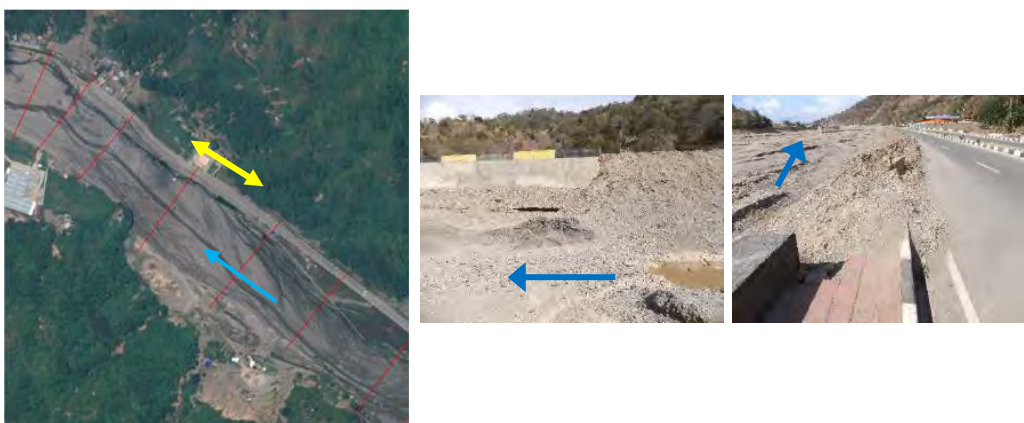
The retaining wall revetment with wet masonry was damaged by 232m in the straight section. Looking at the existing revetment connected to the downstream end of the damaged section, the foundation (about 1.5 m) is exposed and raised. Before the flood, sediment had accumulated in front of the riverbank in this section, but it is probable that it was eroded during the flood and reached the revetment, causing the foundation to rise and collapse. It is desirable to install a high-water basin from the viewpoint of riverbank protection, but it should be noted that installing a high-water basin will attract the construction of houses on it.
