7. 参考資料

Kilu'ufi Hospital Site Inspection Report

Project No:	21120S	Project:	FAE – Construction of Kilu'ufi Hospital
Location:	Kilu'ufi Hospital, Auki, Malaita Province	Date:	21 st – 25 th March 2022
Inspection By:	DH	Conditions at time of visit:	Generally fine / Sunny

TOPOGRAPHICAL SURVEY OF KILU'UFI HOSPITAL, PARCEL 151-001-32,
LOT 4 OF LR 544, MALAITA PROVINCE, SOLOMON ISLANDS

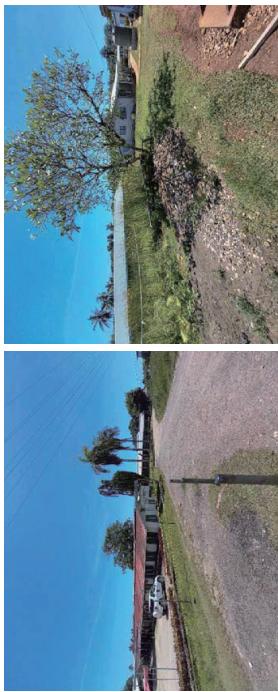
Figure 1: South east view towards hospital

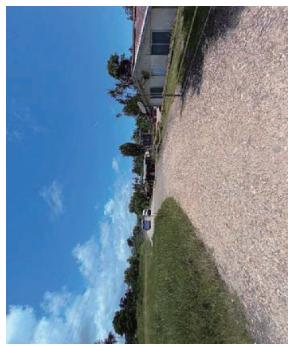
Figure 3: Access Road and main entry to KH

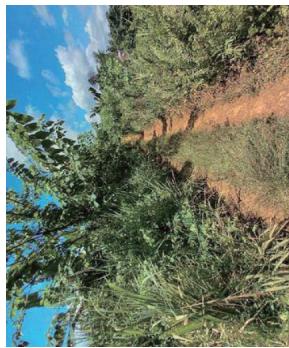
Figure 4: Access Road to western side of KH

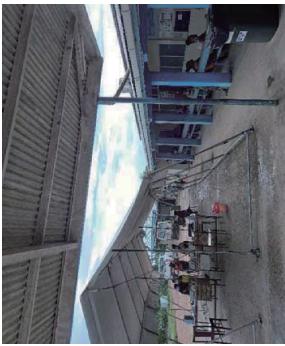
Figure 5: Out-patient waiting area

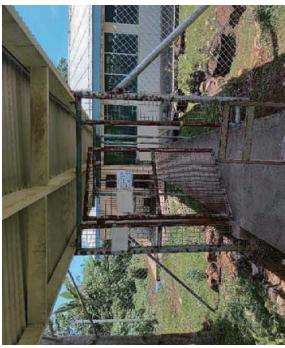
Figure 6: Typical covered walkway to Isolation ward

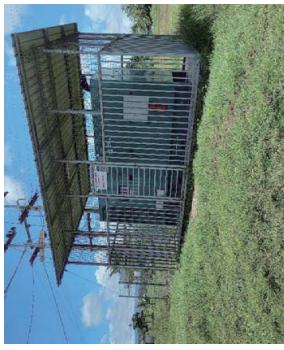
Figure 11: Backup diesel generator

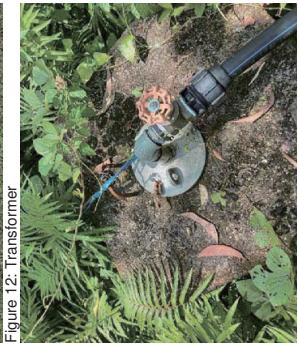
Figure 12: Transformer

Although power supply is reliable the capacity of the transformer maybe limited. This needs further investigation if adding more facilities will require upgrade to the transformer.

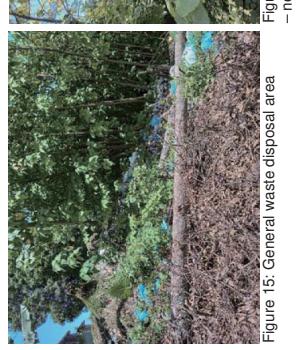
Figure 15: General waste disposal area

Waste management needs careful thought and planning as the current setup is only temporary and not suitable.

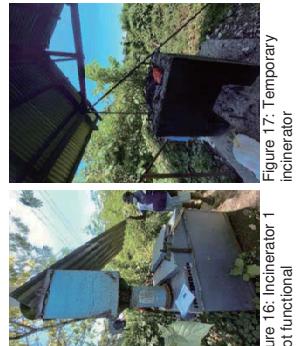
5.7 Waste Management
There are only two main categories of waste management used at KH. General waste is disposed at the north side of the hospital as there is no dump site provided in the area. Clinical waste is disposed by use of incinerator also located north side of the hospital about 70 – 80 m away. KH only uses a temporary incinerator as the proper one no longer works.

Figure 16: Incinerator 1 – not functional

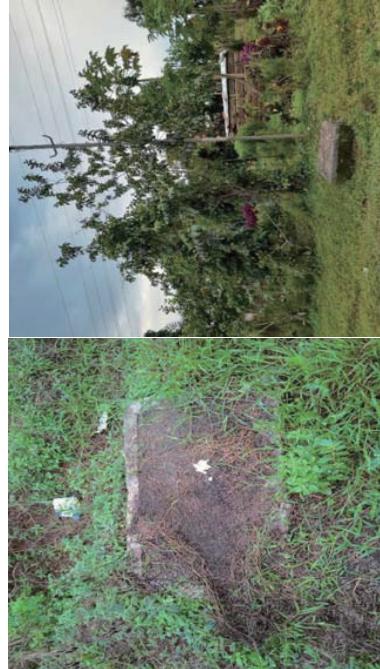
Photo 11 and 12: Telekom manholes

The actual underground location of any underlying ground cables needs to be confirmed with Solomon Telekom Company Limited (STCL) before any construction.

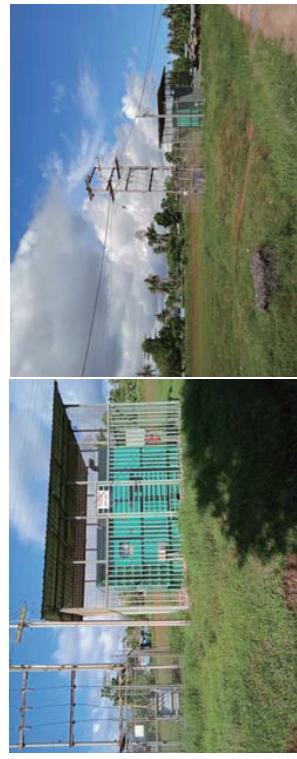
Photo 13 and 14. Transformer and the standby generator

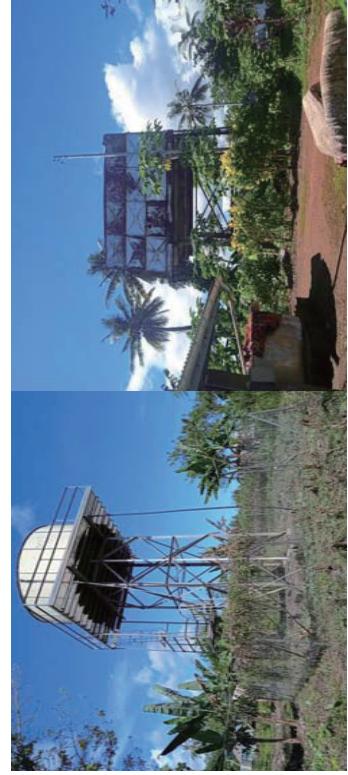
Located northeast of the hospital is the unused gravity tower tank that has a capacity of 48,000 litres, which distributes water to the hospital facilities and staff residences. The gravity storage tank has a volume of 48,000 litres with 8 m tank base height from ground level with 40 mm polyvinyl pipe sizes connected off from the borehole. Currently the borehole and pump are no longer in used because of mechanical problem and no funding to fix.

Photo 15 and 16. The two-gravity storage tank tower surveyed.
